Technical Consultation on Corrosion
in Fertilizer Plants

COUNTRY PAPER FROM INDIA

STRESS CORROSION FAILURES IN REFORMER FURNACE COMPONENTS*

C.V. Srinivasan **

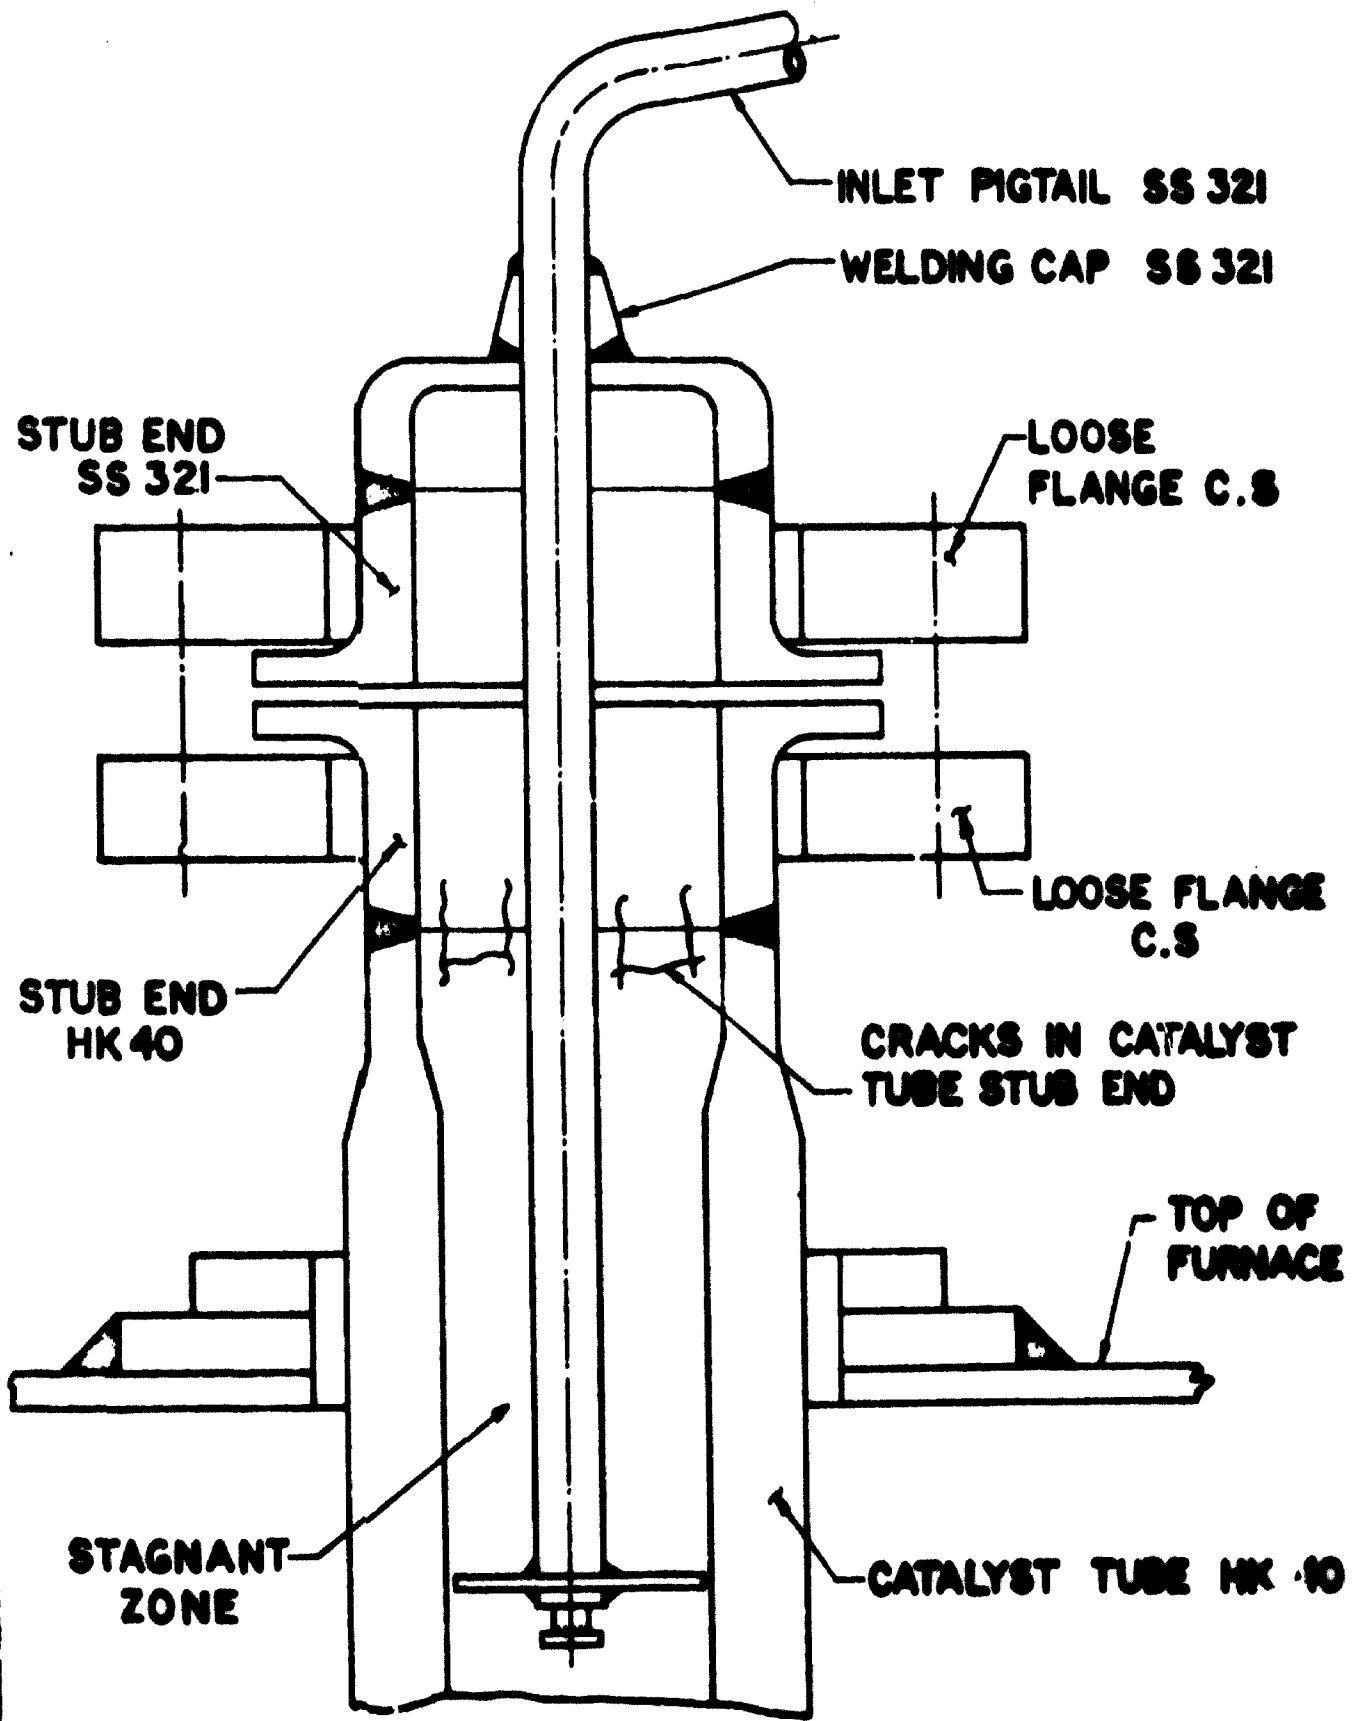
FIG. 1. CATALYST TUBE STUB END

In our case the reformer tube terminates, at the top, in a HK-40 stub-end. The stub-end has a loose carbon steel flange which is bolted to the inlet hair-pin tube (fig. 1) The inlet hair pin tube extended, in the original arrangement, about 18" inside the reformer tube. The inlet pig-tails and reformer top stub-ends are outside the reformer furnace roof.

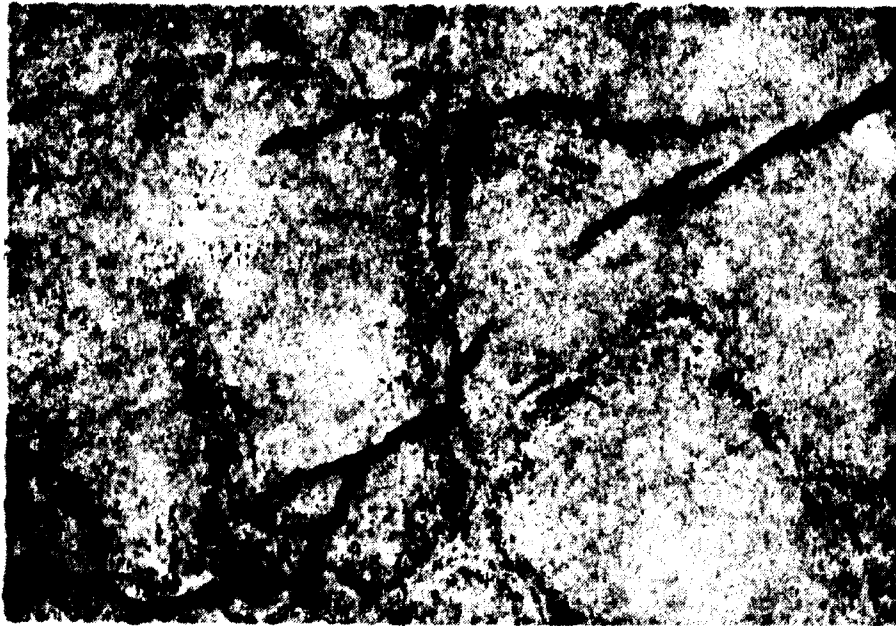
Fig 2(a)

Detailed metallurgical examinations were done on the cracked reformer tube stub end (HK 40) and inlet pigtail (SS 321). The failed stub end and inlet pigtail weld cap exhibited both transgranular and intergranular mode of cracking (fig. 2 and 3). Both the longitudinal (transverse) and the circumferential cracks originated at the inside surface and at the heat affected zone (HAZ) of the parent materials. Many of the longitudinal cracks extended to both sides of the weld. The circumferential cracks originated at the interface of the top weld layer and HAZ at the I. D., and propagated to the top layer of weld in the transverse (thickness) direction.

Predominant transgranular cracking in both the reformer tube stub-end and inlet pigtail weld-cap led to the conclusion that failure was by stress corrosion cracking. Presence of intergranular cracking observed along with transgranular cracks suggested that both chloride and caustic stress corrosion cracking could be the mechanism for the massive failures. Small traces of chloride and alkali present in the steam entering the reformer furnace was considered the possible source of corrodent. Residual weld stress was also the cause for both longitudinal (transverse) and circumferential cracking.

Tangential section near the ID surface, showing transgranular cracks in the HAZ adjacent to the weld at the stub end (HK 40).

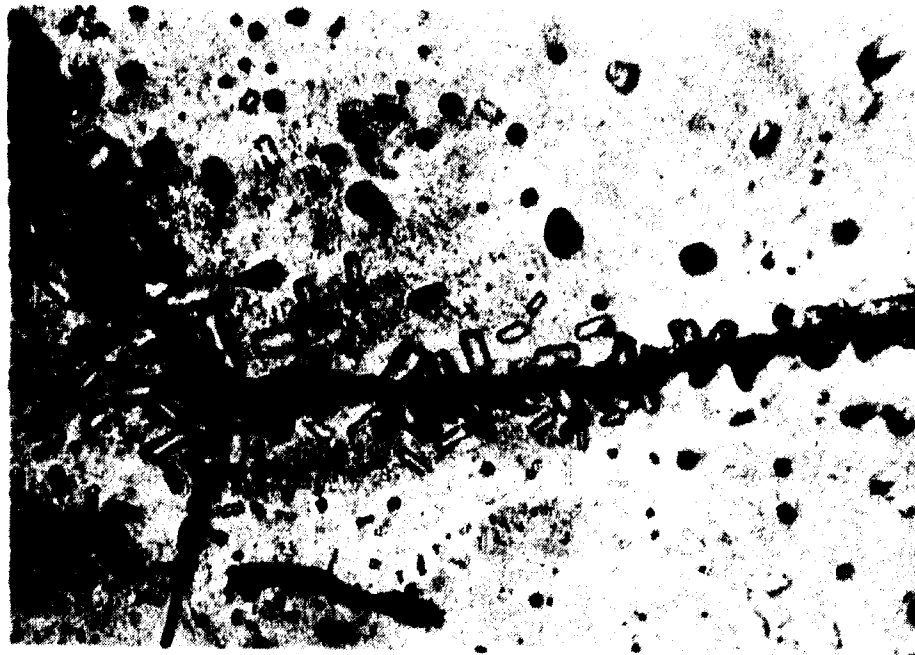
In January 1978 - 14 months after replacing the stub ends in all 240 tubes with Inconel-600 and modifying the inlet pigtail assemblies, we experienced a similar large scale longitudinal and circumferential stress corrosion cracking. This cracking, however, was significantly different from the previous failures and was found mostly in the high nickel Inconel 600 stubs only. Stress corrosion cracking by high temperature caustics and high left-over weld stress was considered the mechanism for the Inconel 600 stub end failures.

Figure 3 (a)
Intergranular cracking in sensitized Inconel-alloy 300
Steant : Glyceragia + Acetic Acid

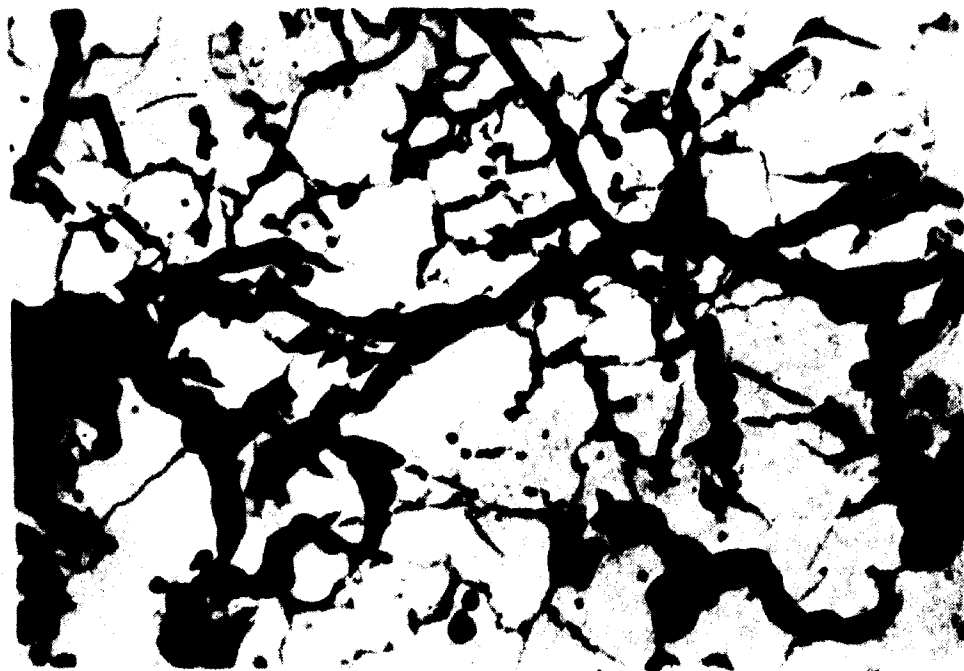
Figure 3 (b)
Intergranular and transgranular cracking in BK 40 catalyst tube.
Photo of longitudinal cracks. Steant:Glyceragia+Acetic Acid.

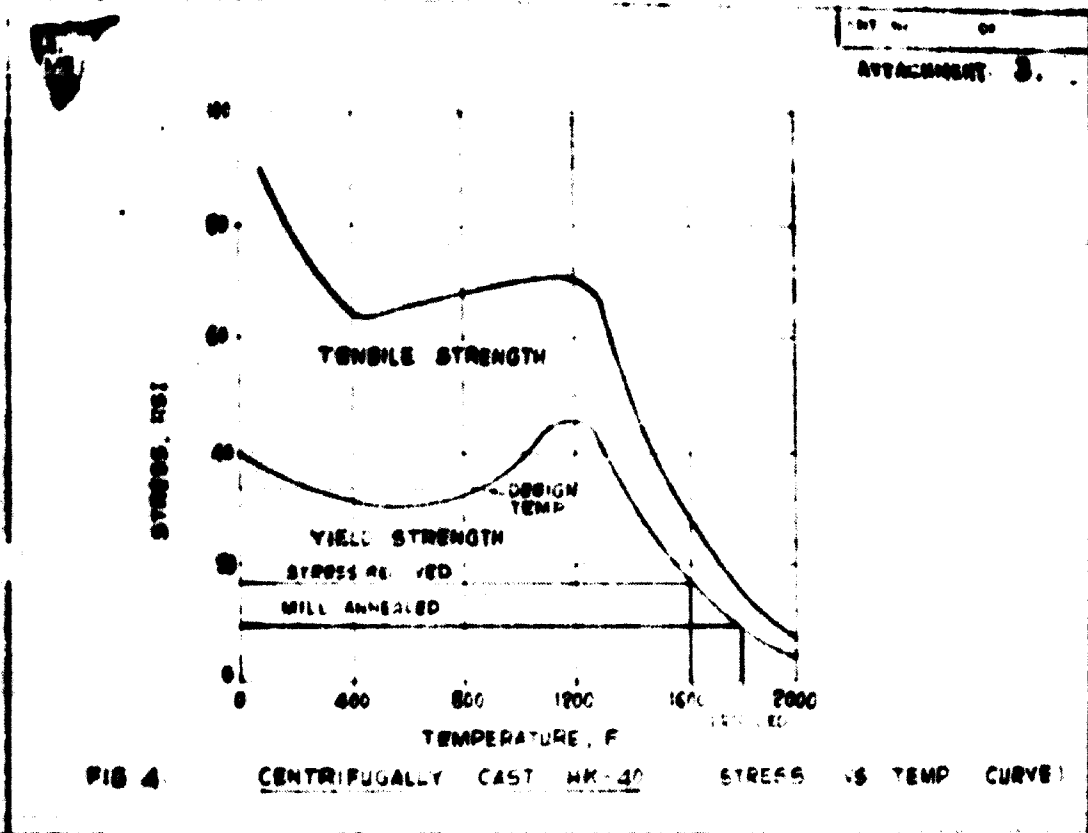
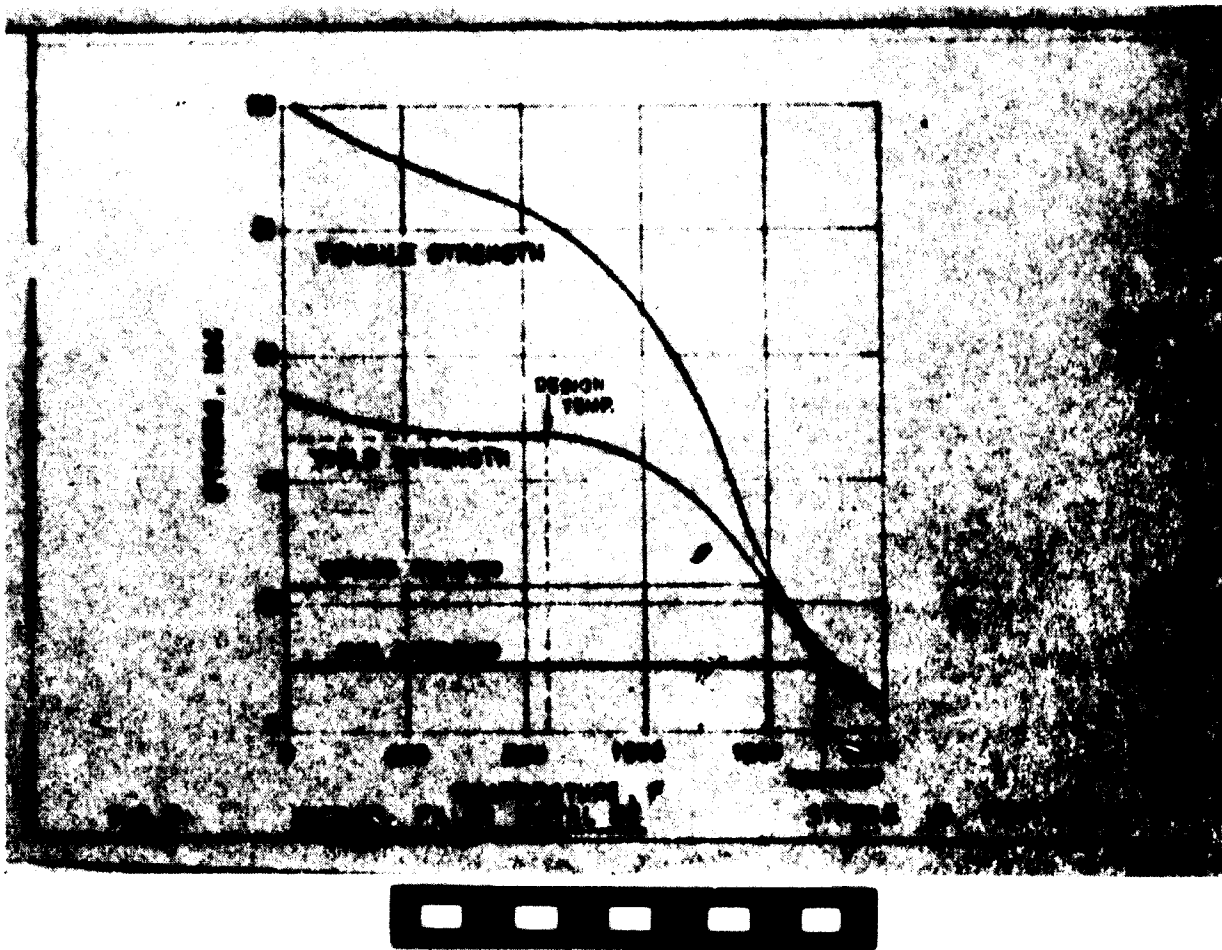
Having identified the role of residual weld stresses in the severity of the cracking, we experimentally studied and evaluated the effects of various heat treatment and welding parameters. Figures 4 and 5 show the yield stress vs. temperature curves for cast HK-40 and Inconel-82-filler wire. Inconel-82 values are similar to Inconel-600. From these curves, it is clear that Inconel-600 alloy has higher yield strength than HK-40. For our design temperature (450°C), the residual weld stress may become approximately 36,000 psi (2530 kg/sq.cm) for HK-40 and approximately 45,000 psi (3760 kg/sq.cm) for Inconel-600.
