SYNOPSIS

The Domsuiza manufacturing facilities were never completed. Some of the production equipment was not delivered. Much of it is outdated.

The existing facilities have suffered extensive deterioration and damage from weather and years of non-use.

DOMSUIZA

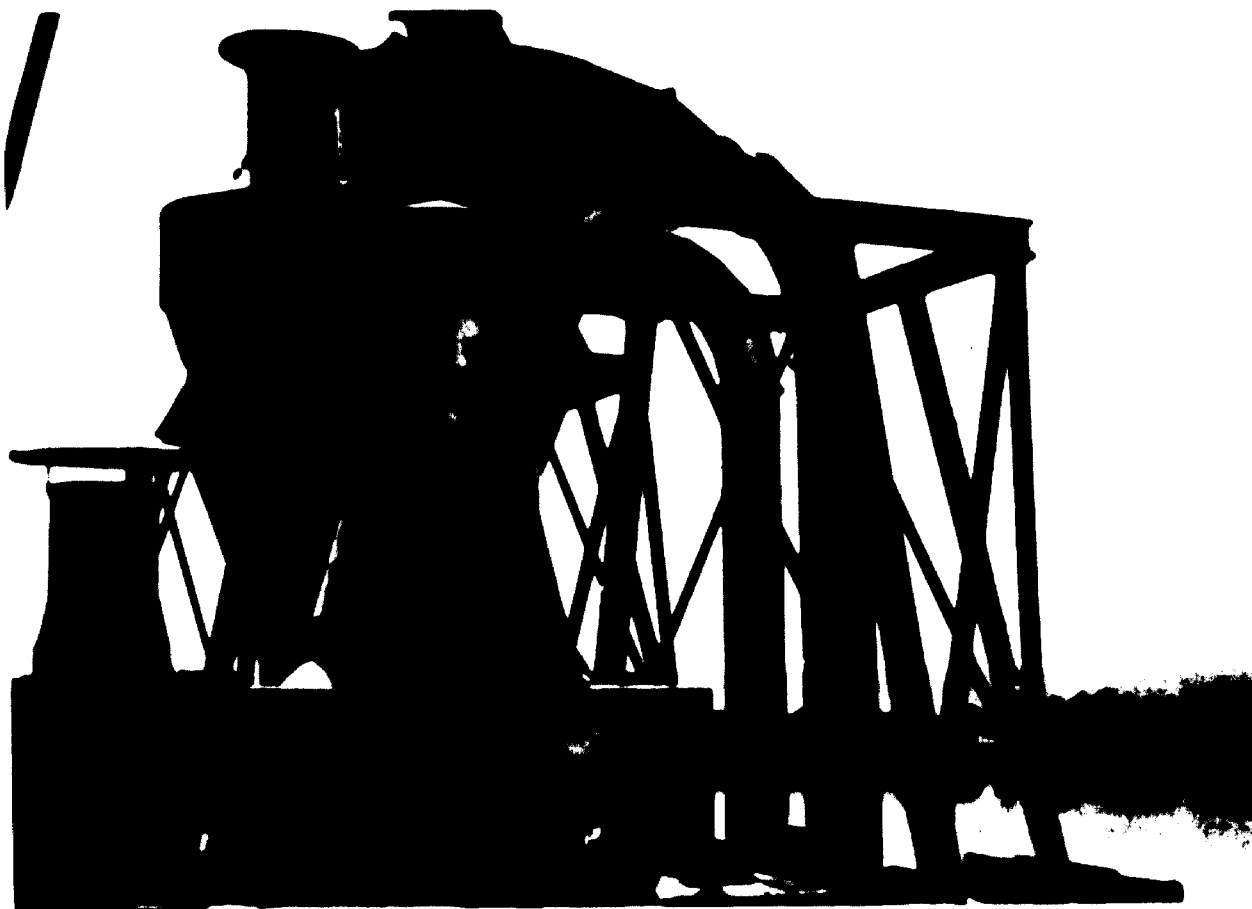
GUNFIRE AND SHELL DAMAGE - 1965
DANO HECHO POR FUEGO
DE ARTILLERIA Y BALAS-1965
