UNIDO/FAI Interregional Meeting on Safety in
the Design and Operation of Ammonia Plants

A REPORT ON A FIRE IN THE AMMONIA SYNTHESIS UNIT

This is a report on the occurrence of fire in Ammonia Synthesis section of the 450 tons per day ammonia plant of Shriram Chemical Industries, Noida.

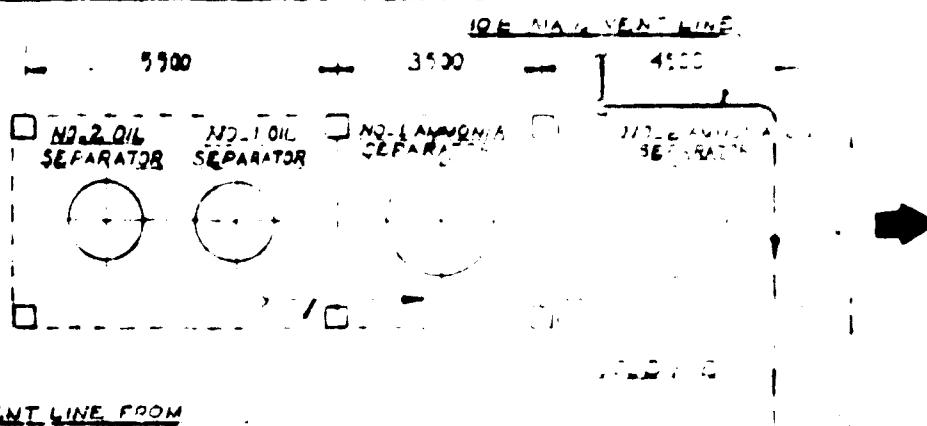
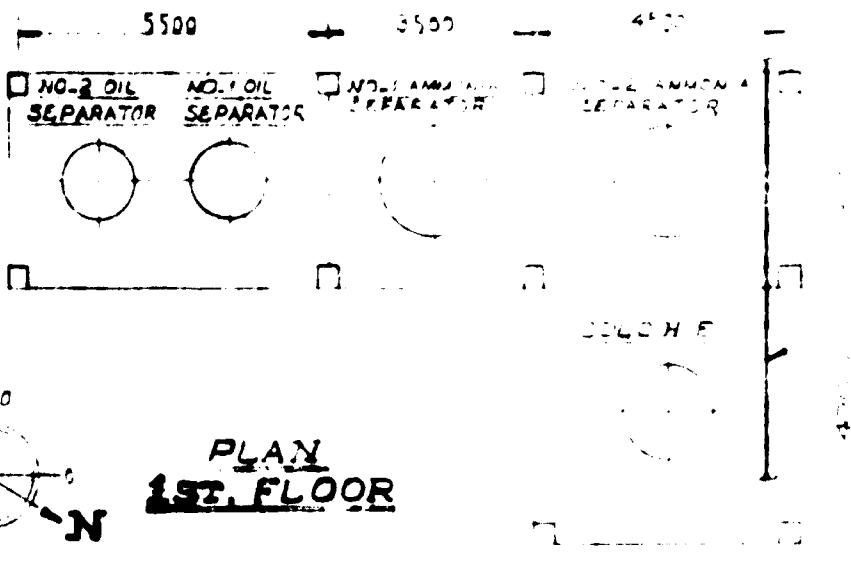
FIG. NO-1

The synthesis loop was immediately depressurised. The fire was in the area of the Ammonia Separators and Ammonia Chillers (figure 1). The material used for cold insulation of these equipment was Thermovale (foam polystyrene) with Bitumen coating for weather protection. The fire spread due to burning of the insulation material on these equipment.

SYNTHESIS SECTION
FLOOR PLAN

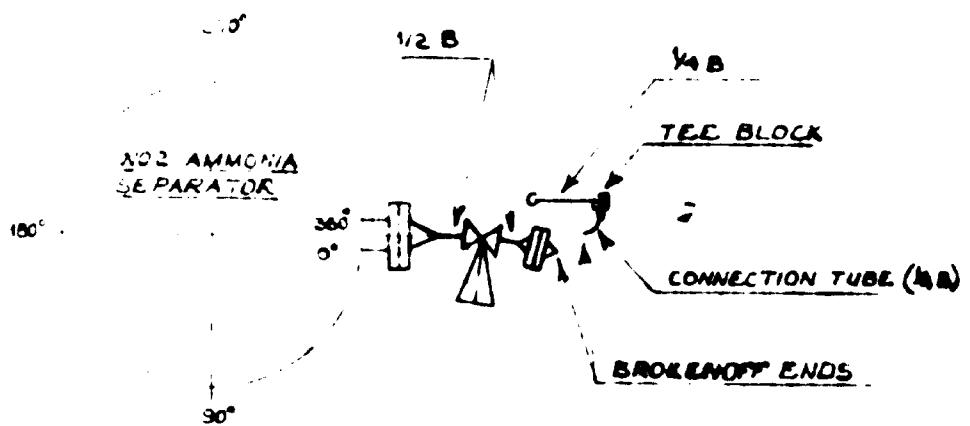
1. The level control instrument tubing on No.2 Ammonia Separator had broken off at the flange neck. The welded part connecting the connection tube of the tee joint and the flange neck of the L.C. tubing was found broken (Figure 2). The details are shown in Figure 3.
2. The liquid side on the L.C. tubing on the Ammonia Separator No.2 had burst at a point 100 m above the first floor level as shown in figure 4. The burst was on the side of the 12 B gas line as in figure. The tubing was also burnt around the bursted part indicating that it had been exposed to heat.
3. The main 10° vent Header had shifted along a considerable length. The synthesis section has a common 10° vent Header to which the various vent lines from the equipment were connected (figure 1). These include the vent lines from :
 - No.1 & No.2 Oil Separators
 - Ammonia Chillers A & B
 - Purge gas chiller
 - Waste Heat Boiler

A crack opened up in the flange neck of the upper LC tubing; gas leaked out through it and got ignited; eventually the crack opened up completely around the circumference of the neck, letting the LC tubing snap away from the flange neck; and the jets of gas spouting out from the open end of the flange neck and the open end of the freed connection tube continued to burn. As to the source of ignition, some tiny particle of iron powder or scale which existed inside the LC tubing might have been blown out by the gas spouting and generated a small spark from impingement on the surfaces within the tubing or the sharp edges of the crack.

A small spark that might have been generated electrostatically by the gas spouting could also have been the cause of ignition. Tests revealed that the crack in the flange neck of the No.2 Ammonia Separator was caused by an uneven stress distribution that had existed in the body of the metal, consisting of the flange neck and connecting tube that had been welded on to the flange neck.

TITLE		
<u>FIG. NO-2</u>		
<u>NO. 2 AMMONIA SEPARA TOR SHOWING PANITZ IN LEVEL CONTROL TUBING</u>	SCALE	DATE 13. 3. 78
	TRACED	APPROVED
	DRAWN	M. J. M.
	CHECSED	
RELT.	ORG. 350	RECORDED

1. The tee connection of the level control tubing was modified.
2. The common vent Header system was removed.
A separate vent was provided for each of the oil separators.
A separate vent was provided for the Ammonia Chiller and purge Gas Chiller.
3. The cold insulation material used was Thermocel bonded with a fire retardant resin. Also the insulation was coated with cement instead of Bitumen for weather protection.

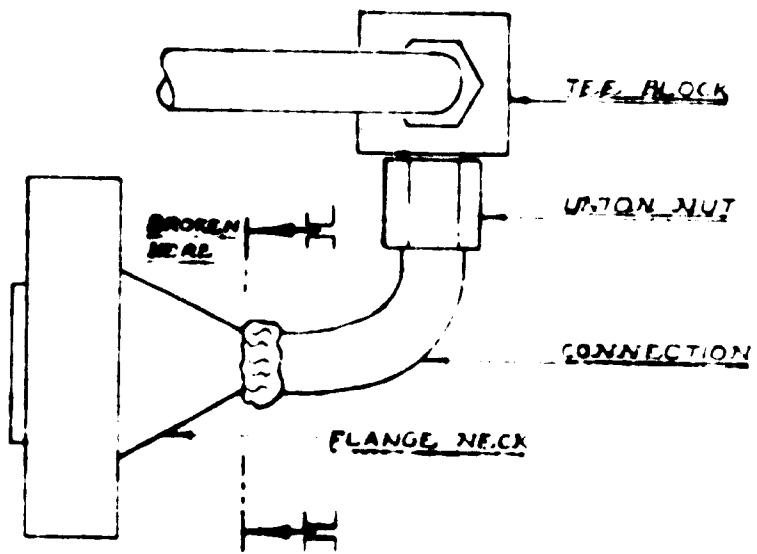
FIG. NO. 2

DETAIL OF LEVEL
CONTROL TUBING.
