Technical Consultation on Corrosion  
in Fertilizer Plants

COUNTRY PAPER BY MAURITIUS  
CORROSION PROBLEMS ENCOUNTERED AT THE  
MAURITIUS CHEMICAL AND FERTILIZER INDUSTRY\*

## CORROSION PROBLEMS: MCFI CASE STUDY

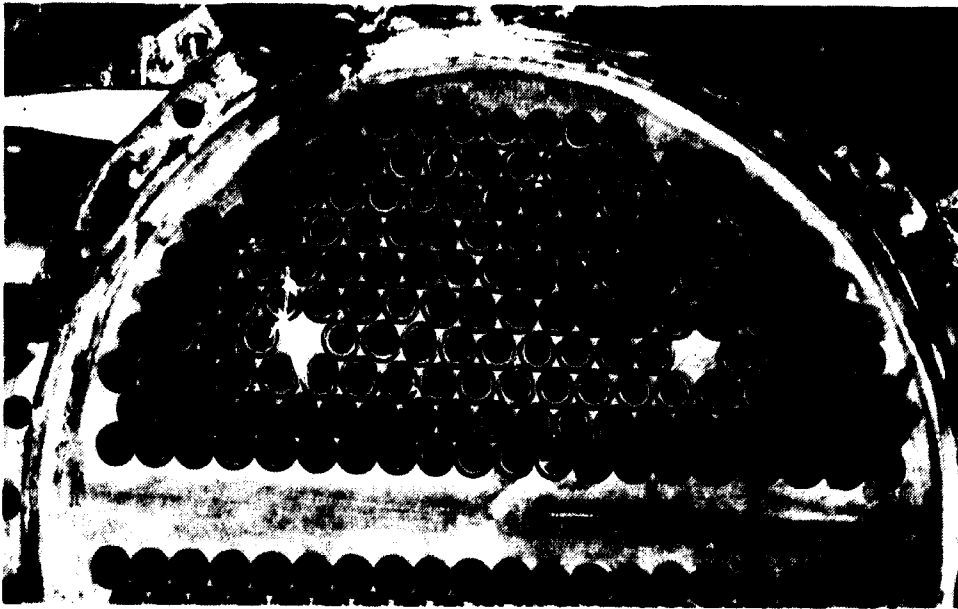
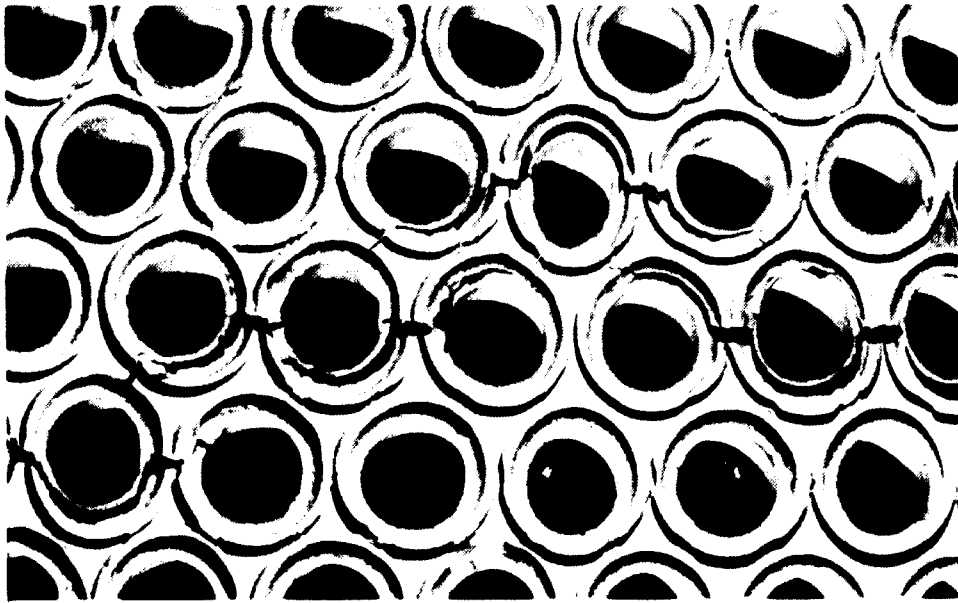
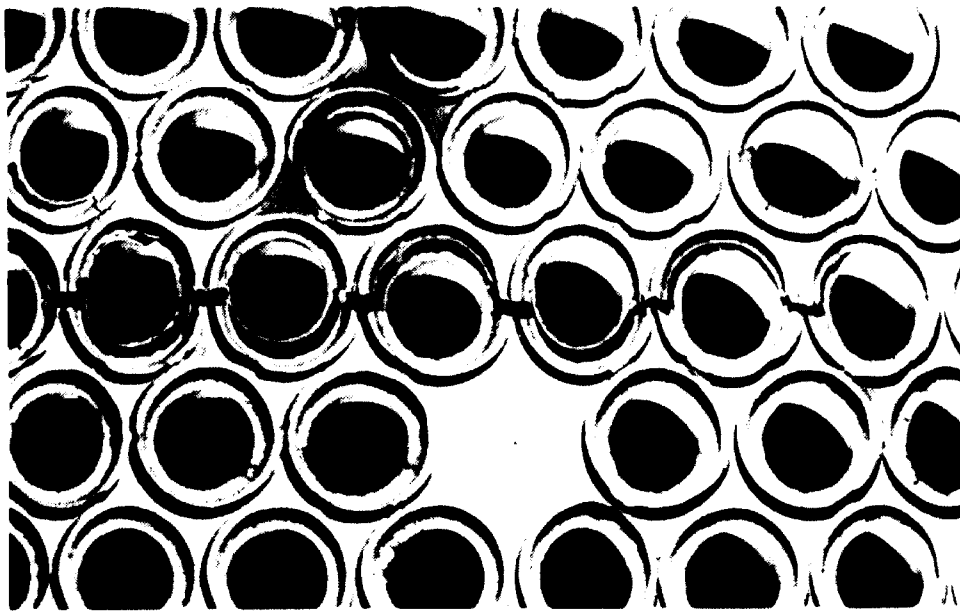
Stresses developed by these thermal gradients are believed to cause cracking of the tubesheet across tube ligaments (see photographs).

After the cracking of the original 2" tubesheet (October 1976), the latter was reduced to 1½" and insulation placed at the cold inlet in a new equipment. But again cracking occurred (August 78), this time on the hot side where the temperature gradient is not significant (500°C). Another 1½" tubesheet, without insulation on cold side, also experienced cracking on the hot side (May 79).

Stresses due to thermal gradients provide only a partial explanation of the cracking of tubesheets. It appears that we are probably in presence of CORROSION FATIGUE. Adding to the stresses developed by the thermal gradient are severe alternating stresses at start-ups and shutdowns. Furthermore, the equipment undergoes stresses in a corrosive medium (NO<sub>x</sub> gases, nitric acid) and under a small pressure difference of 2 Kg/cm<sup>2</sup> which is the pressure drop of process gas across the system.

Indeed, at S/U but mainly during S/D, there is acid condensation inside the system. Blowing the system with hot air causes "revaporization" of this acid. Especially, on emergency shutdowns (for example caused by power failures) when the air compressor trips, blowing of the system after some time (after power is restored) causes acid vaporization at the tube plate. Power failures or power dips occur frequently in Mauritius.

Cracked tube sheet of Tail Gas Reheater

No satisfactory solution has been found to this problem of cracked tubesheets and the reheater has now been replaced three times at MCFI. Being given that no modifications can be brought to the design, except for minor details, and that "tripping" conditions are bound to repeat themselves, it seems that the solution lies in the choice of a suitable material for the tubesheet which will better support the alternating stresses\* and thus extend the lifetime of the reheater. Otherwise, the existing tubesheet could probably be protected inside/outside by overlay welding of strip steel.

\* It should be noted, however, that in order to reduce alternating stresses at S/U & S/D, the plant is now brought on line in 90 minutes (instead of 30 minutes) by gradually increasing the amount of reaction and at shutdown, reaction is slowly decreased to avoid sudden cooling.
