Technical Consultation on Corrosion in
Fertilizer Plants

COUNTRY PAPER FROM SAUDI ARABIA

SPECIAL CORROSION PROBLEM AND THE REPAIR AT SAFCO*

UREA REACTOR

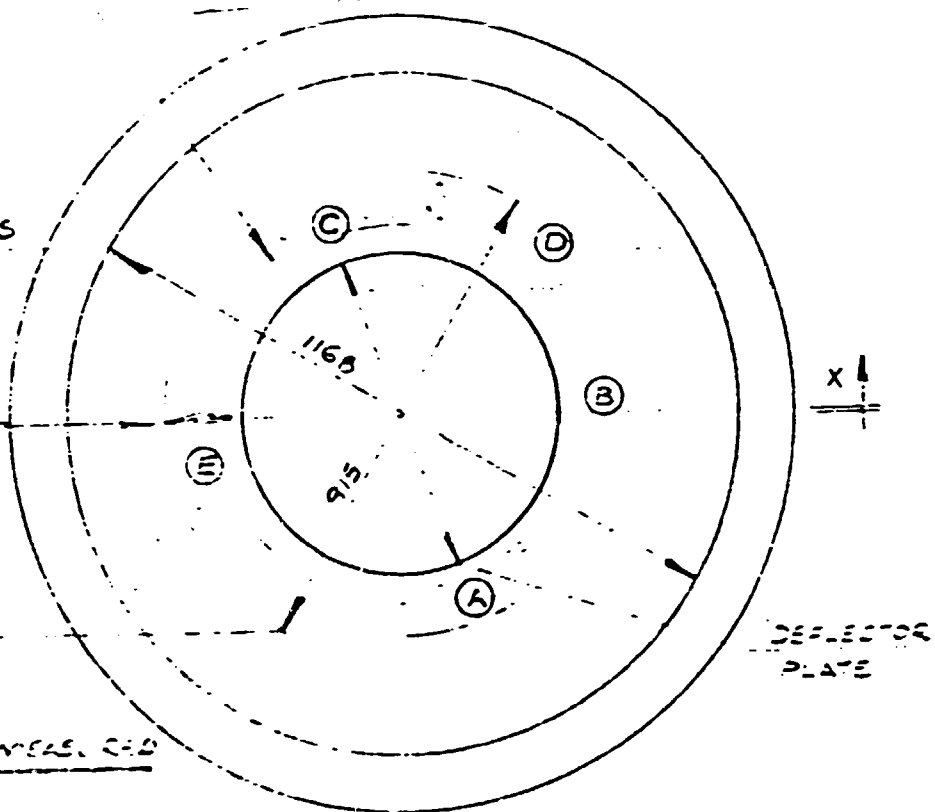
CORROSION/EROSION AREAS OF UREA REACTOR BOTTOM FORGING AT SAFCO

On 10th August 1978, the autoclave developed a leak through the bottom forging. The urea plant was shutdown and the vessel was opened for inspection. Examination of the failure revealed that wide area around bottom distributor was severely eroded/corroded. The extent of damaged area is shown in the attachment-II. At one location, the metal was completely corroded and while in service it developed a small rupture. At the point of failure, the opening was 1.5" long and about 0.2" wide. There were no visible bulges

or deformities on the outside surface of the autoclave bottom. The material loss in the corroded area varied from 0.25" to 3" at certain locations. Generally, the loss was about 2" at most places.

The failure of the bottom of urea reactor is attributed to the gradual thinning out of the S. S. overlay over a period of time. The thinning of weld overlay was due to high velocity of the fluid entering the vessel and deterioration of S. S. 316 L weld deposit. Another factor which could have contributed is the oxygen content in the CO₂ feed to the reactor. It is possible that the oxygen content was actually lower than indicated because of faulty instrumentation.

CORROSION AREAS (DOTTED)

50X50 RUPTURE THRU 1/2" THICK FORGING

- A 50X50 RUPTURE DEEP
- B 175X175
- C 116.6X116.6
- D 91.5X91.5
- E 50X50 RUPTURE POINT

MAXM COLLISION AREA FROM RUPTURE POINT (DOTTED)

1. Remove damaged S. S. overlay.
2. Grind any sharp contours for preparation to deposit weld metal.
3. Build up all cavities by manual metal arc using E-7016 electrode. Continue to build up until correct wall thickness is reached all over. After each bead of weld deposit, care be taken to remove all slag inclusion. At the end of carbon steel welding, the entire surface should be ground out smoothly in preparation of dye-penetrant inspection. Subsequent to dye-penetrant inspection of the carbon steel weld, the entire surface is to be deposited with one layer of E309 - 4 mm electrode. After this overlay, the surface is ground to remove all inclusions and surface defects. Post weld heat treatment to the repaired area is to be conducted to relieve the metal of all weld stresses. The heat treatment procedure is shown in appendix-III. After the post weld heat treatment, deposit the entire surface with E-316L- 4mm electrode in 2 layers. Include also the unaffected areas of the bottom head for the final overlay.

OVERLAY REMOVED OVER THIS AREA & RENEWED TO ORIGINAL THICKNESS
