Technical Consultation on Corrosion in
Fertiliser Plants

COUNTRY PAPER FROM KUWAIT

CORROSION PROBLEMS EXPERIENCED IN AMMONIA AND UREA PLANTS*

Bahaa H. Abdel Nabi **

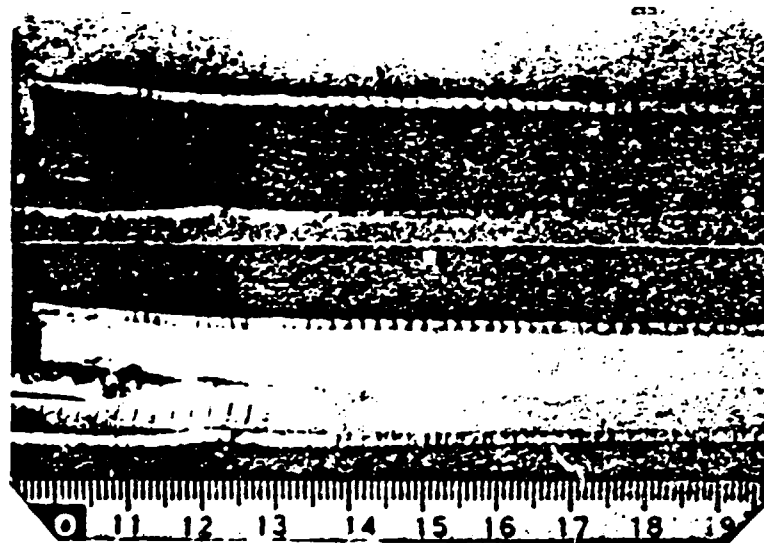
Photo 2 - B View of internal surface.

The whole area was covered with brownish black scale. After descaling leakage was found to take place longitudinally and no significant corrosion was observed in other areas. See Photo (2).

3.1. The Aluminium Brass tubes are considered not suitable a material in our condensers from design and actual operation point of view. As the sea water velocity is excessive enough to cause impingement attack to the tubes material from inside.

Before
descaling.

After
descaling.

- 4.1. Modifying tubes material of the surface condensers. Both Cu/Ni 70/30 and Titanium were put under investigation as alternative materials.
- 4.2. It was recommended to replace the existing channels with rubber lining instead of Epoxy coating.
- 4.3. Screens at sea water pumps section should be of more narrow wire meshes to prevent large solids and marine growth to escape and plugging the tubes.
- 4.4. Proper sea water chlorination to prevent plugging of tubes by large marine growth.

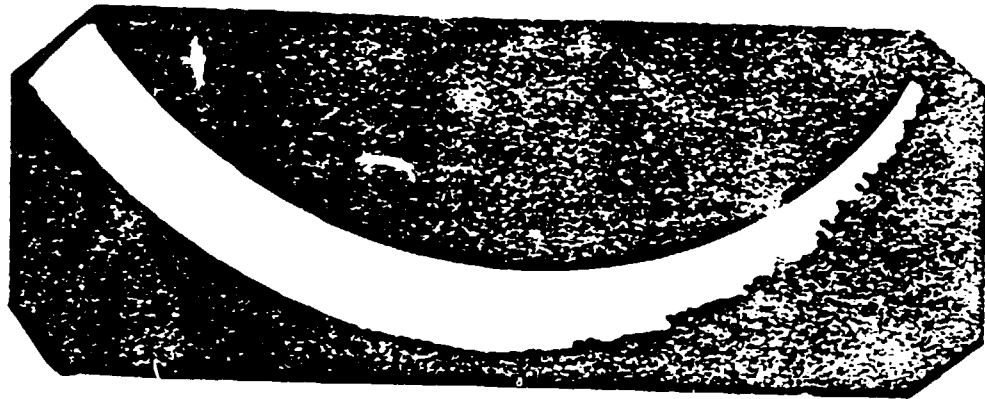
The view of cross section and microscopic observation of longitudinal and circumferential cross section at the leaked and corroded part are shown in Photo 3 & 4. The leakage is caused evidently by the corrosion of outside. However inside of tube, very slight corrosion is recognized as shown Photo (4-d).

Photo 3 A: Leaked part circumferential.

Photo 3 B: Corroded part longitudinal.

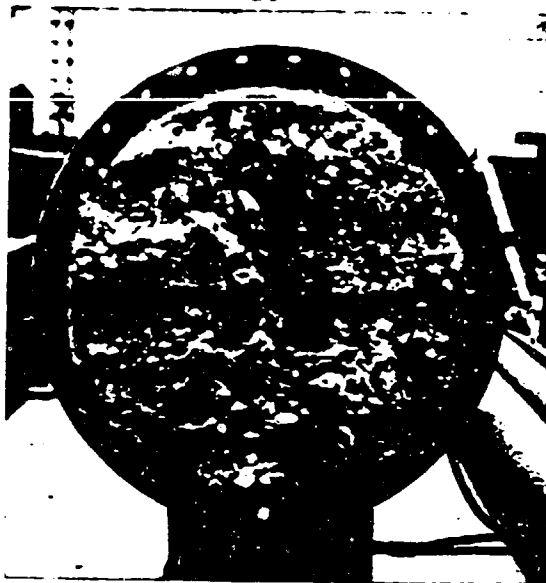
Photo 1)

2.1.1. Tube sheets were found covered by heavy salt deposits of white and blue colour. These salt deposits were heavier on west side tube sheet than that of the eastern one. (See Photos 1 & 2), after cleaning of tube sheets it was noted that a corroded groove around the tube end (1 - 6 mm. depth) and some of these tubes end were found completely eaten out - See Photoc 3, 4. The surrounding areas on the tube sheets were subjected to corrosion of 5 m.m. maximum depth. Generally it was clear that corrosion is more severe in the west tube sheet than in the east one - See Photos No. 5, 6.

West Tube sheet before cleaning.

Heavy corrosion products and sea water salts.

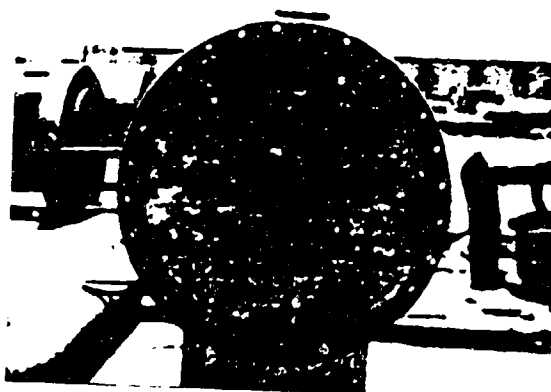
photo 2)

East Tube sheet before cleaning.

Notice the difference between the amount of salt deposits on East and West tube sheets.

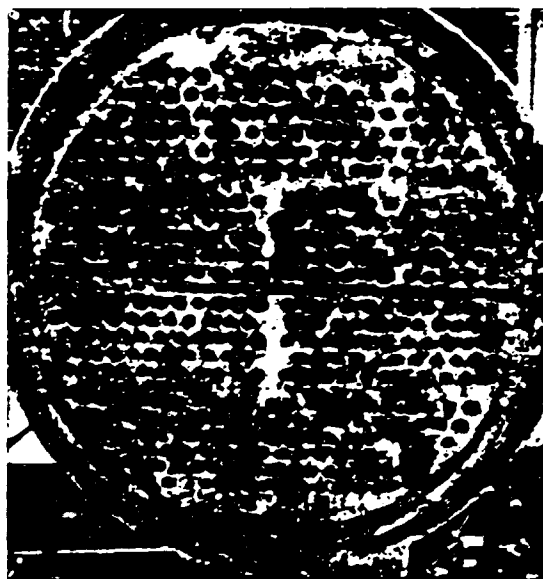
photo (5)

West Tube sheet after cleaning-

All the tube sheet was subjected to corrosion
due to Ammonia attack.

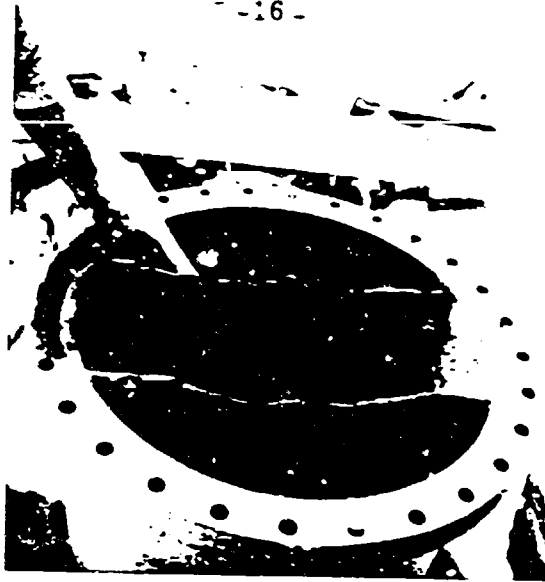
photo 7)

Partition plates edges were found severely corroded at their contact with the tube sheet as illustrated in Photo No. 7. A luster film of crystalline deposits green in colour were found adherent to the internal surface of bonnet between its two partition plates i.e. in the 2nd and 3rd flow passes as illustrated in Photo No. 8.

2.1.4. The three Magnesium anodes fixed on the partition plates of the east Bonnet were found completely missed and the supporting bolts were corroded out. One of the bolts was found completely missed leaving a hole at its position. (See Photo No. 7).

The potential difference exists between the partition plates made of carbon steel and the tube sheets of Cu/Ni on contact with each other after peeling off of coating and anodes consumption produced electron flow between them.

Thus corrosion start and continued on the less corrosion resistant metal (Carbon steel of the partition plate - anodic) caused it to be eaten out.

East Bonnet

Galvanic corrosion on the partition plates edges at their contact with the tube sheet after peeling of coating. Notice the hole at position of the supporting bolts of Magnesium anode.

- 4.1. Magnesium anodes should be replaced by Zinc alloy anodes "C-sentry" which are the suitable and efficient anodes for cathodic protection in sea water medium. Bakelite or rubber washers should be fixed under the bolt heads and nuts to avoid galvanic corrosion of partition plates. However study and evaluation in hand to use Aluminium anodes which is better than Magnesium anodes in sea water service.

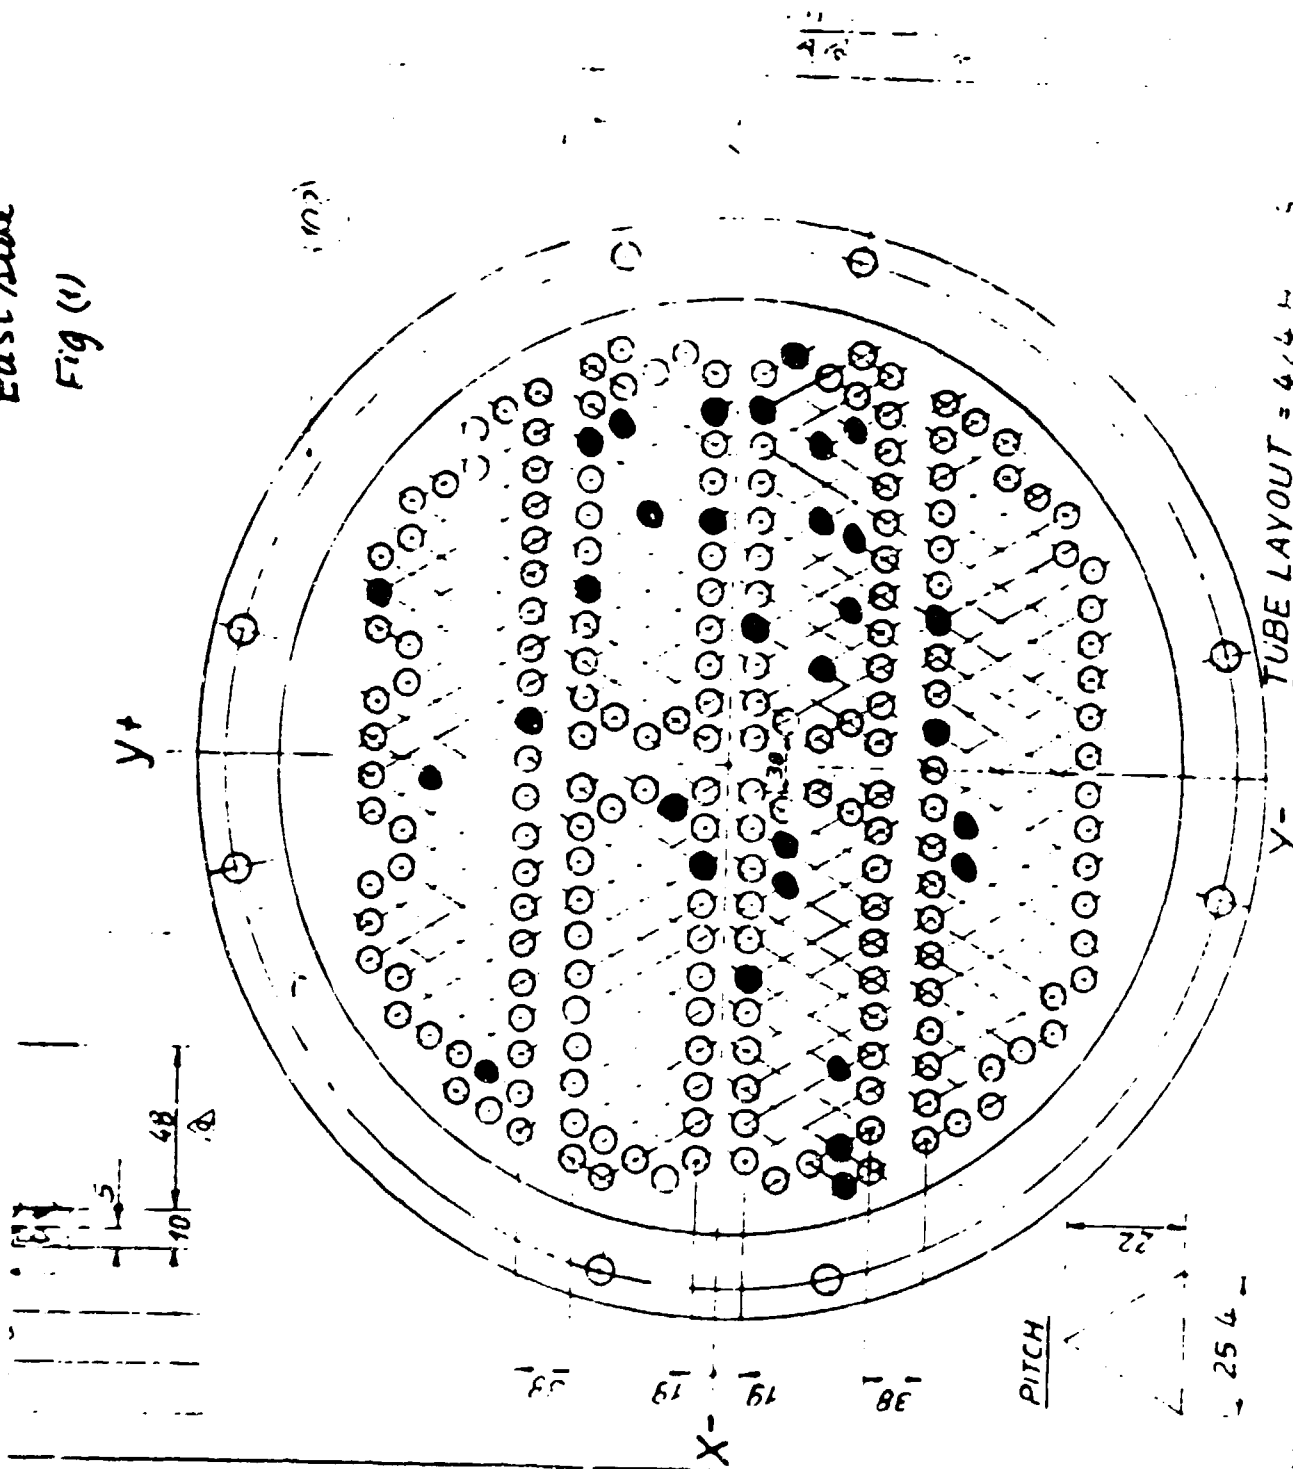
East Side
Fig (1)

2.1.5. Pressure test was carried out at 23 Kg/cm² using water detecting agent, water was found to seep from around 31 tubes on east side and 18 tubes on west side as shown in figures (1) and (2).

- 4.2. Pressure test with the application of water detecting agent should be carried out on any new condenser before putting on line to check that proper expanding has been done by the Manufacturer in case of rolled to tube sheet tubes arrangement.

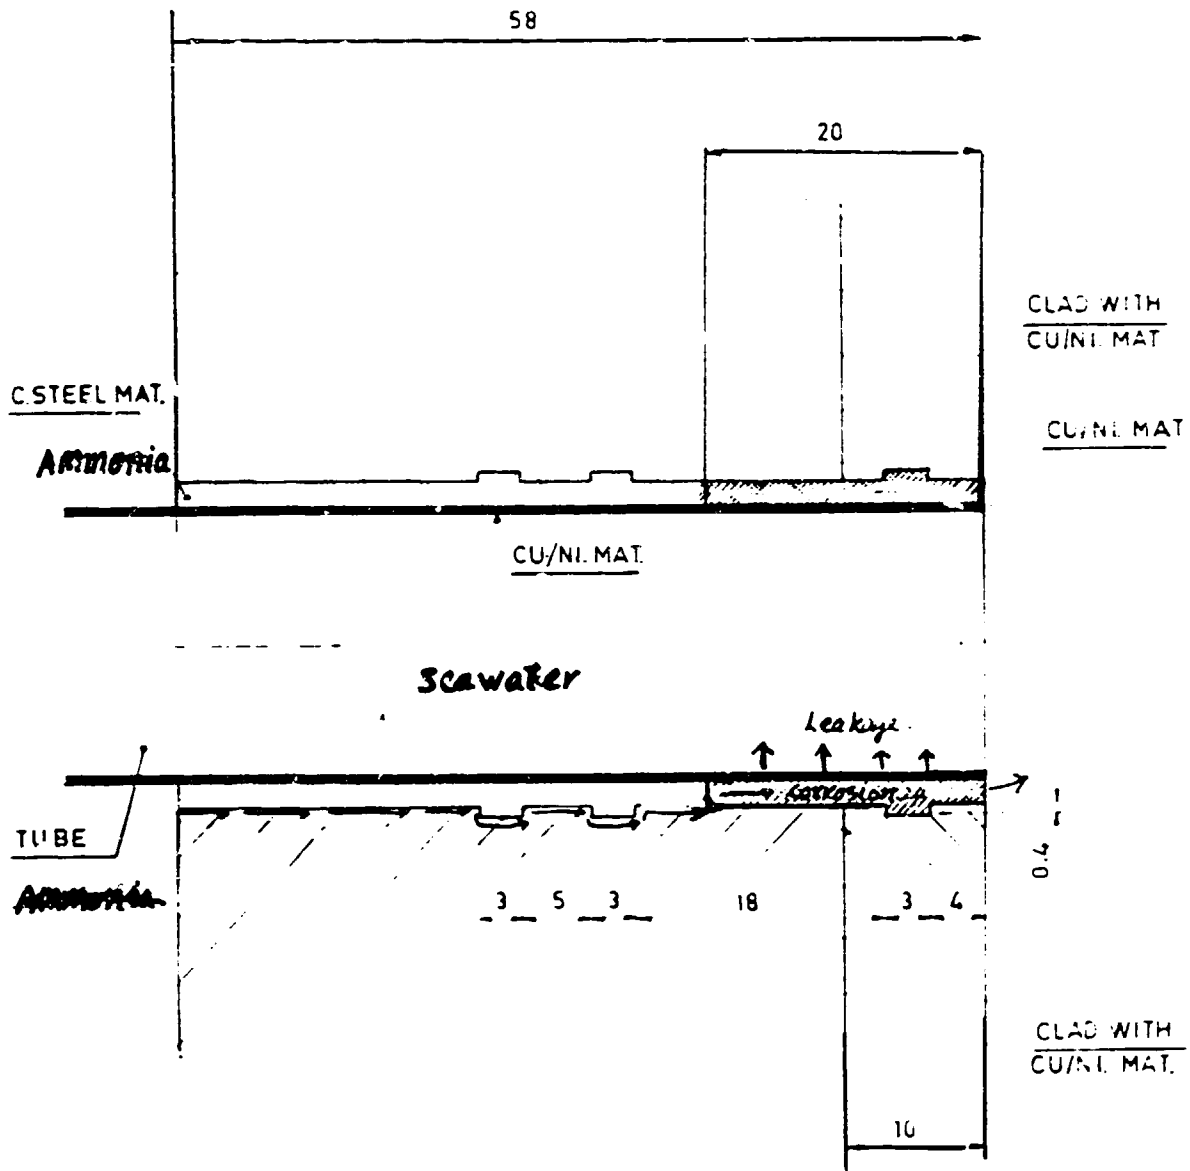
FIG 3

From the attached drawing No. (3) of tube end arrangement it is clear that the outer surface of the tube end inside the tube sheet consists of two metals carbon steel and Cu/Ni 70/30 of 20 mm. length to avoid contact of sea water with carbon steel. Ammonia may be leaked from a point of bad expanding till it became in contact with Cu/Ni material of outer tube end. Then severe corrosion took place on the Cupro Nickel outer tube surface and on the outer surface of the inner Cu/Ni tube causing ammonia leakage to sea water.

- 4.4. New design of tube end illustrated in Fig. (3) is to be revised for future arrangement.

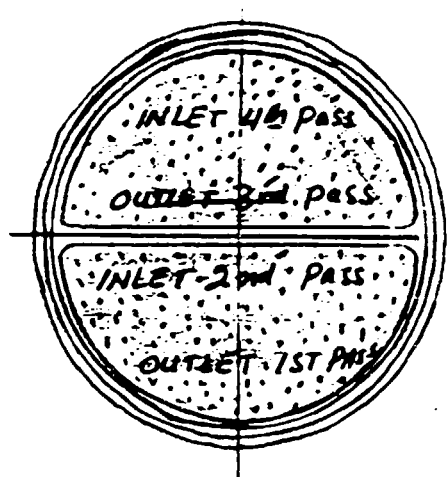
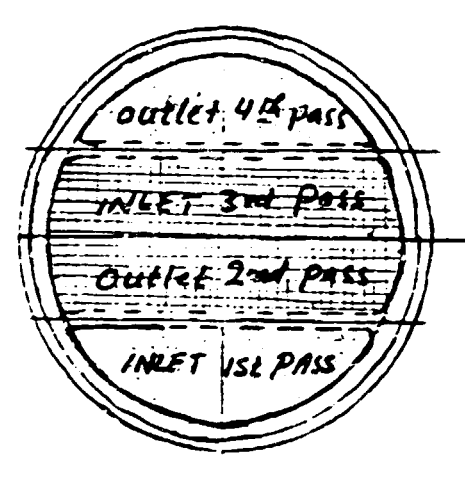
The sea water containing leaked ammonia attacked the Cu/Ni layer on the tube sheets at both condenser ends. This attack is remarkably increased in the order from the 1st to the 4th passes with the exception of the main sea water inlet and outlet at the east side. This is due to that at the inlet the sea water is free from ammonia while at the main outlet the ammonia contaminant in sea water has been consumed in the corrosion reactions with copper and precipitation of sea water salts. (See Fig. 4).

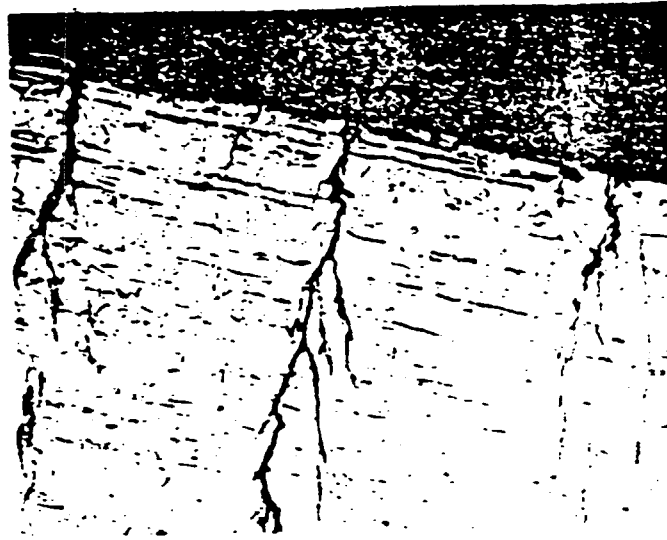
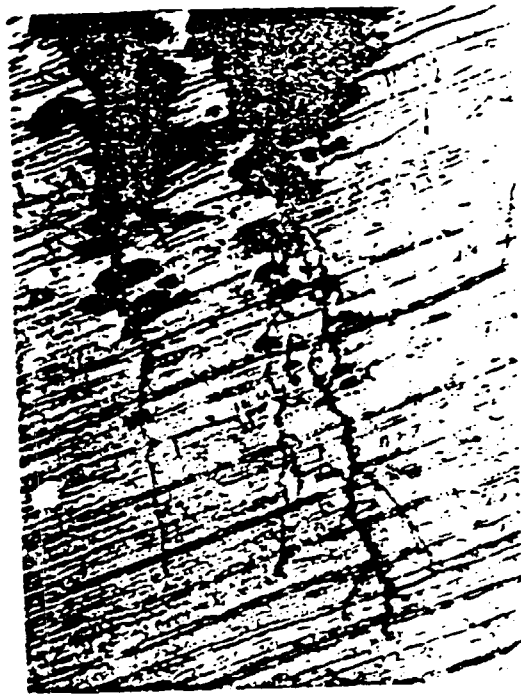
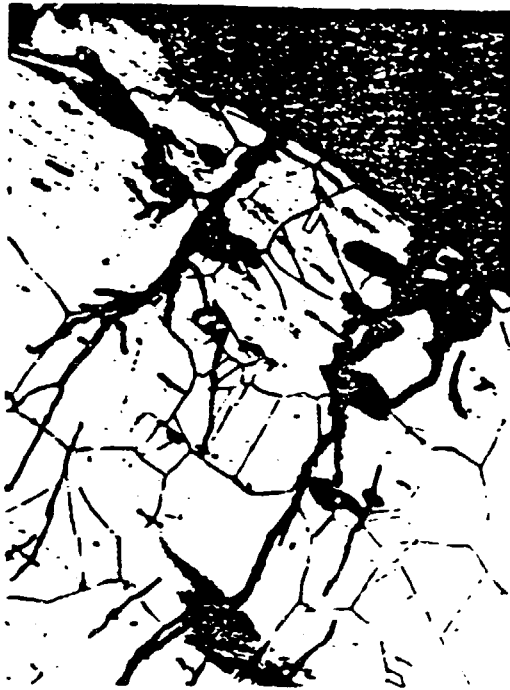
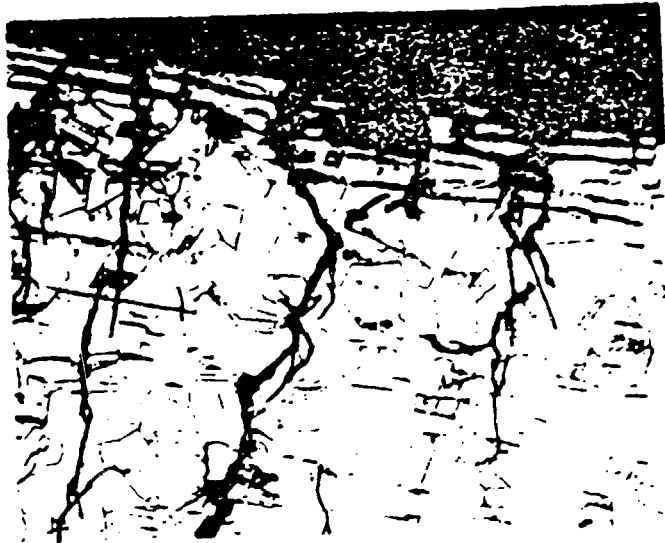
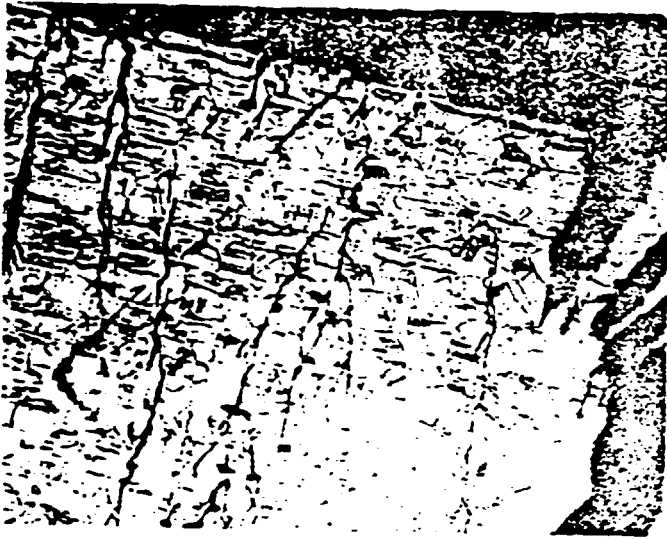
- General structure of the material was found good and free of abnormalities (Micrograph No. 12)
- Numerous corrosion pits formed on local areas on back surface of the strips (Micrographs No. 13 - 17).
and
- A pattern of several cracks radiated from each of the formed pits. Cracks propagated with extensive branching and displayed a transcrystalline mode of progression (Micrographs Nos. 13 - 22).

5.1. Transgranular corrosion was detected with a result of branched cracks in austenitic stainless steels. This type of S. C. C. occurred on strips taken from bulged-and-removed liner sections. The residual stresses induced in the material from bulging and subsequent straightening of bulged sections to re-use them. When stressed material come into contact with chloride ion cracking initiated. Chloride ions may be due to contamination of process liquid due to leaks at some condensers which use sea water and the sources of chloride ions on the back side of the liner may be due to steam injected through leak detection holes between shell and lining.

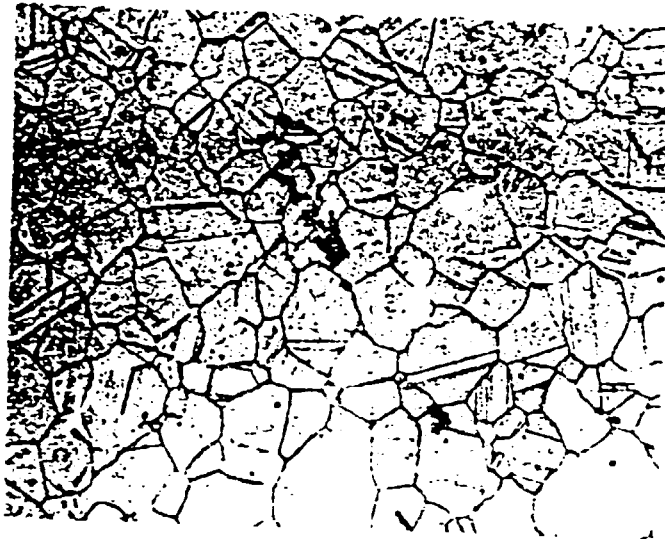
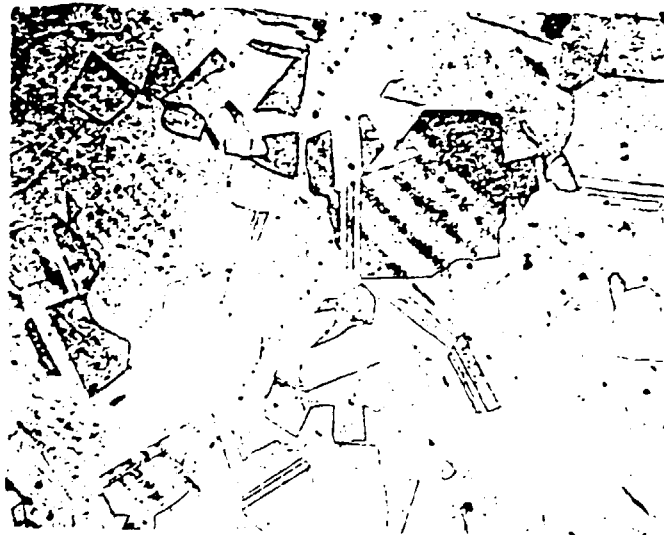
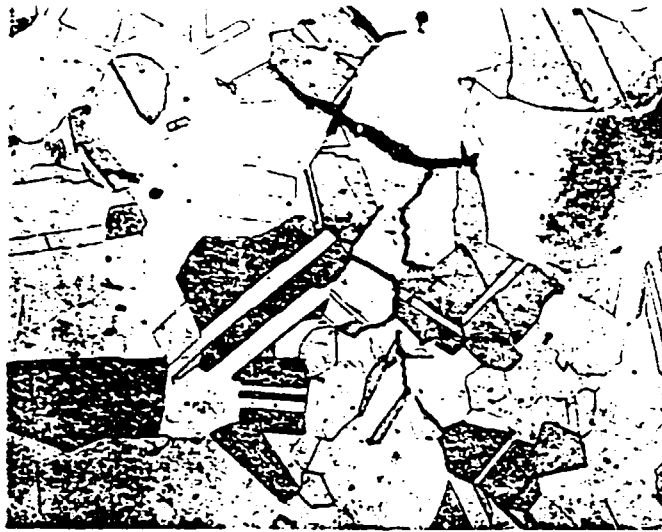
- General structure of the material exhibit inhomogeneity in austenite grain size (Macrographs Nos. 23 - 25).
- Corrosion and/or cracking of strip material developed mostly in vicinities close to weld joints as shown in Macrographs Nos. 26 - 28. Cracks were noted to penetrate through weld metal as Micrographs Nos. (29 - 31).
- Cracks displayed intercrystalline mode of progression as shown in Micrographs Nos. 32 - 34.
- Signs of grain boundary sensitization were noted in areas confined to heat affected zones of welds (Micrographs Nos. 35, 36). Dispersed precipitate was noted at austenite grain boundaries ahead of propagating cracks .
