Expert Group Meeting on Shipbuilding  
and Shiprepair Development for Asian  
and the Pacific Countries

REPAIRS TO BRONZE PROPELLERS\*

A.K. Diyabalanage\*\*

\*\* Production Manager, Colombo Dockyard Ltd.

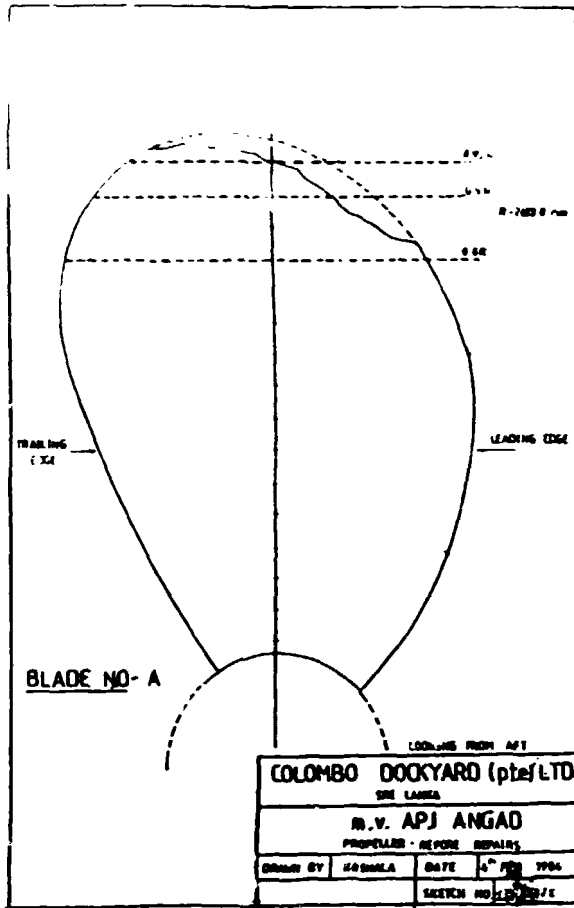
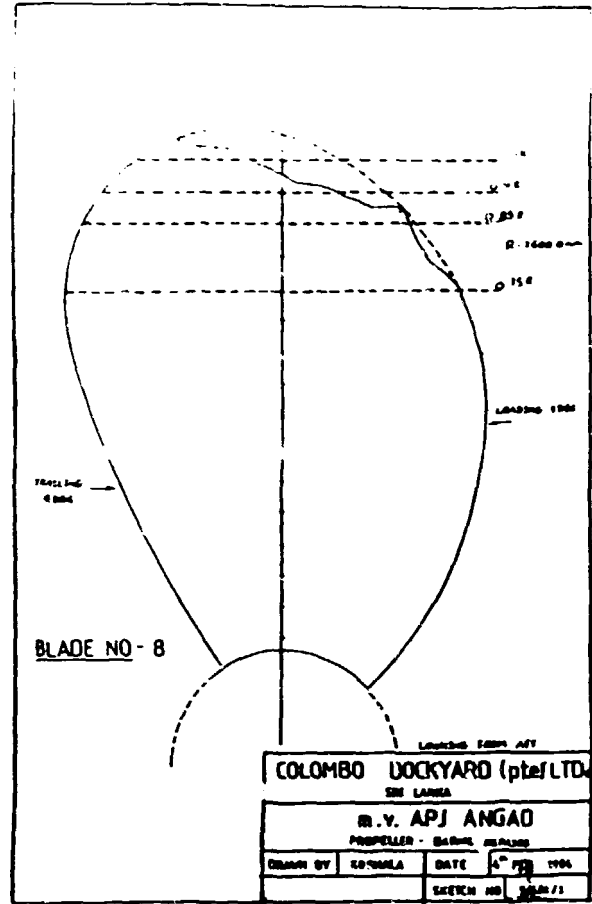
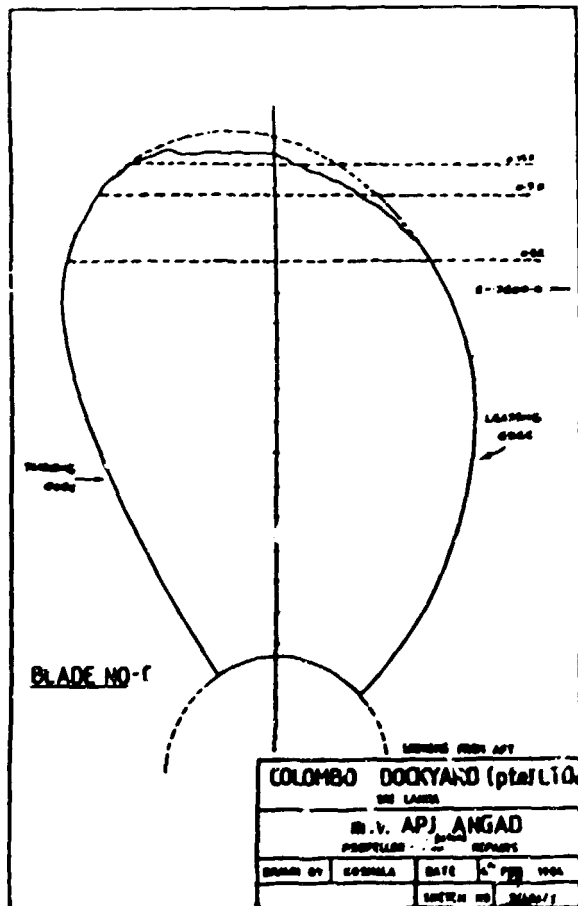
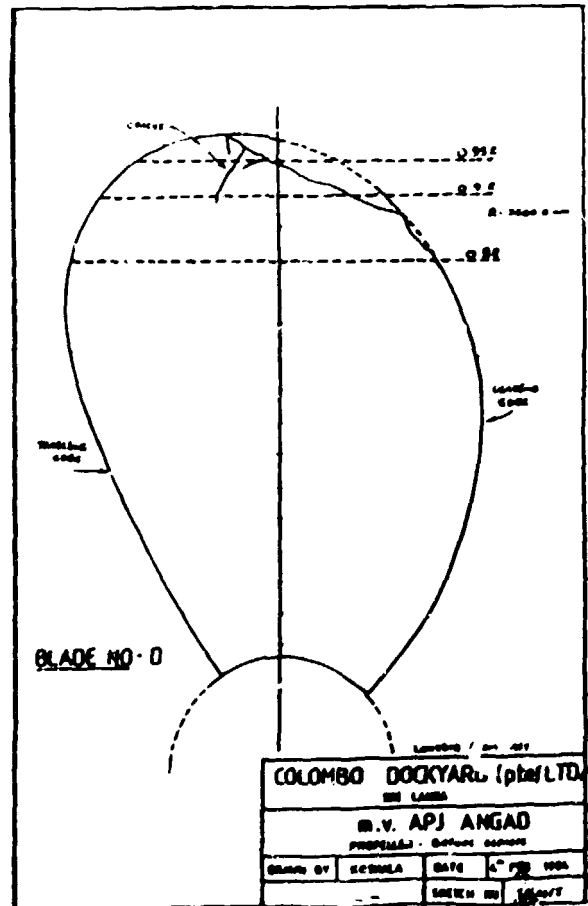
*(For details of damage see Figure IV overleaf)*

*The damage of the propeller under examination has occurred due to grounding and the defects were severe ranging from hairline cracks to complete tearing off of certain sections.*

The defects of the propeller was repaired in the following manner

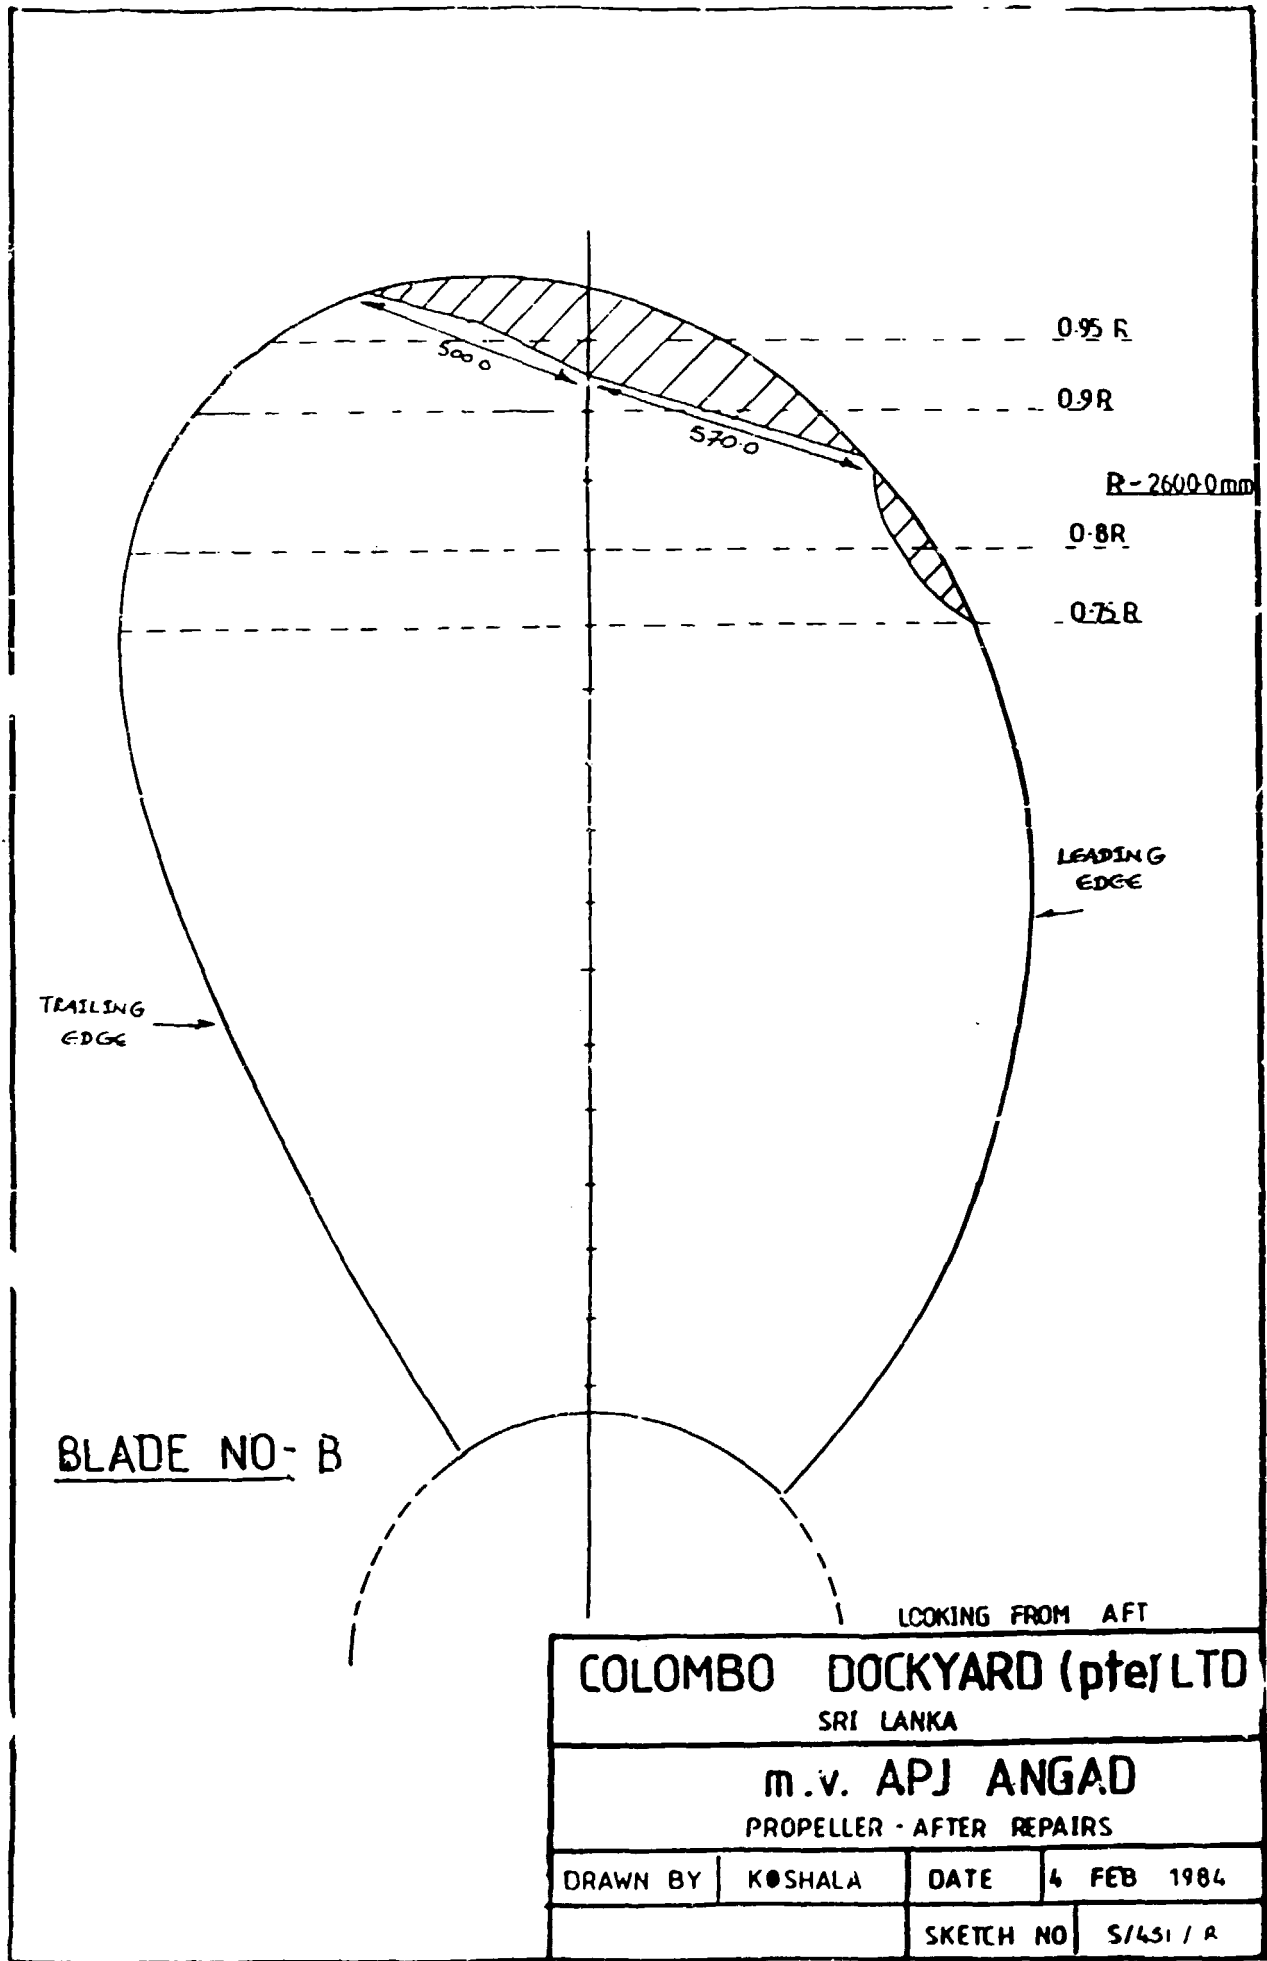
BLADE NO- B

COLOMBO DOCKYARD (pte) LTD			
SRI LANKA			
m.v. APJ ANGAD			
PROPELLER - AFTER REPAIRS			
DRAWN BY	KOSHALA	DATE	4 FEB 1984
		SKETCH NO	S/451 / R

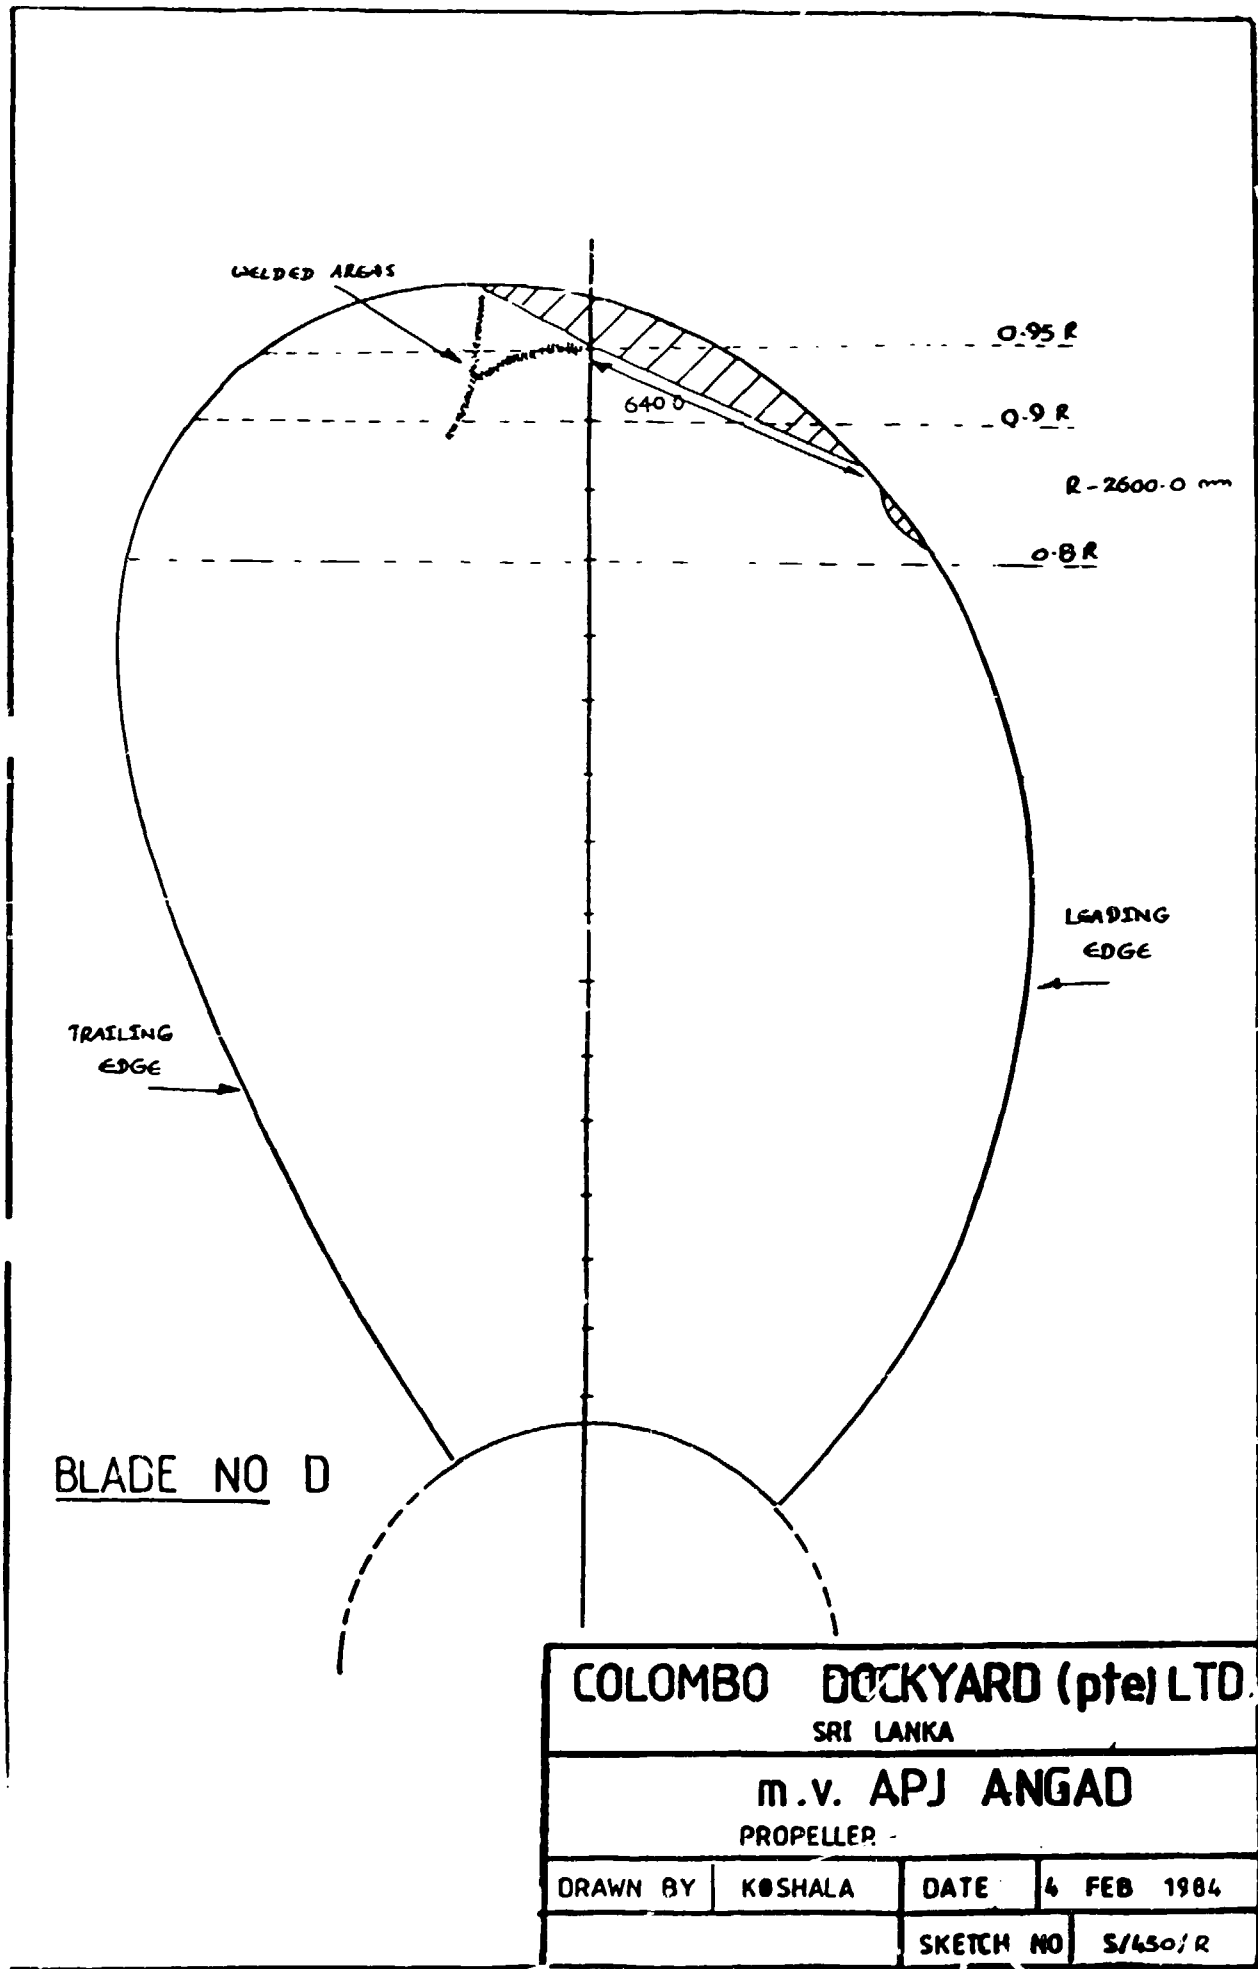
BLADE NO D

COLOMBO DOCKYARD (pte) LTD.			
SRI LANKA			
M.V. APJ ANGAD			
PROPELLER -			
DRAWN BY	KOSHALA	DATE	6 FEB 1984
		SKETCH NO	S/450/R
