# **Improvement of Steel Making Operations**

## **Three Non-integrated Steel Plants**

### **Arab Republic of Egypt**

**KOBE STEEL, LTD.**

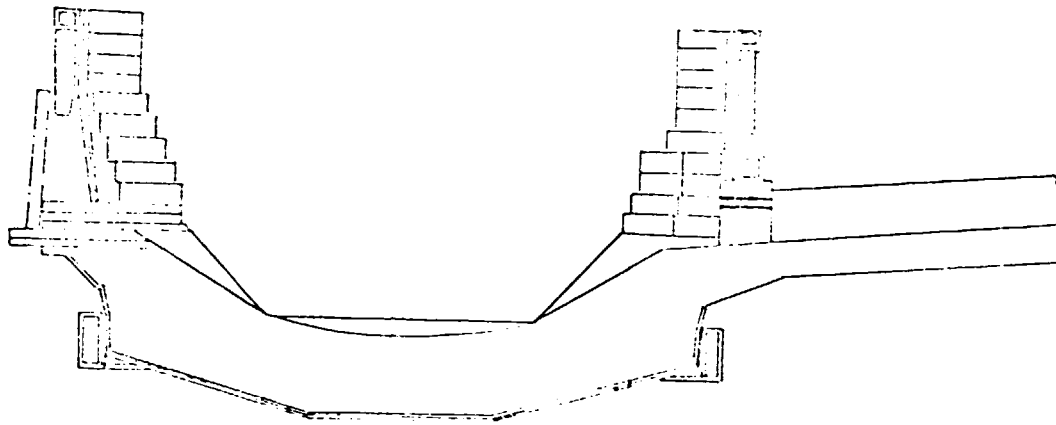
Existing design

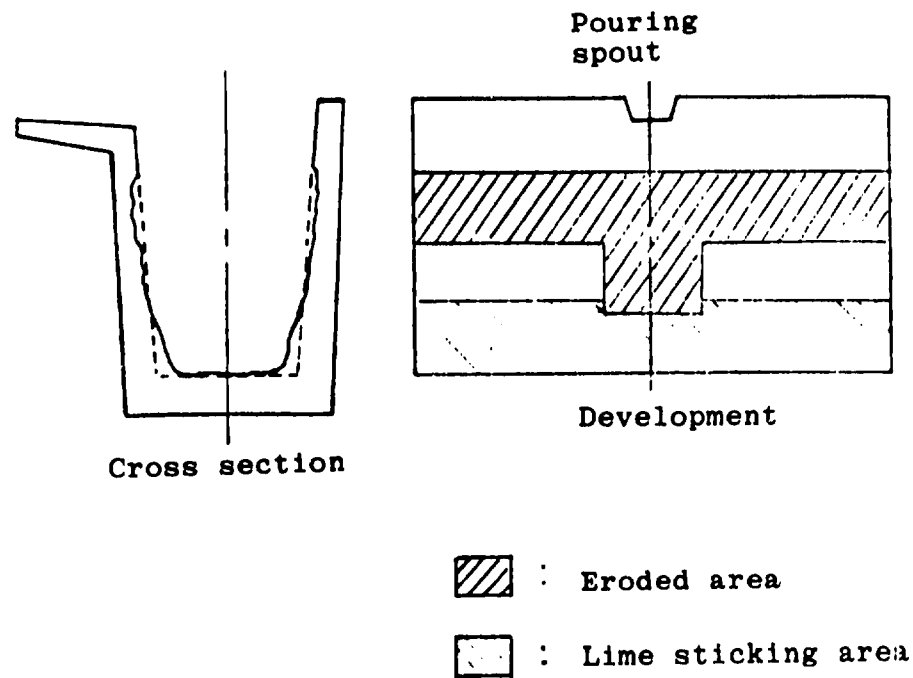
30. Observed eroded hearth condition of induction furnace eight heats after relining (DELTA)

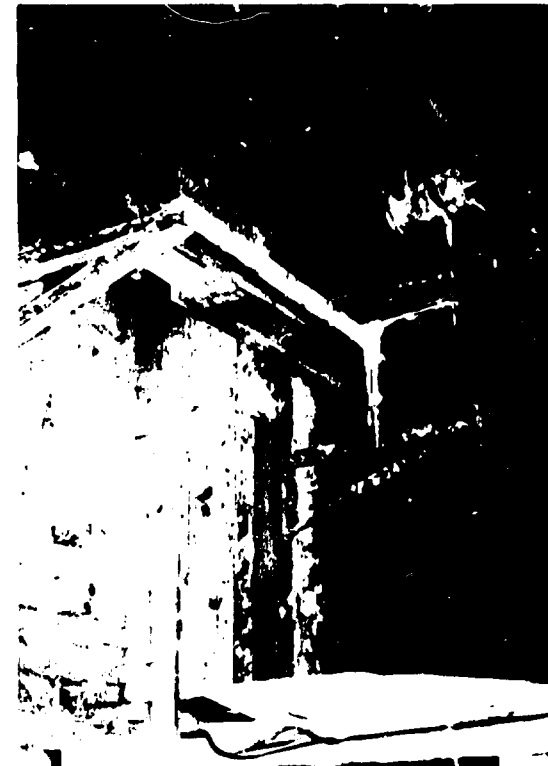
36. Oversized wicket for radiation thermometer (NATIONAL)
