TERMINAL REPORT
SECONDMENT TO THE EGYPTIAN IRON AND STEEL COMPANY,
BLAST FURNACE SECTION

21 November 1981 - 21 February 1982

Arab Republic of Egypt
by
A. Embleton, UNIDO Expert

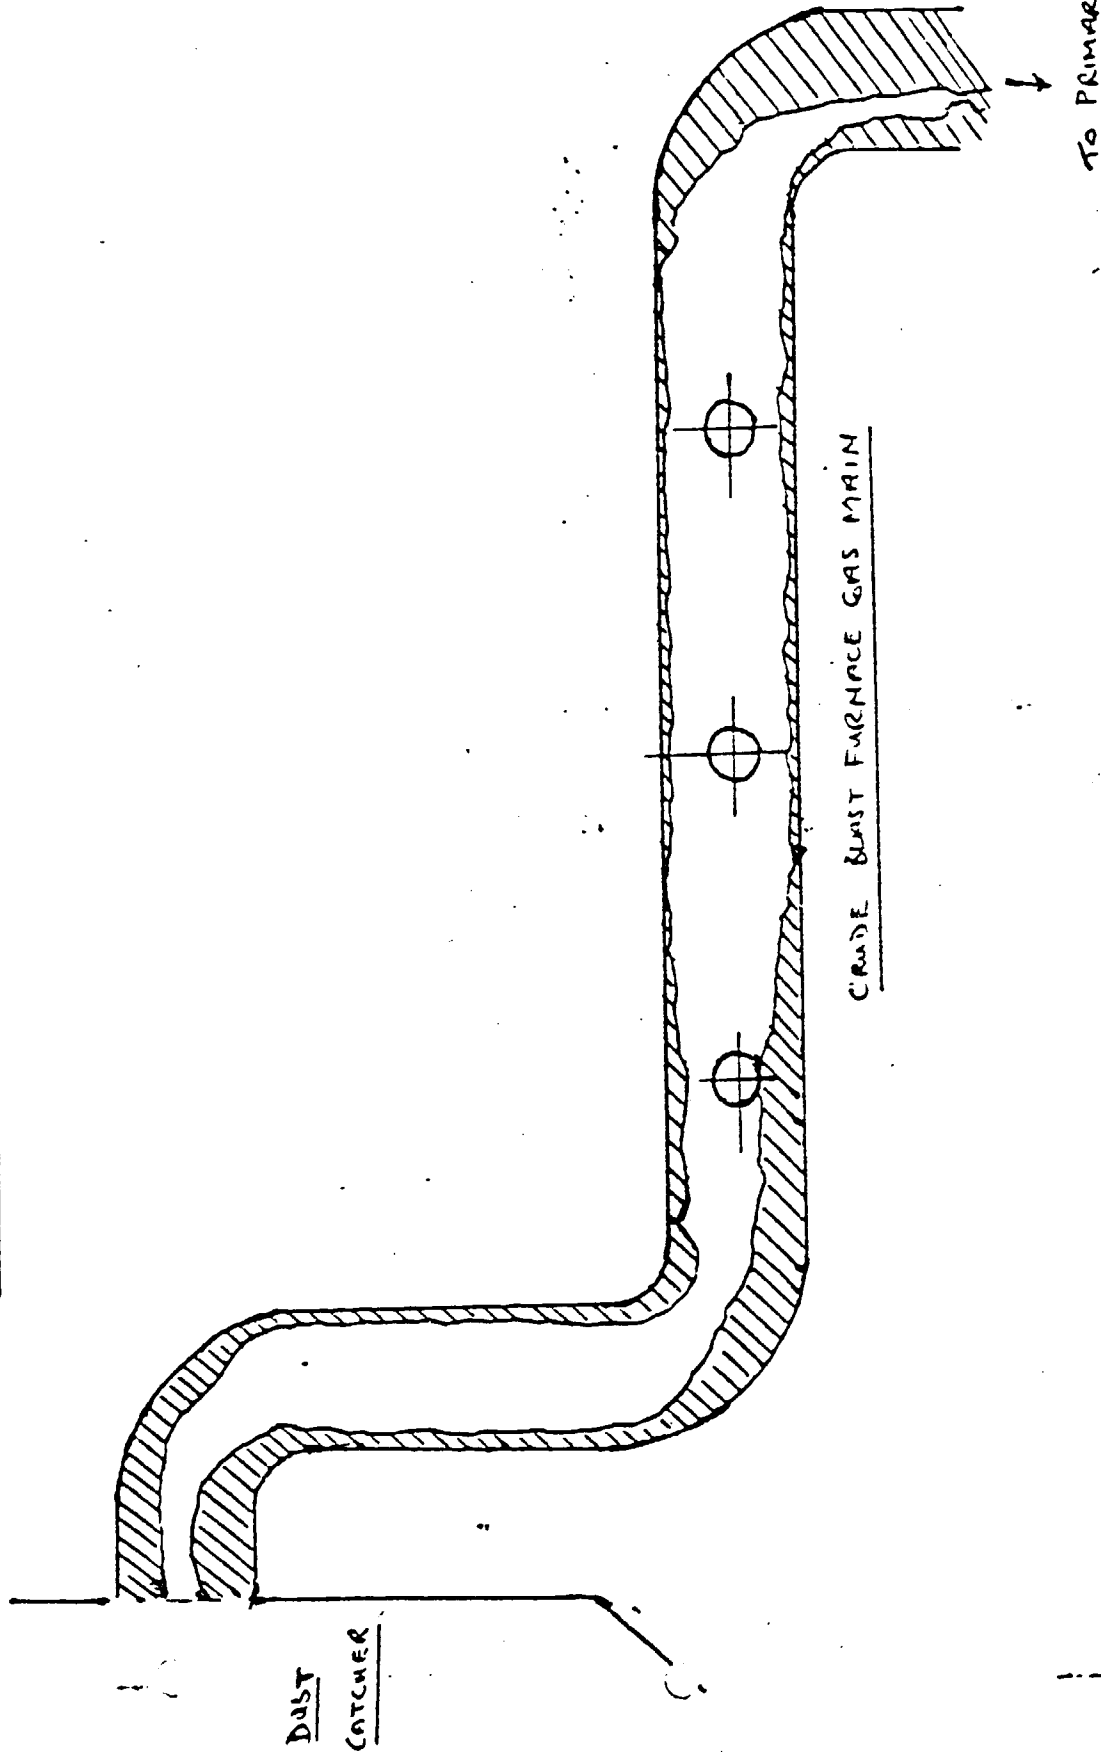
CONDITION OF NO. 4 BUST FURNACE CRUDE GAS MAIN
AT THE TIME OF LARGE BELL LINK ROD FAILURE

- (1) The interior condition of the crude gas main must be examined every six months and cleaning done accordingly. Washing of the Bahariya ore to remove alkalis, chloride, zinc, etc., and nitrogen purging instead of steam will help to reduce the amount of make up in the main.
- (2) Instrumentation for control of large bell operation needs re-vamping to ensure more reliability of operation.
- (3) A more detailed examination of ropes and bell operating equipment should be made on a regular basis and immediate action taken when maladjustment occurs.
- (4) A study is being made of large bell and seat design along with a check on material used in manufacture.
