Hot kiln alignment

F I N A L R E P O R T

REPORT ON HOT KILN ALIGNMENT OF THE ROTARY
KILNS OF HAWARI AND BENGHAZI CEMENT PLANTS

IN BENGHAZI - LIBYA

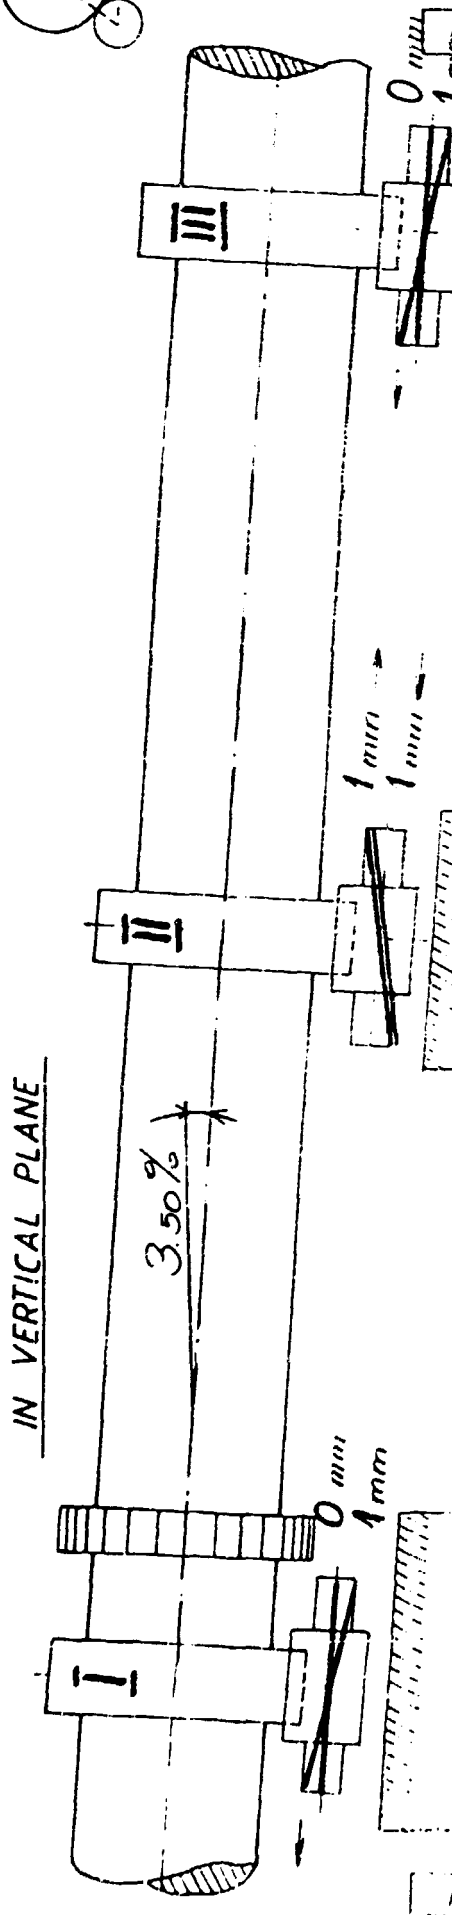
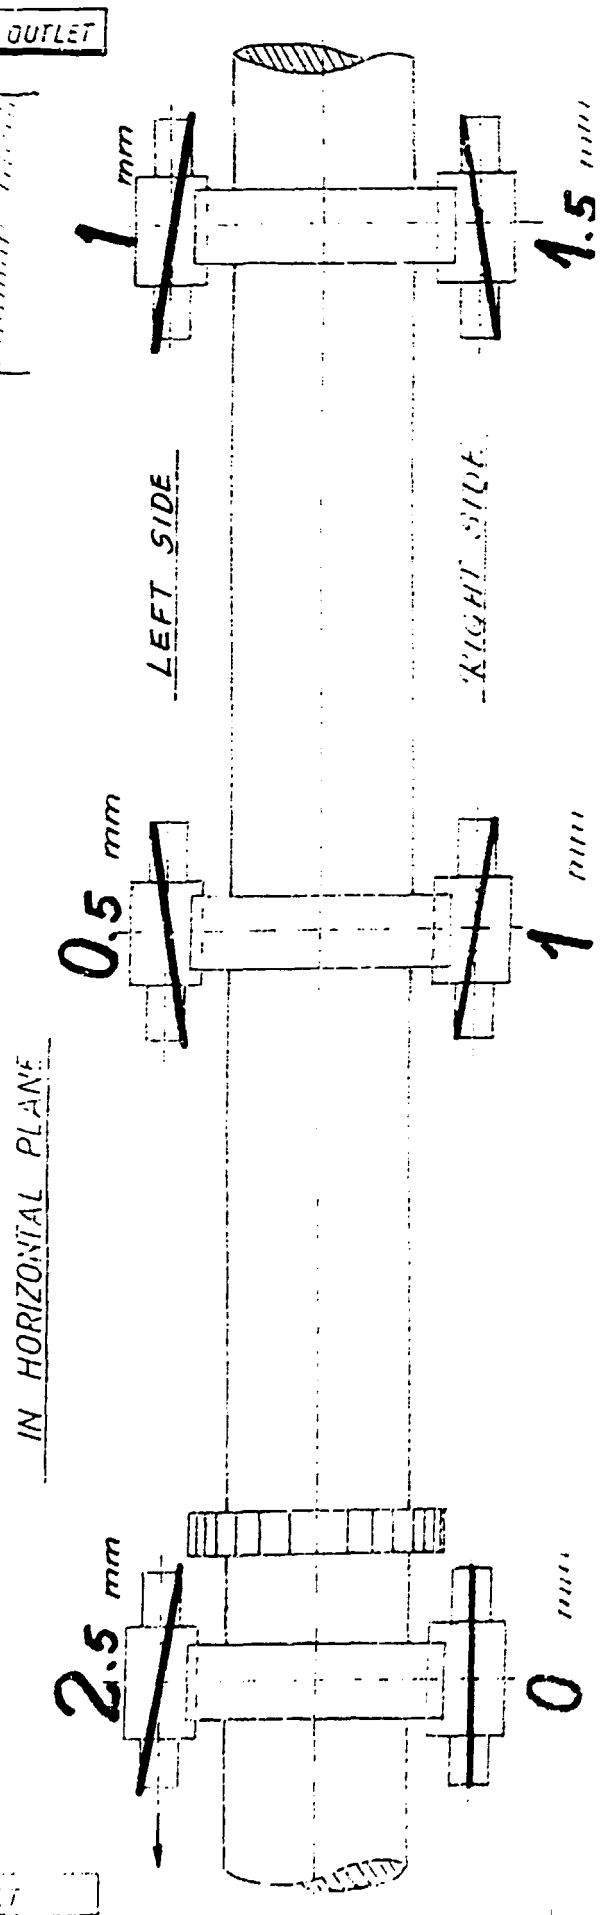
DIAGRAM FOR ROLLERS AXIS TORSION

3.2 The support roller axes torsion in vertical and horizontal planes were found within the tolerance (refer page No5)

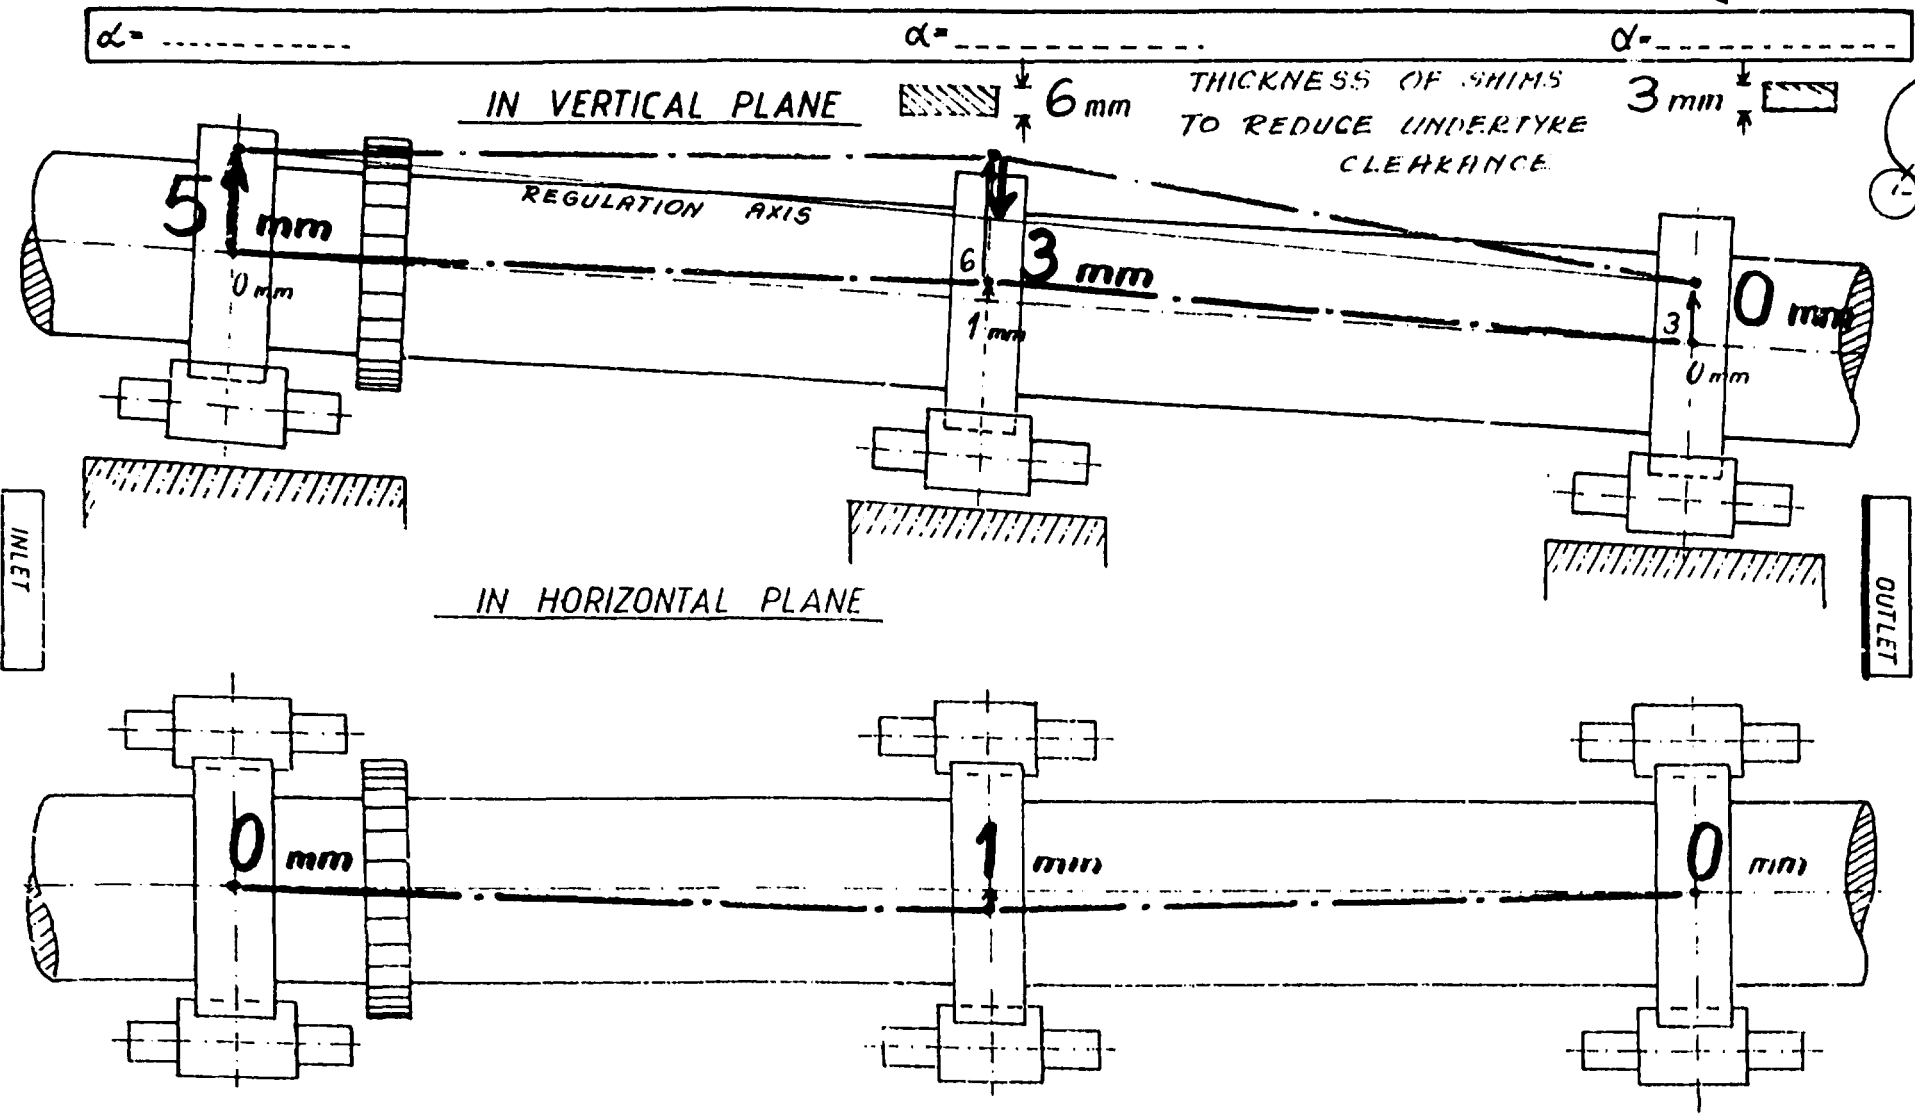
DIAGRAM OF AXIAL DEFORMATIONS - FOR REGULATION

- 3.7 As we were informed about frequent lining failure problems near the 2nd support tyre, A measurement of Kiln's shell deformations was taken (page 13) and during this measurement we have stated a big "crank" in sections 4 and 6 on both sides of the tyre. It also requires some adjustment.

4.6 If the whole adjustment was carried out according to our suggestions it would certainly have a significant influence on decreasing lining failure and would reduce the number of unexpected stoppages.

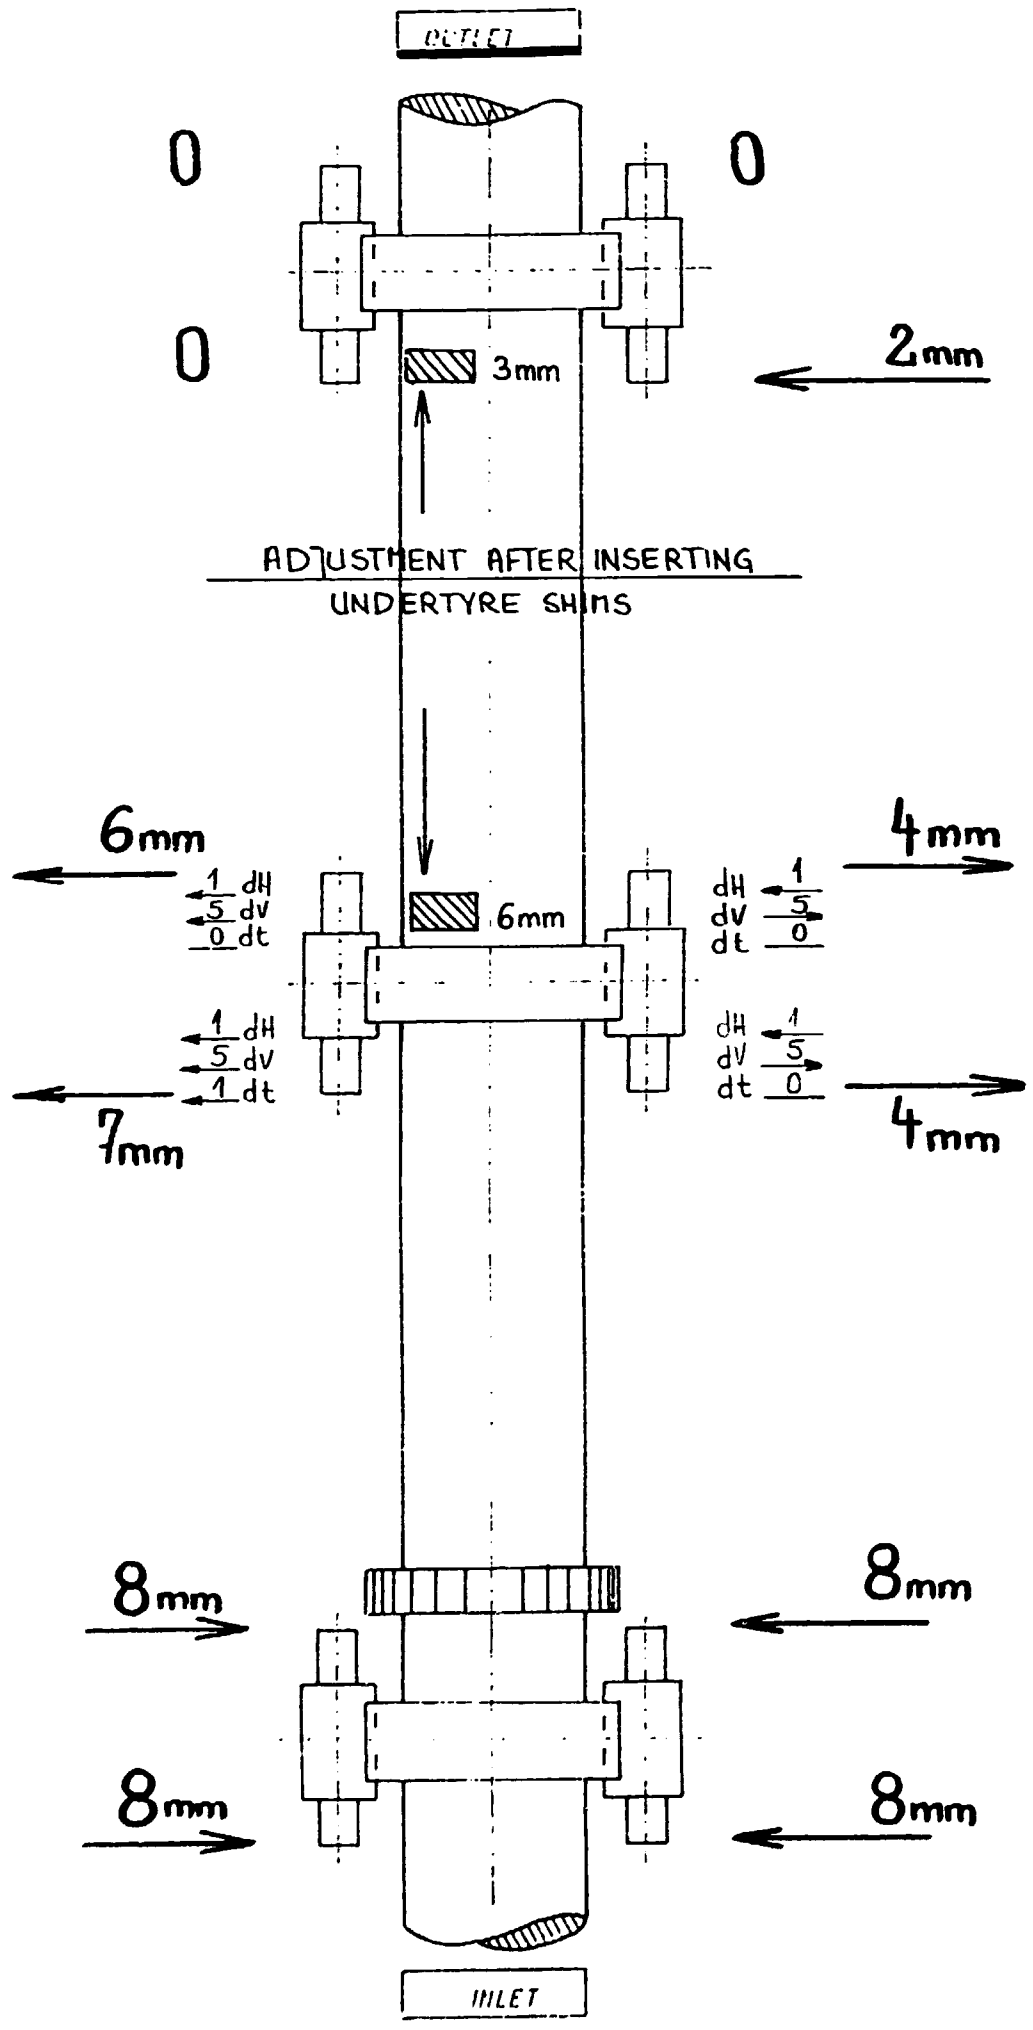
SCHEDULE FOR REGULATION ADJUSTMENTS

- 3.5 The undertyre clearances on supports 2 and 3 are incorrect and require some regulations. The proper value of such a clearance "in hot conditions" varies from 3 to 6 mm.

We recommend to remove old shims and sum up the thickness with new ones.

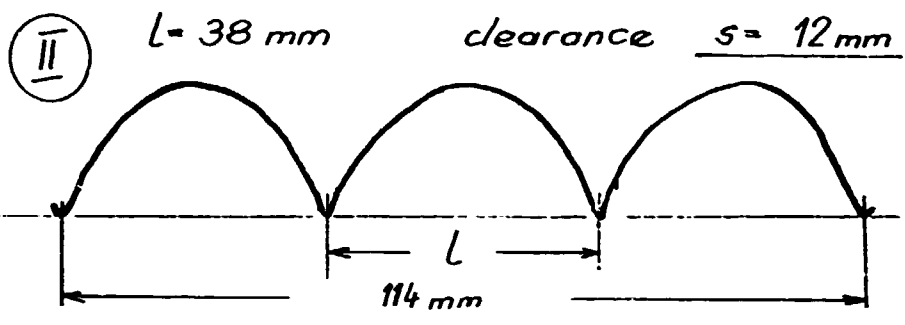
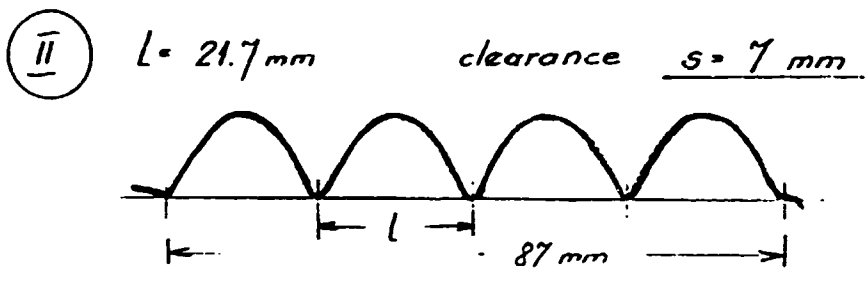
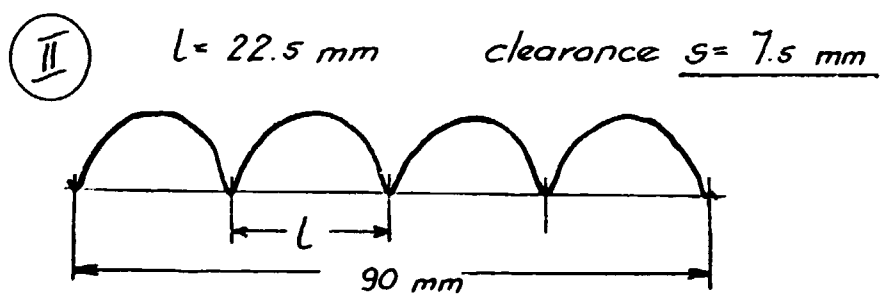
The undertyre clearance of the tyre No 2 has been measured for six times and the real value of this clearance is 7.5 mm. However, during the measurement taken on the 6th of Nov.1992 a considerable difference was noticed when the clearance reached 12 mm. We can only presume that the reason of such differences was caused by a momentary change of the Kiln's shell temperature near the above mentioned tyre.

REAL UNDERTYRE CLEARANCE → 7.5 mm
FOR TYRE II

- 3.5 The undertyre clearances on supports 2 and 3 are incorrect and require further adjustment which should take place during the replacement of the Kiln's shell under tyre 2 and 3. The proper value of undertyre clearance " in hot conditions " is 3 to 6 mm.

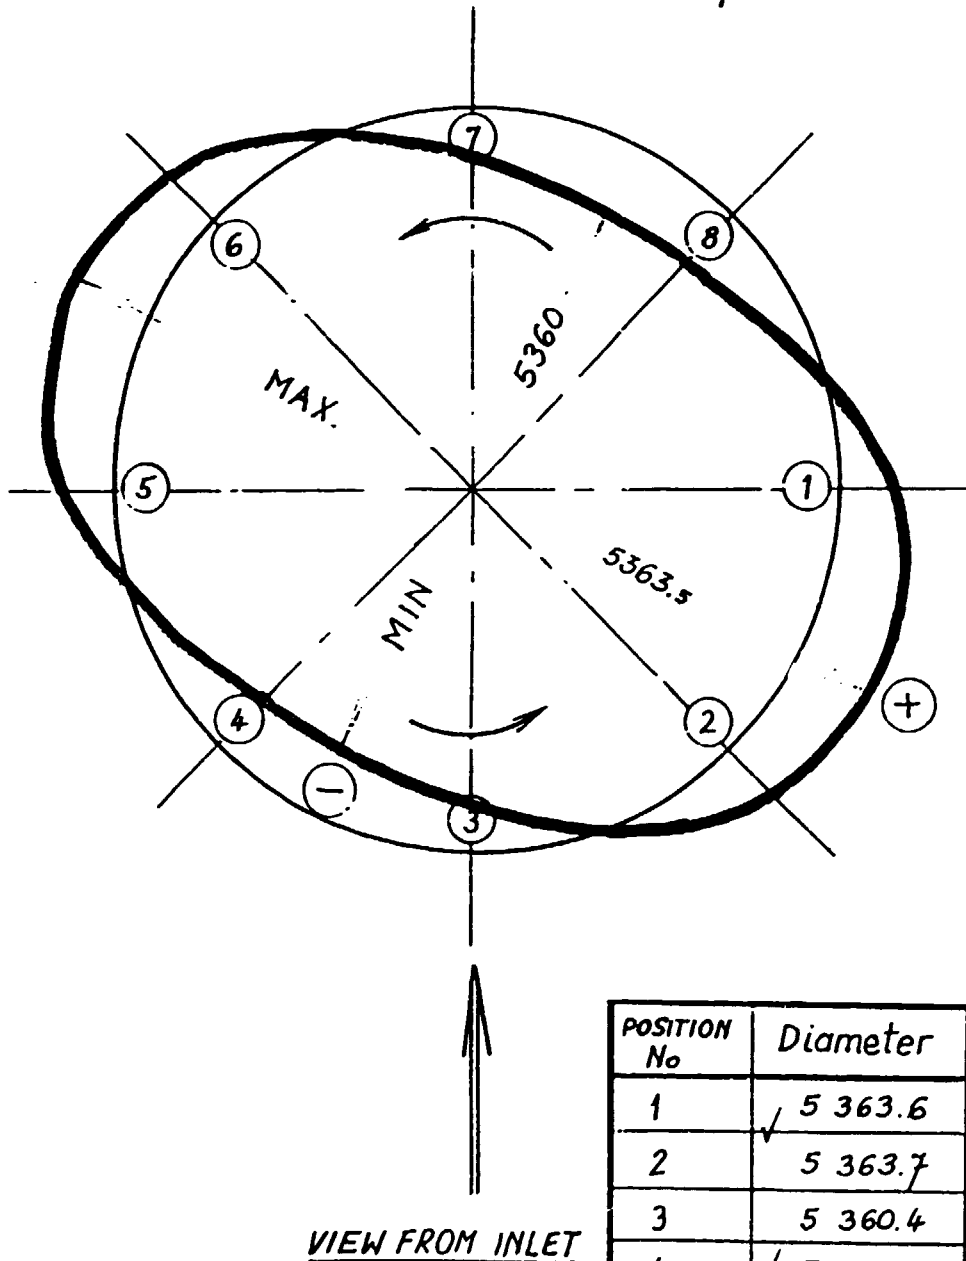
Average diameter 5362 mm

- 3.7 The ovality of the 2nd tyre was measured in 8 different places around this tyre (page 11,12) Differences in diameters are exceeding 3 mm. Improper ovality of this tyre was probably caused by "overheating " the Kiln's shell under above mentioned tyre.

POSITION No	Diameter	Difference to average diameter
1	✓ 5 363.6	+ 1.7 mm
2	5 363.7	+ 1.8
3	5 360.4	- 1.5
4	✓ 5 360.0	- 1.9
5	5 363.6	+ 1.7
6	5 363.7	+ 1.8
7	5 360.4	- 1.5
8	5 360.0	- 1.9

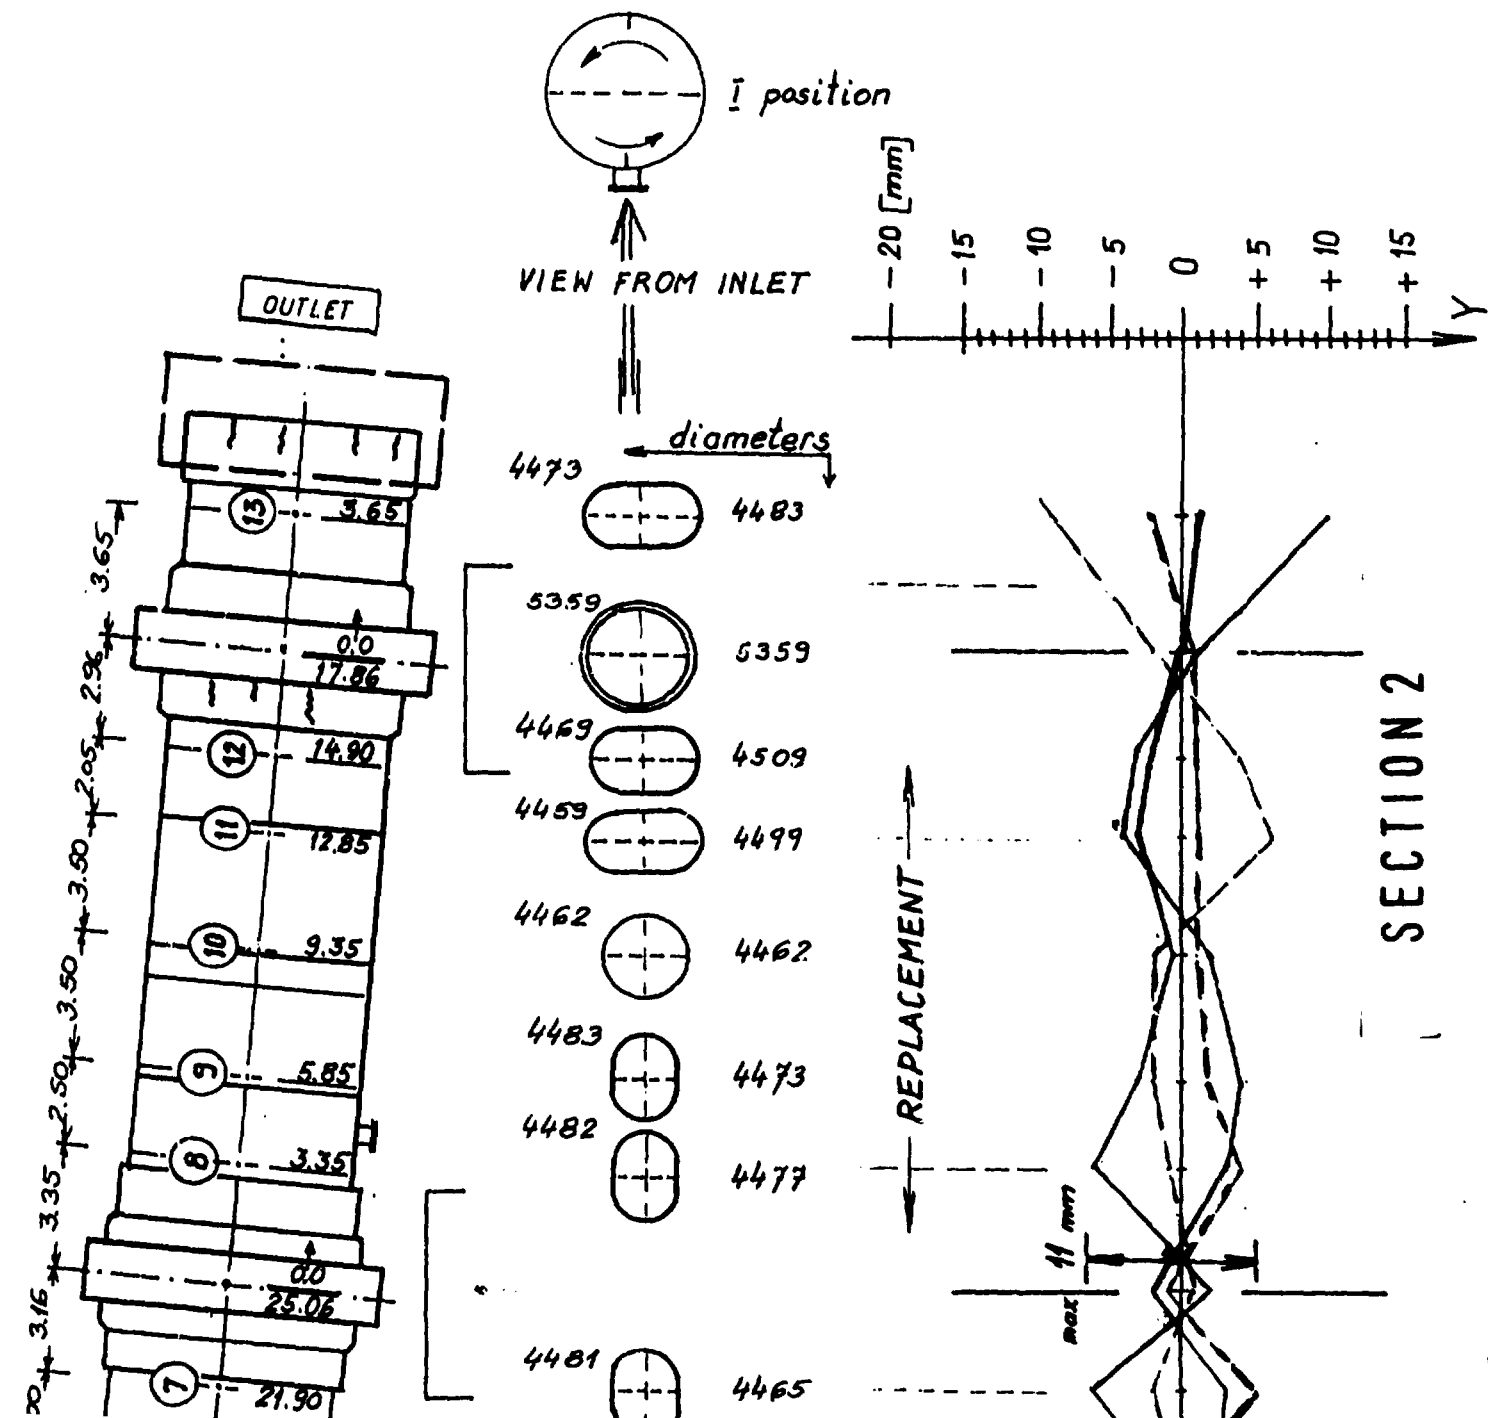
DIAGRAM OF THE KILN SHELL AXIS DEFORMATIONS

- 3.8 In addition a measurement of the Kiln's shell deformations was taken (page 13 shows the details) and a considerable deformations under the 2nd tyre were found. It is recommended to change this part in the nearest future.

The Kiln's shell condition under 2nd and 3rd tyres is poor and some parts of the shell require to be changed. (the sooner the better). The Kiln's shell deformations cause a frequent lining failure.

- 4.1 Except a poor condition of the shell near the tyre No3 we have also noticed a great number of cracks.
- 4.2 Page 13 shows all the parts of the shell that should be changed (orange coloured parts)

4.3 After a proper replacement of recommended parts there should be a significant improvement in Kiln's operation , lining failures and the whole regulation should also improve production by decreasing other failure problems.

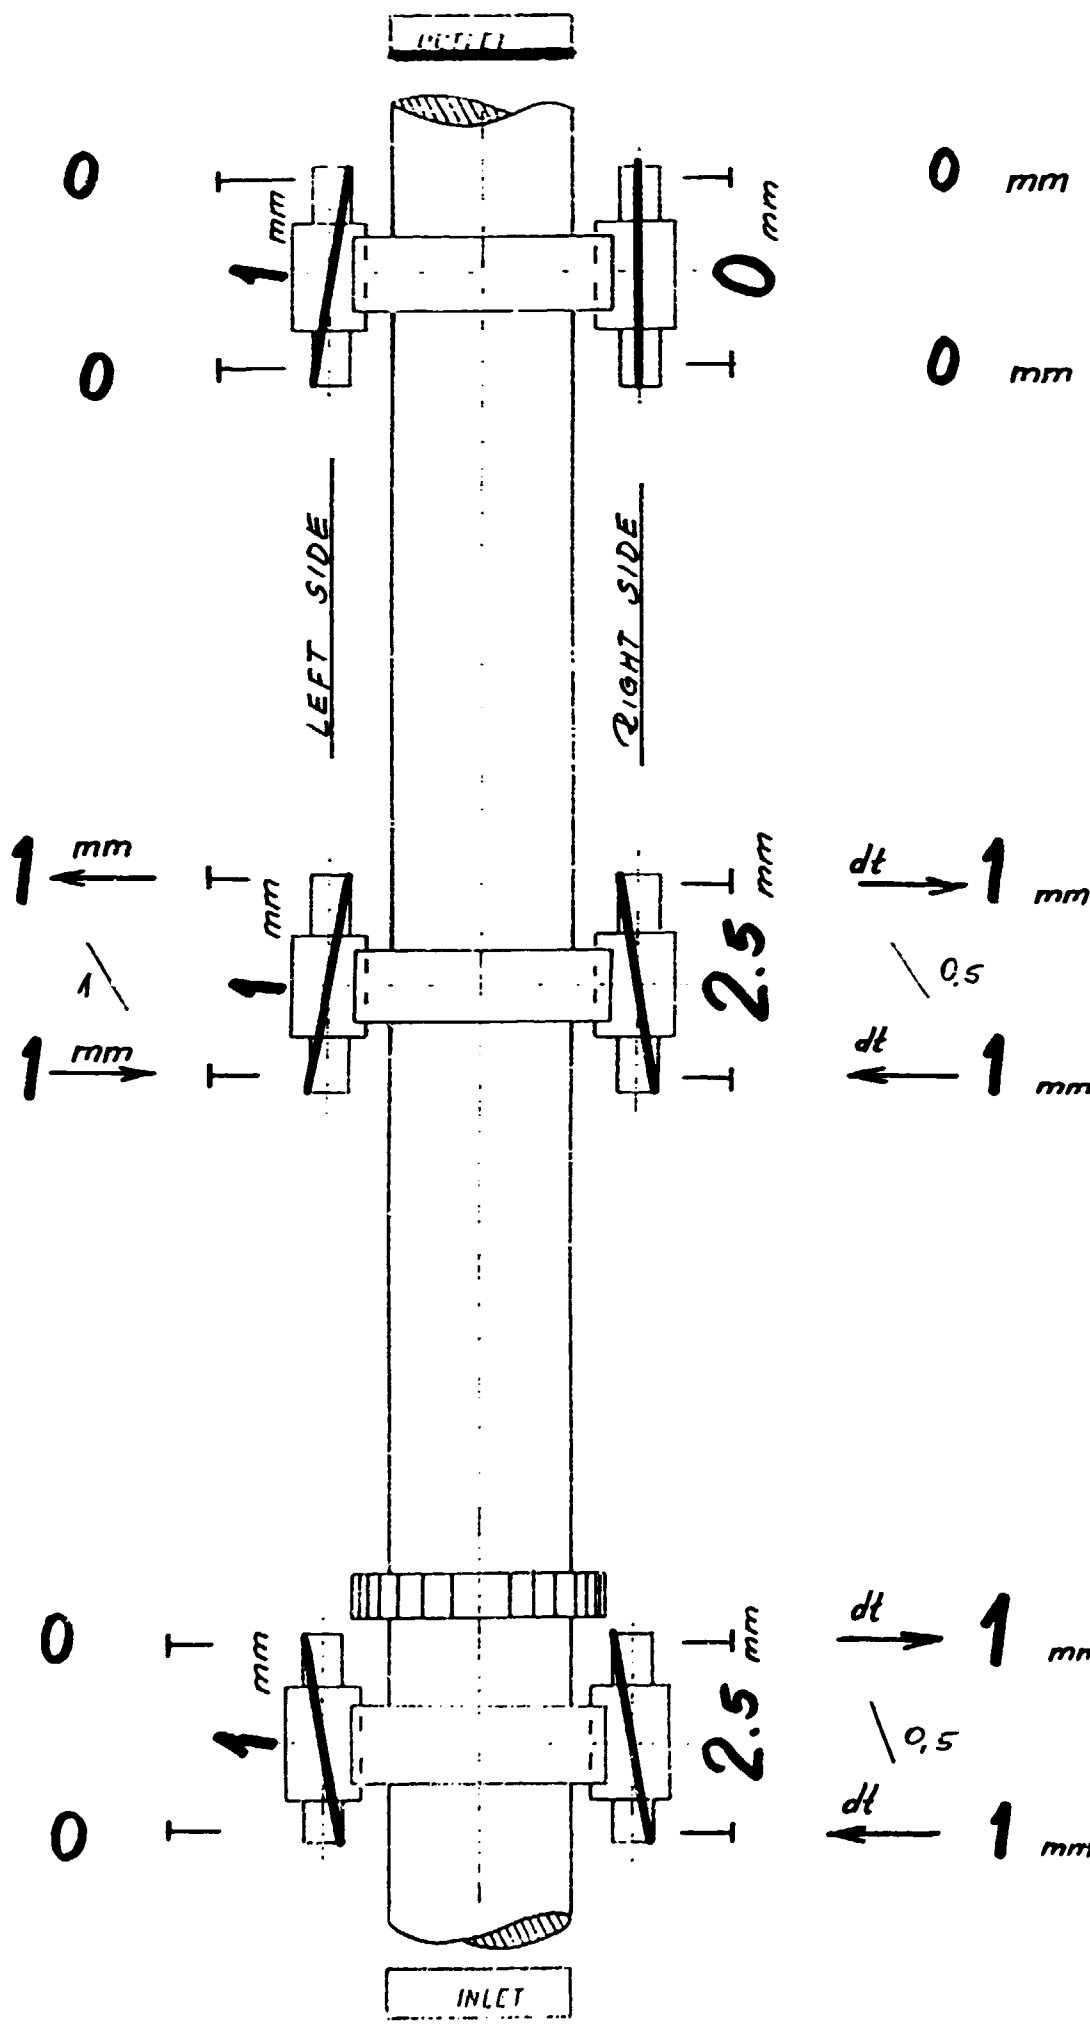
SCHEDULE FOR ROLLERS AXIS TORSION ADJUSTMENTS

3.3 The support roller axis torsions in vertical plane were found within the tolerance (refer page No 5) However, torsions in horizontal plane require some regulations which are shown on page No 7.

3.7 Improper rollers torsions in horizontal plane keep the Kiln in its upper position.

Besides, these torsions make the Kiln's floating impossible to achieve, because of improper thrust rollers performance.(Rollers torsions regulation is shown on page7)

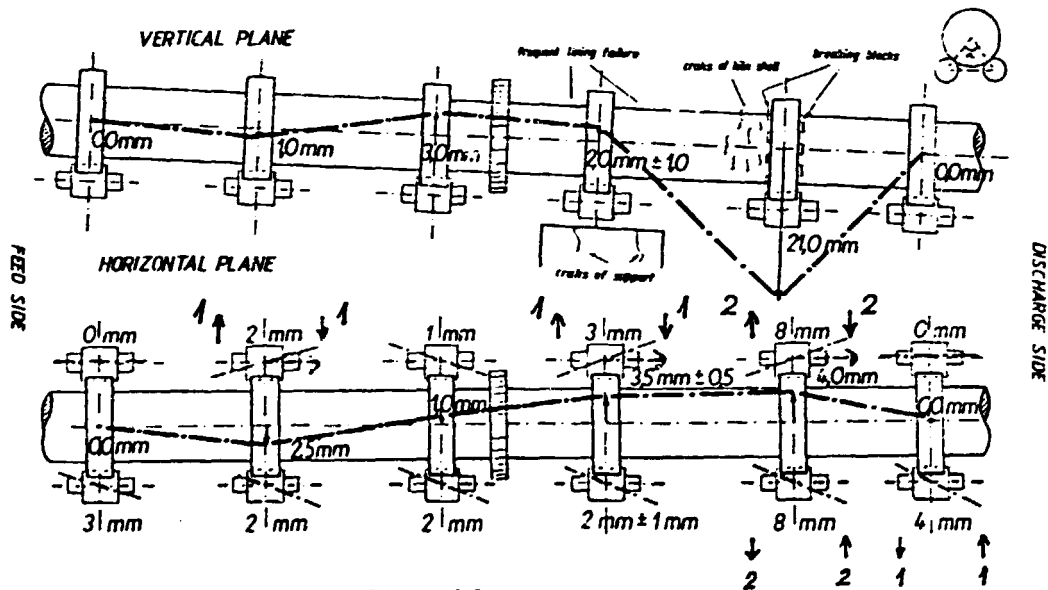
Fig. 12

Figure No.12 shows rollers' torsions of Messrs "ALLIS CHALMERS" kiln.

Rollers' torsions on the right side of kiln are correctly oriented /kiln is pulled up/ but the half of rollers on the right side pushes down.

Of course, the axial force coming from rollers pulling kiln in improper direction has to be equilibrated by pulling up rollers' torsions bigger than needed ones. The torsions of half of rollers on the right side, through correct in orientation are incorrect by starting various axial forces /roller on the second support "pulls" 4 times more than rollers on supports 3,4,5.

This causes considerable wear of the roller and tire surfaces, overheated pivots, increased power consumption of motors, broken thrust blocks at the tires, worn-out plates between tires and the kiln shell etc. Rollers' torsions corrections have been shown on fig. 12.

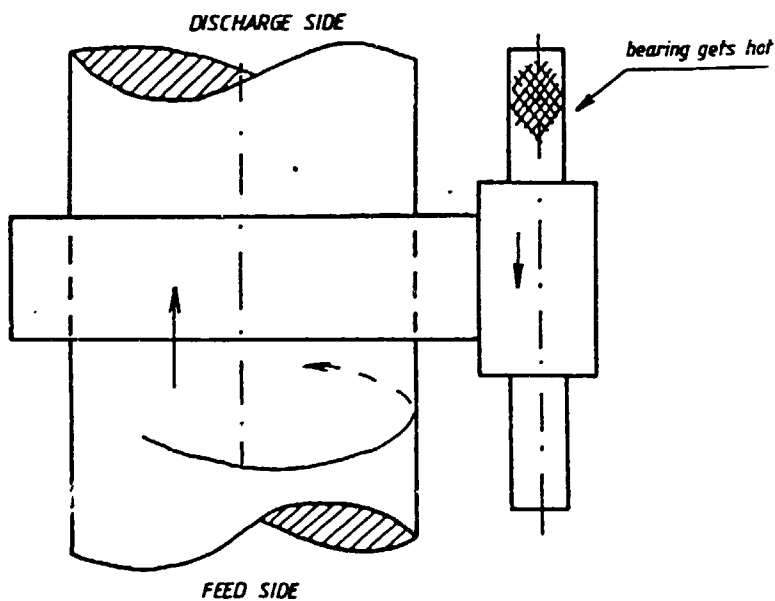
Fig. 15

Figure No.15 presents the roller of type "A" with one of overheated bearing. In most cases mechanics push away the "overheated" end from kiln, but without changing the situation at all, then both ends of roller are carried away from the kiln until the temperature

becomes normal due to the load /kiln weight/ reduction. The described operation results in kiln axis maladjustment, increased load influence on neighbouring rollers and then problems characteristic for non-aligned kiln. The correct operation should be the invert one, namely the overheated pivot should be immediately shoved to the kiln by 1 or 2 mm or the another end of roller should be shoved away from kiln and then cooled the oil and should be changed it, if possible
