WOODEN BRIDGES

UC/DMI/83/095

DOMINICA

Terminal report\*

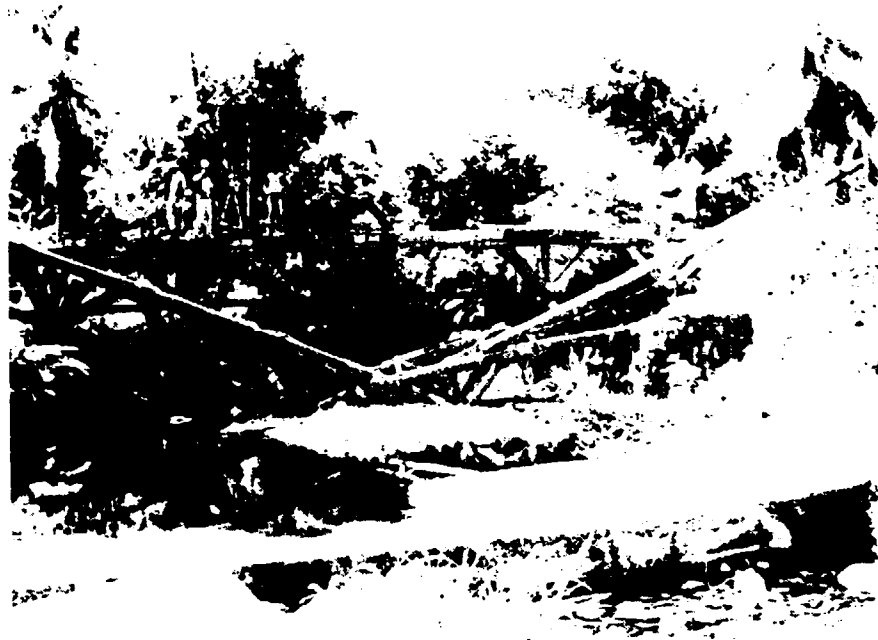
Fig. 12  
Collapsed Girder

Near the end of the launch of the second girder the far deadman anchor pulled through the earth, releasing the main line and dropping the far shear legs. This soil was soft brown silt overlying large boulders. Five days of the girder remained intact but the two leading bays came apart. Fortunately no one was injured and only minor damage was done to the four leading panels.

Figs 12 and 13 show the situation after the collapse and Fig 14 shows the failed anchor.

Lessons to be learned from these mishaps are:

1. All components of the launching equipment must be thoroughly checked, including the soil strength since the soil is as much a component as any other part.
2. Potential hazards can be avoided by limiting the height through which the girder can fall, either by pigstying or other means.

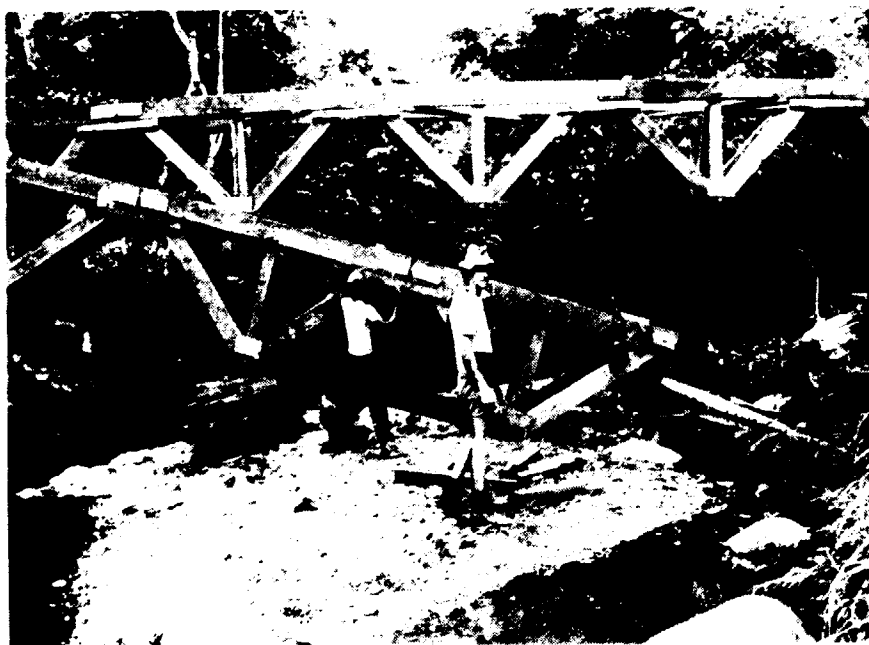
Fig 15  
Girder Being raised

One and a half days were lost while a new anchor was excavated, the shear legs re-erected and the girder lifted up. The situation was retrieved by lifting the nose of the undamaged section of girder with the main line and building a pigsty under it. The two panels originally ahead of this section were replaced and the main line sling was transferred to these. The two panels which were originally leading were brought back to the rear of the girder and launched in the usual way. Fig 15 shows the girder lifted up with one pair of panels replaced.
