KORDIN GRAIN TERMINAL MALTA  
(Contract no. 84/05/HR)  
AMENDMENT NO. 3 - FINAL REPORT

Report prepared for:  
United Nations Industrial  
Development Organization (UNIDO)  
Vienna, Austria.

January, 1986.

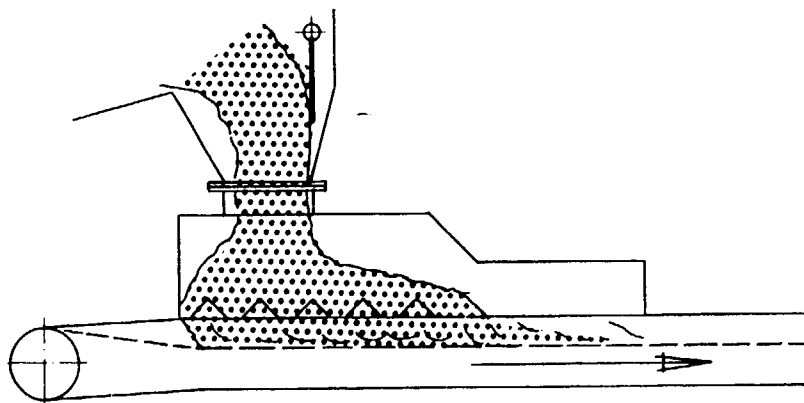
- Proposed and discussed with Mr. O. Karl the following possible solutions to keep the grain under control in the loader transferpoints.

- (a) adjustable triangle shaped plates to be placed under the grain flow as follows.

The triangle shaped plates across the rotating loading shoe underneath the flow from portal belt conveyor transferpoint.
