INVESTIGATION OF CONCRETE STRUCTURES
IN THE AMRAN CEMENT PLANT

SI/YEM/86/801

YEMEN ARAB REPUBLIC

Technical report: Strength assessment of the structure *

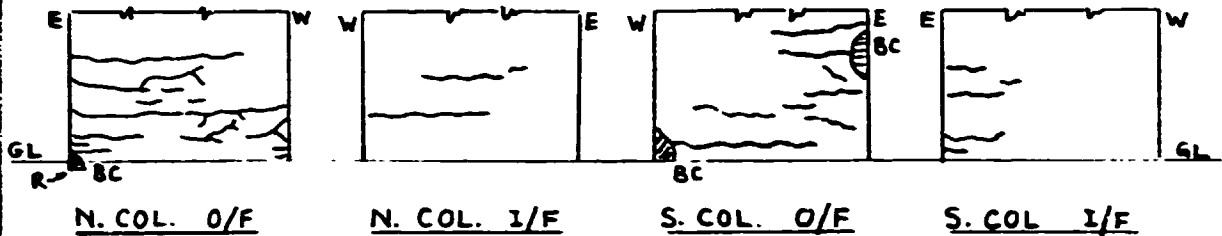
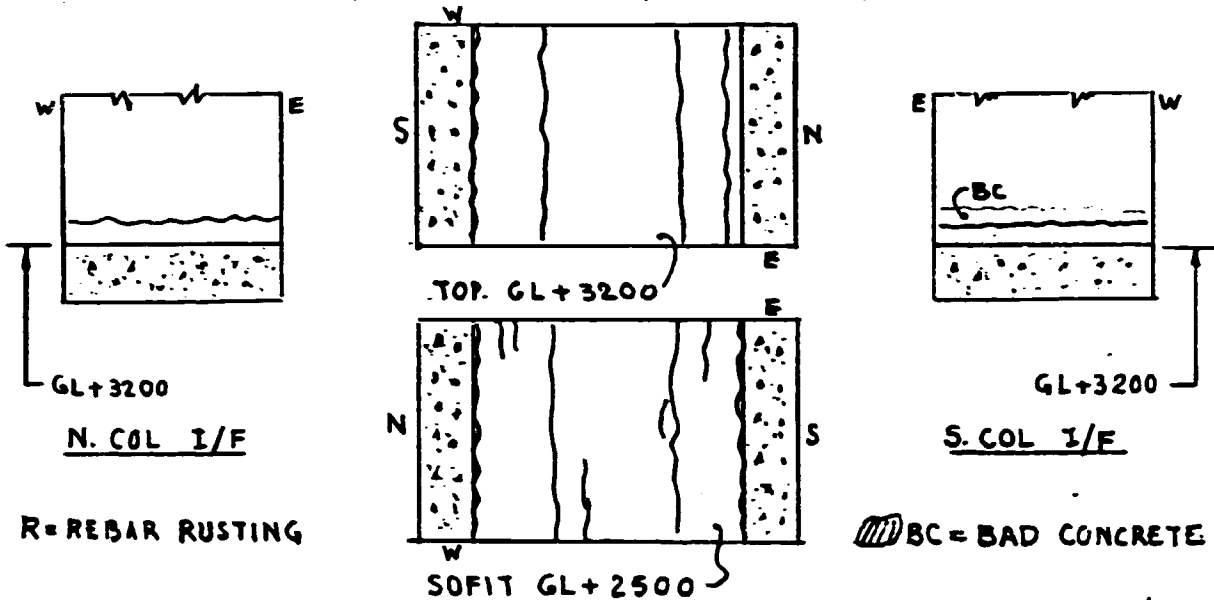
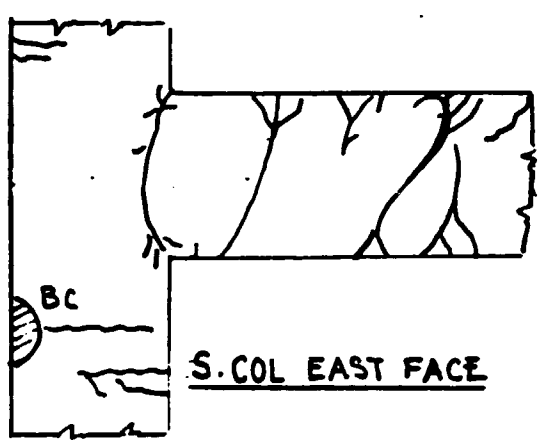
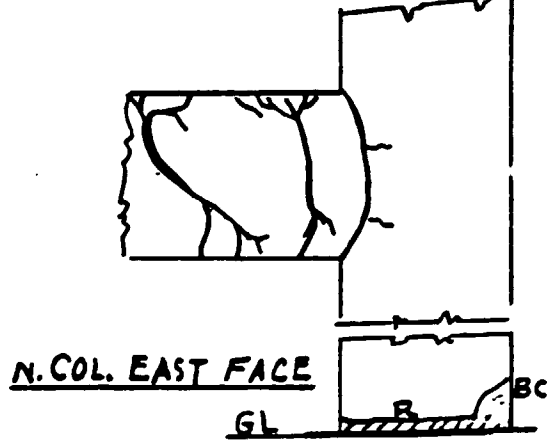
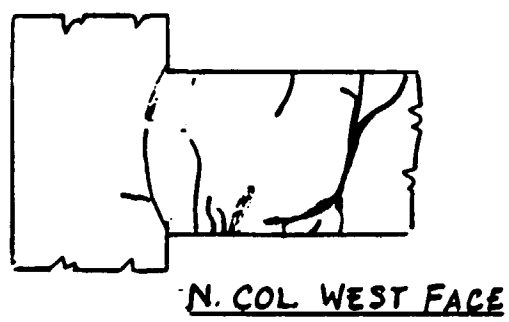
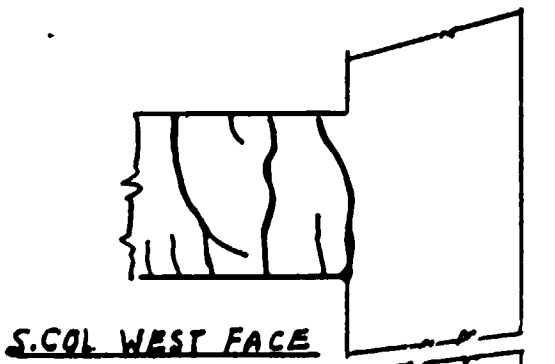
FIG. 4 CRACKS KILN SUPPORT NO.2

- 2.3.9 The three two-storied portal supports for the Kiln are cracked. The middle support is very bad. Structural integrity can be in question. This is very serious.

This report summarises the cracking problem then noticed and gives reasons for each distress. Causes noted are, shock load for LS hopper and Gypsum and Sandy Clay Hoppers, vibrations for girders and shrinkage or shrinkage and temperature for the remaining ten items. The report also suggests a full study by IHI and present guidelines as to how to go about it. They do not approve of the method adopted by IHI for rectification of LS hopper cracking. Consultant's opinion on cracks may be correct at that time. Now the damage to No. 2 kiln support is alarming.

R = REBAR RUSTING

BC = BAD CONCRETE
