ASSISTANCE IN PERFORMANCE IMPROVEMENT OF
FISH PROCESSING PLANTS

GUINEA BISSAU

Technical report: Review by fish storage technology engineer *

Based on the work of Per Ben I. Nesinum,
expert in fish storage technology

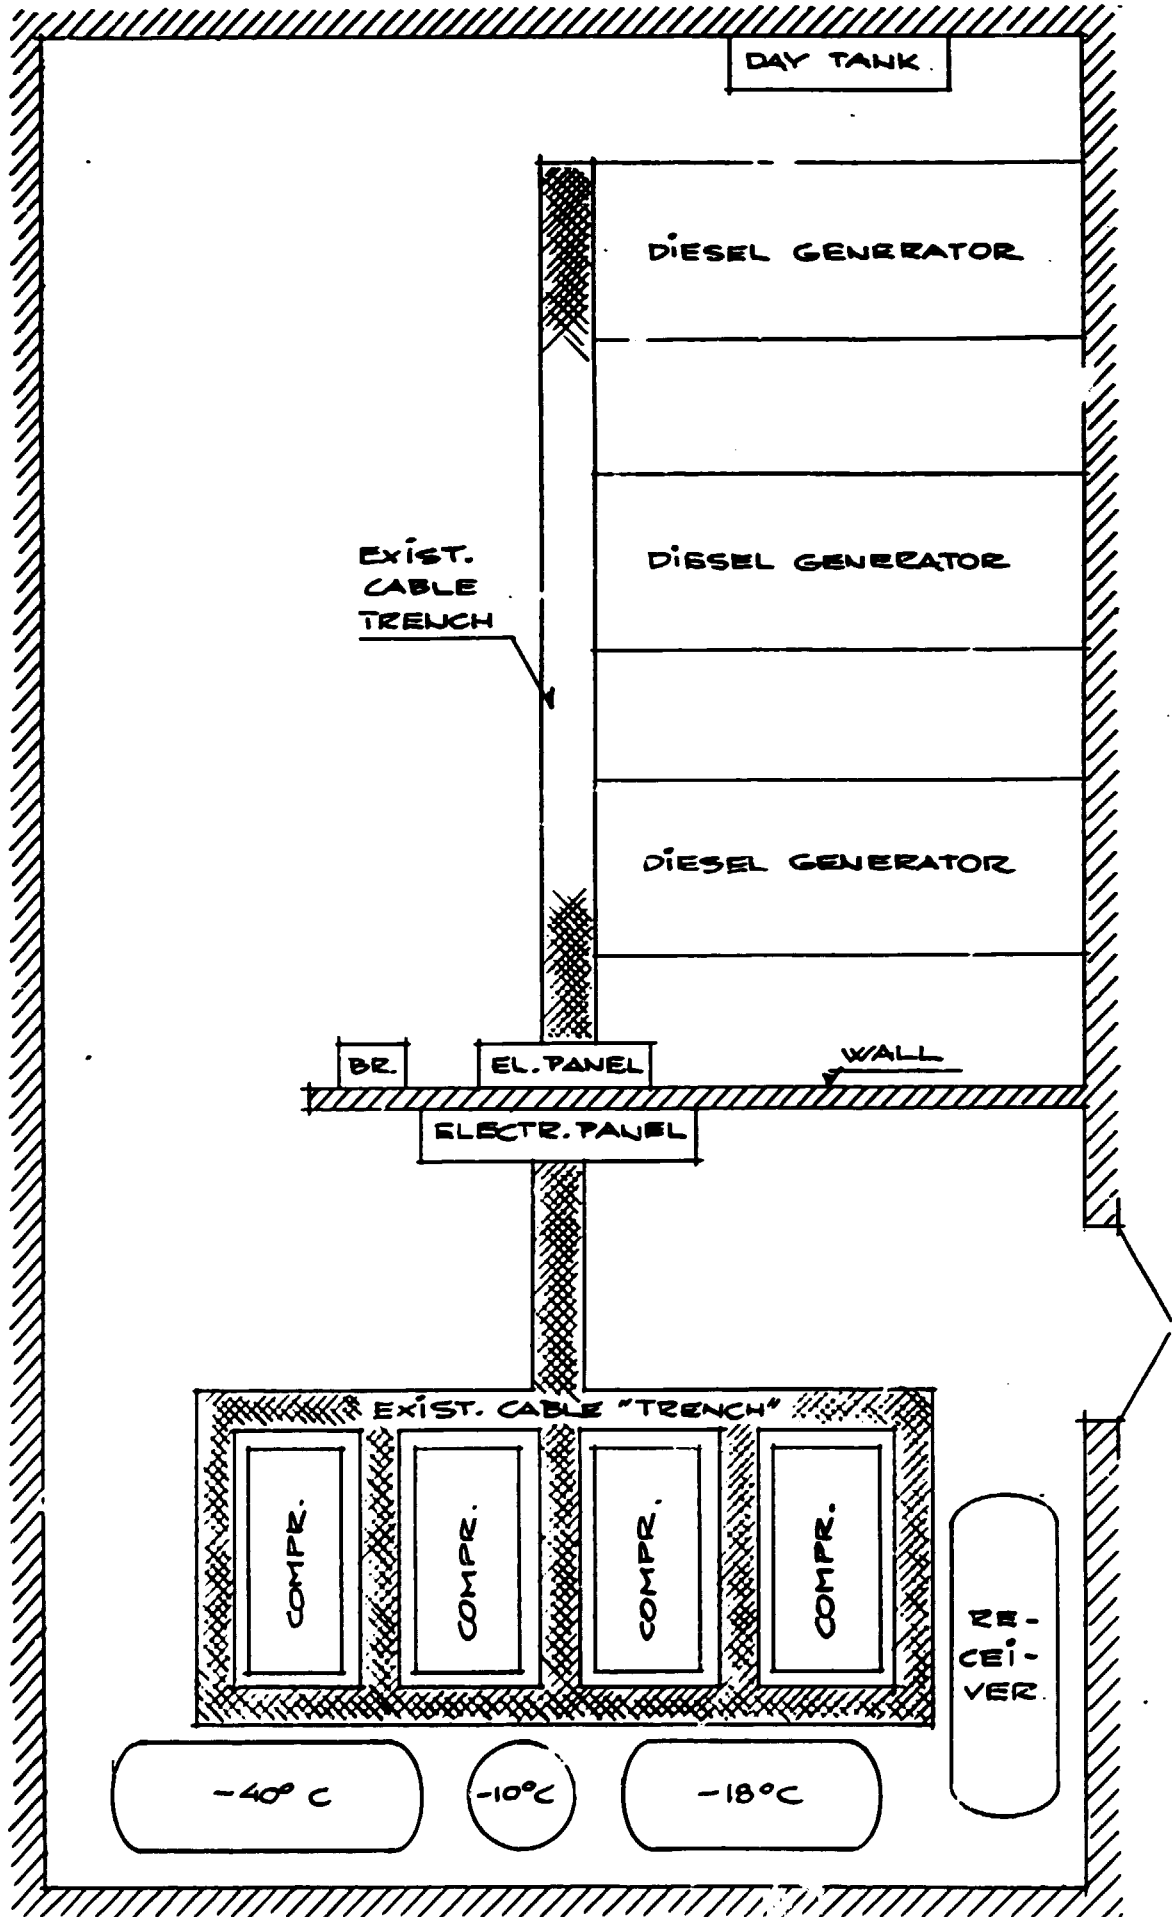
EXISTING ENGINE ROOM.

The floor serves as a base for the cable trenches and foundations for the diesel units. The foundations are elevated to a level of 80 mm above the general floor level. The elevation should be at a level of 300 mm above the floor permitting oil drainage from the crank case and to provide proper conditions for maintenance. The actual conditions causes water pits to remain on the floor.

The lack of proper change-over equipment (needed to shift between public power supply and the generating equipment) forces the operators to conduct the changes by mechanically removing the cables and then to re-arrange and remount them. This procedure is cumbersome and time consuming and is therefore not undertaken until absolutely necessary. It is also hazardous, since there is a constant risk of handling live power cables.

The exhaust system, i.e. the piping from the diesel engine to the free air is not satisfactorily supported. It is at one end resting on a wall bracket and at the other end resting on the cast exhaust manifold of the engine. This arrangement causes unnecessary strain on the engine and produces destructive vibrations to traverse the exhaust system - which inevitably reduces the life time of the system.

The batteries are mounted on top of each engine and are not in any way sealed off from the room. During recharge - when the engine is running - the batteries develop hydrogen which besides being explosive also causes corrosion of all iron and steel structures. The uncladded electric installation suffers to a large extent from gradual deterioration.

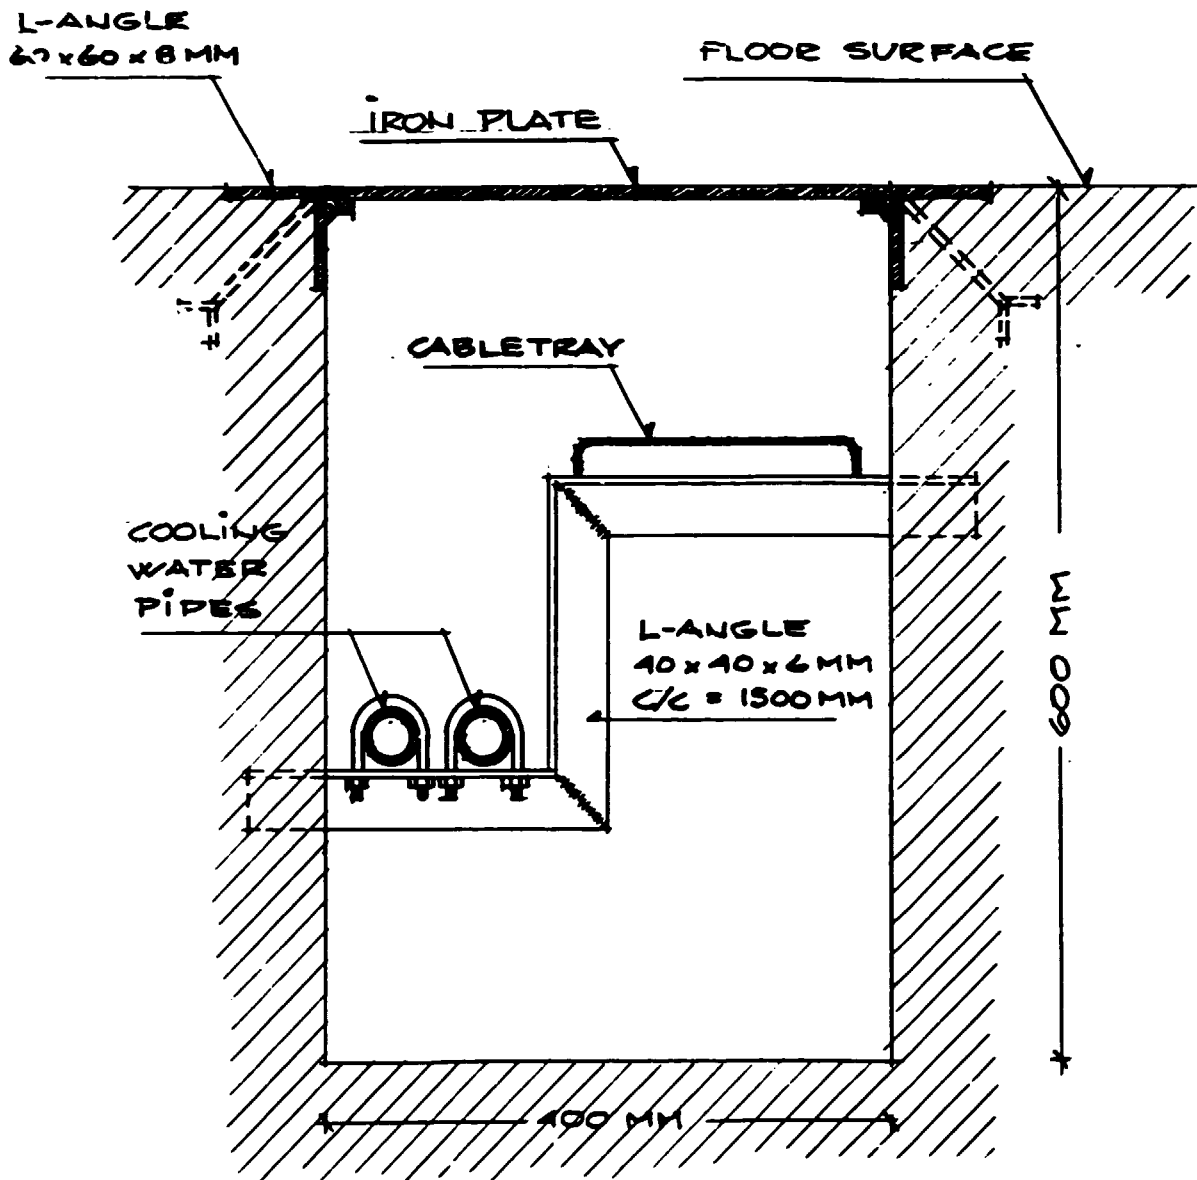
PROPOSE CABLE TRENCH
FOR SEMAPESCA.

The cable trenches are too shallow - only about 80 mm - and constructed with no drain at all. A mix of water and oil causes the cables to rot away as the cables are of the same type as found in the diesel engine room.

It should be kept in mind that a refrigeration machine room cannot be kept dry. A continuous process of altering frosting and defrosting of pipes, valves, compressors, etc.. Draining is a must.

Furthermore, the linkage gates between the cable trench and the sewerage system should be grilled to keep out rats to from the trench as rats damage the cable insulation. Usually, the cable trenches are used as drain, but this requires a different kind of construction design (see sketch 1).
