Regional Hides and Skins, Leather and  
Leather Products Improvement Scheme.

US/RAF/88/100 & US/ETH/88/100

Technical Report

Based on the work of A. Rongved, Expert in tannery  
machinery maintenance.

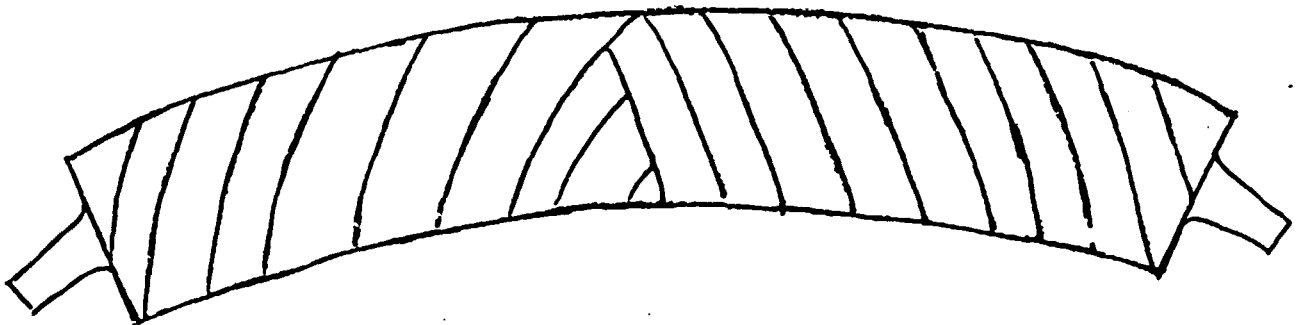
FIG.7

Bent cylinder, excessive force  
has been used on UPPER SIDE

This situation is not too difficult to accept if we think of stretching the cylinder instead of bending it, even though it is the same thing. If we go back to the float diagram in fig.5 the difference can be explained. Bending the cylinder while stretching the material means that we are still in the elasticity area (force less than  $F_1$ ), which means that either we remove the stress or equalize it the cylinder will be straight again. Whereas if the cylinder should have been bent by force we would have been above the force  $F_1$  and the cylinder would have been permanently damaged. This is why we can straighten the cylinder by using more force on the caulking material WHERE THE CYLINDER IS LOWEST.

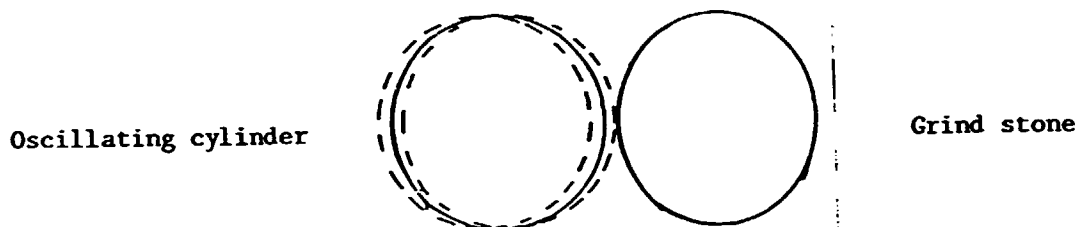
) FIG.10

Oscillating grinding picture

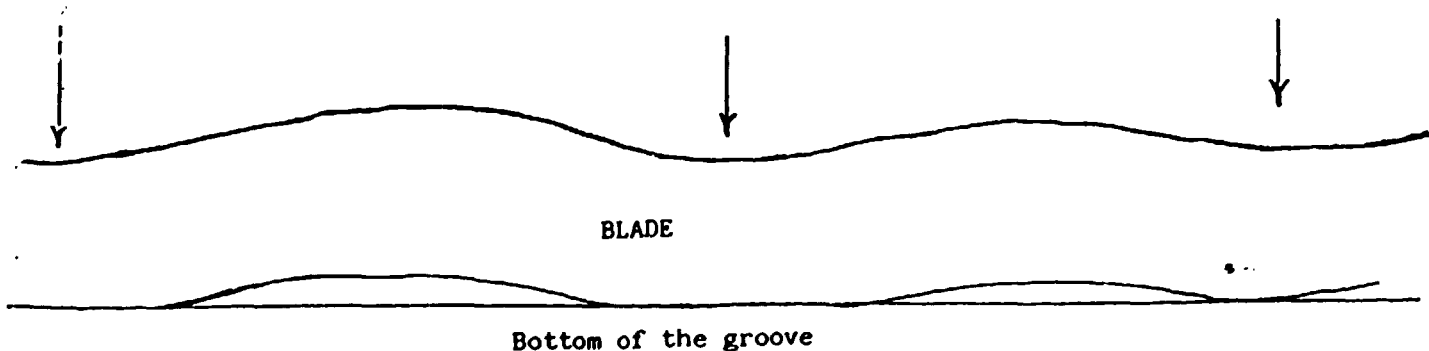
FIG.13 A.

This is a typical re-blading problem. Normally it is caused by the operator who is moving the vice or clamp too long a distance in between each time of locking the blade. Very few blades are having a perfect fit to the diameter being the bottom of the groove. The blade will tend to be slightly bigger. This in many cases gives us the picture illustrated in fig.13 A. The correct picture is shown in fig.13 B.

The length of moving the vice (along the blade) should not be more than 10-12 cm if we want to be certain that the blade is in the bottom of the groove. If the blade fails to be in the bottom we can imagine one of two results. Both shown in fig.14 A and B.

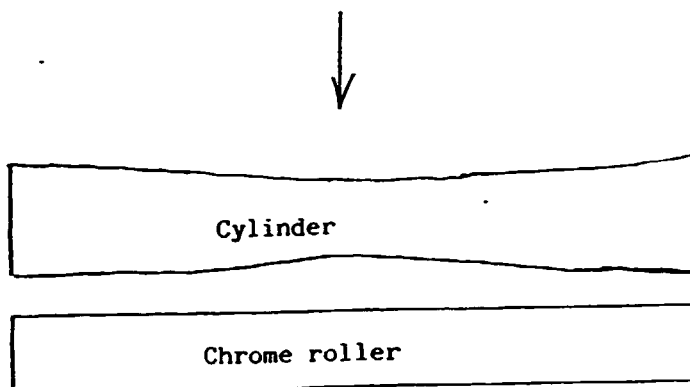
FIG.15 Shows the cylinder shape after centre feed only.

The bad shape of the cylinder shown in fig.15 will also be the shape of the shaved leather. Newer machines have solved this problem by having feed adjustment in several places.

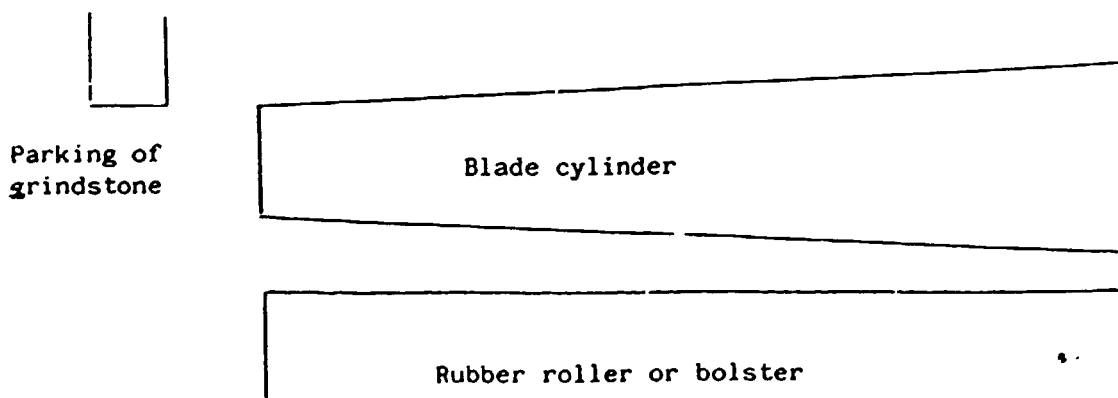
FIG.16.

Most grinding errors takes place in fleshing machines. By any unknown reason fleshing machine operators are never happy with the grinding unless the sparks are illuminating the entire machine. As to what we have just said about the stone wearing off, in fleshing machines the cylinder will look like the illustration in fig.16.

Blade cylinder ground conical

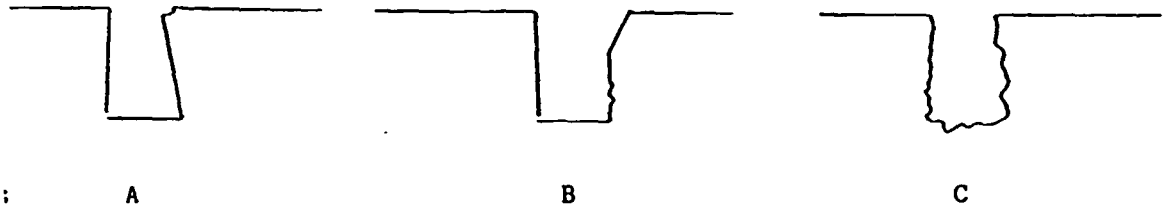
FIG.18

When all the blades are out we need to clean the grooves. Due to damage done in earlier re-blading or during de-blading we often find grooves shaped like those in fig.18 A,B and C.

The worst of these grooves are groove B. This as we want to repair the grooves and the only way we can do so is by removing material. We have to file the groove back to shape. Groove B can only become bigger so we either need a thicker caulking or we have to scrap the cylinder.
