**TECHNICAL AND ECONOMIC ASSESSMENT OF
THE VIABILITY OF REACTIVATING /
COMMISSIONING THREE INCINERATOR PLANTS
IN LAGOS - NIGERIA**

FINAL REPORT

February 1991

**Contract No.: 90/075
Project No.: SI/NIR/89/806**

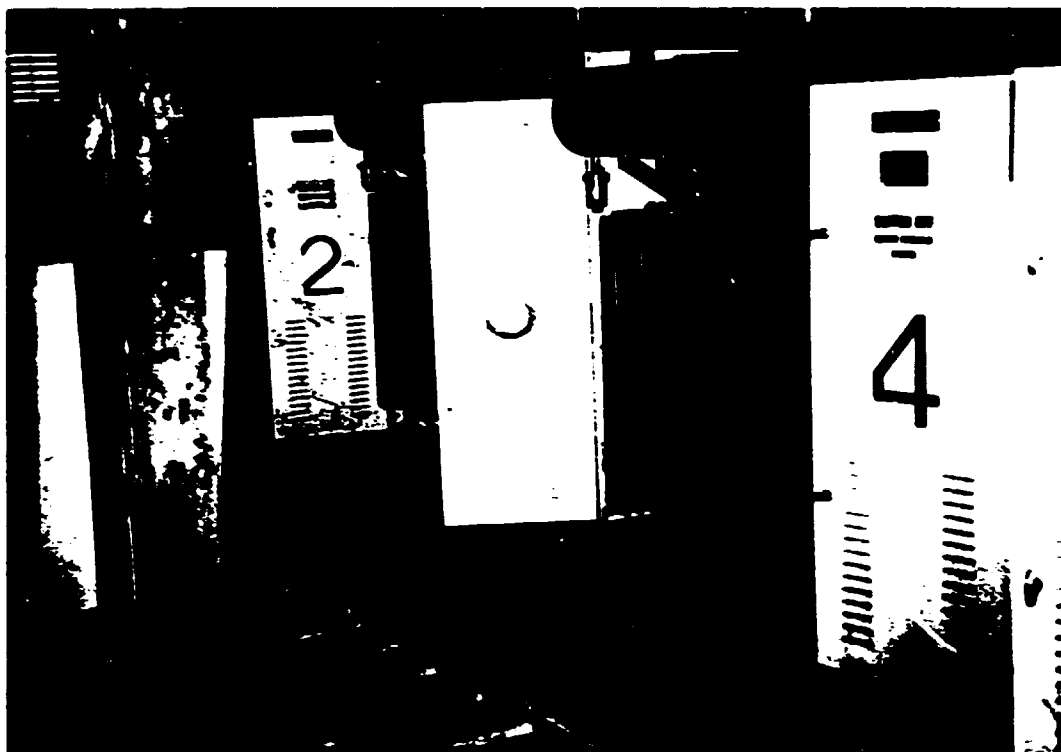
VIEW OF UNDER FURNACE AREA
SLAG TANK (NOTE: COMPLETELY
EMPTY)
