HIGH LEVEL CONSULTANCIES AND TRAINING

DP/SYR/86/009

Technical report: Maintenance and operation of mechanical
components in fertilizer plants*

Based on the work of Zoltan SZABO, expert in maintenance
and operation of mechanical components

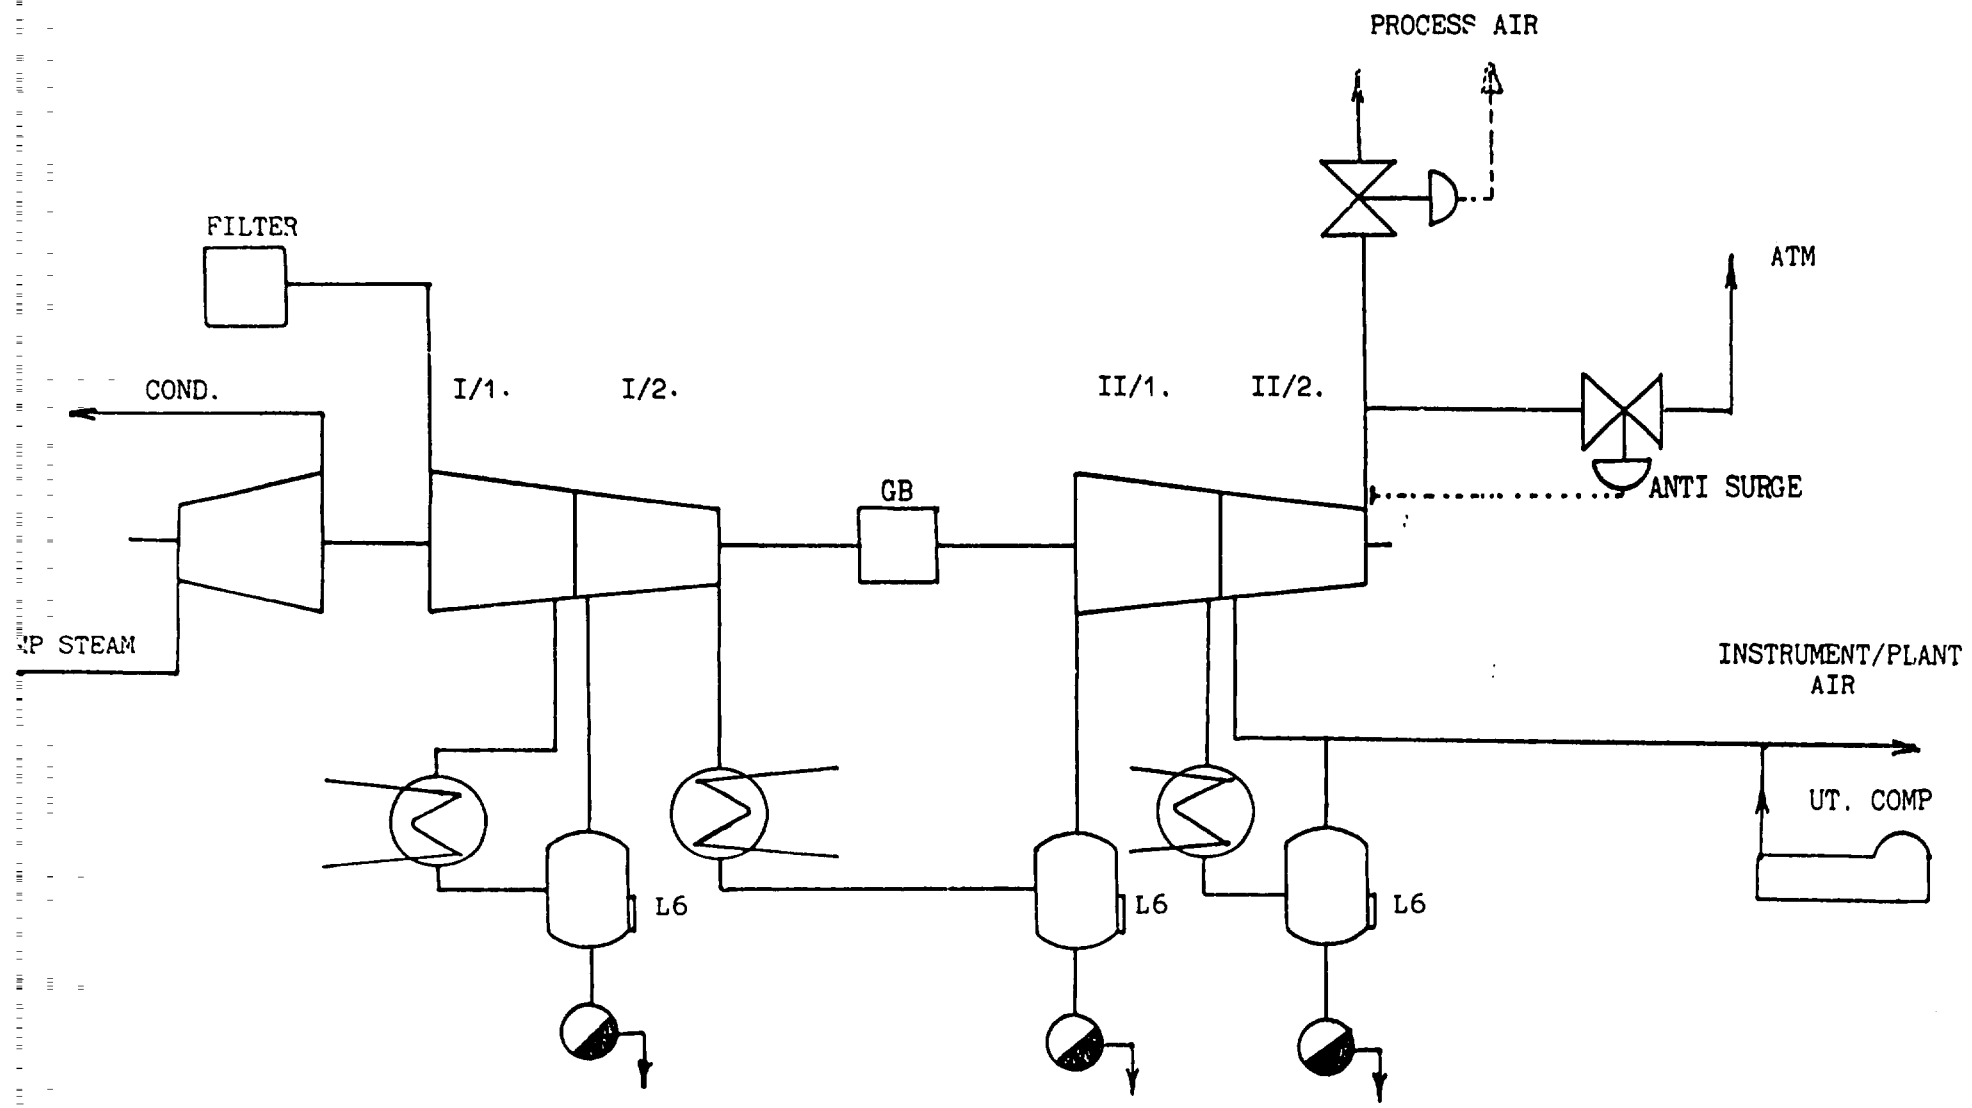
FIG. 2

The simplified adaptation flow sheet of compressor 101 JT is shown in Fig. 2.

The actual status of the compressor at the beginning of April, 1989. Neither the low pressure stage nor the high pressure stage have been opened from the start-up of the Unit. The outlet pressure was dropping day by day, putting in danger further operation. Considering that a complete overhaul is foreseen in about 3 weeks in order to change all refractories at the burners of the primary reformer, the management was advised to act as follows:

- a) Neither of the knock-out drums (or very few) are operating properly. The level controller instrument loops are out of order and the mechanical traps are also in bad condition. As a result of the above, the operators can choose only between the following two possibilities:

- b) The interstage labyrinth seals between the impeller and the stator, furthermore the shaft-mounted guide-vane seals are totally destroyed.

- reduce the instrument air system pressure from 7.9 to 5 barg
- start the instrument air compressor and separate the instrument air system from the process air compressor. (It is a faulty view that the so-called "stand-by" compressor is needed only for the start-up of the Unit.)
- reduce the anti-surge blow-down rate with maximum 5 %. (In the future it would be convenient to reduce the anti-surge blow-down consulting the way with the manufacturer because the present blow-down is too much and this is a complete energy loss.

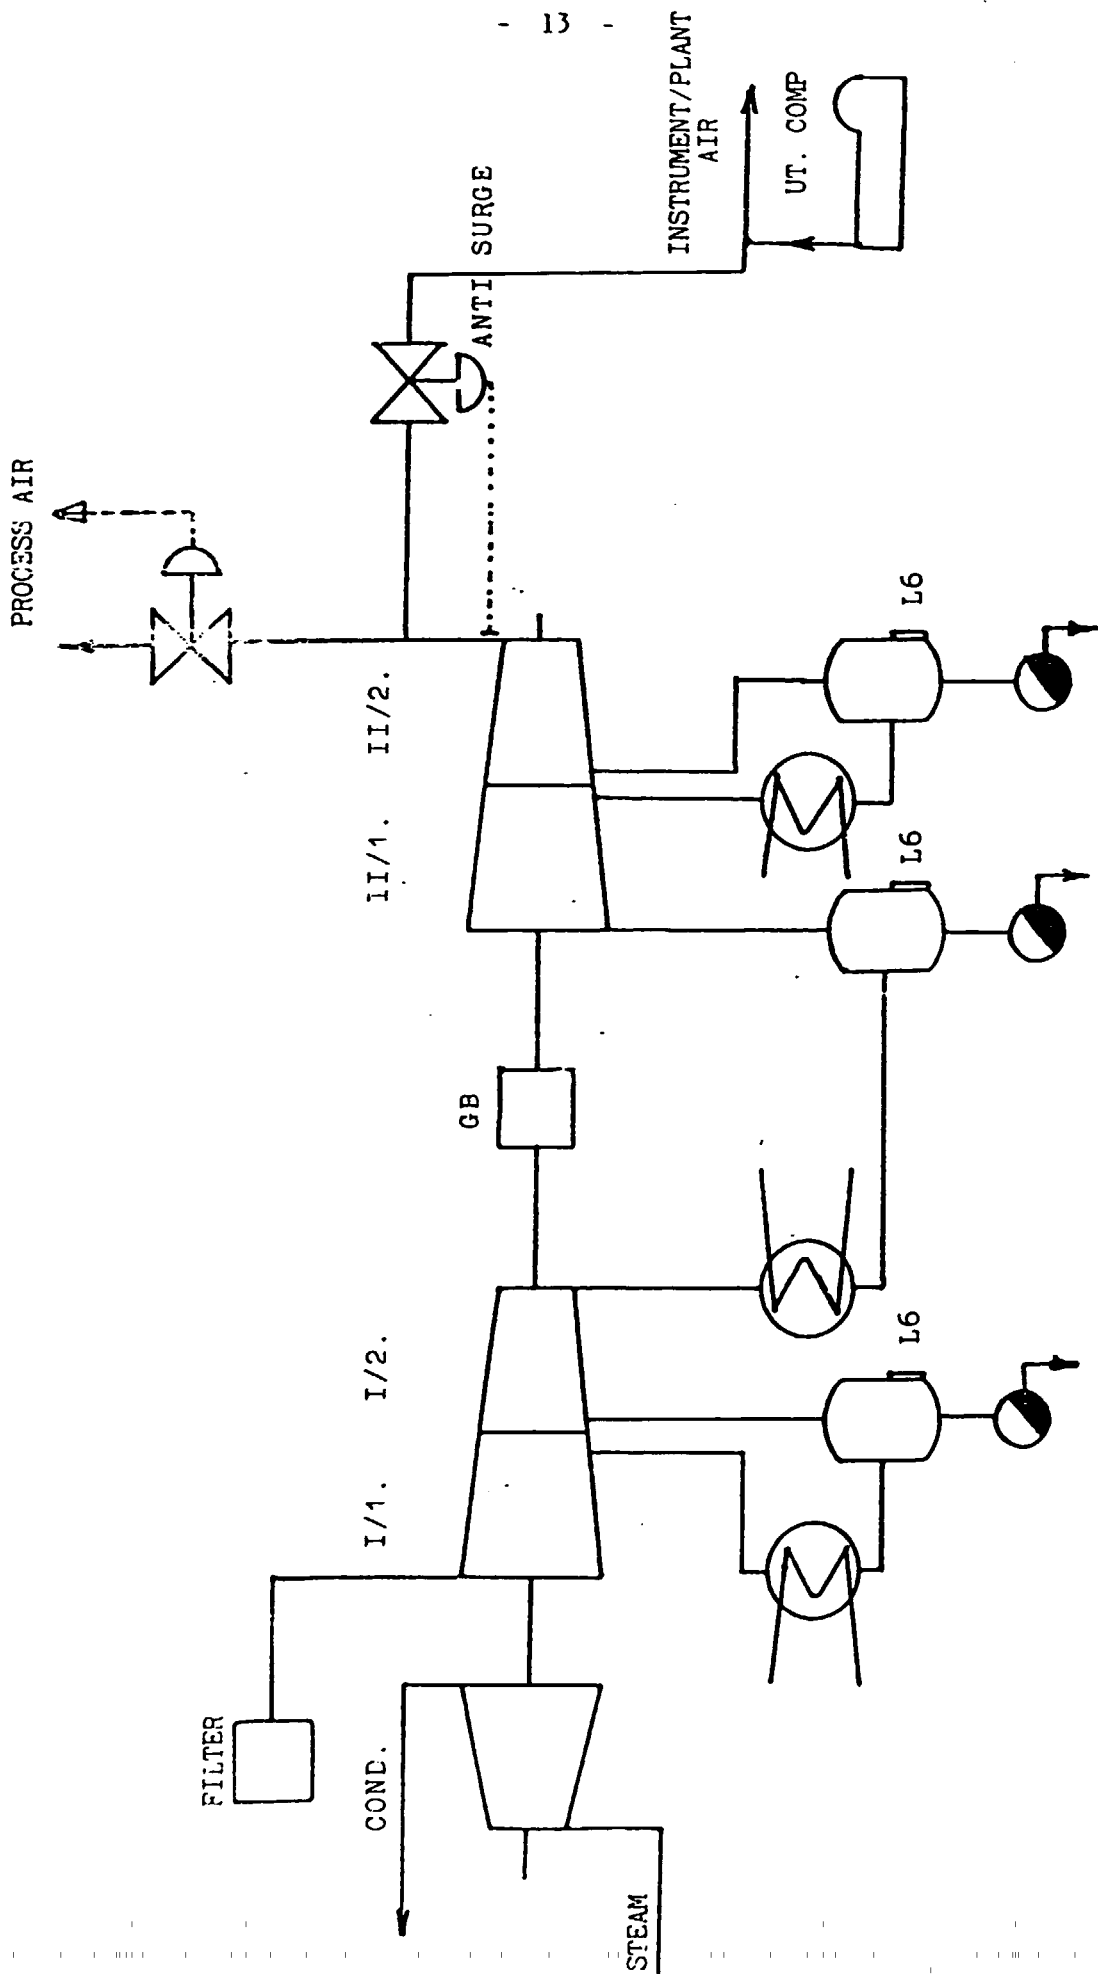
FIG. 3

One of the possibilities is shown in Fig. 3:

Use the anti-surge blow-down as a basis of instrument and service air supply for the whole Company with a common air receiver and eliminate the interstage bleeding.)

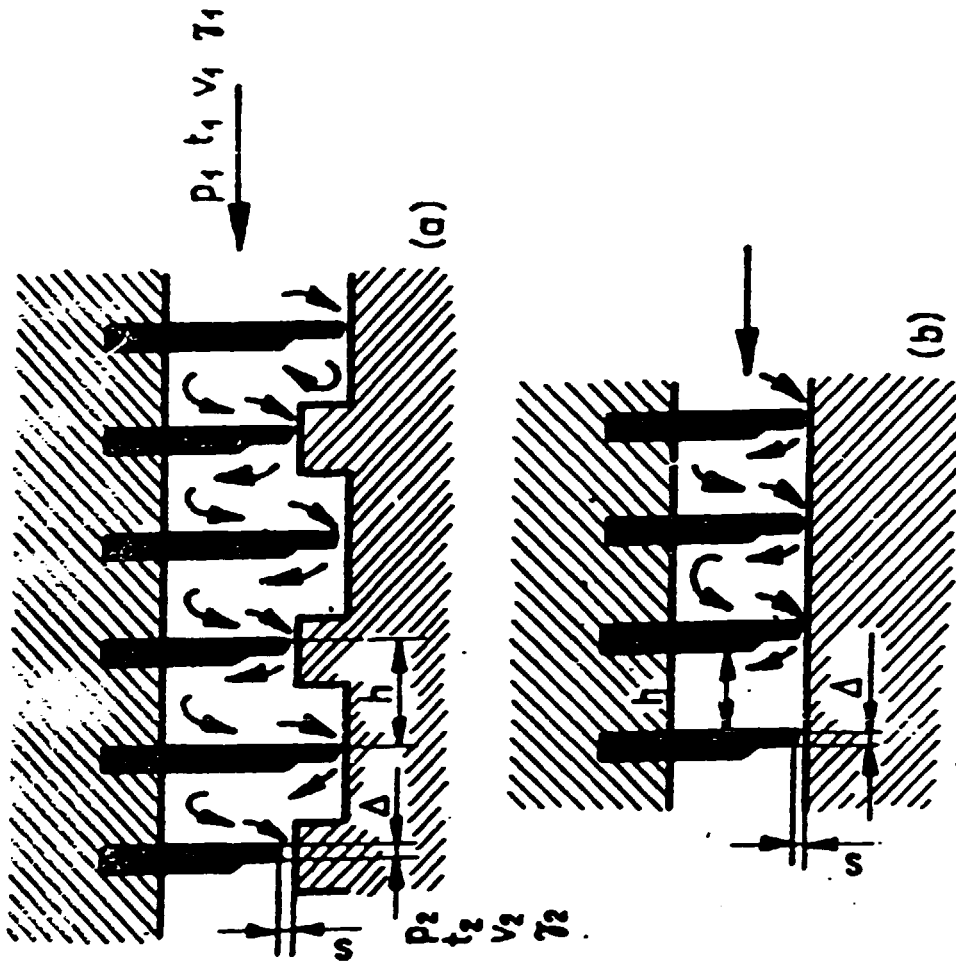
FIG. 4

Considering that the Company intends to produce the spare labyrinth seals locally and the damaged labyrinth seals would be one of the main reasons for the reduction in discharge pressure, some theoretical and practical information are given herebelow: The principle of the arrangement of labyrinth seals is shown in Fig. 4.

The labyrinth seal may be of stepped (a) or plain (b) construction. The sealing action of the labyrinth seal is ensured by the adiabatic expansion of the gas in each chamber.

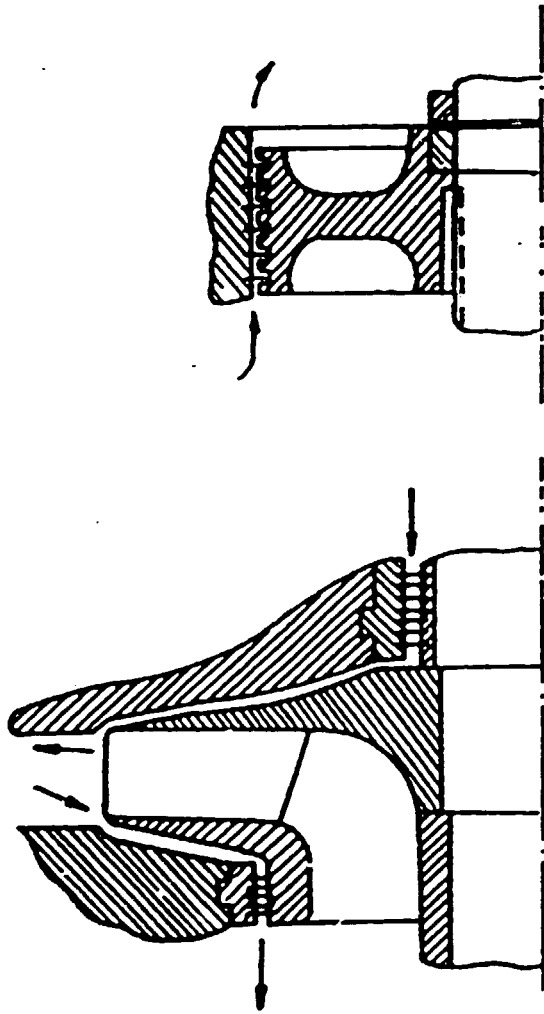
FIG. 6

The usual application of the interstage labyrinths is shown in Fig. 6. The cylindrical surfaces of the ring on the shaft and the impeller against the labyrinth strips are also attrited.

It is recommended to check and re-finish these surfaces, if necessary and/or possible.

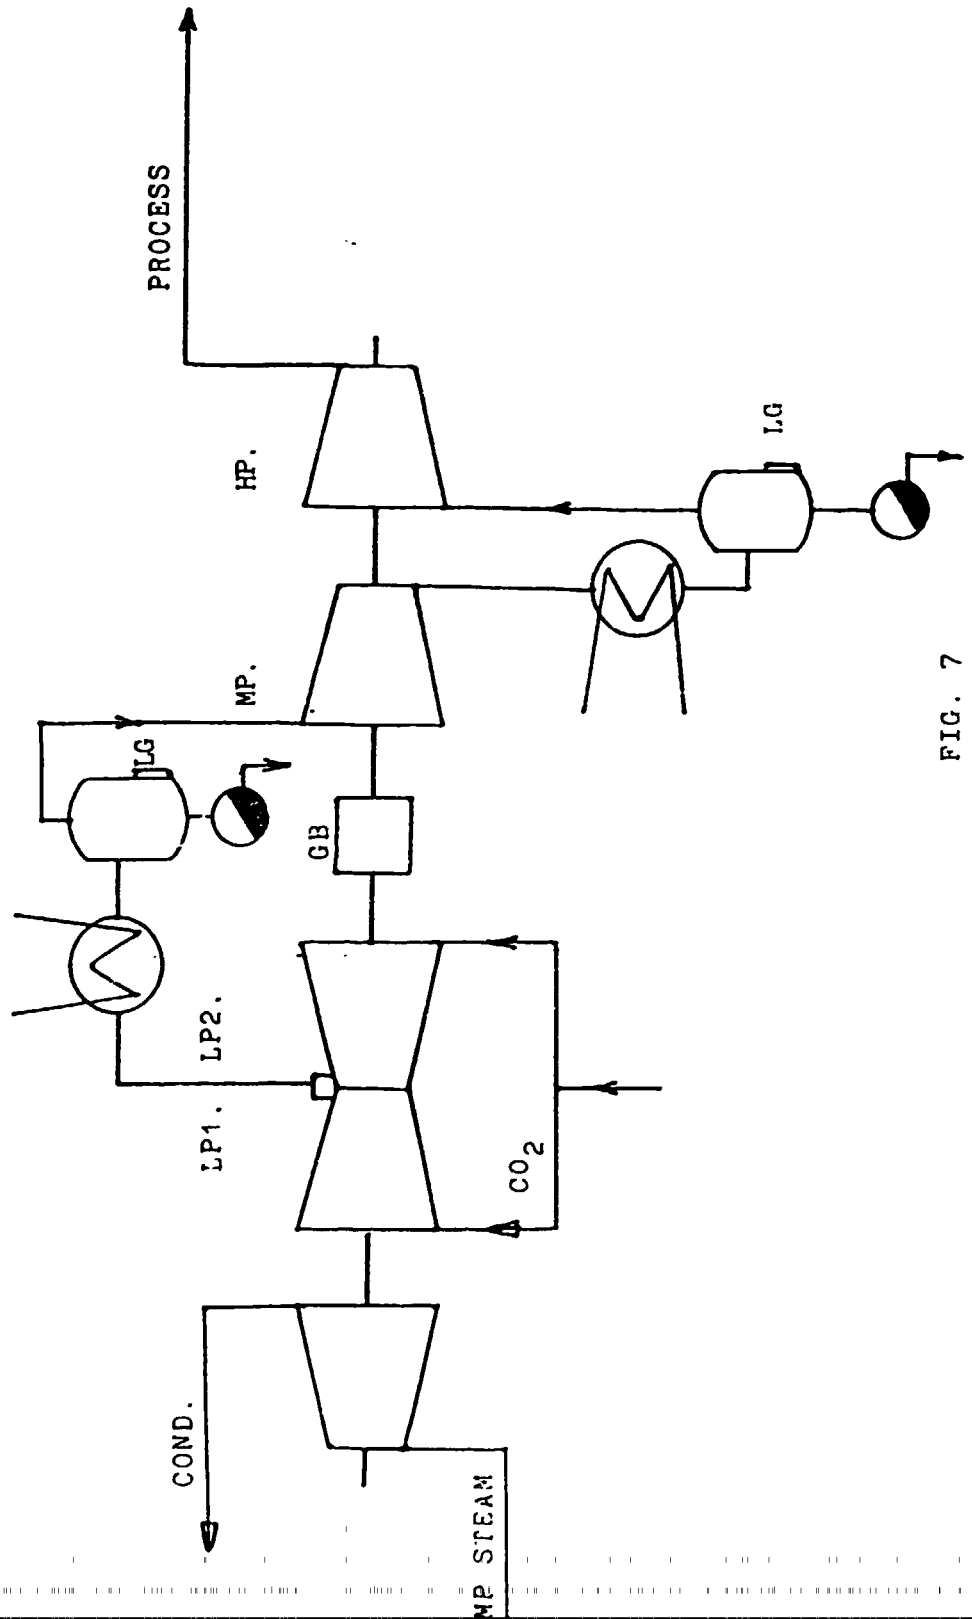
FIG. 7

- knock-out drums are not operating properly because of the level controllers' failure,
- the labyrinths are attrited,
- the O-rings between the stages and also between the rotor block and the casing are loosing their elasticity and with this the capability for sealing.

This is because moisture drops enter the compressor absorbing CO₂ and carbonic acid is formed. The carbonic acid at this pressure is very corrosive. To increase the life-time of these O-rings the following steps are to be taken:

- = do the proper maintenance of the level controller of the knock-out drums, and inspect/service them regularly,
- = contact directly the manufacturer of such sealing materials to find the most suitable material for this service.
