PROGRAMME OF DIRECT SUPPORT TO INDUSTRY IN DEVELOPING COUNTRIES:  
FACT-FINDING AND PROJECT IDENTIFICATION MISSIONS

Technical report: The cement industry in Nicaragua\*

Prepared for the Government of Nicaragua  
by the United Nations Industrial Development Organization

Based on the work of B. Bülow Andersen, mechanical engineer  
and A. Nérholm, process engineer

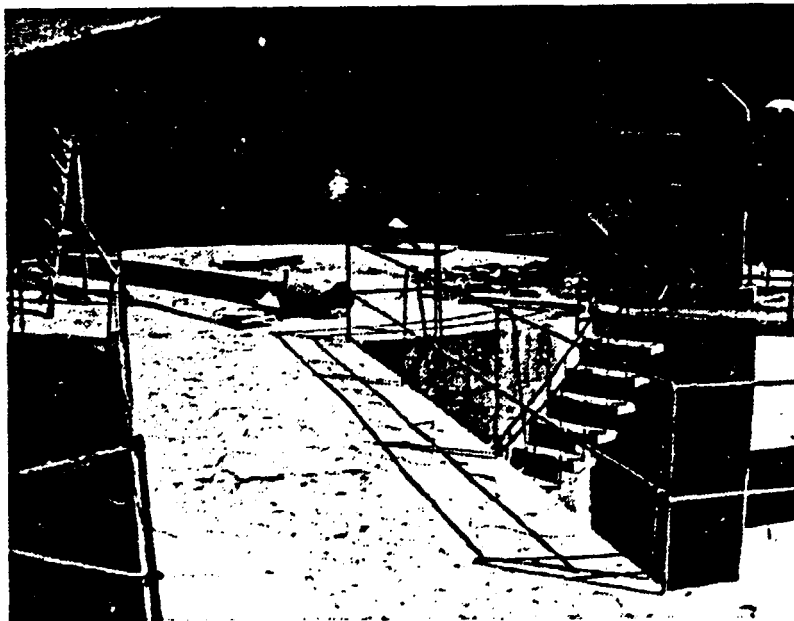
Still functioning, but the situation is critical. The mechanical performance level of the drive stations, dampers and associated screw conveyors is not satisfactory. On the silo roofs bits of screw sections were observed in dismantled state, which makes it impossible to fill all the compartments of the silos.

Roof of clinker silo. Note dismantled screw for distribution in silo compartments.

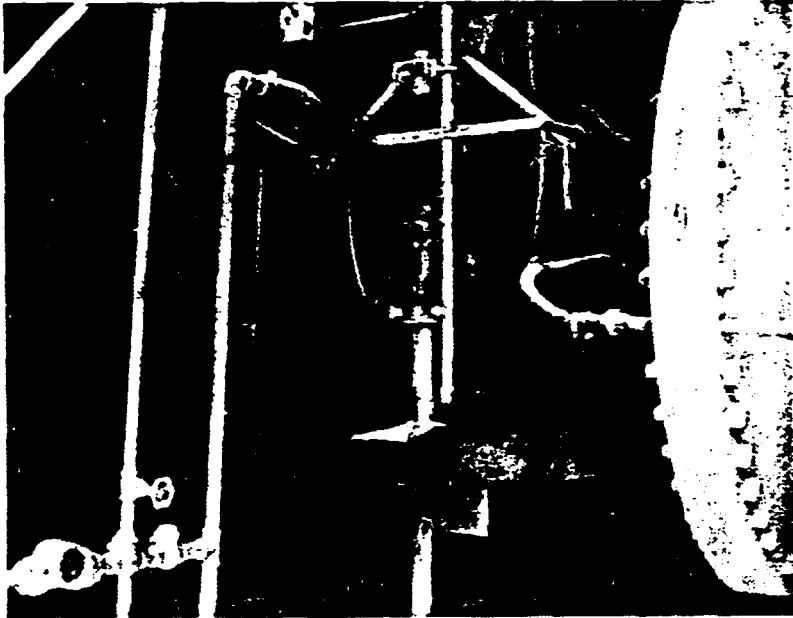
The condition of the water injection system is so poor that a reconditioning of the system will hardly be worthwhile. Servo-operated dampers for regulation of the air flow through the mills are without connecting arms to motors, but are regulated by strokes applied by hammer. Extensive oil spill observed at gear rims.

Water injection system, cement mill no.2.

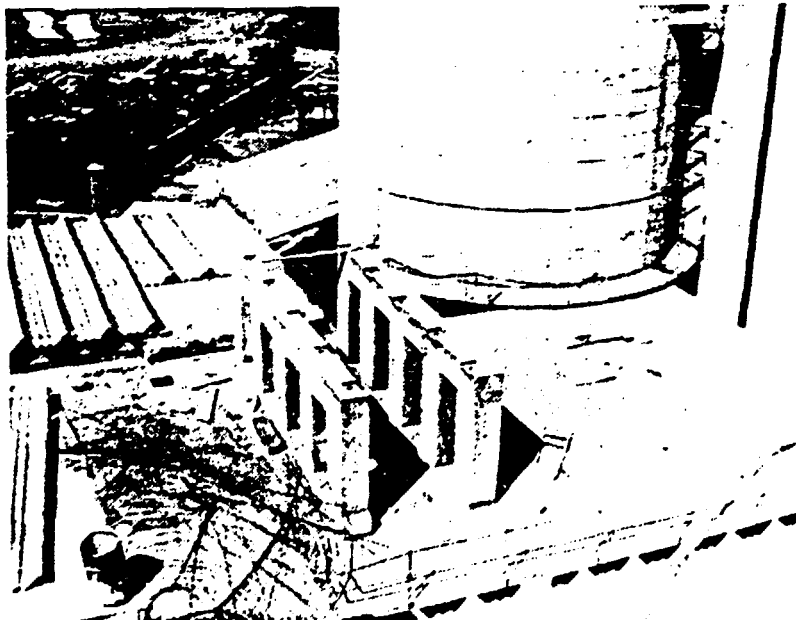
The electrostatic precipitator for the mill has not been installed. The mill will go onstream without the precipitator installation. (Enclosure No. 59).

Baseplate for missing electrostatic precipitator for cement mill no.3.
