Distr.
LIMITED
ID/WG.333/6
13 November 1980

Interregional Meeting on Safety in Production,
Transportation and Storage of Fertilizers
New Delhi, India, 8 - 10 December 1980

IN-HOUSE TEAM IMPROVES SAFETY, PRODUCTION AND
PROFITABILITY *

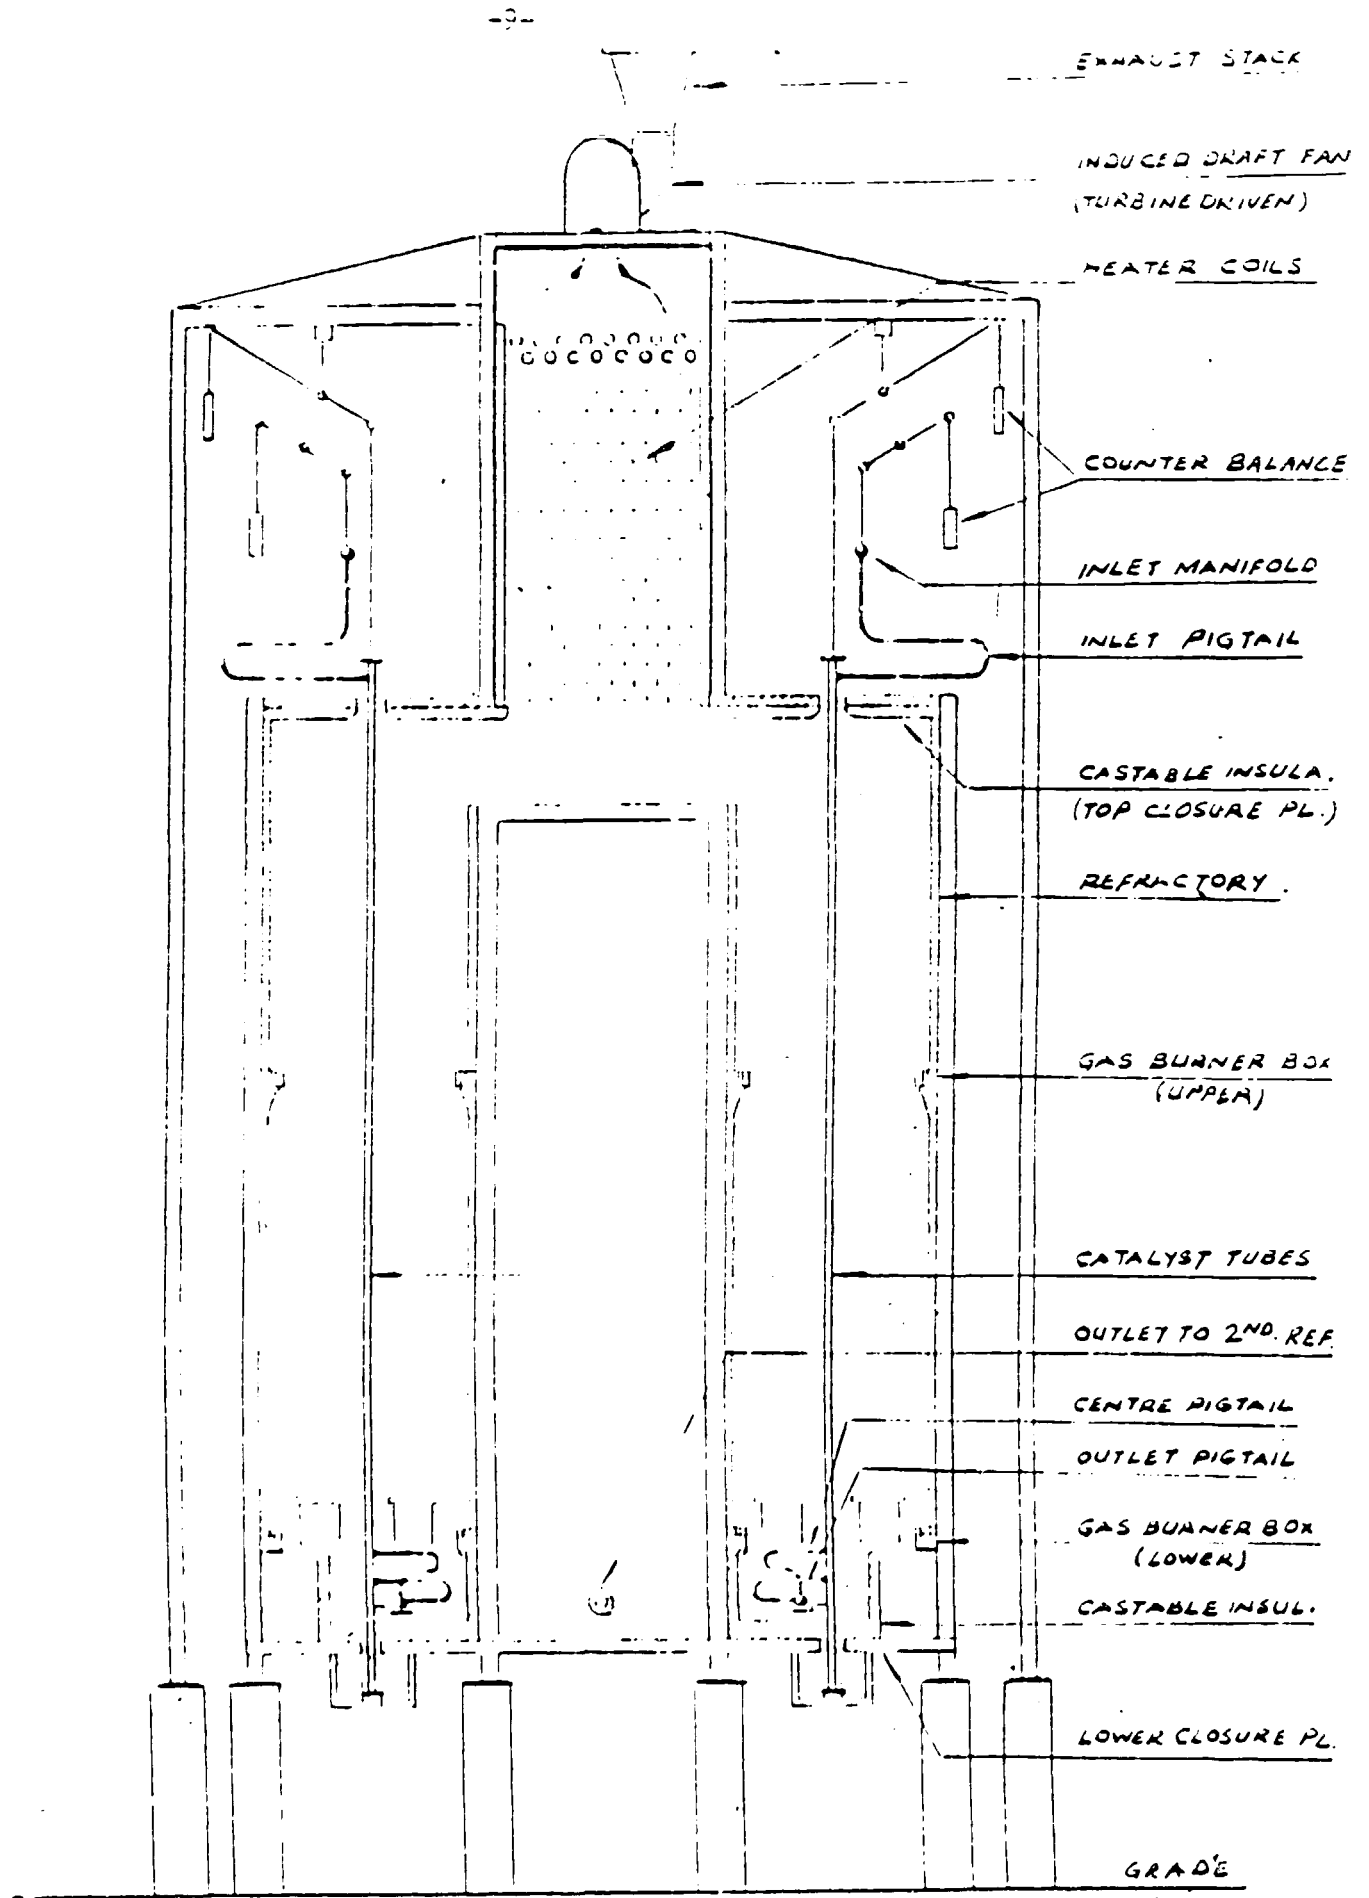
FIG. 1

In the original design the two cell, side wall fired, Alcorn primary reformer furnace had top and bottom flanged catalyst tubes. The tubes were butt welded to 1" Sch 40 Incoloy 800 pigtails which were also butt welded to the outlet collection manifold. Details are shown in Figure 1. The original pigtails configuration is depicted in Figure 2, which shows that the center pigtails (total 16) had two bends and the regular pigtails (total 160) had only one bend.

Pigtail cracking posed a significant problem due to this configuration. Cracks were propagated as the tubes and header changed position due to heat during furnace operation. Cracking was first noticed in 1970 in the heat affected zone at both tube and outlet header with circumferentially and in some cases the cracks extended through the wall and the pigtail.

By 1975, the magnitude of furnace tube failures went on increasing and became such a serious problem that a special crew was assigned round the clock to nip pigtails.

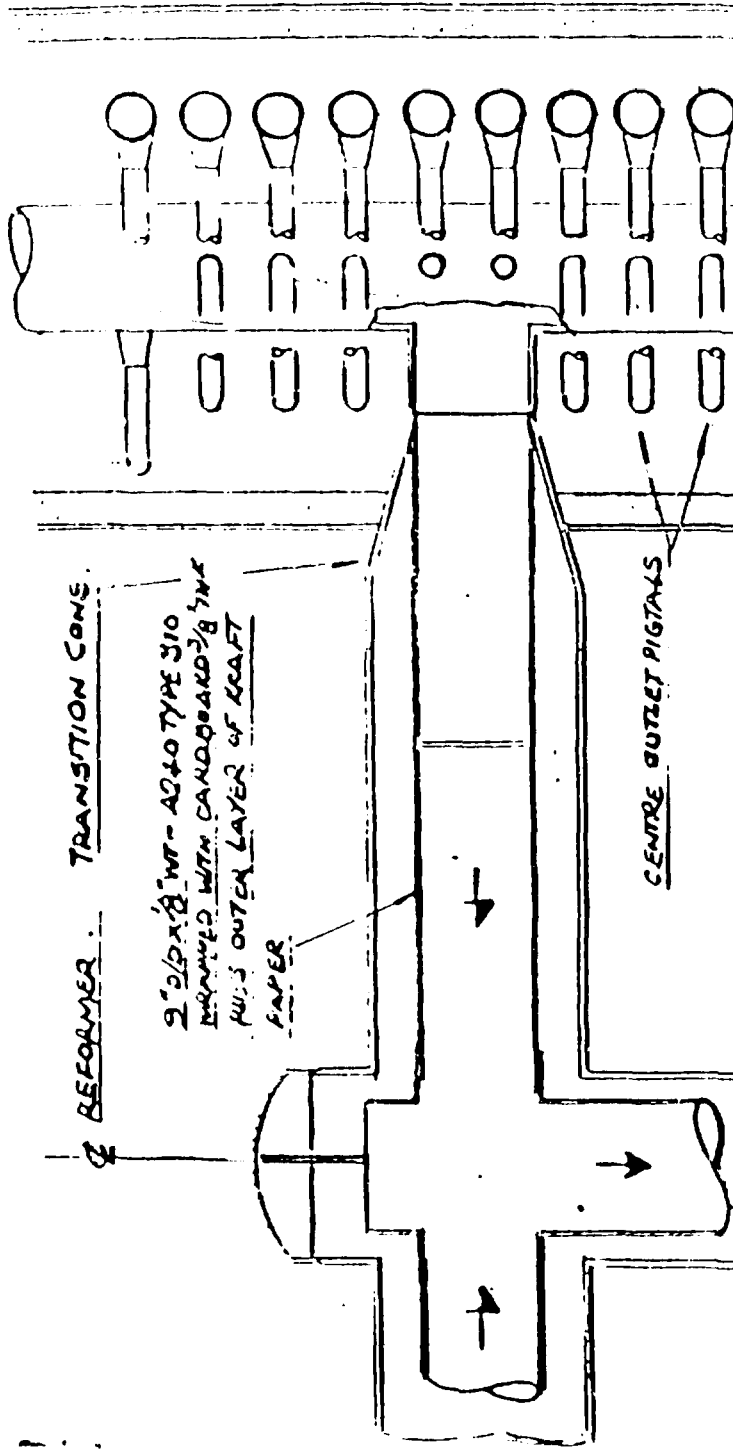
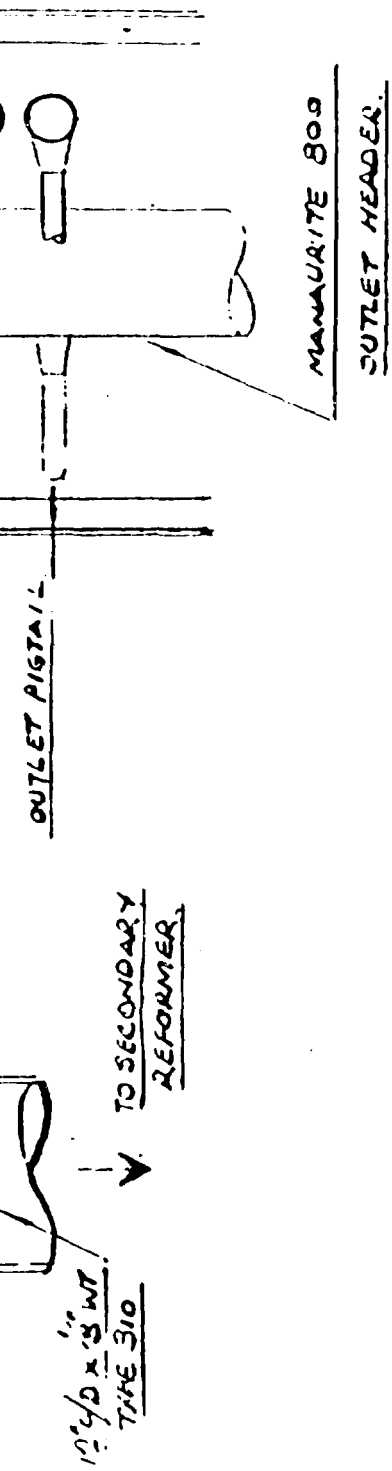
SECTION THROUGH OUTLET TO SECONDARY REFORMER. FIG 3.

This problem propagated and developed further failures. In 1974 a crack was discovered in the weld between the outlet "Tee" and the reducer to the transfer line on west box as shown in Figure 3. In 1975, the first catalyst tube failed due to a 8" vertical split. Fortunately this tube was located 4" from the north wall away from other tubes.

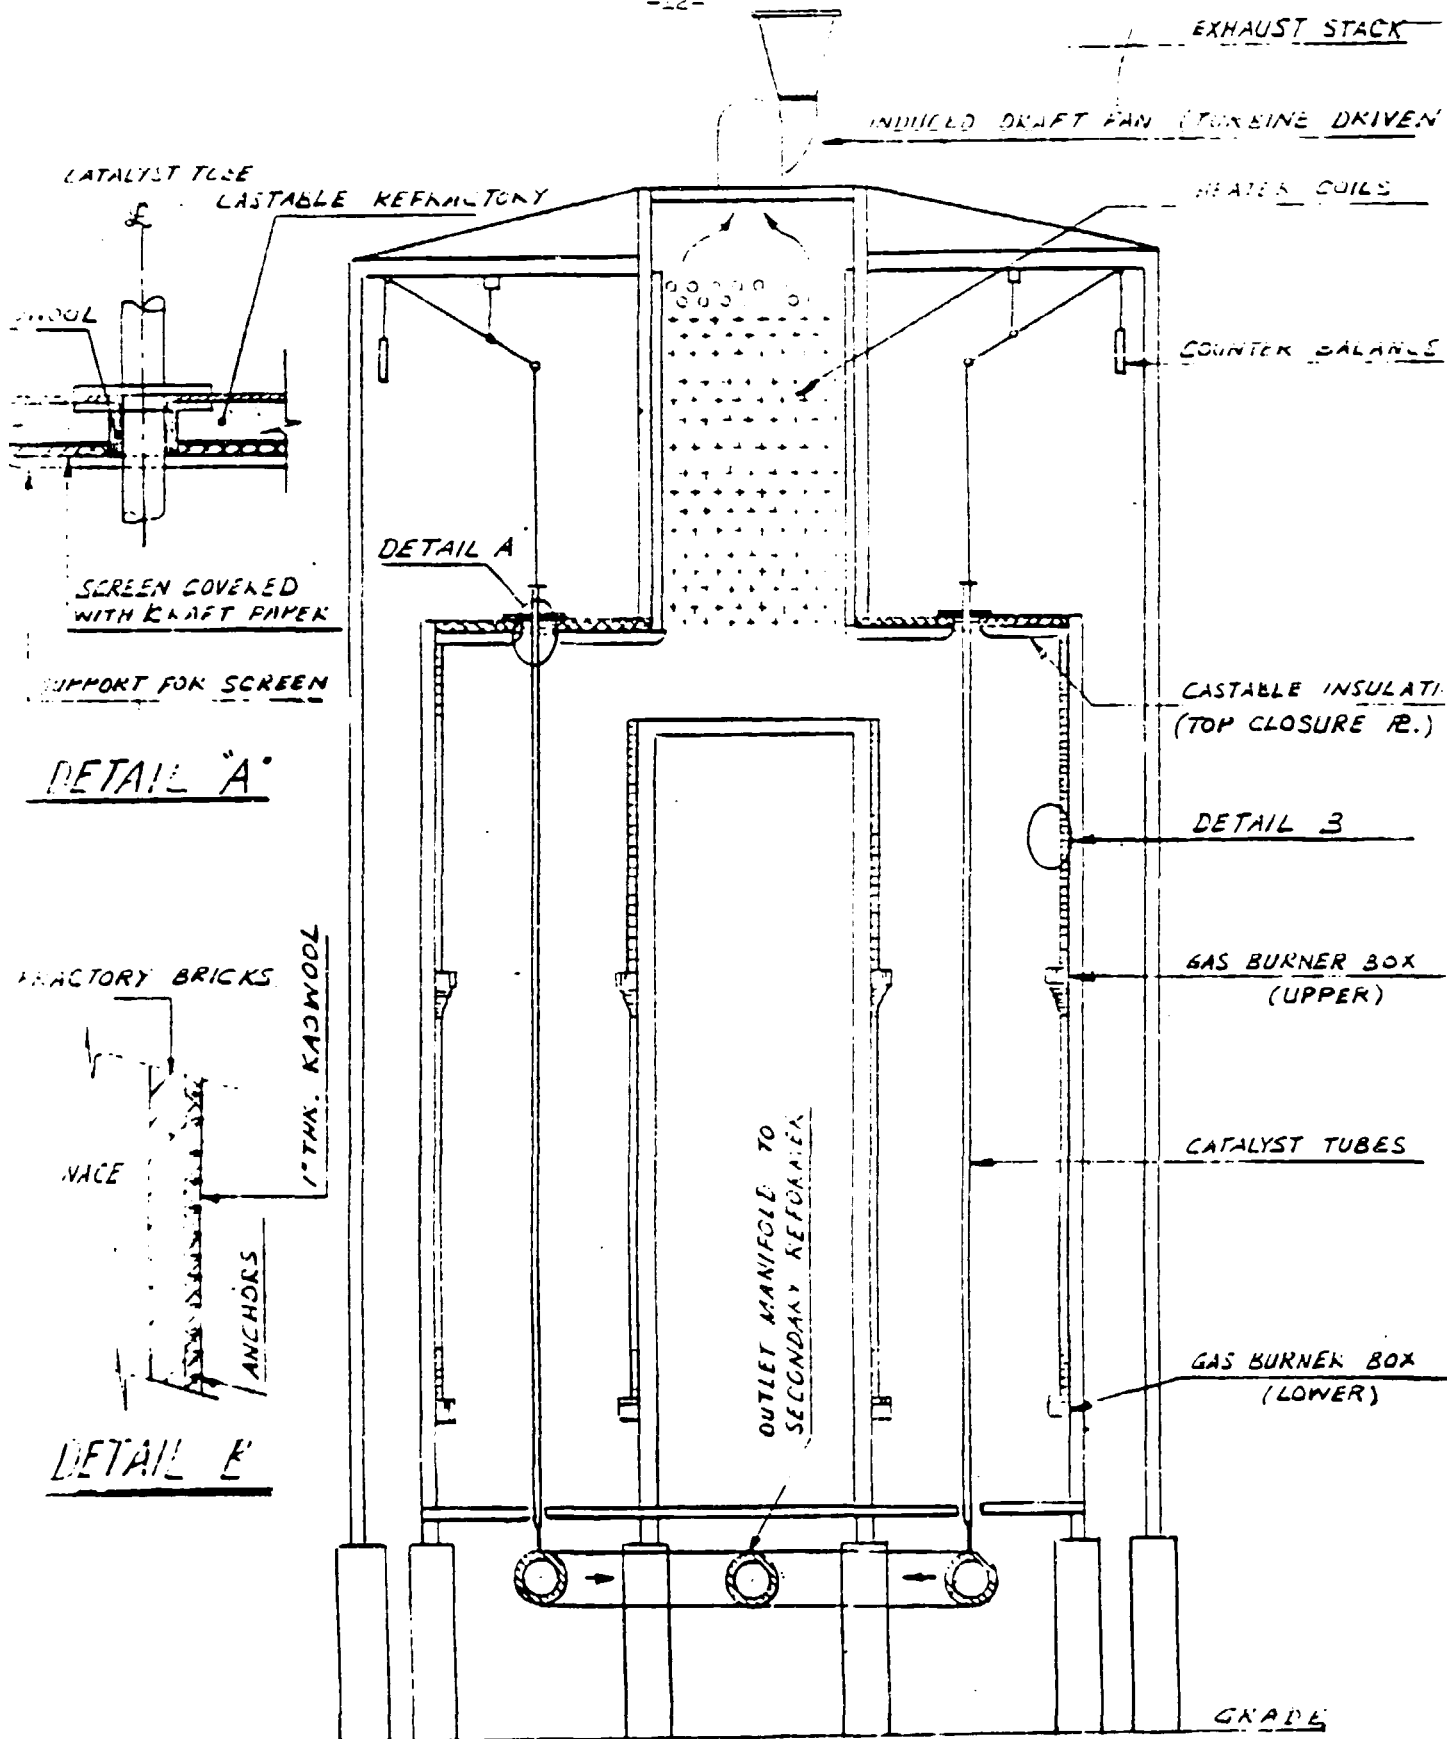
FIG. 4

Safco had considerable problem with refractory on the vertical walls of the reformer in the area between the top and bottom burners. In this region refractory bulged and the bricks around burners collapsed.

Failure of the arch bricks supported from roof structure, caused the bricks to fall down and leave a wide gap. The hot gas would weaken the support of other bricks causing them to fall thereafter.

- c) The reformer catalyst tube top seal arrangement was modified as shown in Figure 4 by using Kaowool blanket to provide maximum flexible roof seal. The fire bricks inside the furnace box were replaced by Kaowool blankets with stablizer spray to counter the draft effect.
