Improvement of Steel Making Operations

Three Non-integrated Steel Plants

Arab Republic of Egypt

June, 1977

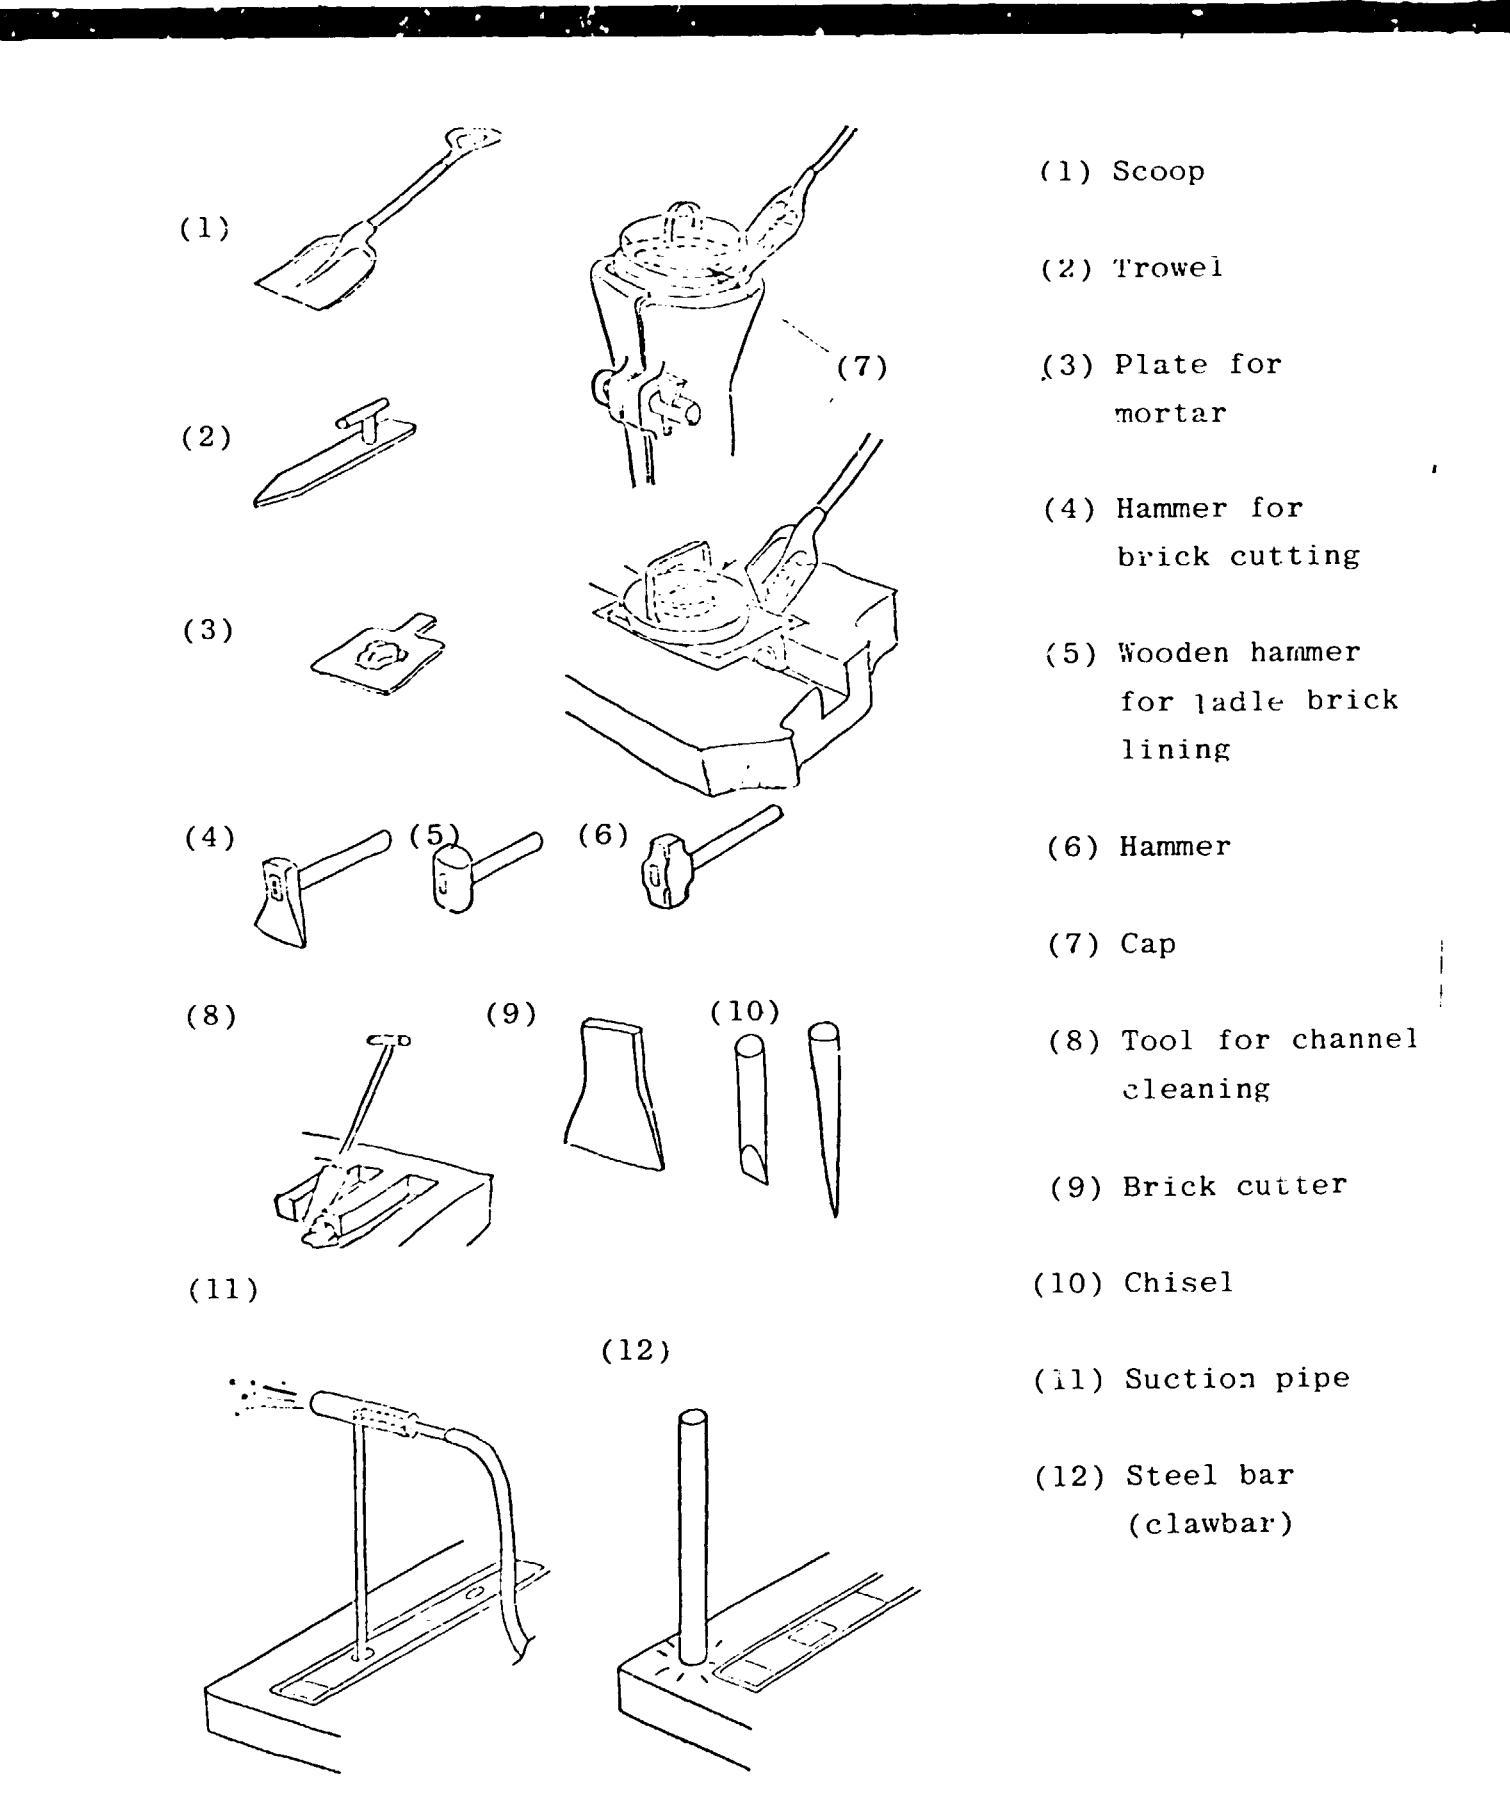
1. Jigs for stool brick lining, pouring tube setting and mould setting. (KOBE)

As preventitive measures, it is essential that stool brick lining, pouring tube setting and mould setting be performed correctly,step by step, with the aid of tools intended for those purposes. (Fig. 1) In order to improve such defective practices, it is recommended as follows:

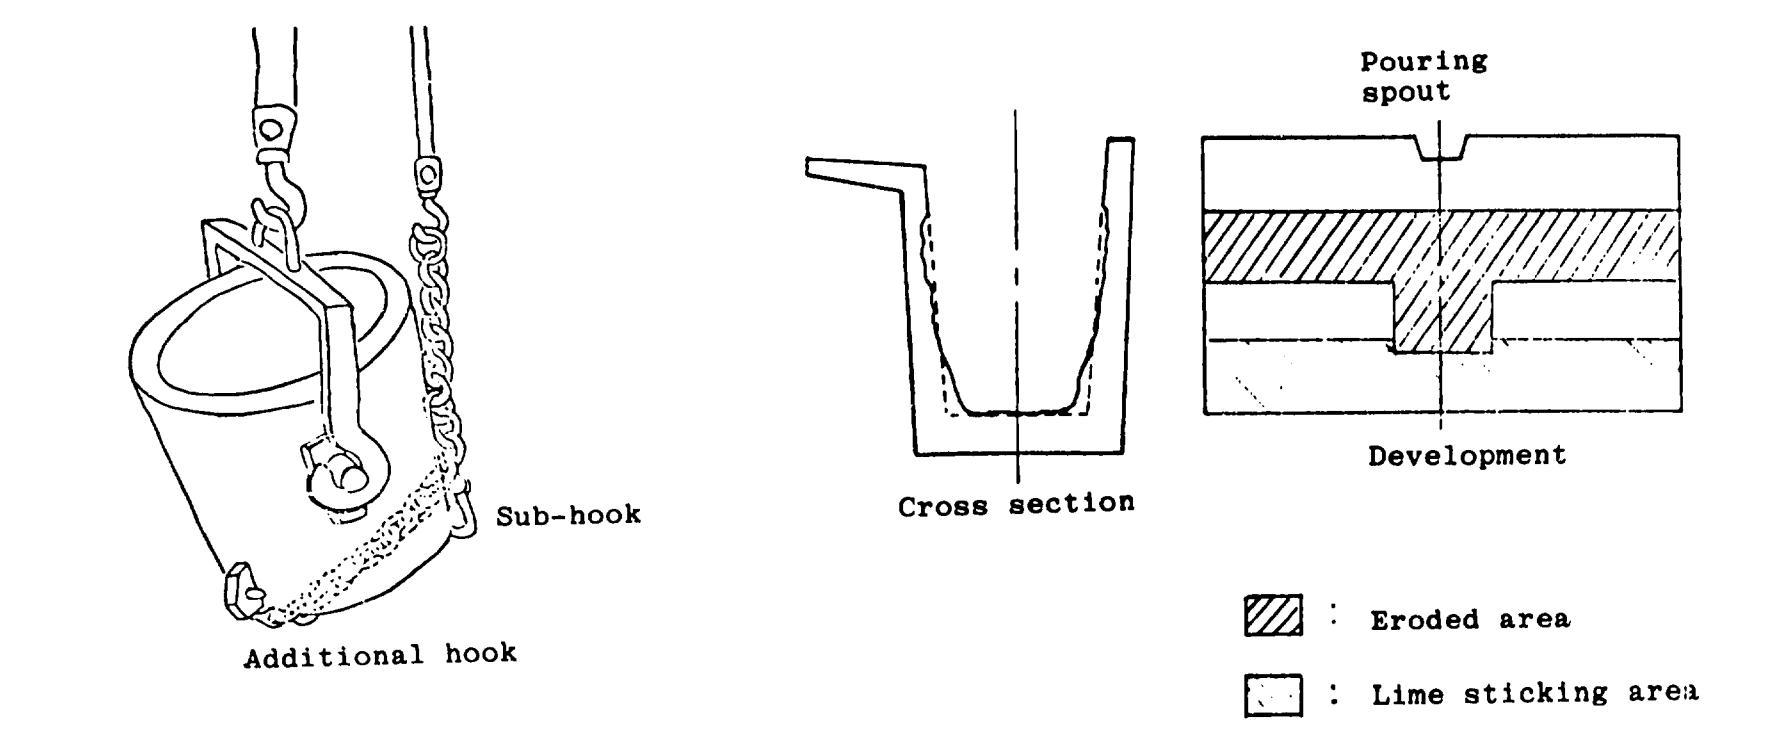
- 29. Additional slinging hook on ladle (KOBE)
- 30. Observed eroded hearth condition of induction furnace eight heats after relining (DELTA)

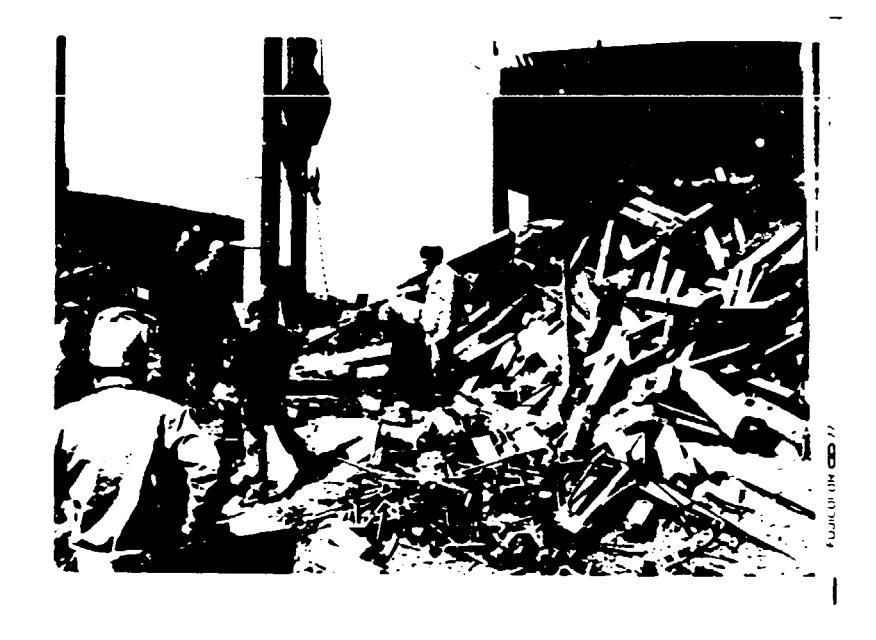
40. Dumped pit scraps and short ingots, not disposed into charging box (NATIONAL)
