Horlivka Chemical Plant remediation

A project for the Ministry of Ecology and Natural Resources of the Government of Ukraine funded equally by the Delegation of the European Union to Ukraine and the Swedish International Development Cooperation Agency, and implemented by the United Nations Industrial Development Organization

Annual Project Report 2014

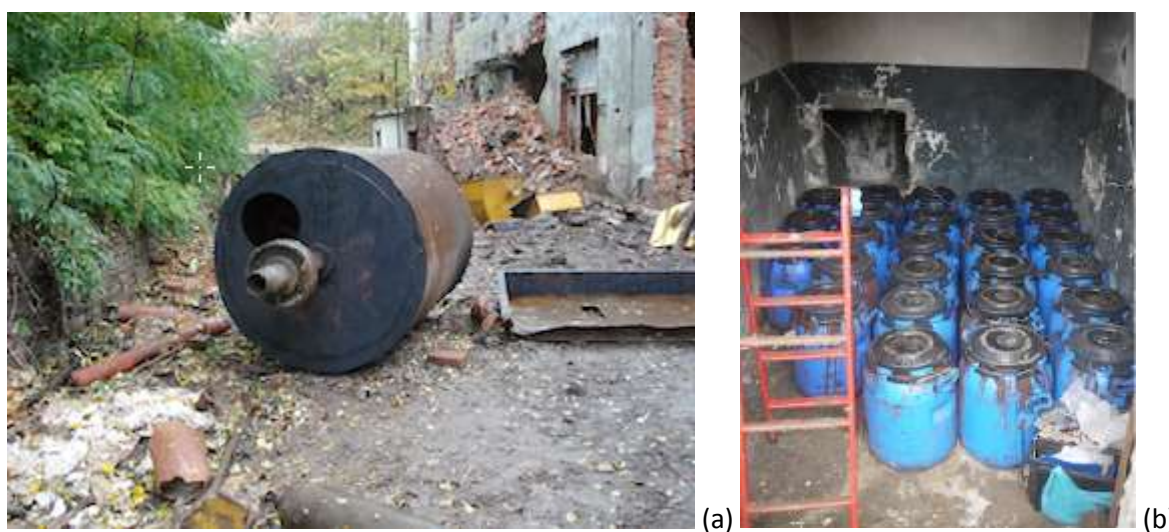
After the toluene was nitrated in building 4b and washed and purified in building 7a, it used to be dried and flaked in building 37b. Two large drying tanks and six large round drums (Figure 1a) used to chip or flake the TNT were dismantled, removed from building 37b and washed. TNT remnants from the equipment were collected and stored in plastic drums in the temporary secure storage facility (Figure 1b). Wastewater from the washing was treated in the wastewater treatment system.

Figure 1: (a) TNT chipping equipment cleaned by hand, steam and flame (to remove trace elements of TNT), and (b) TNT securely stored in temporary storage

- Dismantling of, and extraction of TNT from all equipment and piping;
- Sending all equipment and piping for physical cleaning, steam cleaning and flame cleaning at the designated cleaning site near building 4b; and,
- Collection, packaging and warehousing of TNT production products in the temporary storage facilities.

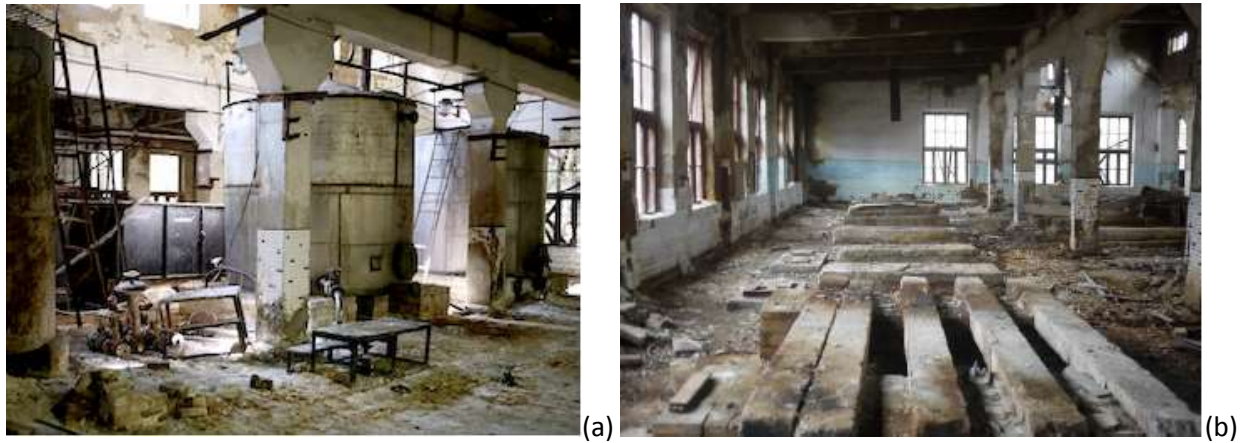
Building 7a contained a number of tanks used to wash TNT and collect acid water (Figure 2a). These tanks were removed, washed and repurposed to create the wastewater collection and neutralization system that the Blacksmith Institute used to treat all wastewater from the site.

Figure 2: (a) Interior of building 7a before dismantling and removal the TNT production equipment, and (b) after removal of the TNT production equipment

- Dismantling and removal of all equipment and piping (Figure 2b);
- Removing of nitric products from technological equipment and pipelines;
- Sending all equipment and piping for physical cleaning, steam cleaning and flame cleaning at the designated cleaning site near building 4b;
- Collection, packaging and warehousing of TNT production products in the temporary storage facilities; and,
- Collection and neutralization of all acidic wastewater.

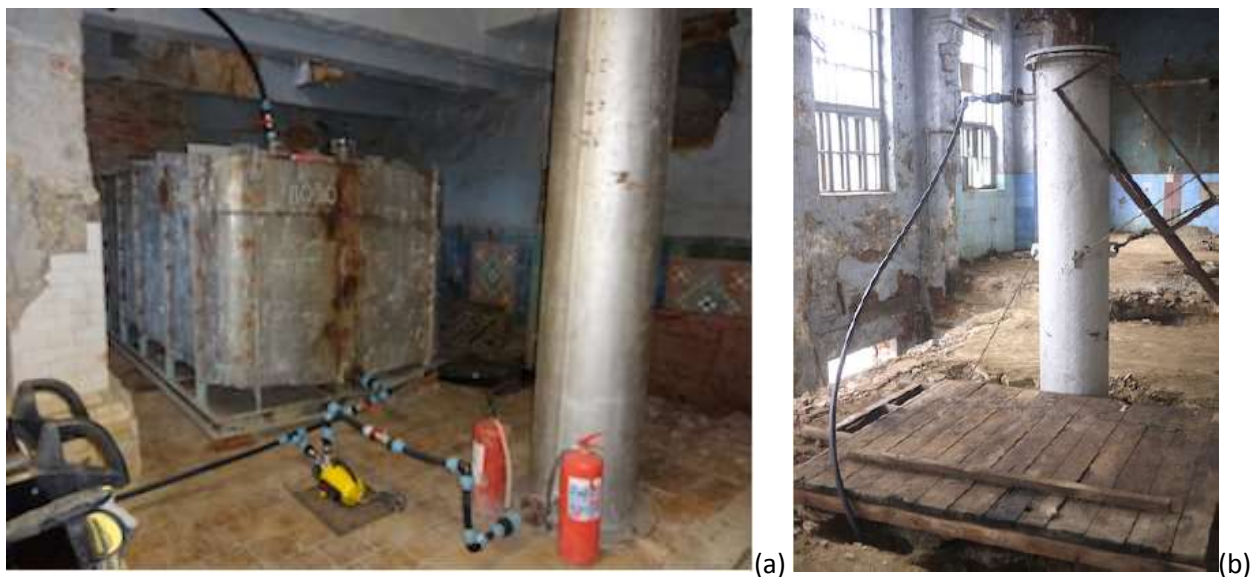
Figure 3: (a) Wastewater treatment and neutralization system, and (b) top of the active carbon absorption column

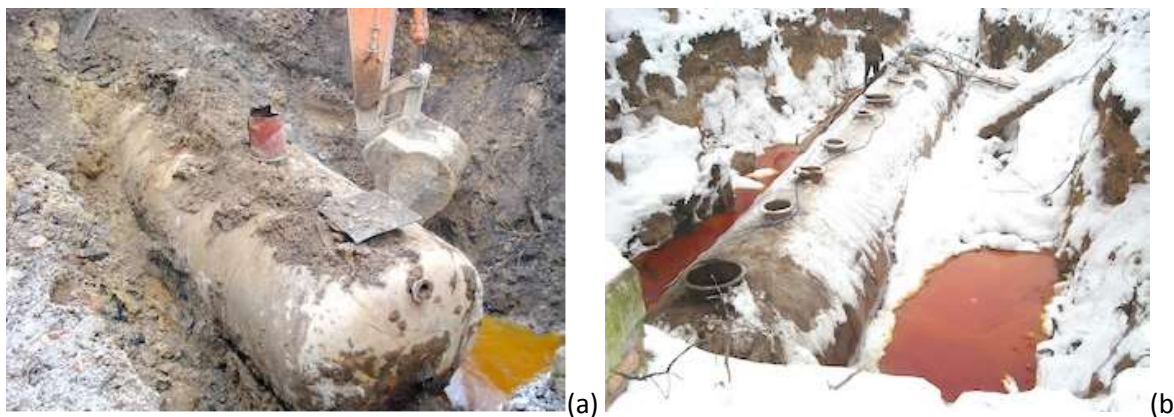
1. Tank structures were compromised over the years and materials moved in and out of the tanks. Acids probably leaked out of the tanks and mud filtered in;
2. The volume of material inside the tanks was roughly twice what had been estimated; and
3. The area around the tanks was contaminated with acids and, potentially, organics components (TNT or precursors) due to holes in the tanks.

Figure 4: (a and b) Excavation of emergency tank

- Clearing all equipment, debris, contaminated dirt and sludge out of the building and storing any contaminated material in the temporary TNT storage facility, including trays and channels used during emergency “flushes” of the TNT production system;
- Construction of a cleaning area outside building 4b where physical cleaning of equipment by shovel and brush, by steam and by flame took place;
- Completion of acid wastewater neutralization system using a soda solution and an active carbon absorption column;
- Soil excavation around the emergency tanks to inspect the tanks and evaluate options for accessing the interior of the tanks and raising the tanks to ground-level (Figures 4a and 4b);

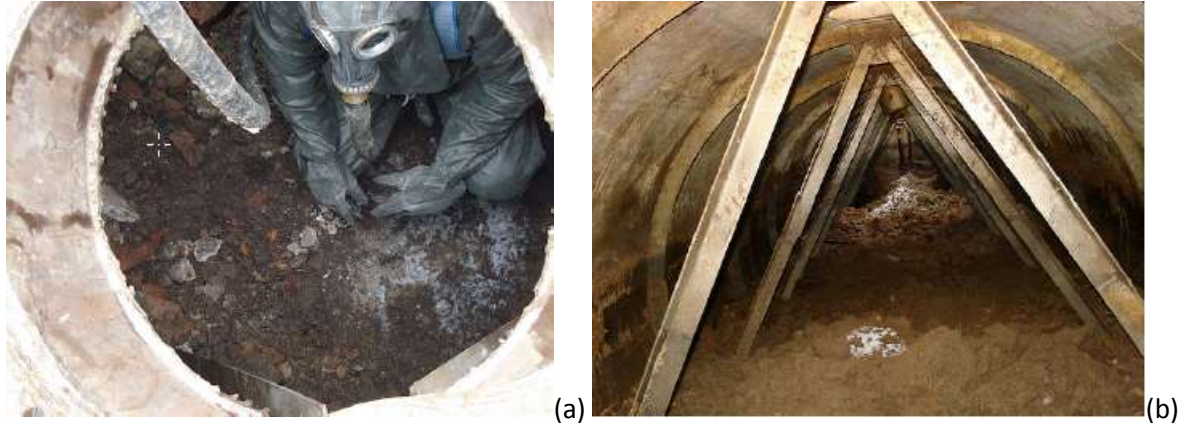
Figure 5: (a and b) Sampling of material in emergency tanks

- Sampling of materials inside the emergency tanks to understand the approximate volume of materials inside tanks and the composition of that material (Figures 5a and 5b). This assessment included an analysis of the material’s susceptibility to explosion by shock;

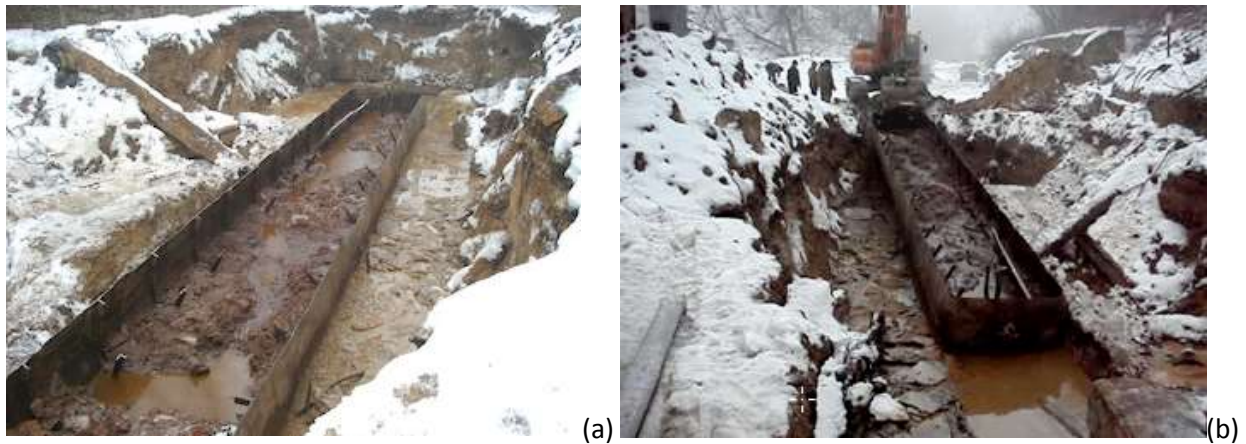
Figure 6: (a) Opening of emergency tanks, and (b) removal from excavated pit.

- Opening the tanks and removing them from the excavated pits (Figures 6a and 6b);

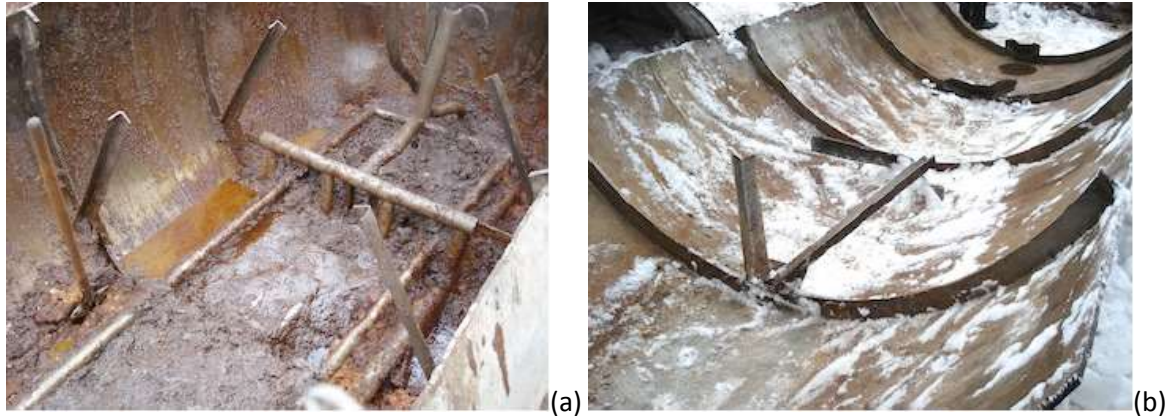
Figure 7: (a and b) Cleaning of emergency tanks

- Removal of acidic mud and TNT materials from inside the tanks (Figures 7a and 7b);
- Isolation and storage of TNT and TNT precursor materials from bottom layers of material inside the tanks in the temporary storage facility; and,
- Analysis of neutralized wastewater to ensure no traces of TNT remains – conducted by third party Research and Production Enterprise “Zarya,” in Rubezhnoe city.
