Symposium on Maintenance and Repair in Developing Countries

MAINTENANCE AND REPAIR TECHNIQUES

A.H. Hall
Imperial Chemical Industries Ltd.
Billingham, United Kingdom

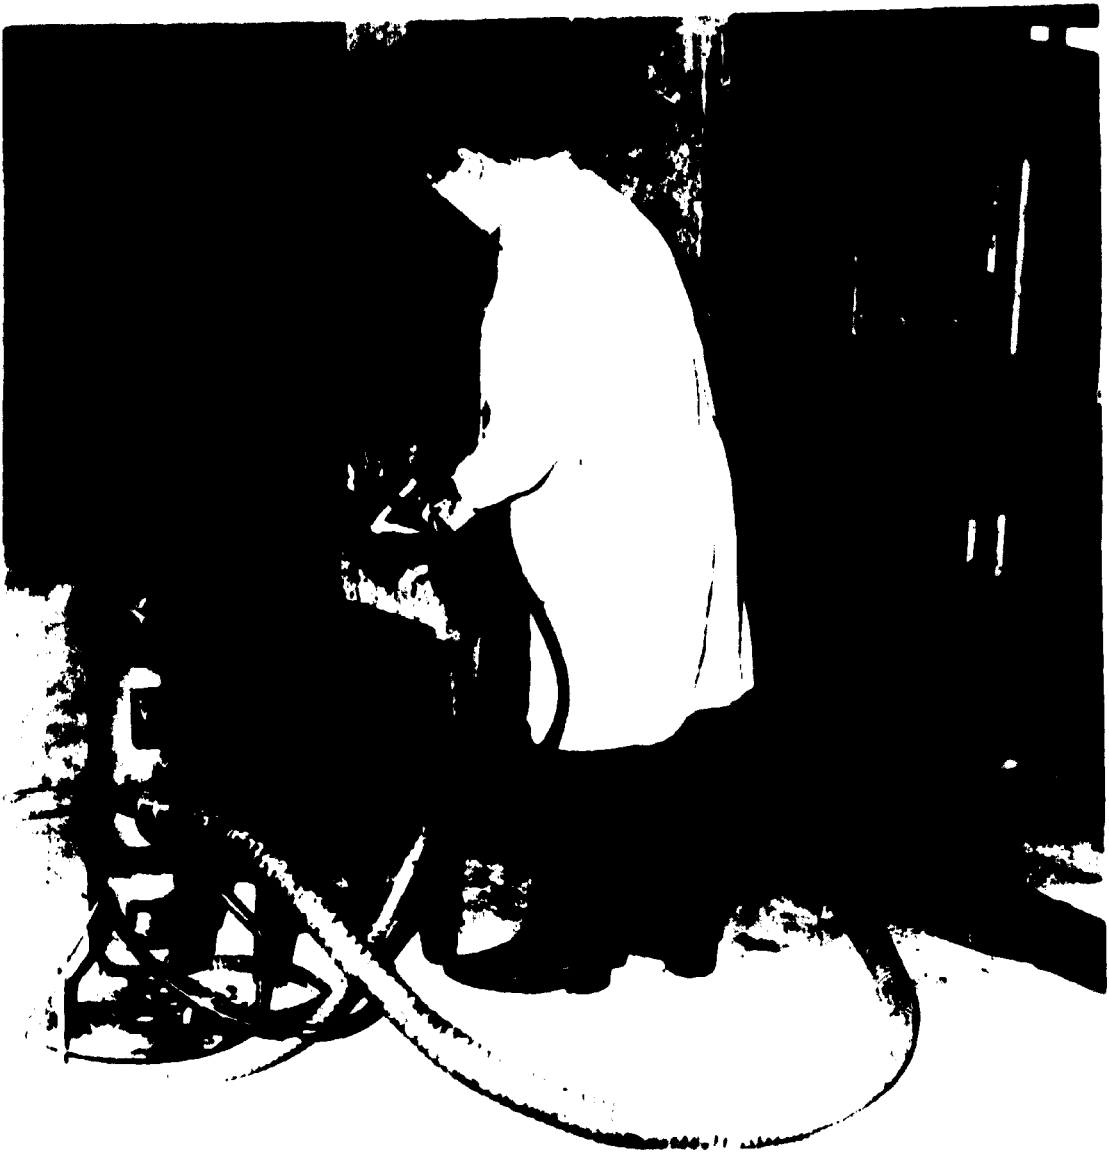
Fig. 2 Grit Blasting Equipment

The preferred method for surface preparation is grit blasting. Grit blasting equipment is available to deal with a variety of conditions. It ranges from large units designed to deal with large surface areas which are heavily contaminated to small units holding about 2 lbs. of grit which can be used for surface areas of the order of 2 to 3 sq. ins. Three units are illustrated in Figs. (1), (2) and (3). None of these units are expensive, the larger two costing about \$100 each. The largest unit is designed for open blasting and full protective clothing is required. The biggest difficulty with this equipment is the air supply. The requirement is for 125 cu.ft. per minute at 100 psi. The medium sized unit, which has its own recovery system needs 45 cu.ft. per minute at 100 psi. The small unit will work at 50-60 psi and the consumption is very low. However, blasting equipment is not always available, and even if available, cannot always be used. Therefore, other methods of preparation have to be considered. Power grinding equipment is useful for preparing local areas, but the tool which should always be available is the wire-brush.
