**Report on Phase-2 of Pilot Demonstration Project on  
cleaning-up of Contaminated Sites- PPO-Tengeru Site;  
Tengeru, Tanzania; July 31- August 20, 2014**

**Prepared by: Nouri Abdalla  
Regional Coordinator for SADC Sub-Region**

**Date: October 9, 2014**

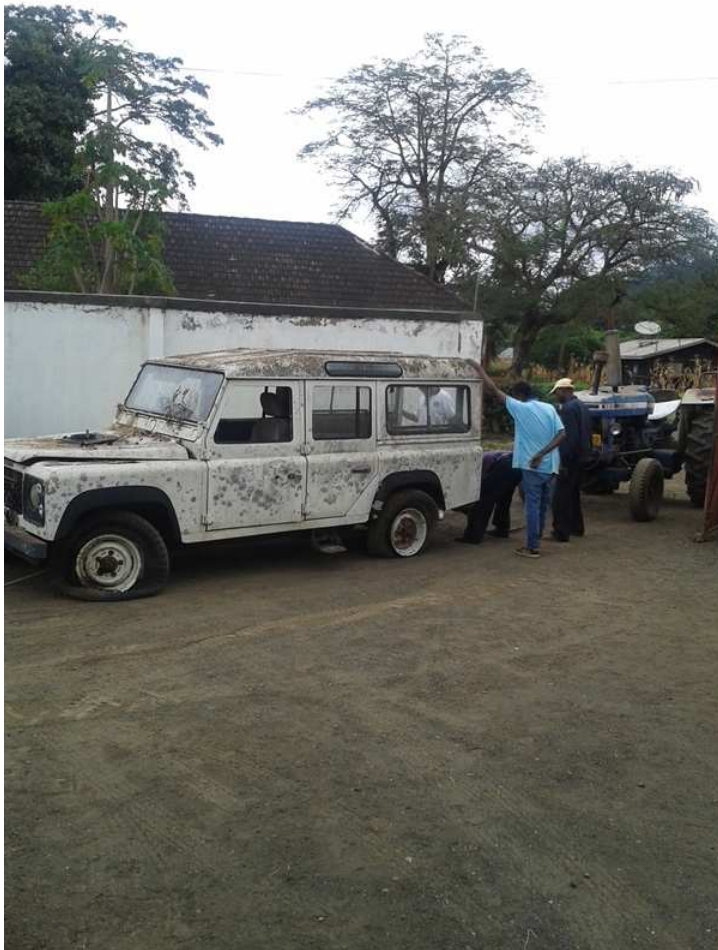
*Clearing the site using a tractor*

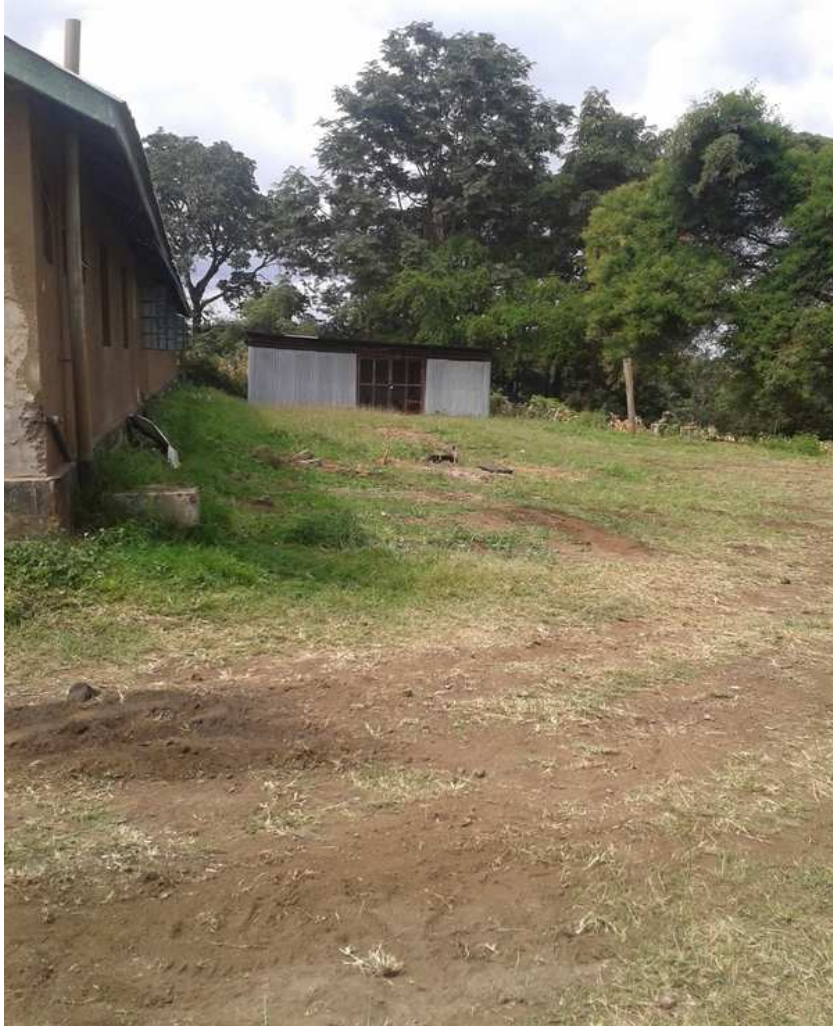
*The site cleared from all vehicles- July 31, 2014*

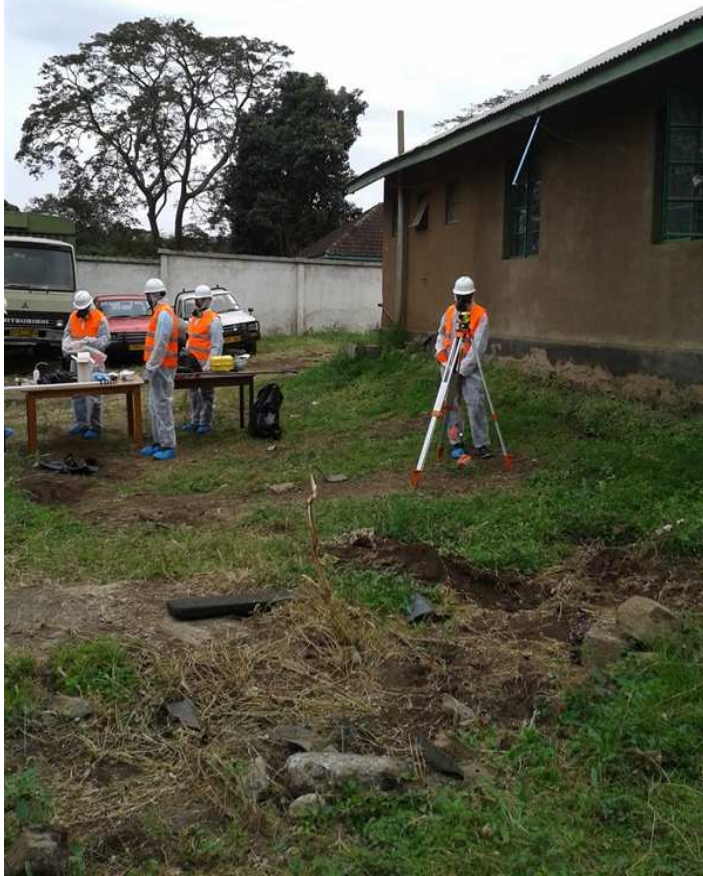
The site survey using survey equipment was conducted on August 1 and 2, 2014. Survey equipment used were: Survey measuring tapes (KESON® 1/2"W Freewheeling Fiberglass Tape Measures; GPS/GNSS systems; Picks/pins, Level (hand level, e.g. CST/Berger® Topographic Abney Level) and Leveling rod. The purpose of conducting such site survey was to learn more about the different elevations of the site, and subsequently determine the direction of the flow of the surface and/or the ground water.

*Site survey using topographic Abney level*

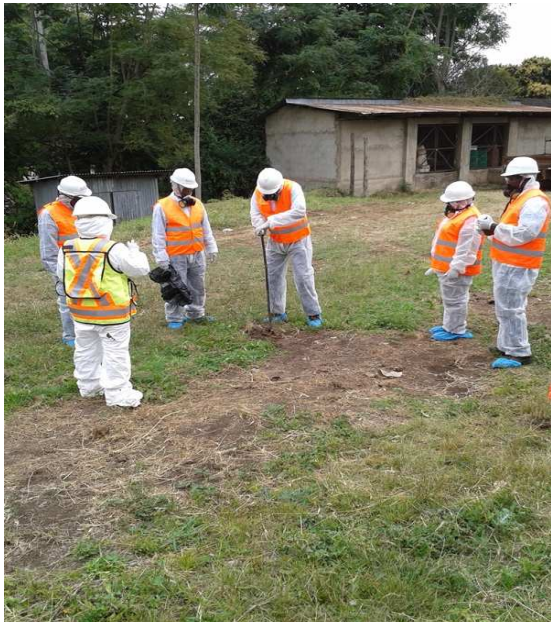
On August 4-5, 2014, surface sampling using a hand auger was taken from twenty nine points in the site for chemical and physical properties analysis. The maximum depth used to collect the surface sampling was 20cm. Additionally, four surface samples were taken from the maize field which is adjacent to the contaminated site as well as two more samples were taken for chemical analysis from downstream spring water which is about 1.5km from PPO site. The Tropical Pesticides Research Institute (TPRI)- UNIDO contractor, of Arusha helped in collecting the surface samples. Fourteen (14) samples out of the twenty nine samples taken during the PSI-S2 were sent to TPRI's laboratory for analysis. Soil sample for physical properties' analysis were to be analysed by the Project Technical Assistant at a later date to determine the geotechnical property of the soil in the contaminated area.

*Surface sampling- PSI-S2*

- The manual drilling using hand auger to obtain top soil sample (20 cm in depth) was quite tedious and time consuming due to soil compaction;
- The first three holes for top soil samples (PSI-S2) revealed the existence of thin plastic layer which was put by the Ministry of Agriculture staff a few years ago in an attempt to cover the emission of lindane (Gamma-Hexachlorocyclohexane) from the

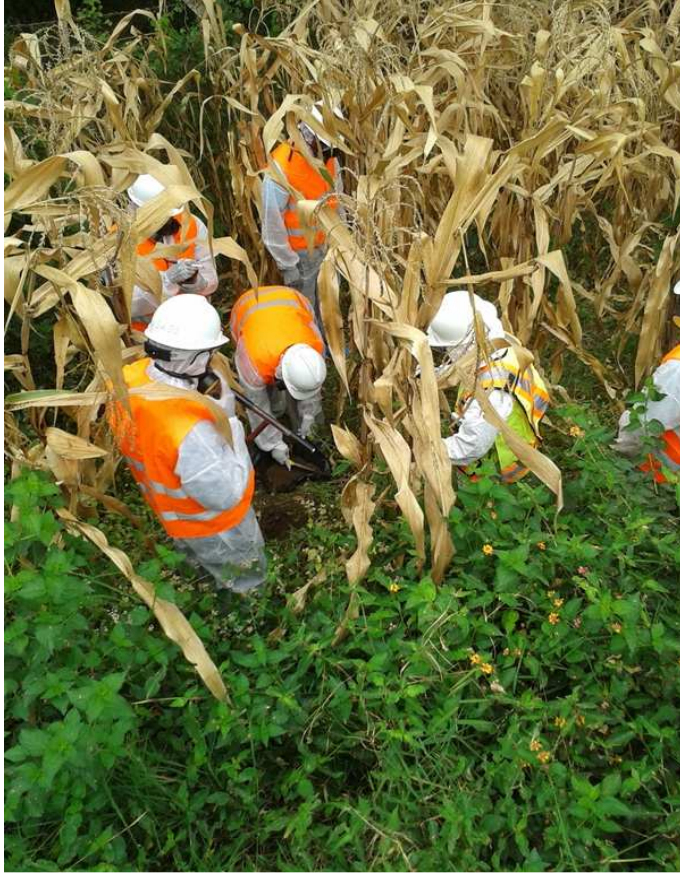
*Surface sampling from the Maize field adjacent to the contaminated site*

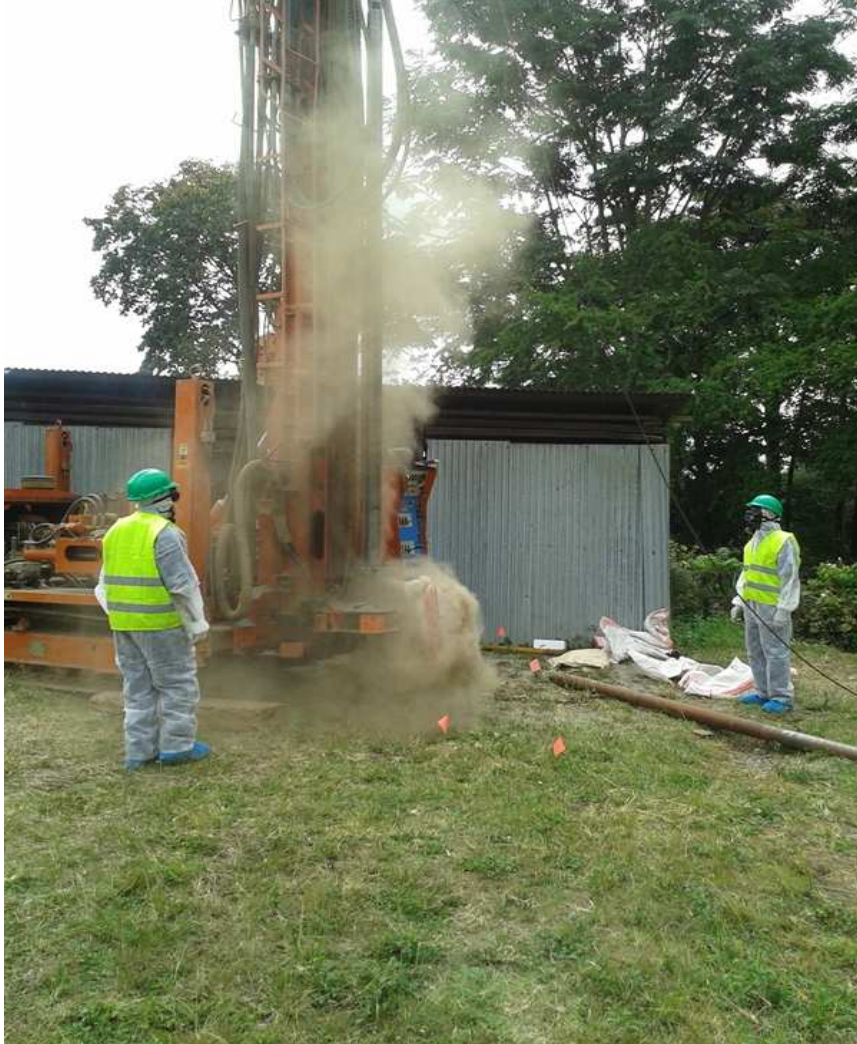
On August 12-15, 2014, a detailed site investigation was conducted at the PPO-Tengeru site. With the help of Water Solutions Drilling Company- UNIDO Contractor, eight (8) boreholes were dug at different locations in the site with special emphasis on the heavily contaminated area. The whole DSI process entailed drilling of eight boreholes and profile soil sample at interval of 50cm for each borehole was taken for chemical and physical properties analysis. Two boreholes were dug to a depth of seven (7) meters each and they were located about a half meter from the Old Storage Building, while the other six were dug to three (3) meters deep each. During the drilling for all boreholes, a sample was taken at every half a meter (50cm) level using air extraction. The samples were collected in amber bottles provided by TPRI and those samples were taken to TPRI's laboratory. In addition to samples collected in amber bottles for laboratory analysis, samples were also simultaneously collected in zip-lock bags (at each 50cm depth) to conduct soil particles analysis. Of the samples collected in amber bottles and sent to TPRI's laboratory, twelve samples were then analysed by the latter.

*Profile core sampling- DSI*

- During drilling of the boreholes (DSI) it was discovered that the hard rock aquifer was at a depth of seven meters. This means that the loamy/volcanic soil layer, ends somewhere before seven meters and lindane could only be absorbed within this layer;
