**10 April 2002**

**Regional Programme for Pollution control in the Tanning Industry  
in South-East Asia**

**SAFE LANDFILL FOR DISPOSAL OF SLUDGE FROM TANNERY  
EFFLUENT TREATMENT PLANTS**

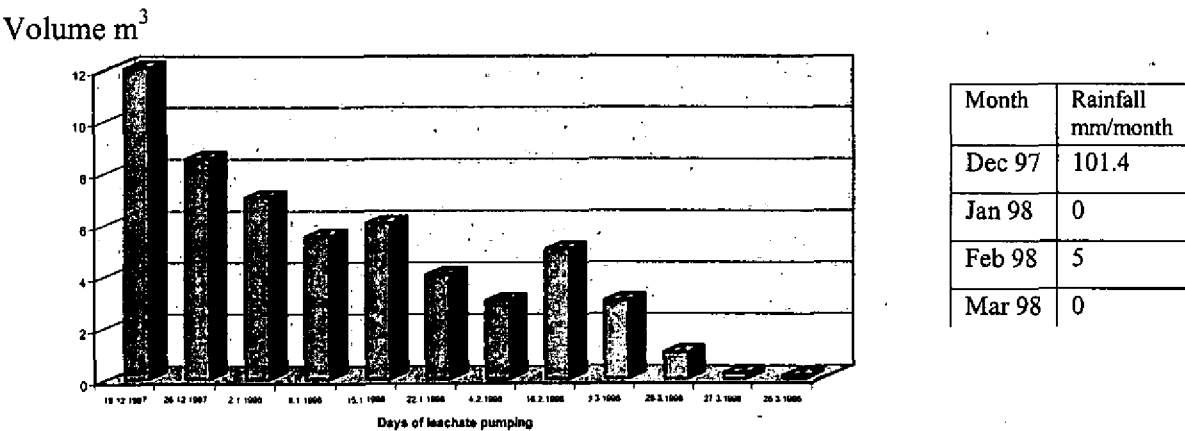
Chart 1: Reduction in leachate volume with leachate recycling

Accordingly, the leachate was sprayed back weekly from second week of December 1997 on top of the deposited sludge heap. This arrangement was found very effective, as the volume of leachate progressively reduced and finally stopped altogether. The volume of leachate pumped out (measured approximately using the pumping rate) is given in Chart 1: The rainfall during the period in the area too is given for reference.

Following this experiment, the cell number 2 was cleared of the sludge deposited and was taken for mass balance studies (first part) and a detailed mass balance report was prepared. The major result of the mass balance study was that chromium leaching from the sludge was practically nil. It indicated that only less stringent standards were required for landfills established for tannery sludge. The solidification of sludge taking place in the landfill possibly resulted in immobilisation of chromium.

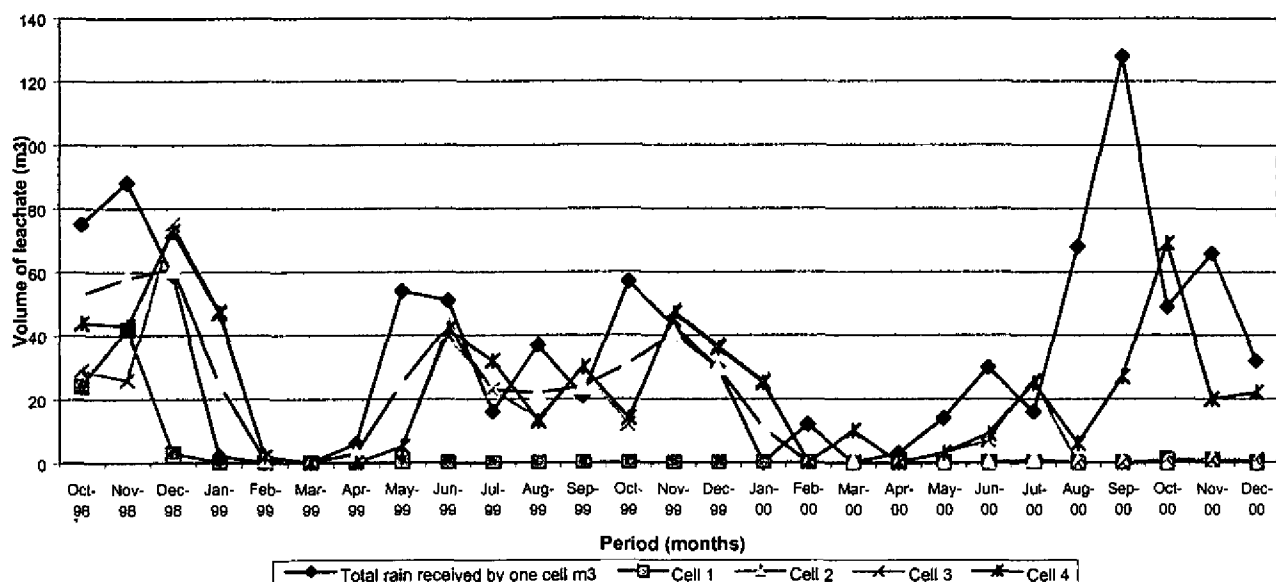
**Chart 2: Rainwater versus leachate generation**

No regular and monitored pumping of leachate from the cells was carried out till the beginning of October 98. From October 98 onwards, regular pumping of leachate was started. The volume of rain water that entered the cells and the leachate pumped out from October 98 till date are given in Chart 2:

Following closure of the cells, the leachate generation has become virtually negligible. This supports the hypothesis that much of the leachate generated from sludge dumped in the landfill is due to the entry of rainwater and not due to crushing of the sludge.

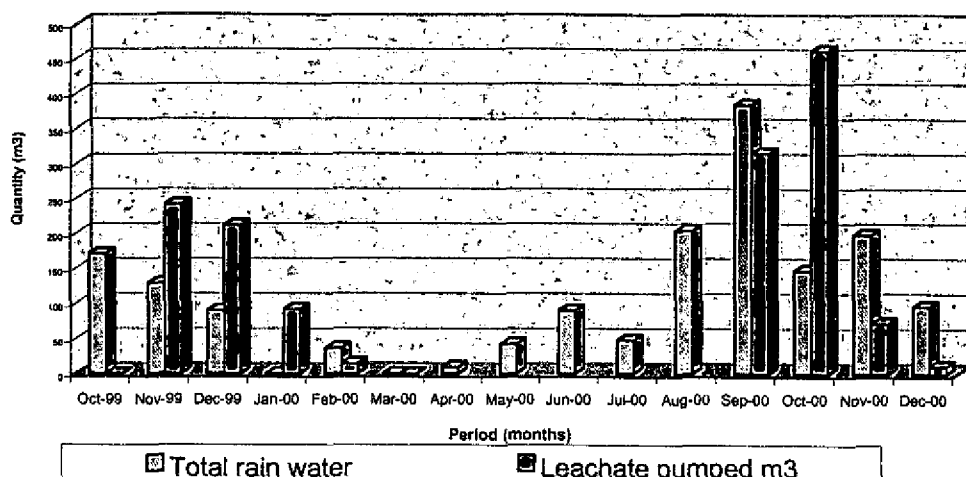
**Chart 3: Water received by landfill due to rainfall and leachate generation**

Until now, leachate was generated by the landfill only during two stretches and the entire leachate was pumped back to the top of the landfill for evaporation. The volume of leachate generation during the two stretches of leachate pumping along with the total volume of water received by landfill as rainfall is given in Chart 3:

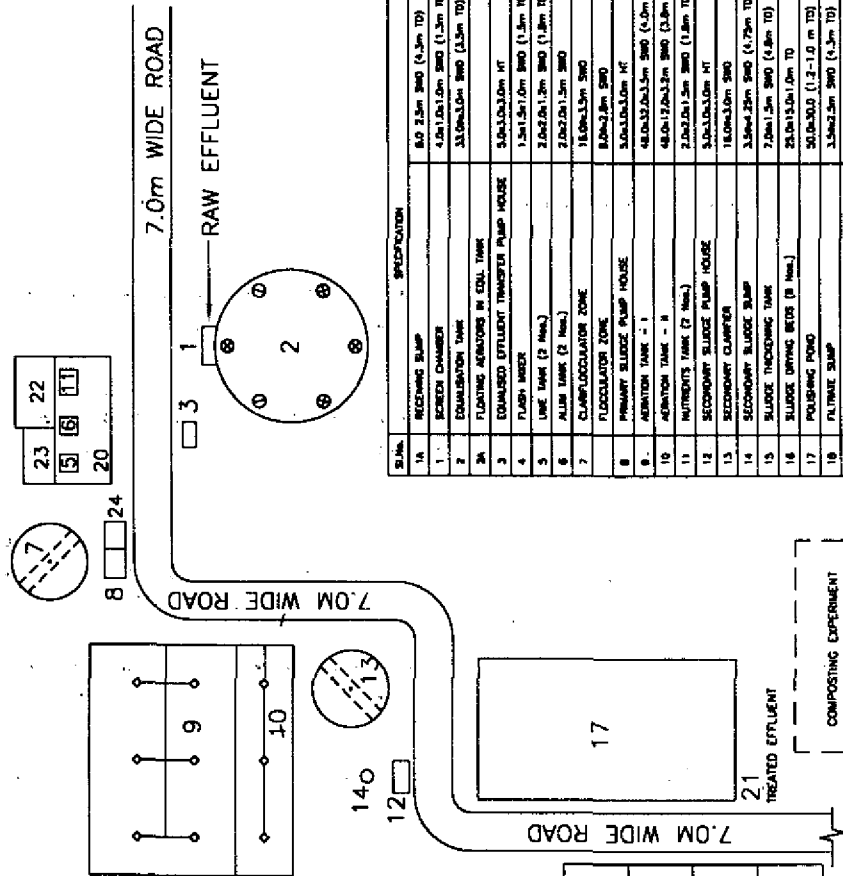
Annex 2 Dwg. 2: LAYOUT OF CETP AT MELVISHARAM INCLUDING LANDFILL

S.No.	SPECIFICATION
1A	RECEIVING SLUMP
1	SCREEN CHAMBER
2	COAGULATION TANK
2A	FLOATING AERATORS IN COAG. TANK
3	COAGULATED EFFLUENT TRANSFER PUMP HOUSE
4	FLASH MIXER
5	LINE TANK (2 Nos.)
6	ALUM TANK (2 Nos.)
7	CLAMPLOCULATOR ZONE
8	FLOCCULATOR ZONE
9	PRIMARY SLUDGE PUMP HOUSE
9A	AERATION TANK - I
10	AERATION TANK - II
11	NUTRIENTS TANK (2 Nos.)
12	SECONDARY SLUDGE PUMP HOUSE
13	SECONDARY CLAMPER
14	SECONDARY SLUDGE SLUMP
15	SLUDGE THICKENING TANK
16	SLUDGE DRYING BEDS (8 Nos.)
17	POLISHING POND
18	FITRINE SLUMP
19	FITRINE TRANSFORMER PUMP HOUSE
20	CHEMICAL HOUSE
21	TREATED EFFLUENT CHANNEL
22	TRANSFORMER TANK
23	OIL ROOM
24	INSTRUMENTATION CONTROL ROOM

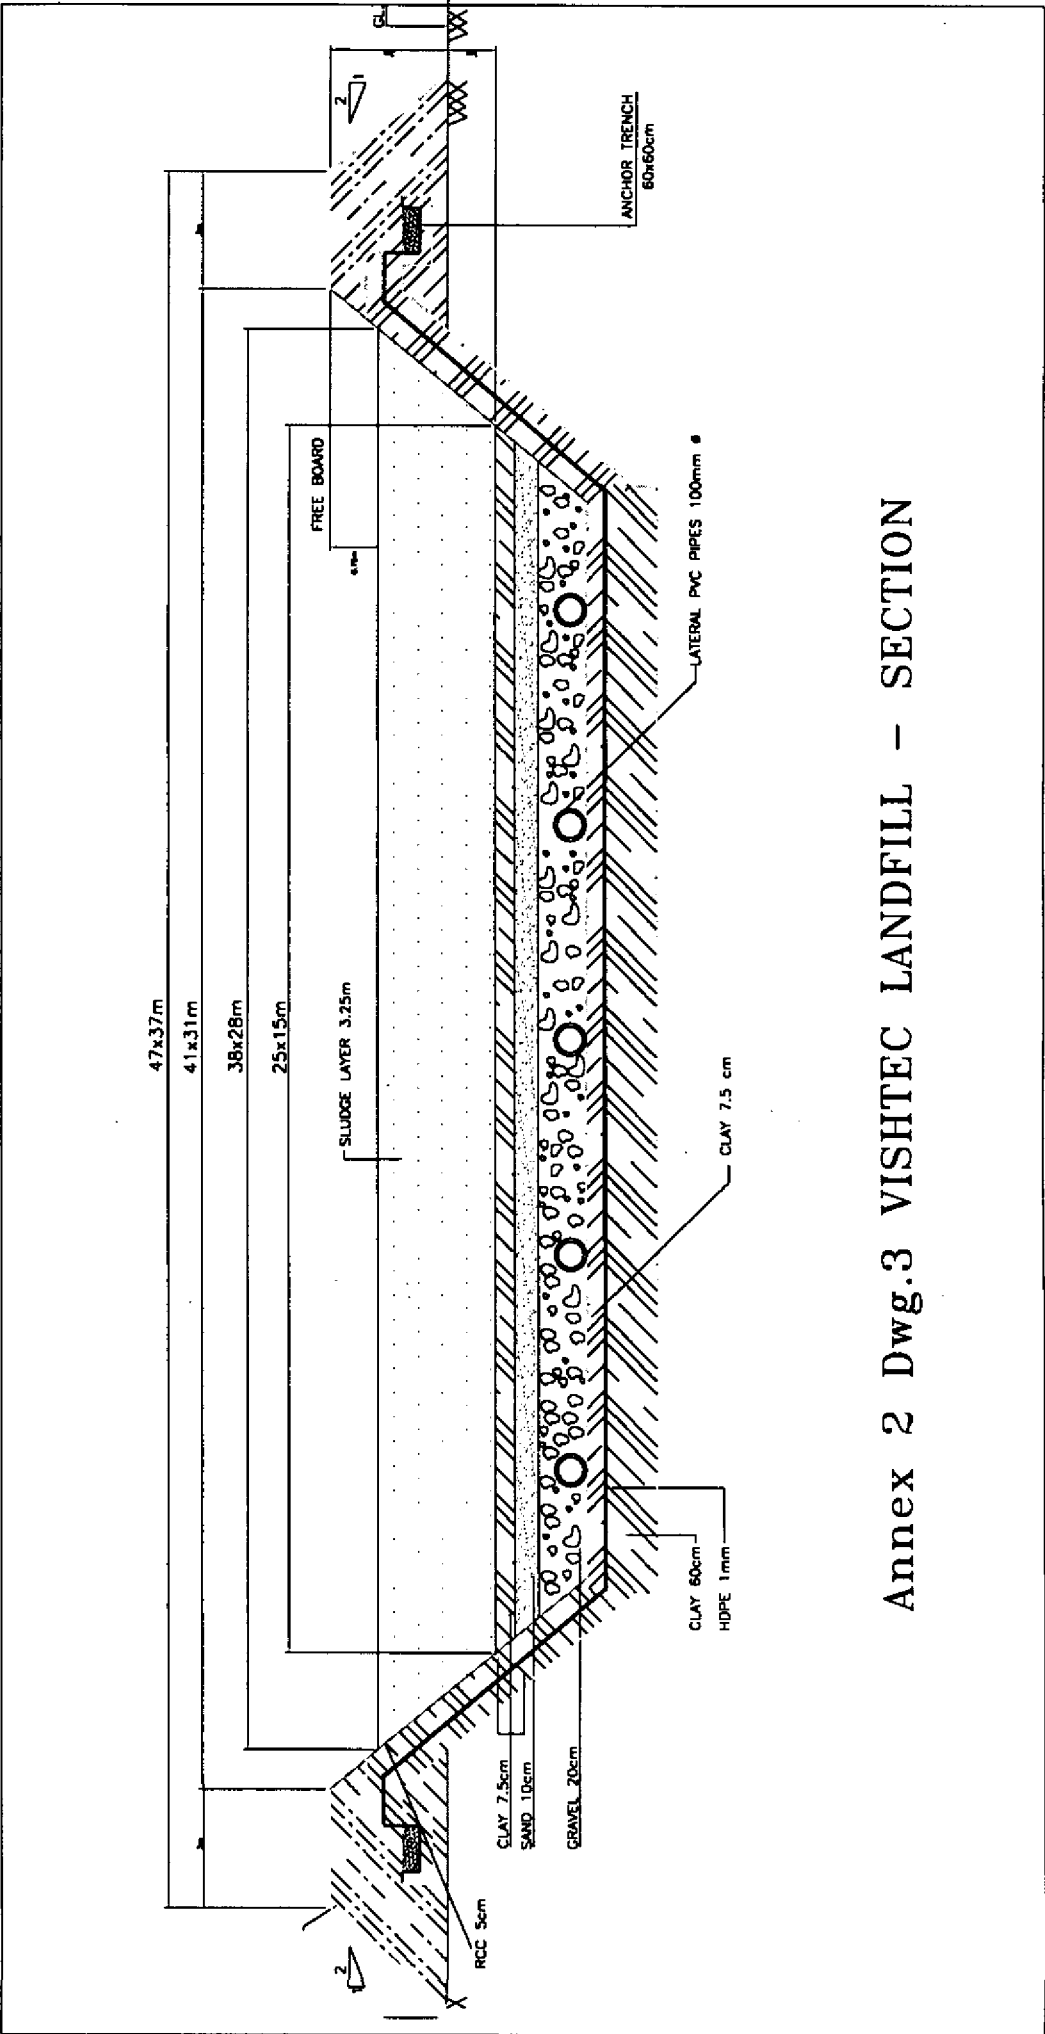
Annex 2 Dwg.3 VISHTEC LANDFILL - SECTION

The design of the landfill envisages it to be partly below and partly above the ground level. The waste layer (bottom) is 1m below the ground level and the total depth of drainage layer and clay foundation is around 0.9 m. Accordingly, the total depth of earth excavated was about 2 m.

After excavation, foundation with clayey soil was laid to a depth of 600 mm (after compaction), which also acts as a barrier for leachate transport. The quality of clay used generally conformed to the following characteristics:

After giving smooth finish to the foundation, HDPE sheet (1 mm thickness) was laid over the entire bottom area and the sides. The HDPE sheet had permeation rate  $\text{g/m}^2\text{-hr}$  :  $<0.9$ , density  $>0.935 \text{ g/cm}^3$  and tensile strength of  $337.5 \text{ kg/cm}^2$ . The sheet was sealed using thermal welding and was anchored in anchor trench. The size of anchor trench is 0.6 m in width and 0.6 m in depth. The HDPE sheet was taken into the anchor trench and filled with sand to prevent sliding/slipping. After laying the HDPE liner, a clay cover of 7.5 cm was given.

It is rather unusual to have an RCC cover on top of the clay over the synthetic sheet liner on the embankment. This was necessitated by the slipping of clay over the HDPE sheet and due to the lower slope (2:1) than the normal (3:1) adopted. However, for a small unit as of Vishtec landfill, it was found economical to have the present arrangement rather than the higher slope. The additional cost for maintaining the slope at 3:1 was estimated to be INR 320,000 and discounting the possible additional volume of 900 m<sup>3</sup>, the additional cost for the same volume would have been around INR 210,000. But the RCC cover did cost only INR 115,000. As the purpose of the cover was to hold the clay over the sheet and to prevent direct exposure of the HDPE sheet to sunlight, even if the RCC cover corroded away in the course of time (which is unlikely given the characteristics of tannery sludge), the arrangement here would have served the purpose. Small installations may therefore consider this option. However, for larger installations increased slope of embankments with clay cover on the inner sides is recommended.

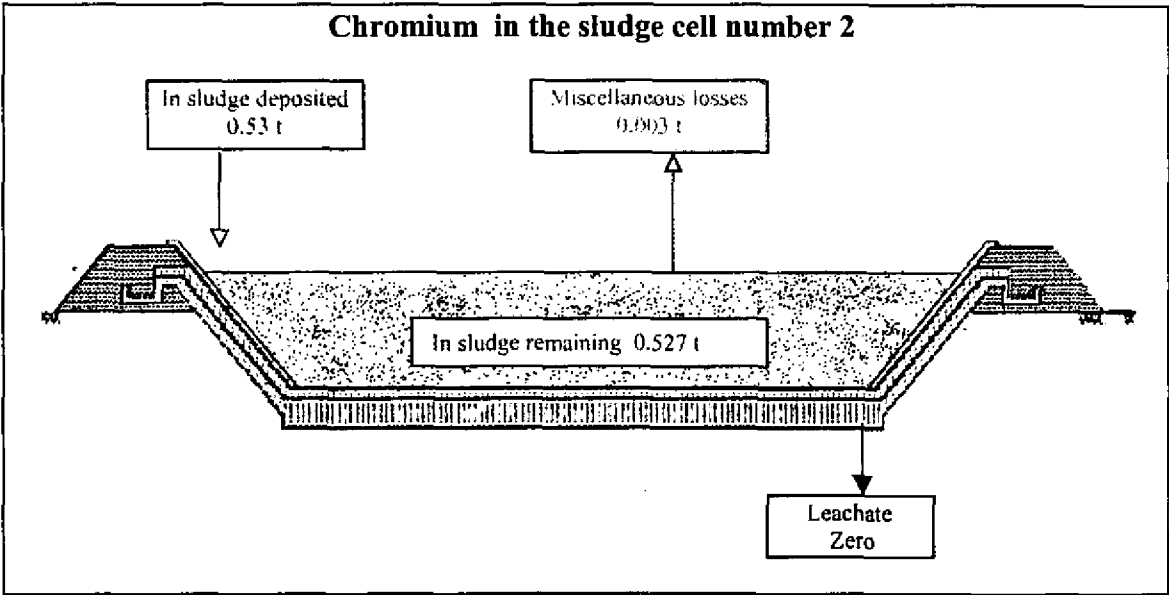
**Overall mass balance of sludge landfill at Ranitec (Part -1)**

Total quantity of sludge remaining =  $488.2 \text{ t}$ .

Total quantity of chromium remaining in the sludge deposited =  $488.2 \times 1.08/1000 = 0.527 \text{ t}$   
 Total quantity of chromium reduced in the sludge deposited (due to analytical errors etc.) =  $0.003 \text{ t}$ .  
 Total quantity of chromium lost due to leachate = Nil

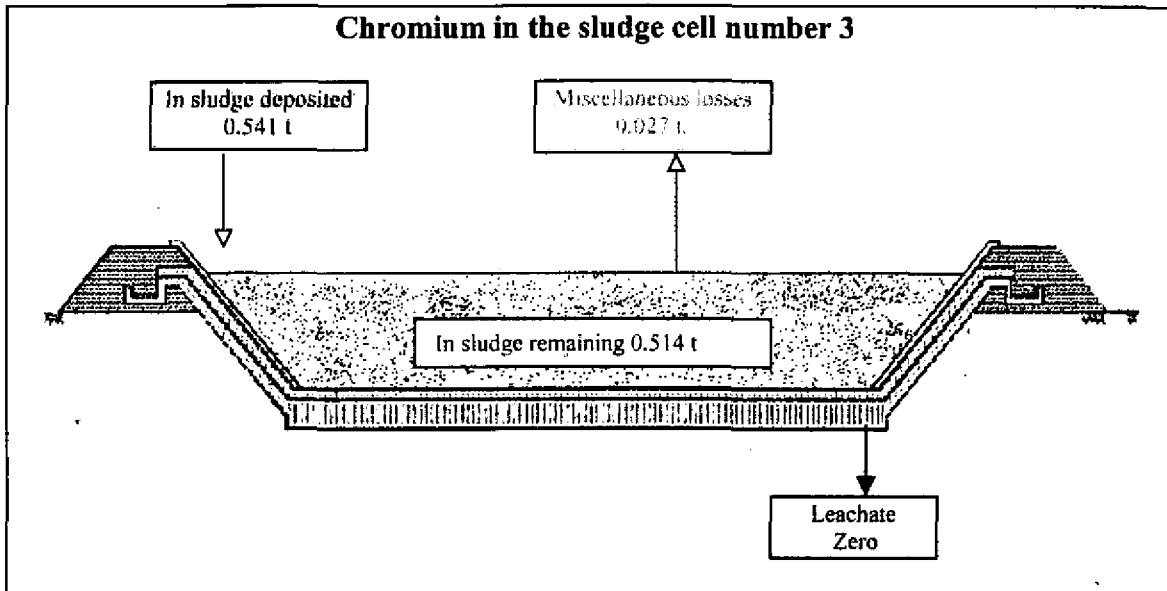
### Chromium in the sludge cell number 3

Total quantity of chromium found reduced in the sludge deposit (due to sampling or analysis errors etc.) =  $0.541 - 0.514 = 0.027$  t.

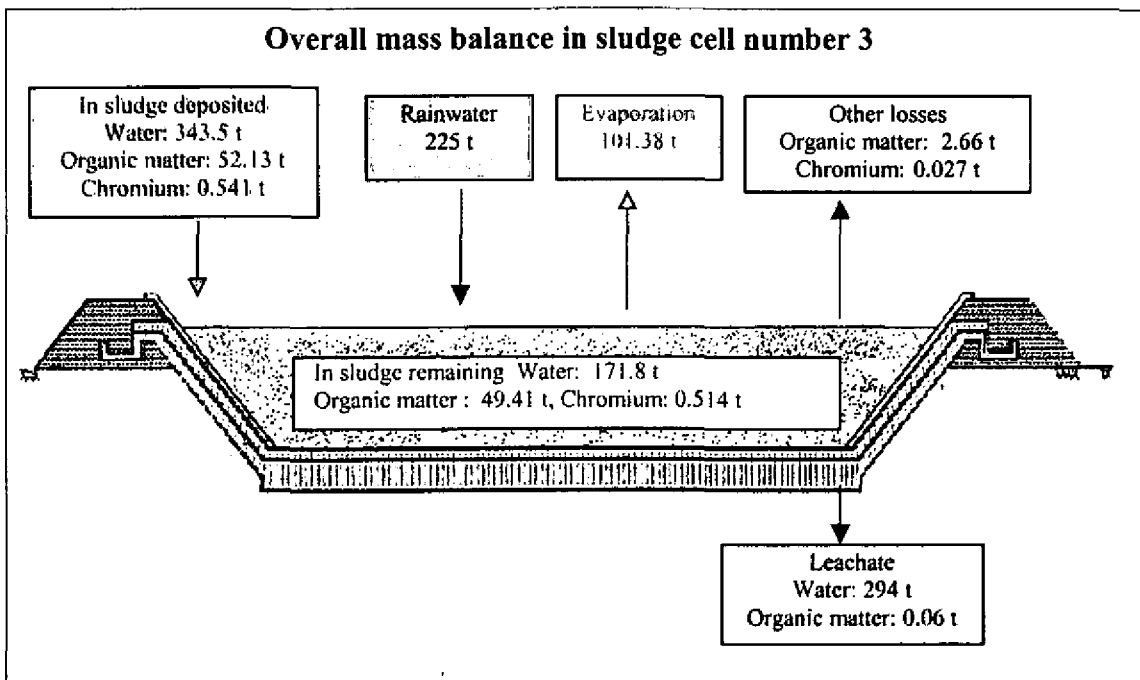
#### Overall mass balance in sludge cell number 3

### Overall mass Balance of sludge landfill at Ranitec (Part –2)

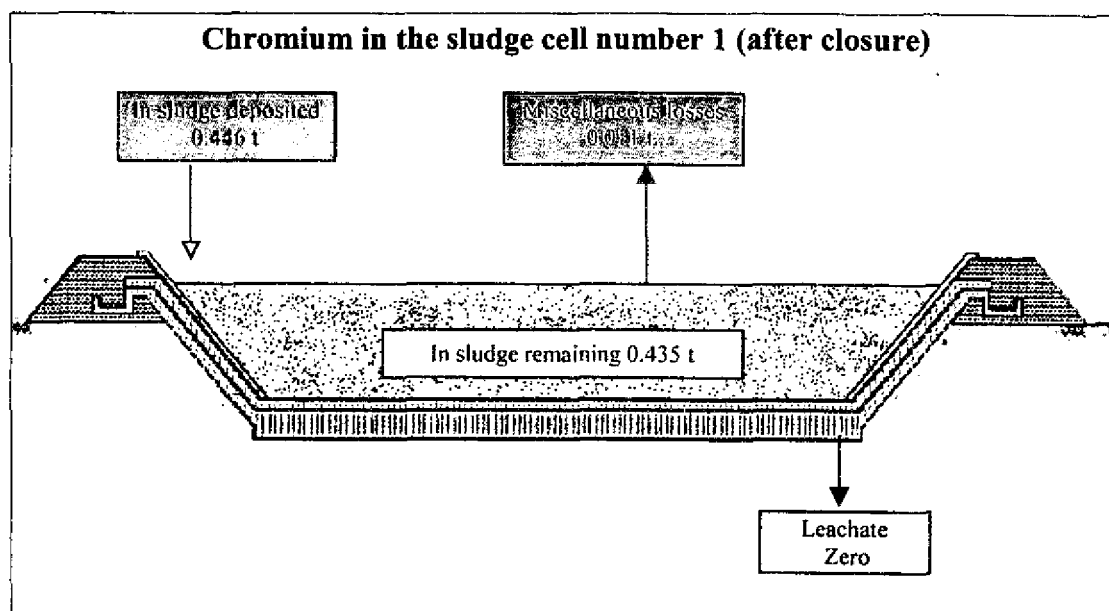
**Overall Post closure mass balance of Cell-1 of sludge landfill at Ranitec (Part -3)**

Total quantity of chromium remaining in the sludge deposited after fifteen months =  $712.94 \times 0.61/1000 = 0.435 \text{ t}$

Total quantity of chromium found reduced in the sludge deposit (due to sampling or analysis errors etc.) =  $0.446 - 0.435 = 0.011 \text{ t}$ .

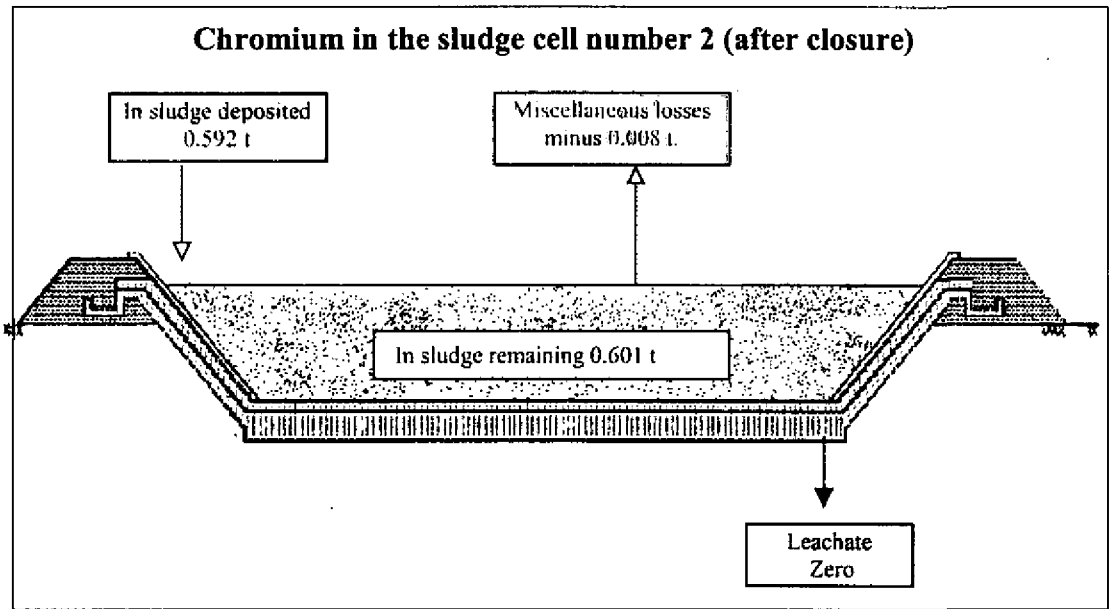
Overall Post closure mass balance of Cell-2 of sludge landfill at Ranitec (Part –3)

Total quantity of chromium remaining in the sludge deposited after fifteen months =  $731.79 \times 0.82/1000 = 0.60 \text{ t}$   
 Total quantity of chromium found reduced in the sludge deposit (due to sampling or analysis errors etc.) =  $0.592 - 0.60 = - 0.008 \text{ t}$ .

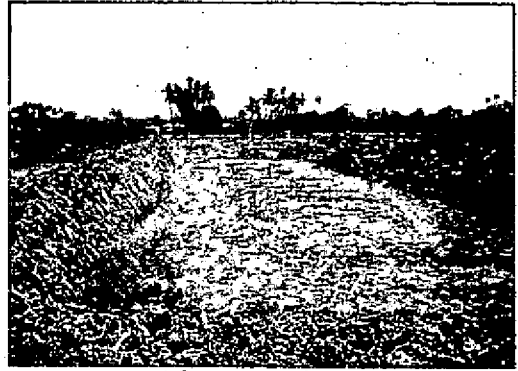
After excavation

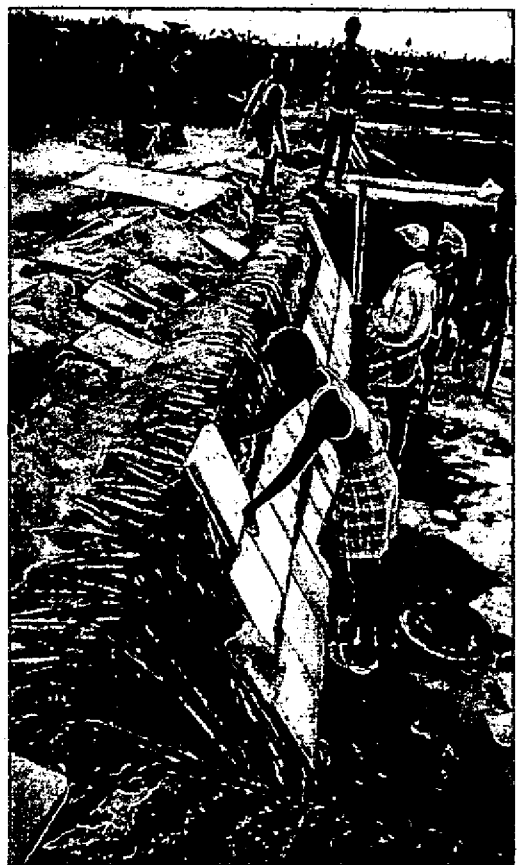
Fixing concrete slab on sides

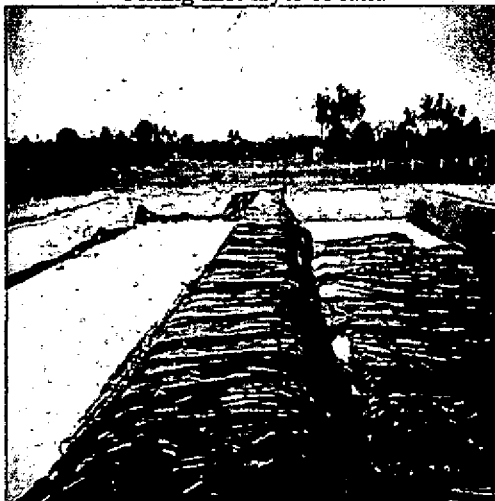
Laying LDPE sheet

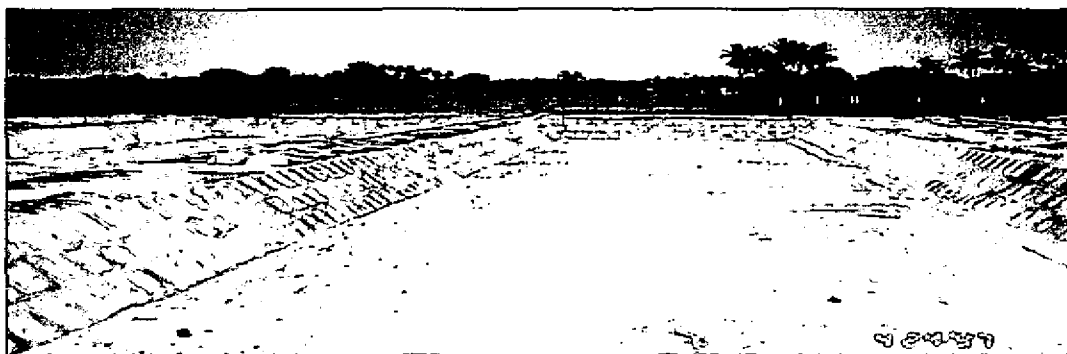
After concreting bottom & sides

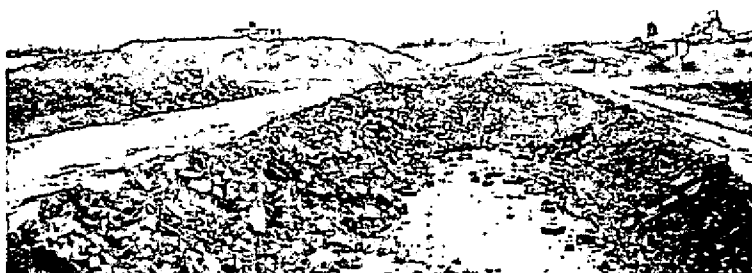
After first set of filling

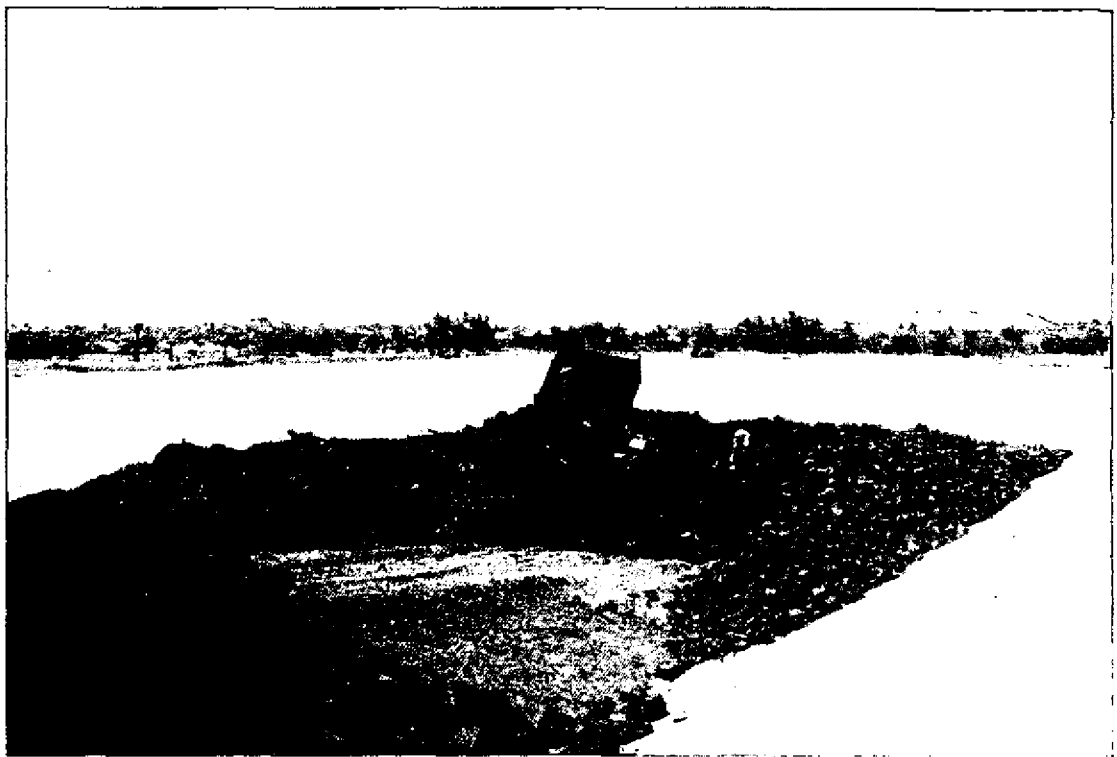
*Sludge deposited in the landfill*
