Interregional Workshop on the Promotion of Welding  
Technology in Developing Countries

RECLAMATION OF A SET OF COGGING MILL ROLLS

BY WELDING\*

C.A. Waters\*\*

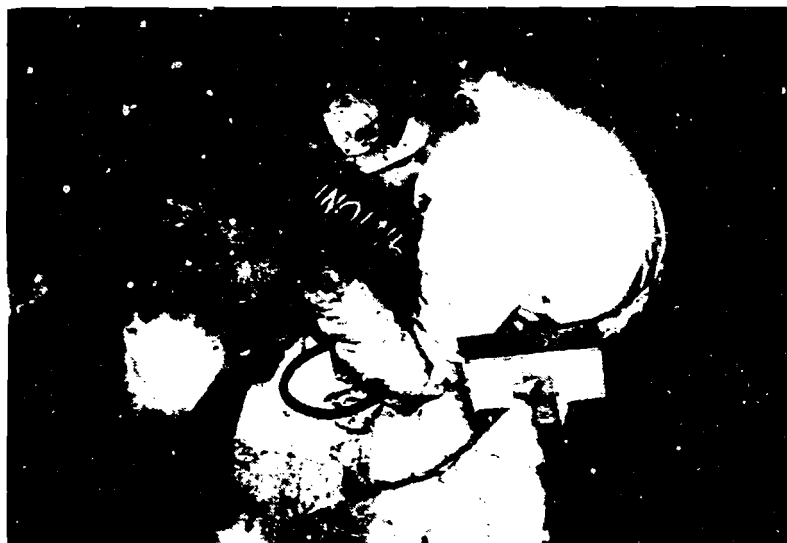
All the welding was carried out in the horizontal position, Photograph 4, by removing the hot box lid.

Photograph 4: Horizontal positional welding

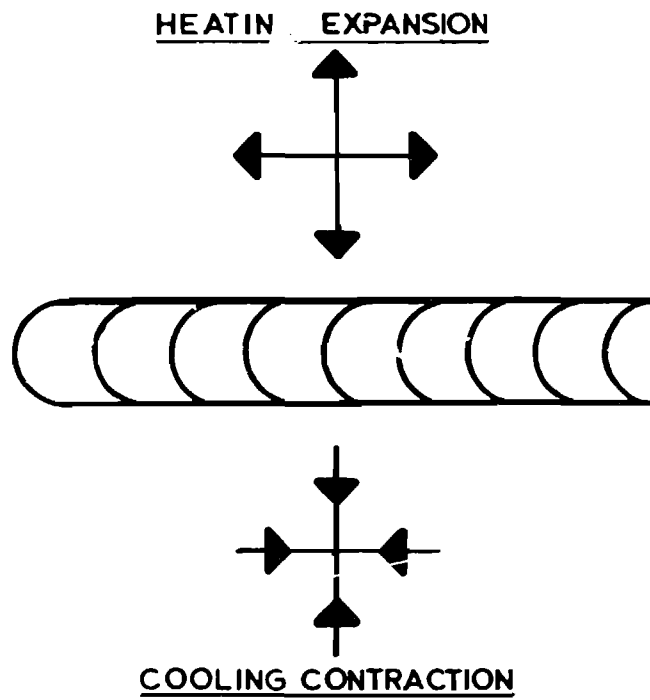
- 1) Restraining stresses evolved from the thermal expansion and contraction of the weld metal and heat affected zone against the restraint of the cooler mass of metal surrounding it. On heating expansion is constrained and compressive stresses are set-up while, on cooling, tensile stresses are induced during contraction as depicted in figure 4. Hot peening, Photograph 5. in conjunction with the preheat relieves these stresses and prevents hot cracking.
- 2) Hot peening of the intermediate austenitic buffer layer was carried out to prevent the precipitation of carbides in the grain boundaries.

FIGURE 4 ...RESTRAINING STRESSES.
