Distr.
LIMITED
ID/WG.379/14
1 October 1982
ENGLISH

Interregional Cement Technology Forum

PRESENT STATE OF BASIC REFRACTORY LINING
OF THE SINTERING ZONE *

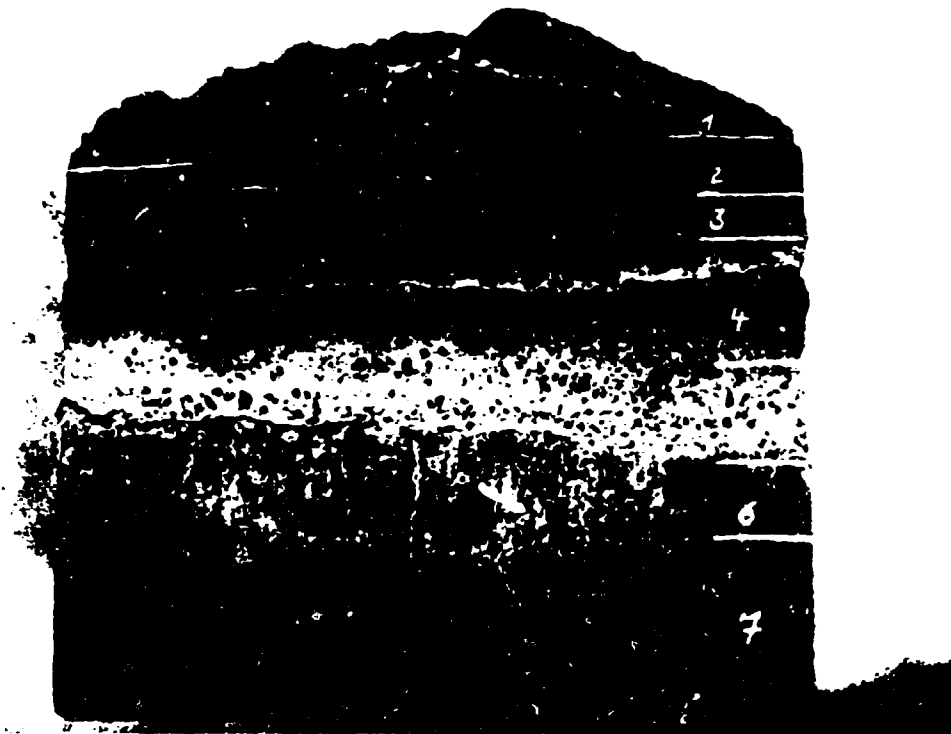
Fig. 14: Profile of a used dolomite brick

Figs. 13 and 14 show the profile of a used dolomite brick before and after being cut open after 10 months' service in a Lepol kiln. The pattern of wear presented by the brick is representative of the chemicominalogical changes of dolomite brick during use. Although the brick has retained almost all of its original thickness, its chemical and mineralogical character has undergone considerable changes. Fig. 15 presents a concentration profile showing the new minerals formed in the brick from the hot to the cold face; the positions of the cracks that have developed are also indicated.

A triple zonal subdivision of the lining is discernible, resulting in mechanical separation and extensive spalling of the brick zones. The zone at the hot face is characterized mainly by the absorption of ferritic phase from the clinker and by crystal growth of the CaO and MgO present in this zone. In the densified middle zone of the brick the alkali sulphates from the kiln atmosphere have crystallized after attaining their solidification temperatures. At the same time, the SO_2 from the kiln gases has reacted with CaO to form calcium sulphide. Recarbonation of CaO to CaCO_3 has occurred at the cold face. The MgO content of the dolomite brick has not participated in the reactions with SO_2 and CO_2 .
