Seminar-Workshop on the Exchange of  
Experiences and Technology Transfer  
on Mini Hydro Electric Generation Units

CASE STUDY OF THE PLANNING AND CONSTRUCTION OF  
A MINI HYDRO POWER PLANT\*

Norwegian Water Resources and Electricity Board (NVE)  
Oslo  
Norway

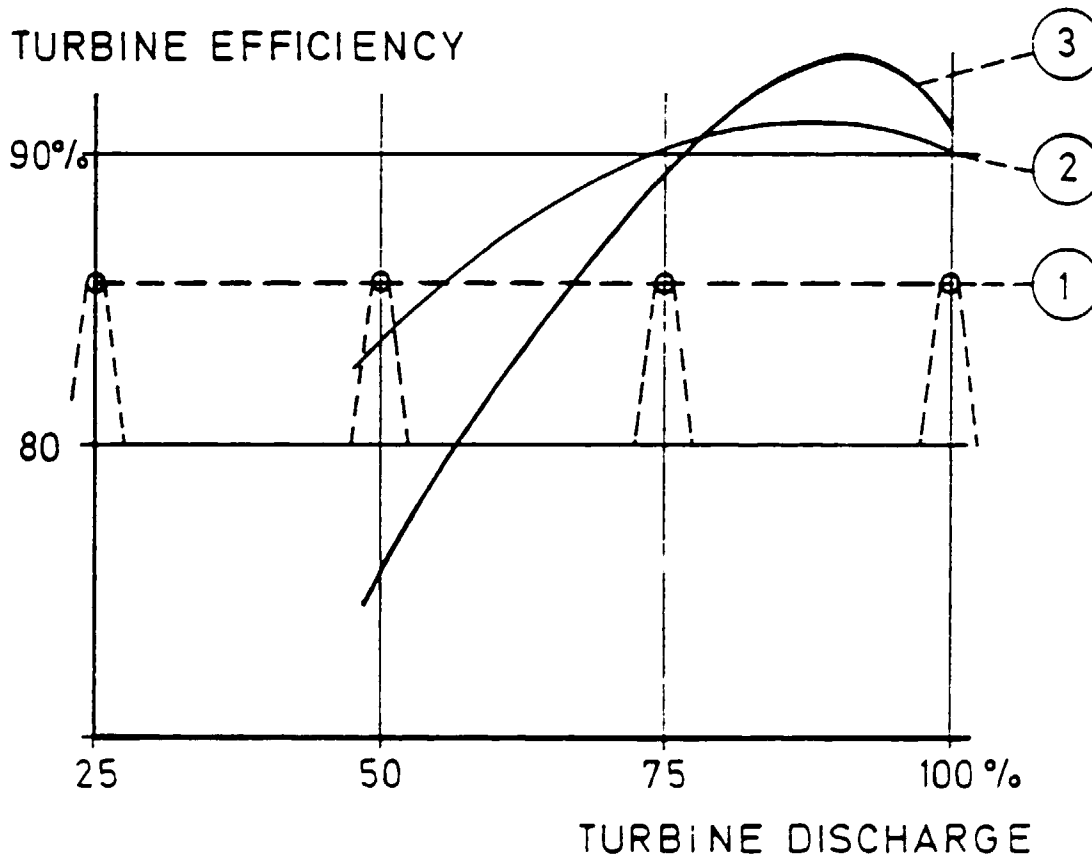
TURBINE EFFICIENCY AT NET HEAD 8m BY:

- ① 4 no. of propeller turbine units.
- ② Kaplan turbine with fixed guide vanes.
- ③ Francis turbine

As the turbines vary in design and characteristics, the efficiencies also vary. These factors must also be taken into consideration.
