**KASUR TANNERIES POLLUTION  
CONTROL PROJECT - DP/PAK/93/006**

Assessment of Drainage System Civil Works

Final Report

July 1997

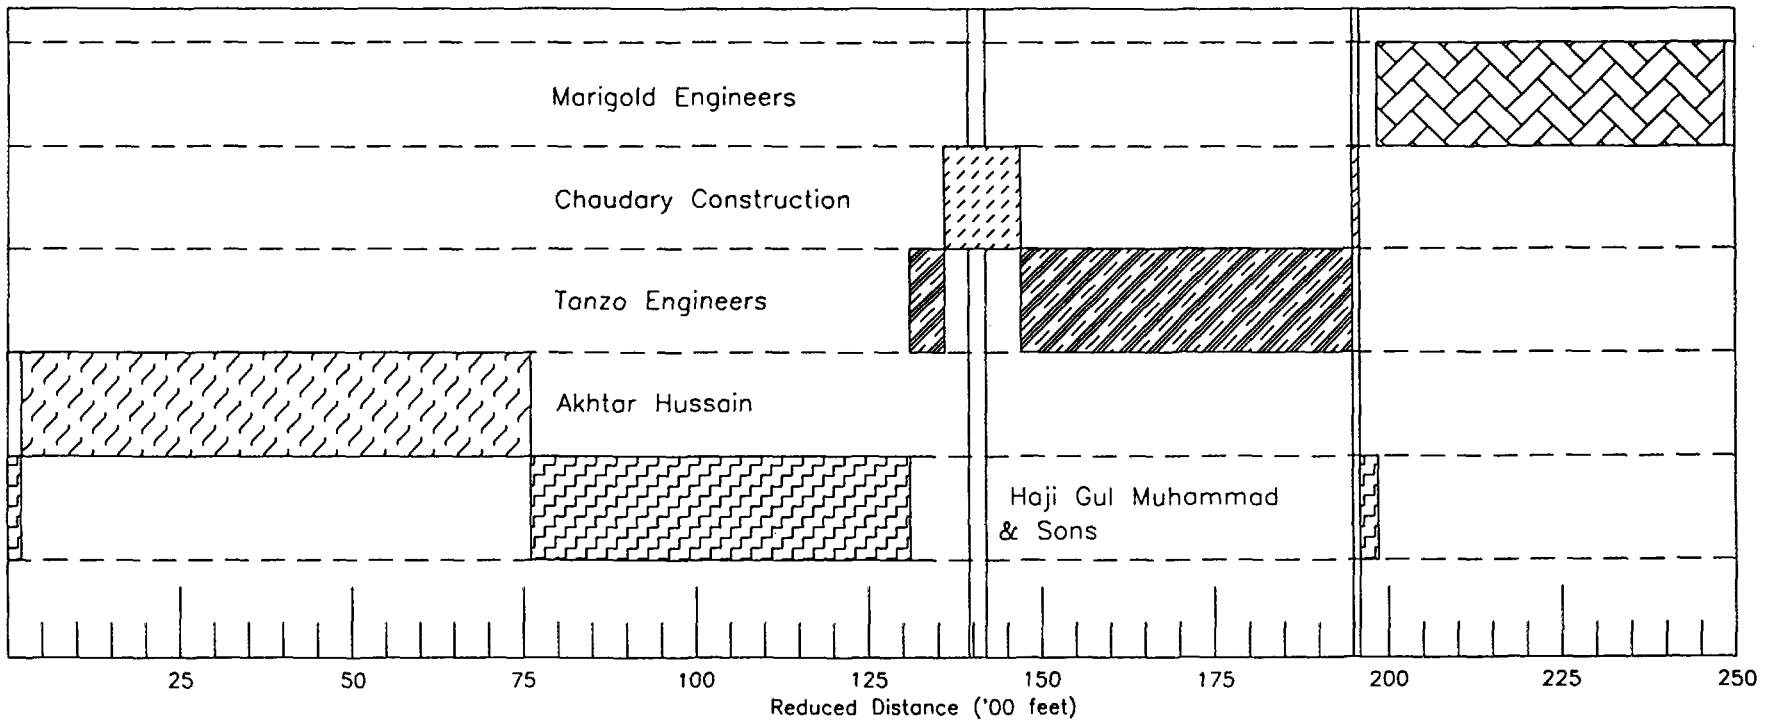
KASUR TANNERIES POLLUTION CONTROL  
 EVALUATION OF DRAINAGE SYSTEM  
 CONCRETE WORKS  
 CONTRACT BOUNDARIES OF CEMENT TYPE  
 FIGURE 2.1

An important concern during the construction was the type of cement type to be used in manufacturing concrete pipes and in constructing the open channel. It is reported that initially Ordinary Portland Cement was used in all types of construction. Later the contractors were asked to use Sulphate Resisting Cement in all types of construction. Subsequently use of slag cement was recommended and, after its use for eight days, contractors were asked to switch back to sulphate resisting cement. Based on the site engineers record, Figure 2.1 presents the length of sections constructed with various cement types. However no record was maintained on the use of slag cement.

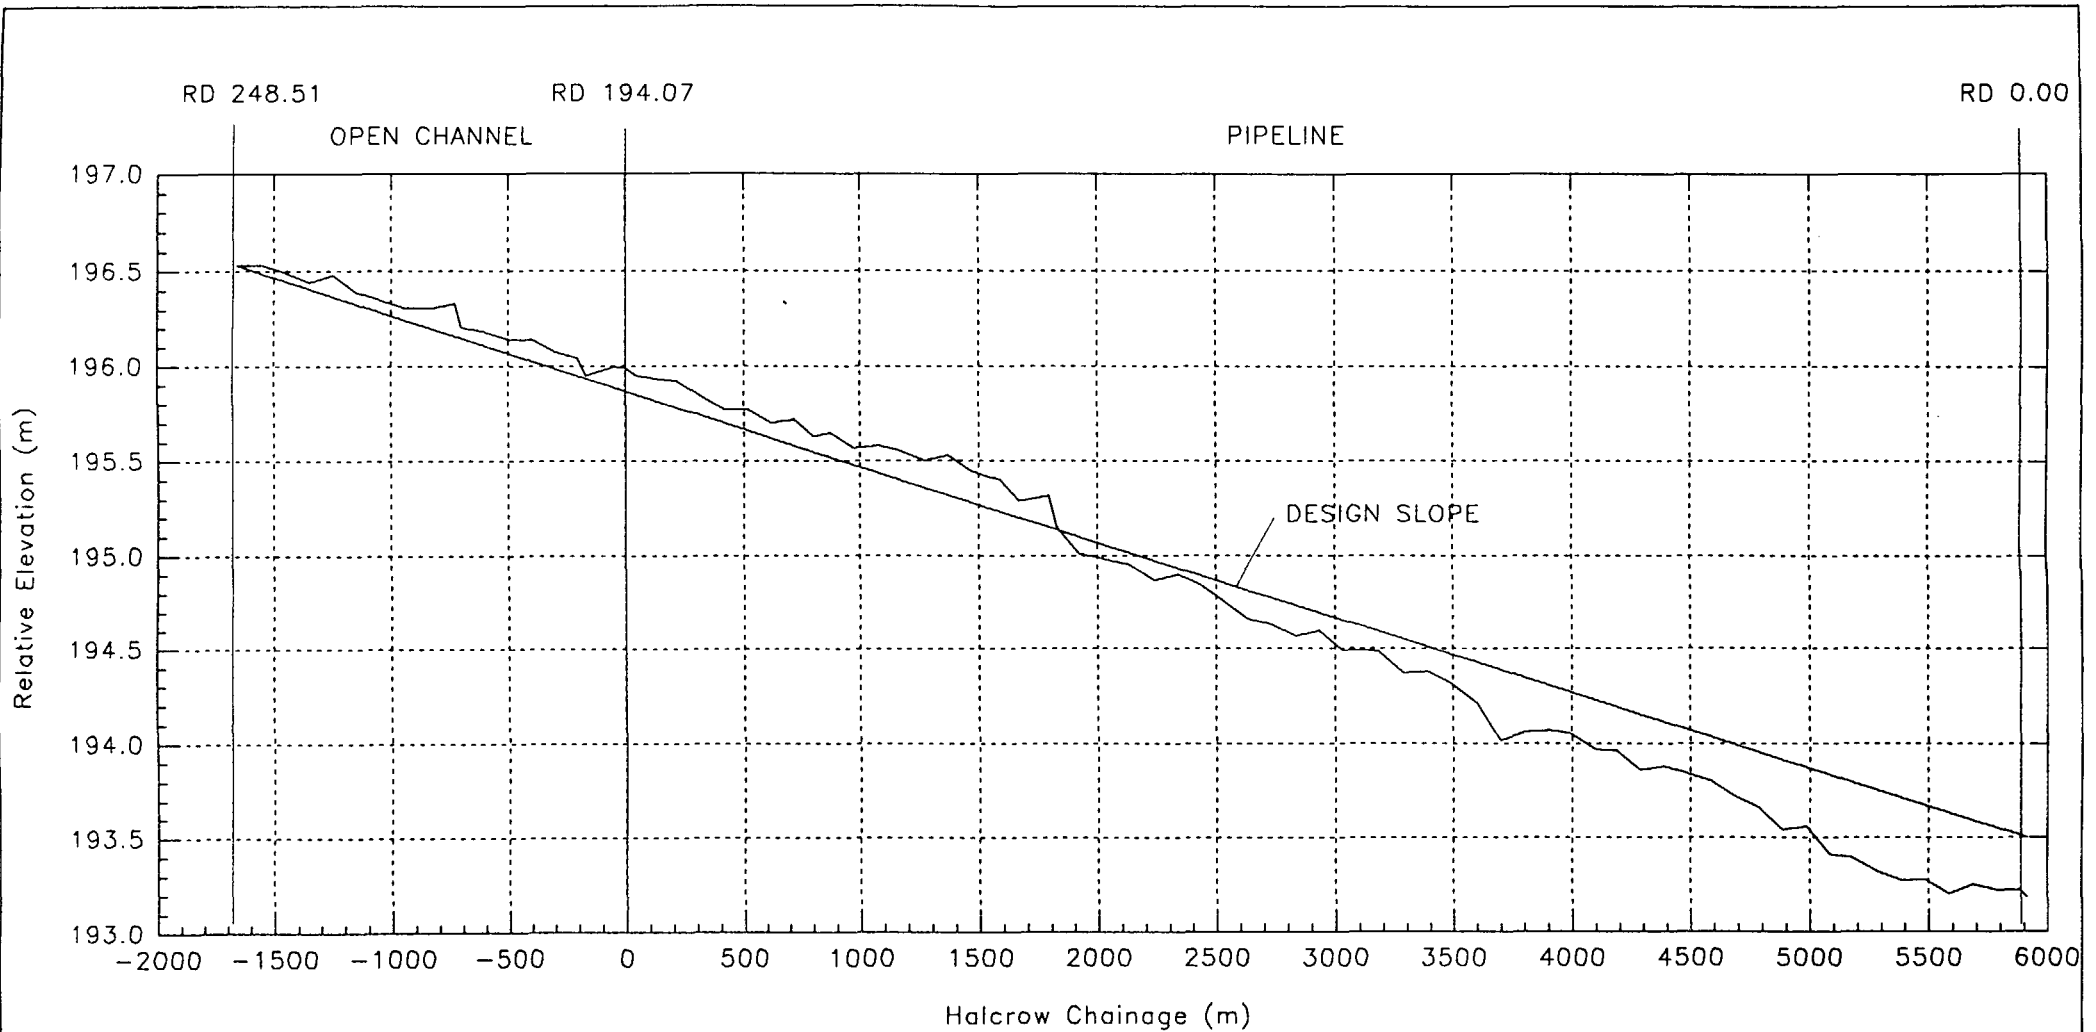
FIG 3.1

The overall slope of the open channel and the pipeline is steeper than design however there are significant deviations from a uniform profile, indicating poor survey control during construction. There are constrictions in the open channel cross section and unless they are removed, the flow conditions will significantly affect the channel hydraulics.

United Nations Industrial Development Organisation  
 Kasur Tanneries Pollution Control Project DP/PAK/93/006  
 HYDRAULIC GRADE OF OPEN CHANNEL & PIPELINE

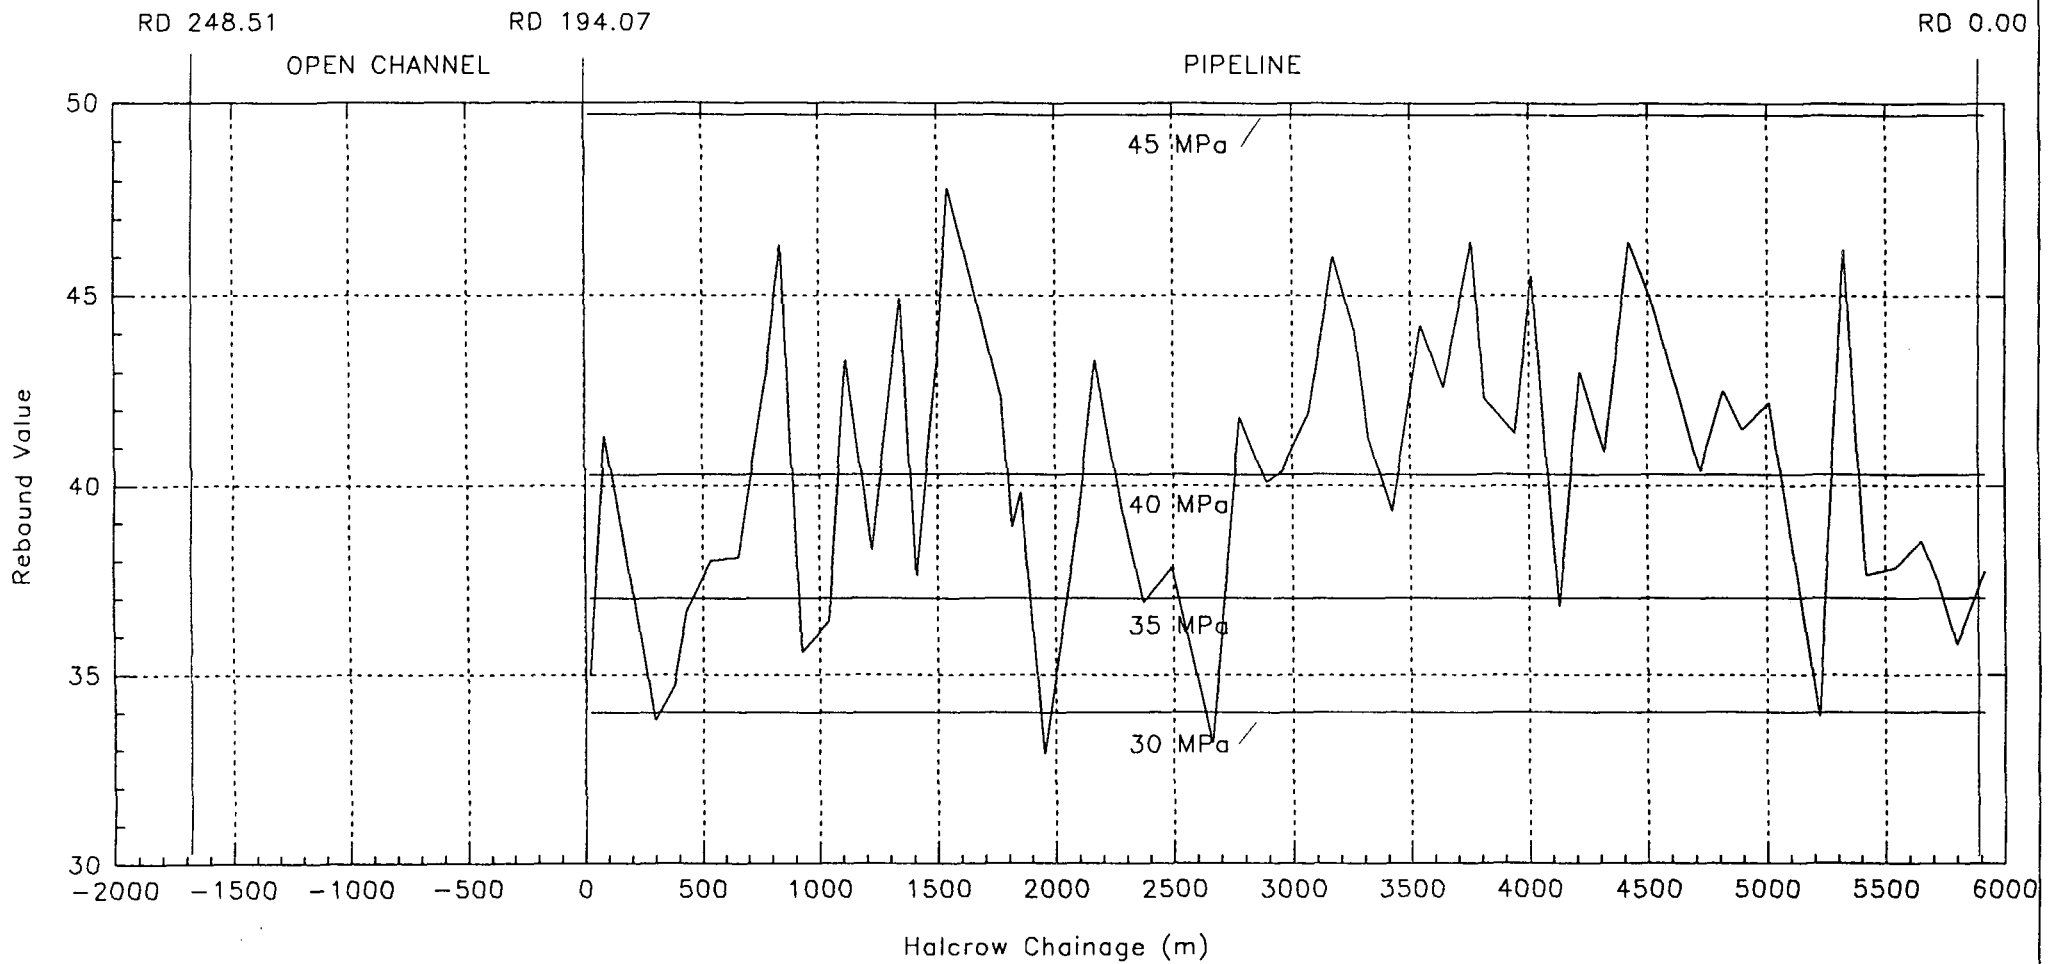
FIG 3.3

A graphical representation of non-destructive testing results (Figures 3.3& 3.4) give trends of compressive strength for both types of concrete. It is observed that both the non-destructive testing and laboratory compressive strength testing of concrete follow very similar trends (Figures 3.3 & 4.1). Both types of test show large variations over the length of the concrete pipe line and indicate significantly lower strengths in some sections. These reported results cannot, however, be used to provide an absolute estimate of concrete strength and probably represent upper and lower bounding values. Non-destructive testing results can be affected by the size of aggregate and/or presence of reinforcement close to concrete surface. Due to presence of closely spaced reinforcement, compressive strength testing was undertaken on smaller than normal sized samples, this may have affected the measured strengths even though a size correction has been applied.

The measured non-destructive test results vary significantly along the pipeline length. The rebound values indicate a dense relatively high strength concrete, but the variability of the measured values indicates inadequate construction quality control. Certain sections of the pipeline showed consistently lower rebound values, this may be related to construction practices followed by different contractors.

United Nations Industrial Development Organisation  
 Kasur Tanneries Pollution Control Project DP/PAK/93/006  
 NON-DESTRUCTIVE TEST RESULTS - PIPELINE

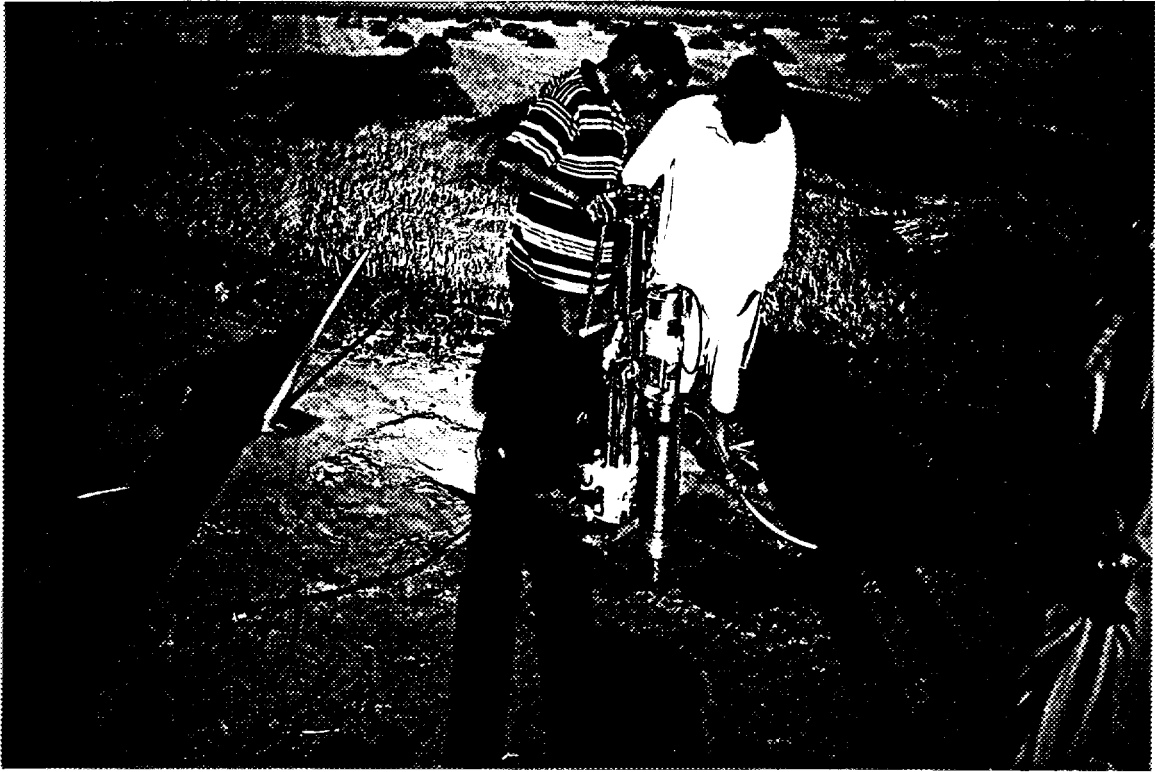
Photograph 3 Concrete Sampling with Drill Press Mounted Core Cutting Machine

Concrete cores of 83 mm diameter and 100 mm nominal length were obtained at ten locations for a total of 16 cores. A sample of plaster from the open channel was also obtained. Details of samples and laboratory testing are given in Table 3.8. Each sampling location was subsequently repaired with fresh mortar prepared with sulphate resisting cement (Photograph 4).
