#### **BWI KP Aerofill**

## **FINAL REPORT**

**UNIDO PROJECT: MP/SYR/96/121**

GASTON BANNA & SONS
CFC REPLACEMENT PROJECT

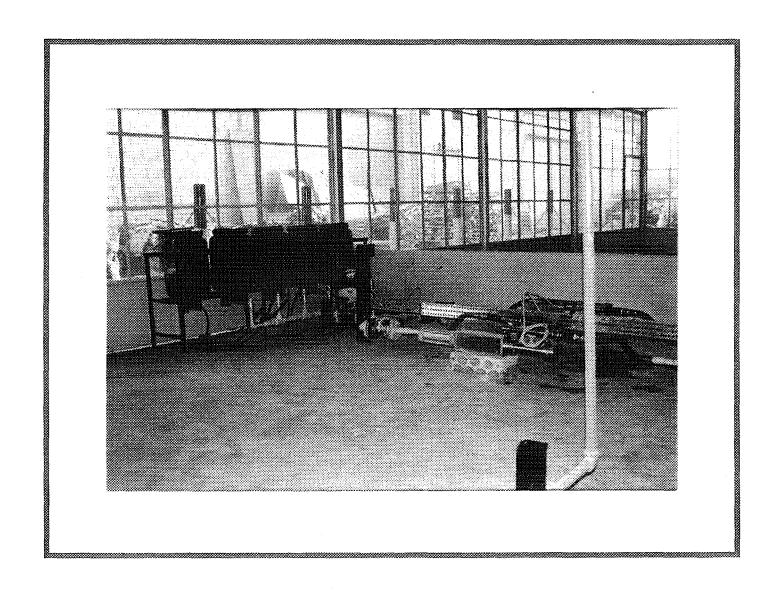
VIEW OF L.P.G. CYLINDER RACK AND PROPELLANT DELIVERY PUMPS

- 3.1 The outstanding installation work was carried out by R. Sidhu on the 13/10 and with the arrival of a new bottle of calibration gas on the 14/10 the two gas detectors in the LPG cylinder compound were recalibrated and the alarm levels reset at 10% of LEL.

There had been reports that one of these detectors had been giving
  - fluctuating signals and on the night of the 14th the sensor located near to two MK6 pumps went into alarm mode without apparent gas leakage being detected.

- Both compound sensors were recalibrated and the alarm levels set at 20%: a very faint smell of LPG could be detected at the pump sealing gland of one of the pumps and as a precaution the gland nut was fractionally tightened. To date no further problems of this nature have been experienced.

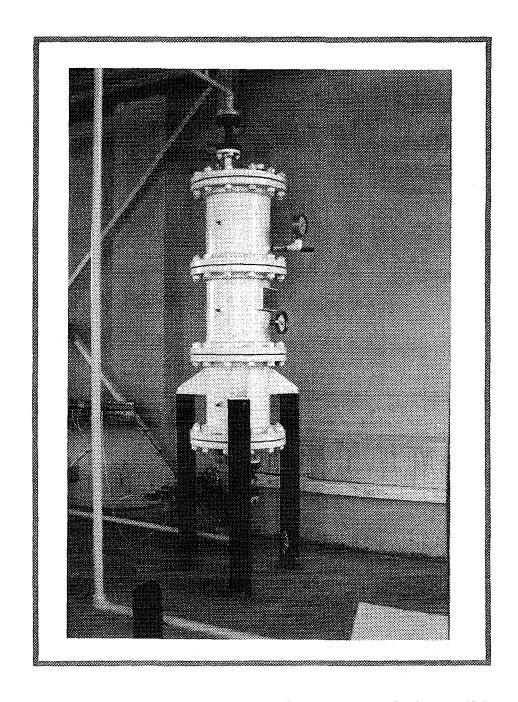
THREE COMPARTMENT DEODORISING COLUMN

Designs for a suitable storage compound were produced as part of the Guidelines and the pipework was prefabricated in accordance with these plans. Some modifications to the pipework were necessary during the installation phase and local specialist welders were utilised to carry out the modifications. Following the installation phase the entire pipework system and the destench column were purged with nitrogen to

- a) create an inert atmosphere inside the system in preparation for the first charging of the system with LPG and
- b) to test the system prior to filling with LPG. The test pressure was 11 bar.

A small number of screwed connections were found to be leaking but the leaks were soon stopped by tightening the appropriate joints.

Once the system was considered leak free it was left pressurised overnight for a period of 12 hours and as there was no evidence of pressure drop during this period the system was charged with LPG in readiness for the commissioning of the filling line.

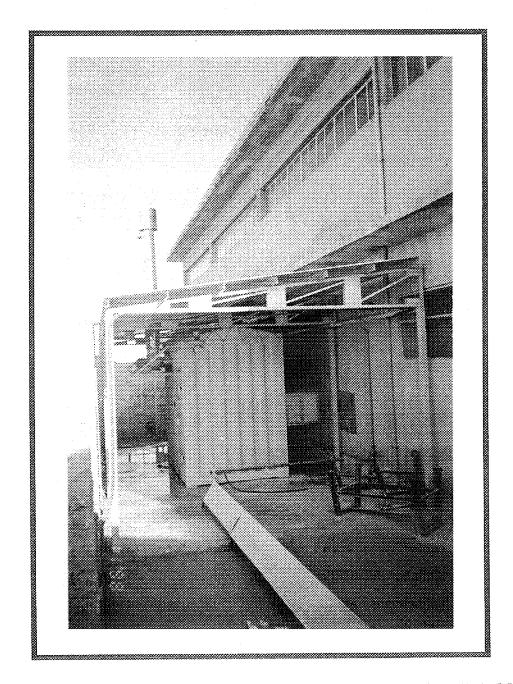
VIEW OF GAS FILLING ROOM SHOWING PROPELLANT SUPPLY PIPEWORK AND VENTILATION DUCTS

- First by ventilation to dilute and remove the vapour from the room. Two systems are used, one to remove the gas from the immediate Propellant Filler Area, the second to draw air from the floor of the room. (Gas is heavier than Air).

- These systems are two speed and the extraction can be increased by 100% if necessary.
- This action is automatic and is controlled by a system of Gas Detectors installed in the room. If any detector signals a gas concentration of more than 20% of the lower flammable limit (LFL) of the gas that is 20% of 2% gas in air, so still well below the flammable range, then the fans are automatically switched to high speed and audible and visual warnings are given.

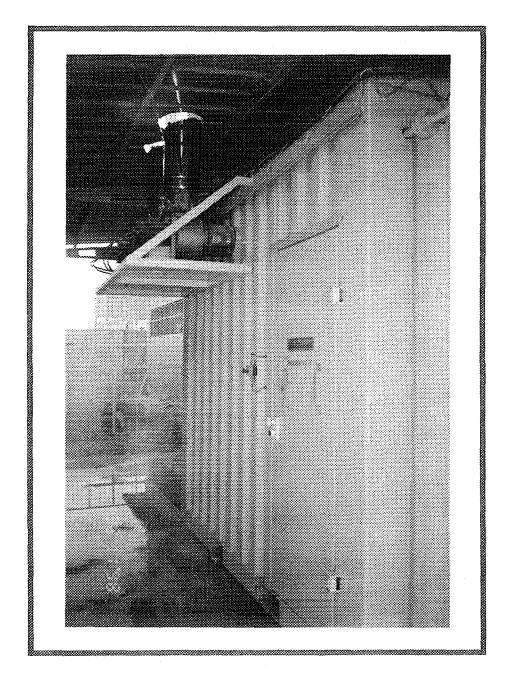
**DETAIL OF VENTILATION FANS**

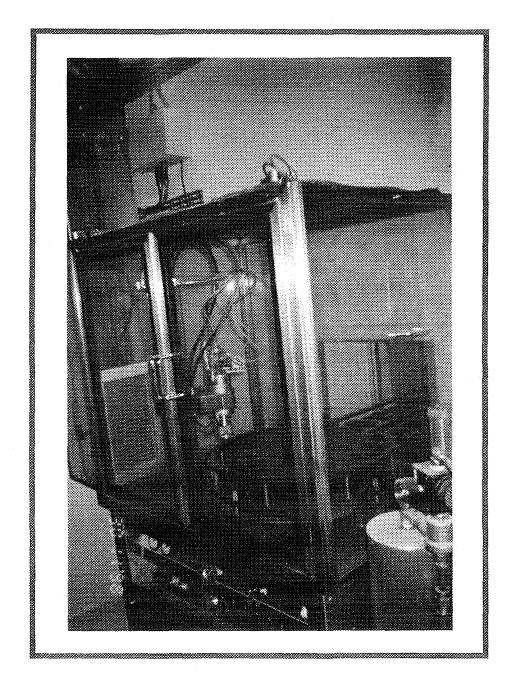
**DETAIL OF M16 PROPELLANT FILLER**

- 3.2 The acceptance trials were limited in duration because of the small number of prefilled and crimped cans available; Banna only have semi-automatic Pamasol product filler and crimper and these cannot match the output of the M16 gasser which was set to fill 40gm of LPG at 38 cpm.

The gasser filled consistently at 38-40gms although Mrs Sanchez was concerned when a filling head with no can under it discharged gas onto the machine base. It turned out that the injection pressure was set too high causing the injection nozzle servo-piston to open prematurely. The head pressure was adjusted to a lower setting and no recurrence of the problem has occured.

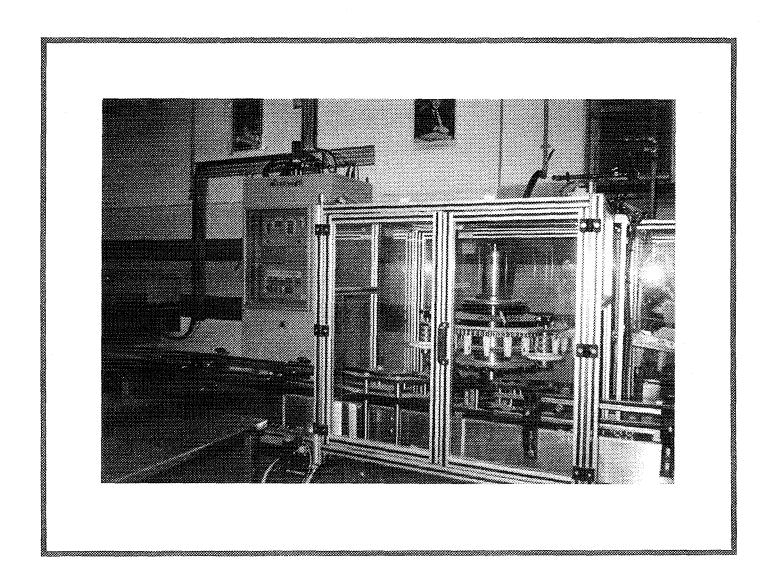
# VIEW OF TEST BATH TURRET SHOWING "GAS MANAGER" CONTROL PANEL IN BACKGROUND

The filling line and gas house were positioned without significant problem. However the electrical supply to the Test Bath heaters was inadequate and there were severe supply voltage fluctuations (down to 315v).

To circumvent this limitation in the short term the number of heater elements in service was reduced by about 35%.

This would affect the bath "warm up" period but not the running load once the water was up to temperature.

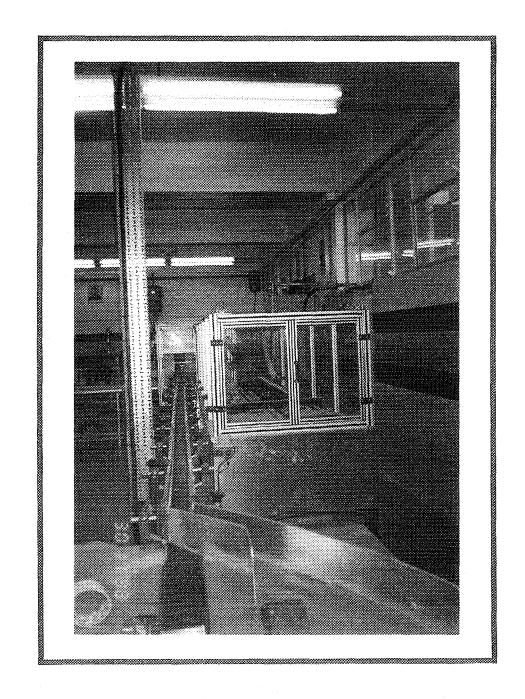
GENERAL VIEW OF LINE FROM OUTFEED TABLE END
