**Integrated Program to Support the National Strategy on
 Industrial Competitiveness in Cuba**

Date : **October 18 – Nov 2 2000**

Ort: **Havanna, Cuba.**

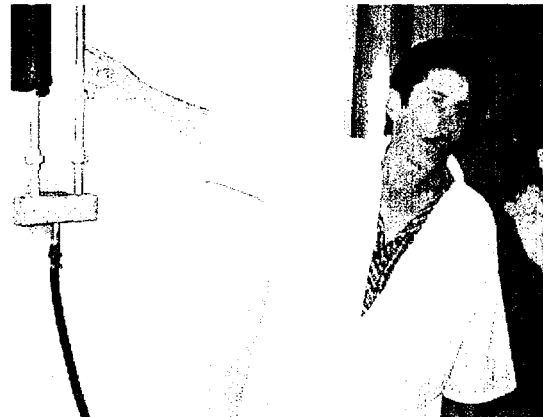
Figure 5-1 Available water mixer

For the cleaning it is required to use water in different temperatures, which are obtained mixing hot water with cold water; the problem consists that the water provision takes place with different pressures, because while the hot water (85 °C) is 6 bar, the cold water from the storage tank (20 °C) has only 2 bar, when they try to mix them, the hot water invades the cold water pipe until overflow in the storage tank

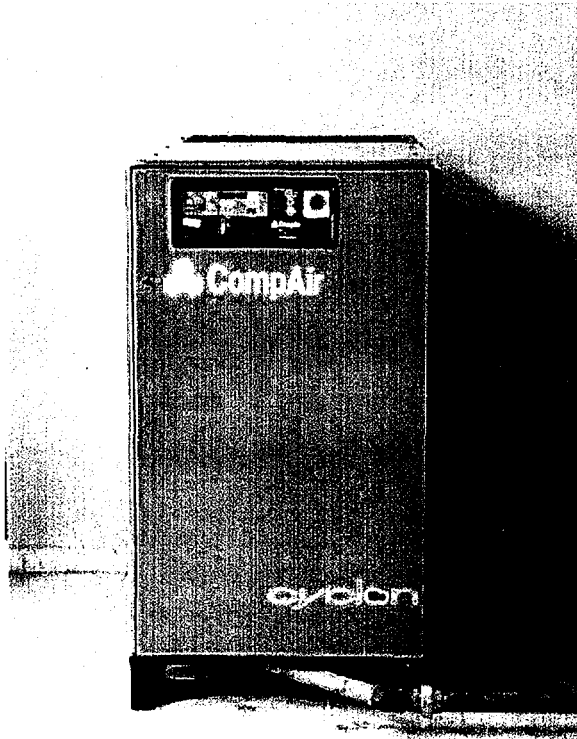
Figure 5-2 Air Compressor

23 OFF. The pressure fall from 8,1 to 7,6 bar

The packing machine consumption reaches 1,2 m³/min

As it can be seen, the compressor operation pressure fall near the consumption of the plant, and for this reason its operation becomes very frequent. It would be possible to use an additional storage tank, available in the factory, by means of which, although the times of load of the compressor are extended a little, the pauses of the same one would be also much greater, unloading this the electrical system per longer periods.
