International Conference on
Carbon Fibre Applications

MECHANISMS OF FRACTURE IN FIBRE REINFORCED STRUCTURES*

Heinrich W. Bergmann**

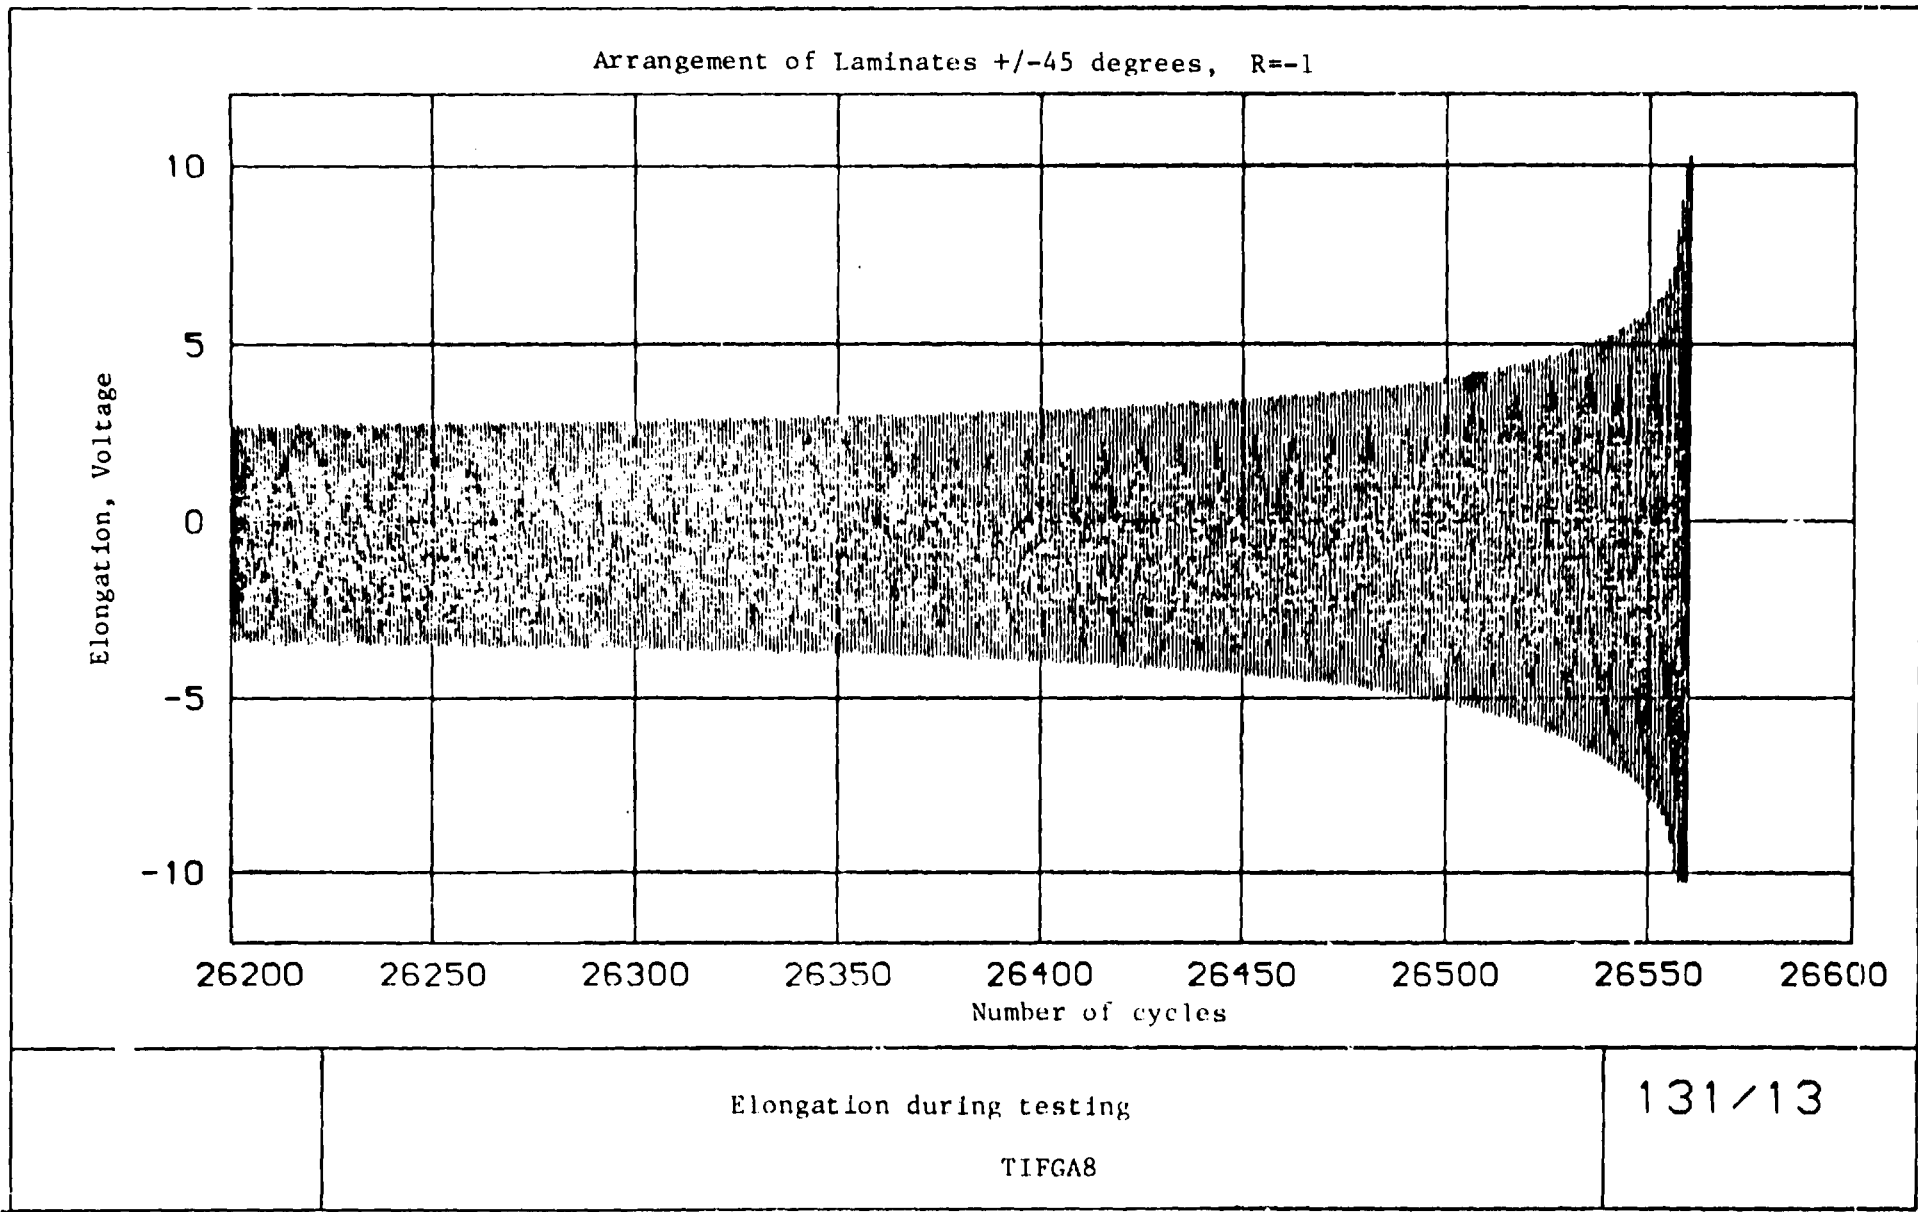
Fig. 3

Accompanying the gradually increasing damage state is a noticeable reduction of the overall laminate stiffness. Depending on the stacking order, this reduction may be as pronounced as shown in Figure 3 for a matrix-controlled $[\pm 45]_{2S}$ -laminate, or as subtle as in the case of the fiber-controlled $[0_2, +45, 0_2, -45, 0, 90]_S$ -laminate shown in Figure 4. In both instances, however, a particularly critical combination of local failure modes develops finally which leads to a rapid deterioration of the stiffness in only a few additional cycles and to what is commonly called "sudden death" of the specimen.

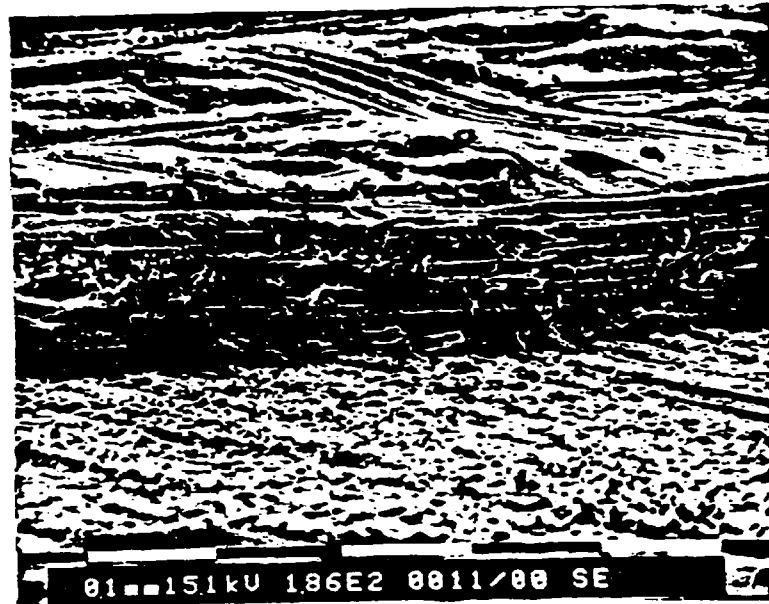
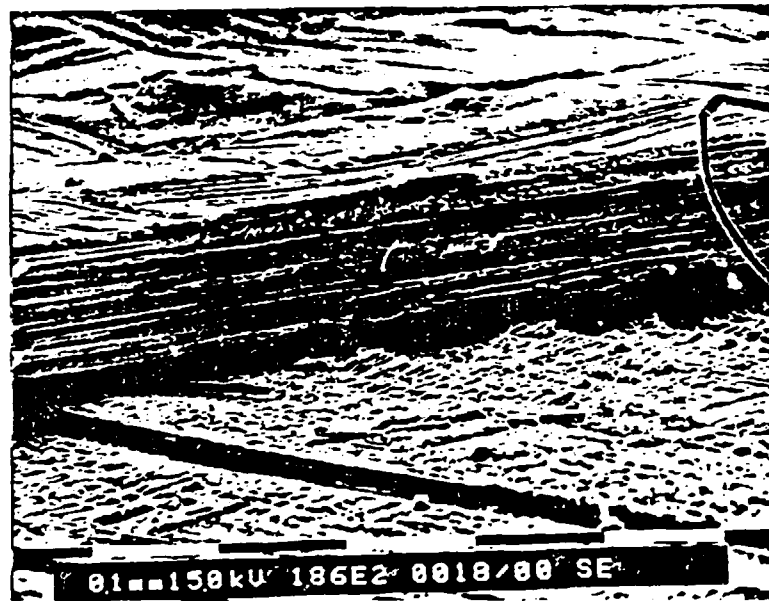
Fig. 8

Prior to Cycling

After 3480 Thermal Cycles

Typical Fracture Areas of 914C - Specimens Before and After Thermal Cycling

The loss of adhesion between fiber and matrix is often referred to as debonding. The cause may be a locally faulty surface treatment, or the gradual deterioration of an initially good bond by mechanically or thermally induced fatigue. An example of latter is given in Figure 8, showing the fracture surfaces of tension-loaded specimens before and after severe thermal cycling. While prior to cycling the many specks of resin adhering to the fiber surfaces indicate a reasonably strong bond, the much smoother

surfaces after cycling seem to signal the loss of it. It may be expected that similar degradations take place under mechanical loads. As a consequence of progressive debonding, a gradual deterioration of the laminate stiffness might be expected. Figure 9 seems to lend credence to this argument although it is not clear to what extent additional cracking contributes to the stiffness degradation.

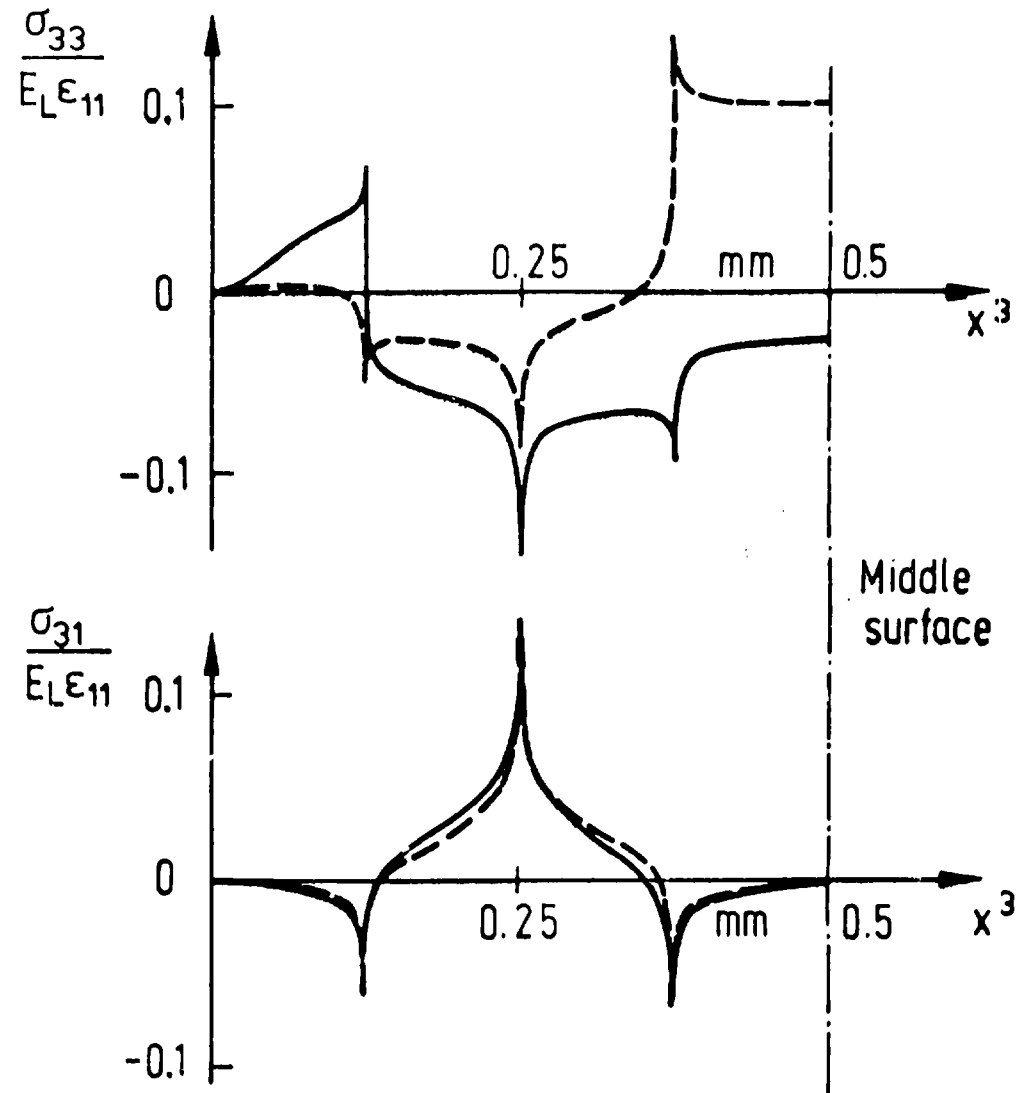
Fig. 11

Stacking sequences
 ——— $[90^\circ, -45^\circ, +45^\circ, 0^\circ]_s$
 - - - $[0^\circ, -45^\circ, +45^\circ, 90^\circ]_s$

Free edge stresses under axial tension for different stacking sequences of a laminate

A very different behavior of the two laminates was observed during fatigue loading with $R=+0.1$ and an upper stress level of 75 % of their respective static strengths. As expected, microcracking and edge delaminations occurred relatively early in the $[0, \pm 45, 90]_S$ -specimens. Monitored by contrast-enhanced radiography, as shown in Figure 12, the delaminations proceeded from both sides toward the center of the specimen until, shortly before failure, they were separated only by the narrow strip recognizable in Figure 13. The $[90, \pm 45, 0]_S$ -specimens, in contrast, exhibited relatively minor evidence of damage. The appearance of a typical free edge, shortly before failure, is shown in Figure 14. Incipient delaminations are recognizable between those plies where, according to Figure 11, the internal stresses are most severe.
