SYNOPSIS

The Domsuiza manufacturing facilities were never completed. Some of the production equipment was not delivered. Much of it is outdated.

The existing facilities have suffered extensive deterioration and damage from weather and years of non-use.

DOMSUIZA

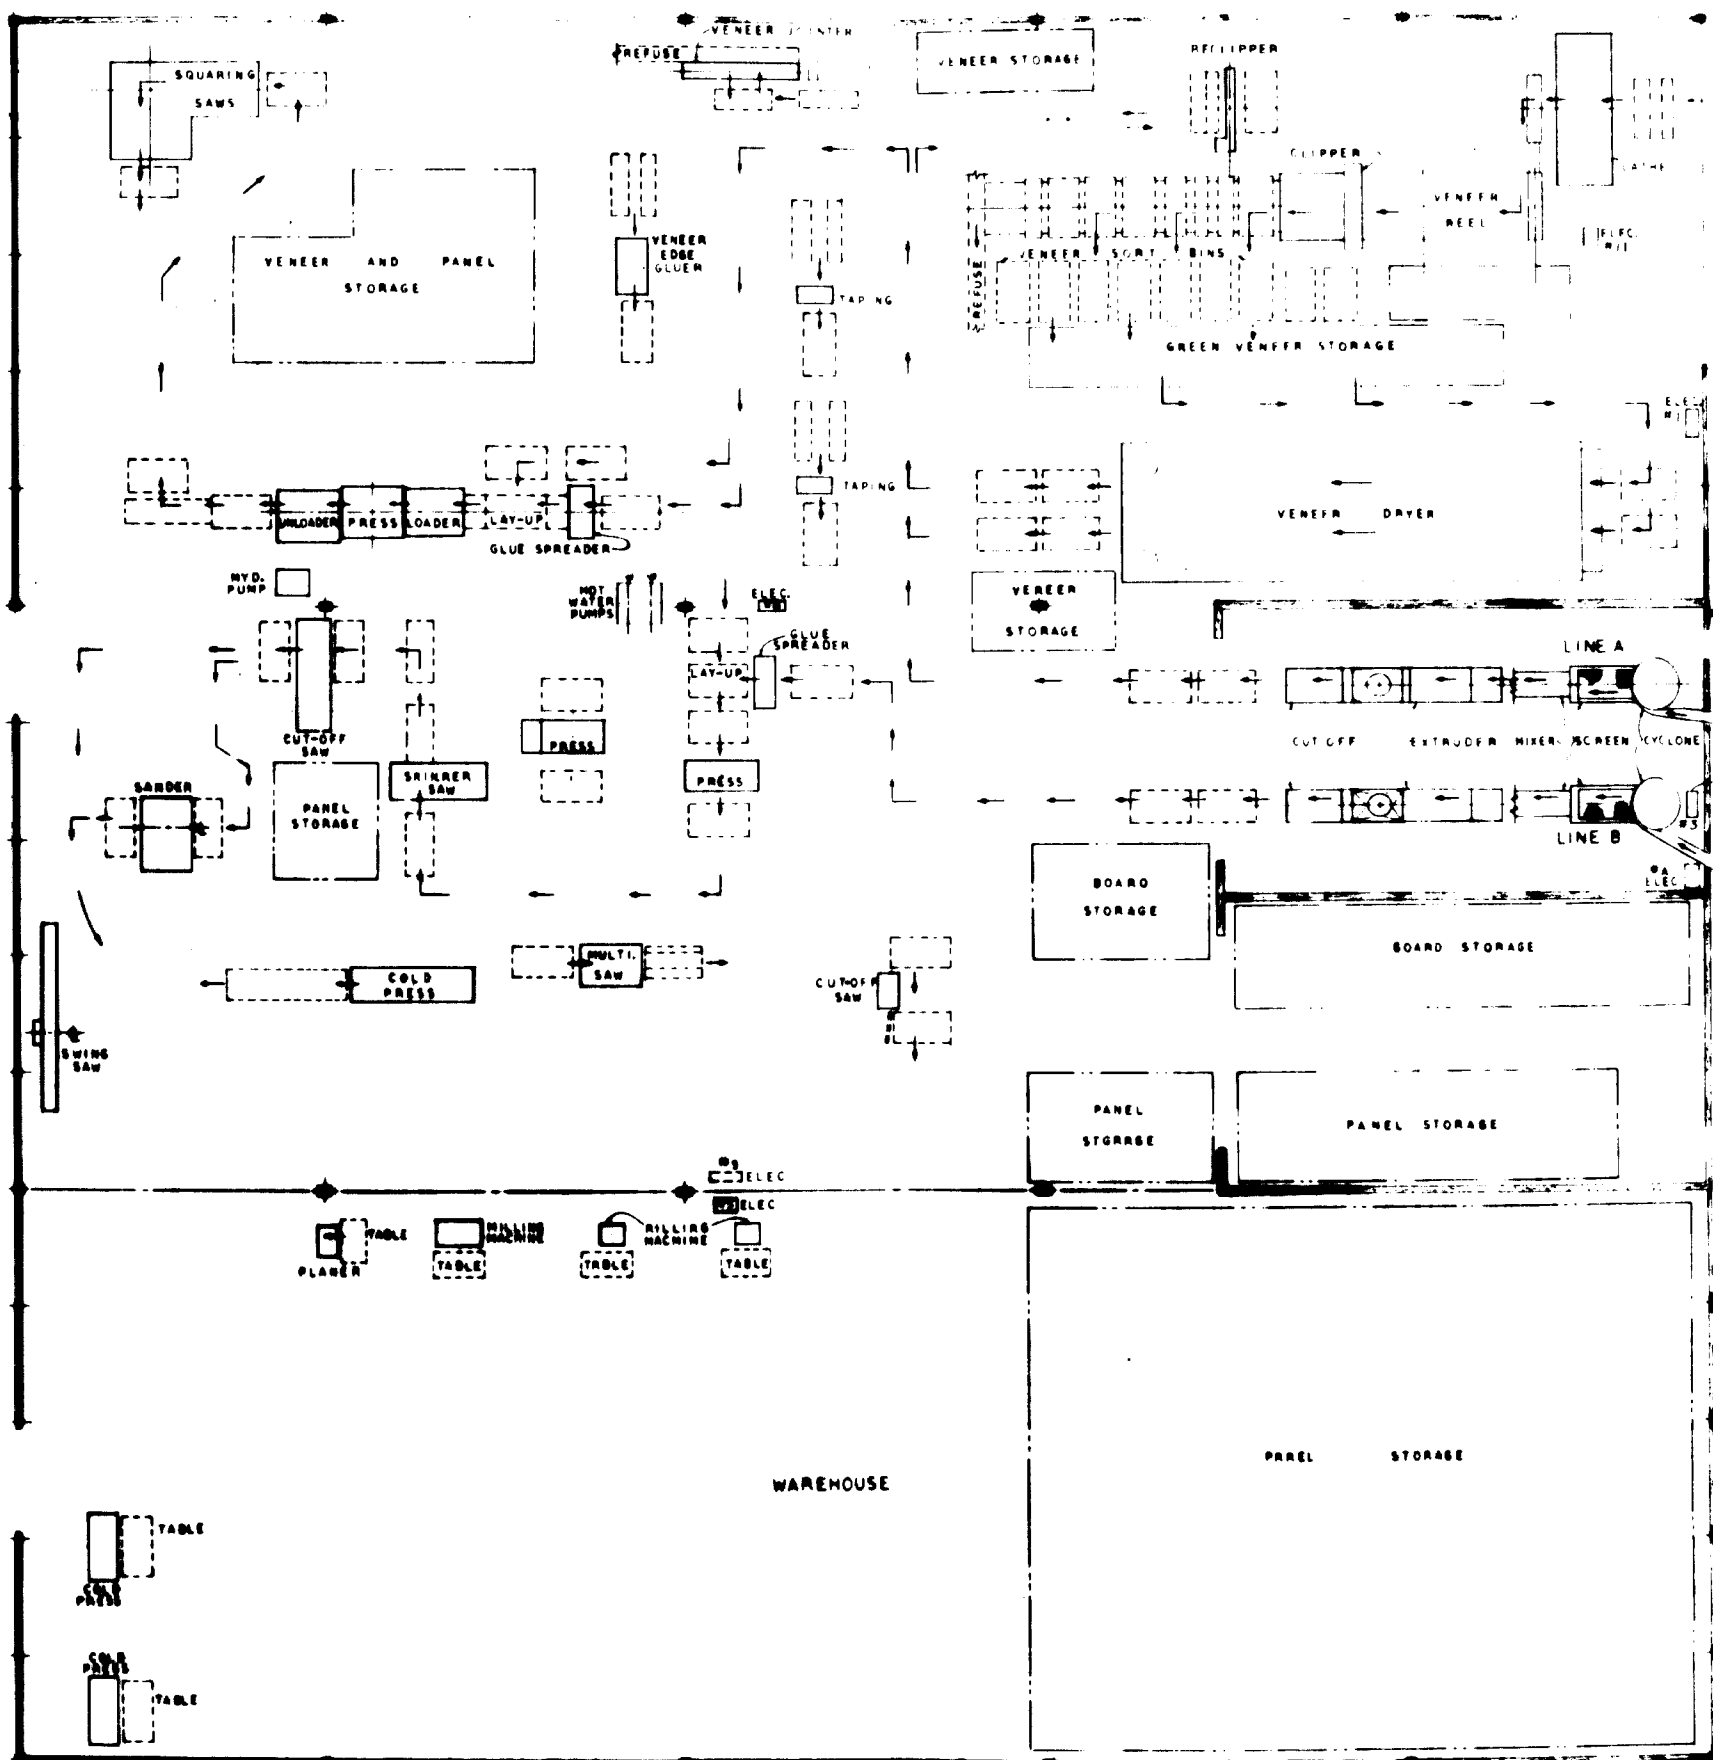
NOTES:
 1. MISSING EQUIPMENT REQUIRED FOR THE PROCESSES IS SHOWN BY DASHED LINES ON THE LAYOUT. FOR DETAILED INFORMATION SEE INVENTORY SHEET.
 2. BOARDS AND VENEER REQUIRED TO SHOW MATERIAL FLOW THROUGH THE PLANT ARE SHOWN BY DASHED LINES ALSO.
