UNIDO/FAI Interregional Meeting on Safety in
the Design and Operation of Ammonia Plants

A REPORT ON A FIRE IN THE AMMONIA SYNTHESIS UNIT

This is a report on the occurrence of fire in Ammonia Synthesis section of the 450 tons per day ammonia plant of Shriram Chemical Industries, Noida.

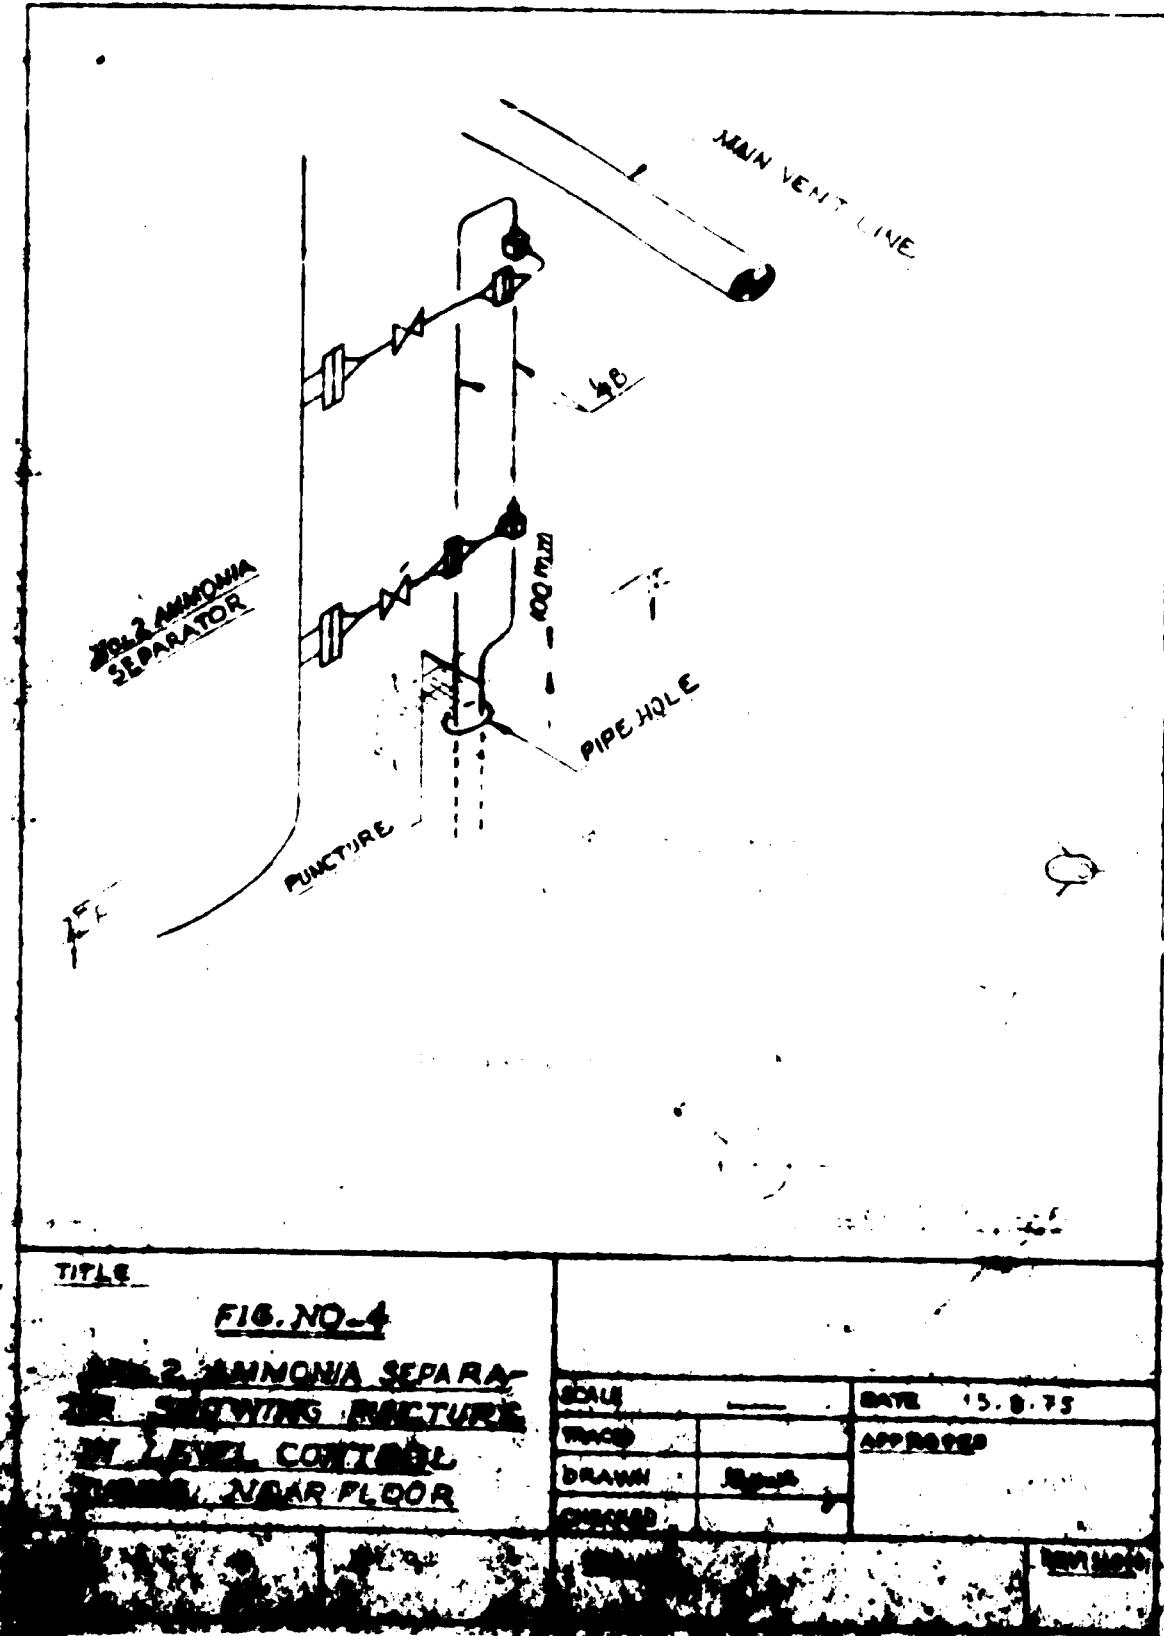
DETAIL OF LEVEL
CONTROL TUBING.

1. The level control instrument tubing on No.2 Ammonia Separator had broken off at the flange neck. The welded part connecting the connection tube of the tee joint and the flange neck of the L.C. tubing was found broken (Figure 2). The details are shown in Figure 3.
2. The liquid side on the L.C. tubing on the Ammonia Separator No.2 had burst at a point 100 m above the first floor level as shown in figure 4. The burst was on the side of the 12 B gas line as in figure. The tubing was also burnt around the bursted part indicating that it had been exposed to heat.
3. The main 10° vent Header had shifted along a considerable length. The synthesis section has a common 10° vent Header to which the various vent lines from the equipment were connected (figure 1). These include the vent lines from :
 - No.1 & No.2 Oil Separators
 - Ammonia Chillers A & B
 - Purge gas chiller
 - Waste Heat Boiler

A crack opened up in the flange neck of the upper LC tubing; gas leaked out through it and got ignited; eventually the crack opened up completely around the circumference of the neck, letting the LC tubing snap away from the flange neck; and the jets of gas spouting out from the open end of the flange neck and the open end of the freed connection tube continued to burn. As to the source of ignition, some tiny particle of iron powder or scale which existed inside the LC tubing might have been blown out by the gas spouting and generated a small spark from impingement on the surfaces within the tubing or the sharp edges of the crack.
