Technical Consultation on Corrosion  
in Fertilizer Plants

COUNTRY PAPER BY MAURITIUS  
CORROSION PROBLEMS ENCOUNTERED AT THE  
MAURITIUS CHEMICAL AND FERTILIZER INDUSTRY\*

## CORROSION PROBLEMS: MCFI CASE STUDY

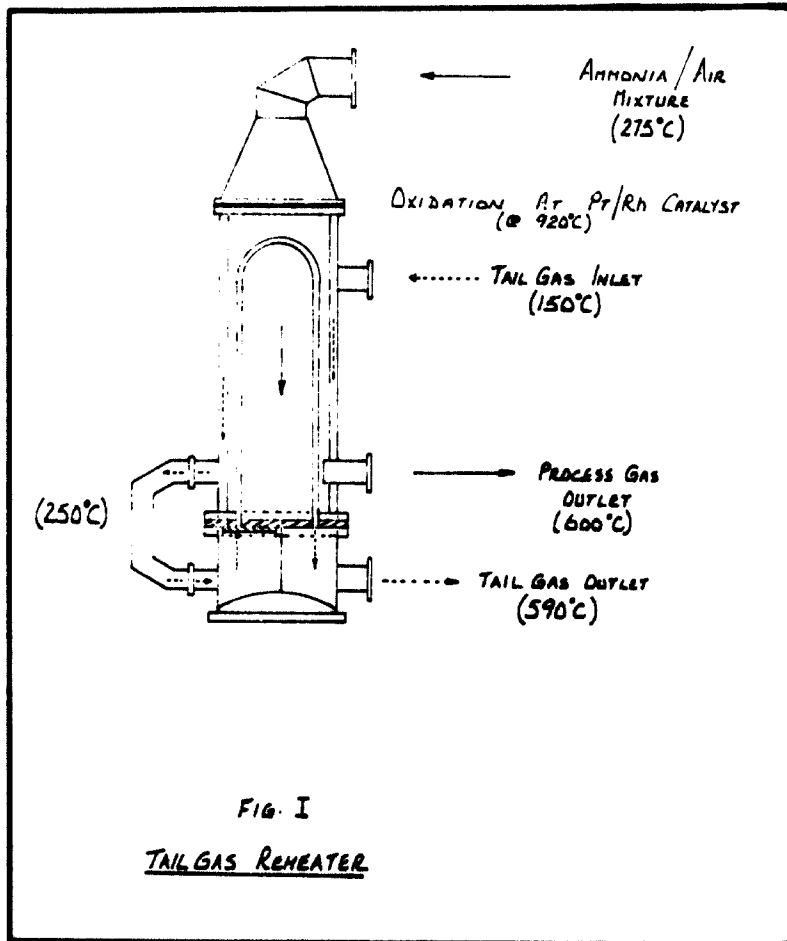
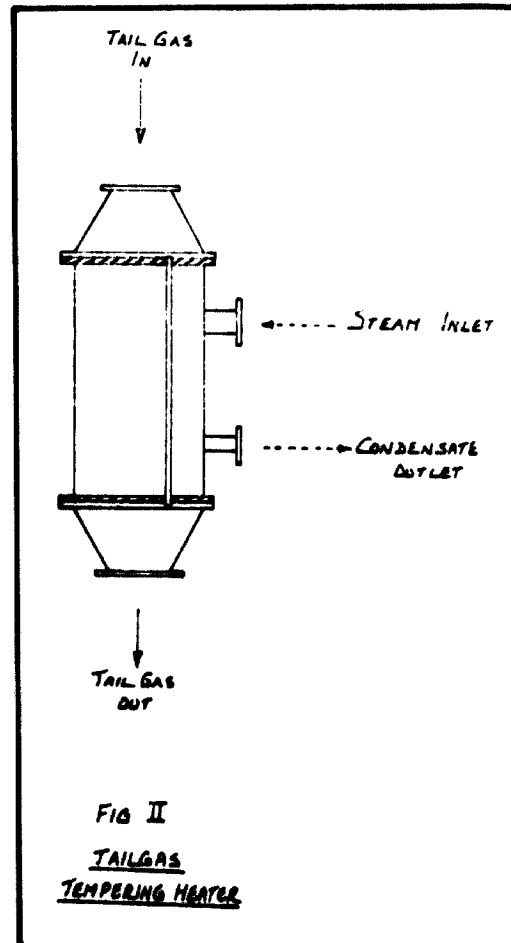
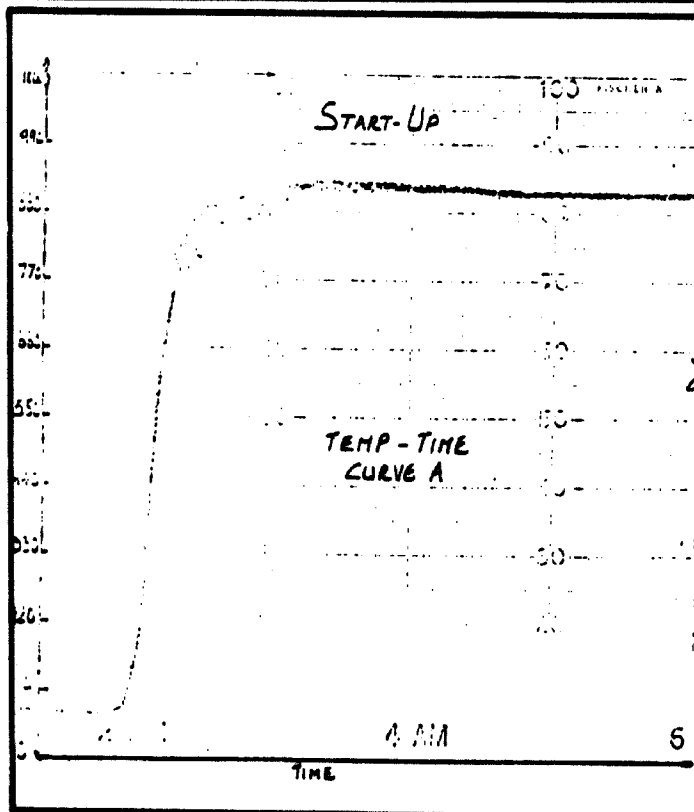
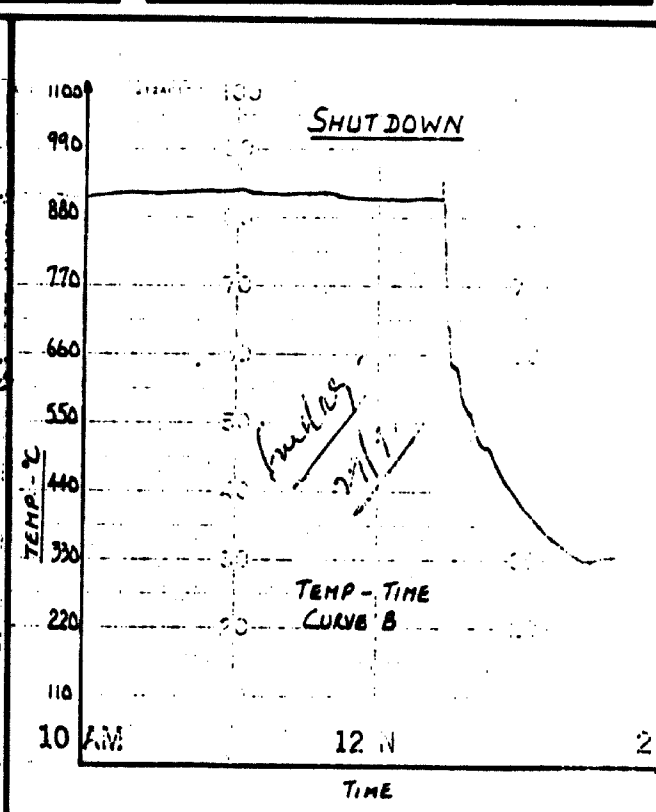
At the vicinity of the steam inlet to the exchanger, the tube metal temperature is hot enough to boil off droplets of acid carried over from the absorption column and the mist separator. This results in severe corrosion of the tubes at the inlet, immediately at the backface of the tubesheet. Leaking tubes at the top of the tempering heater have caused severe damage to the carbon steel shell which has been eaten up by the acid spray. (see photograph).

It has been suggested that Teflon sleeves could be used to protect the tubes at the inlet of the heat exchanger to move the area of corrosion so that the tubesheet could be reused when the unit must be retubed. The damaged unit at MCFI has been replaced by a new one, where the 304L tubes have been replaced by SANDVIK 3RE60. SANDVIK 3RE60 - which is ferritic austenitic - is somewhat less resistant to acid and oxidising medium than austenitic steel 304L and problems are expected to crop up in the near future.

SANDVIK 2RE10, which is reported to be more resistant under similar operating conditions, would have probably been a much better choice.
