Technical Consultation on Corrosion in
Fertilizer Plants

COUNTRY PAPER FROM SAUDI ARABIA

SPECIAL CORROSION PROBLEM AND THE REPAIR AT SAFCO*

UREA REACTOR

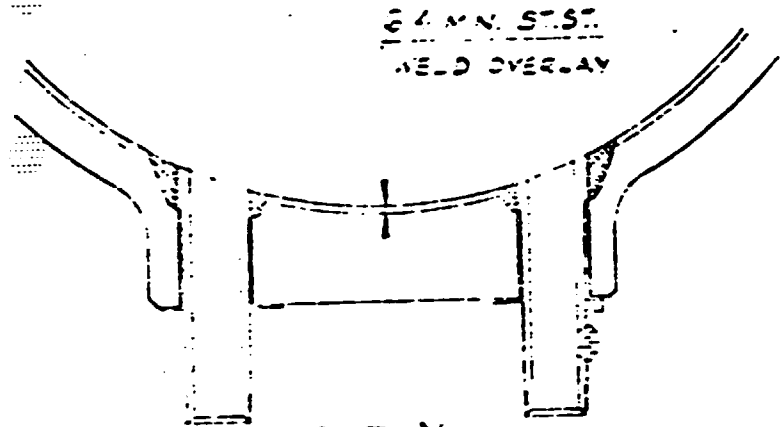
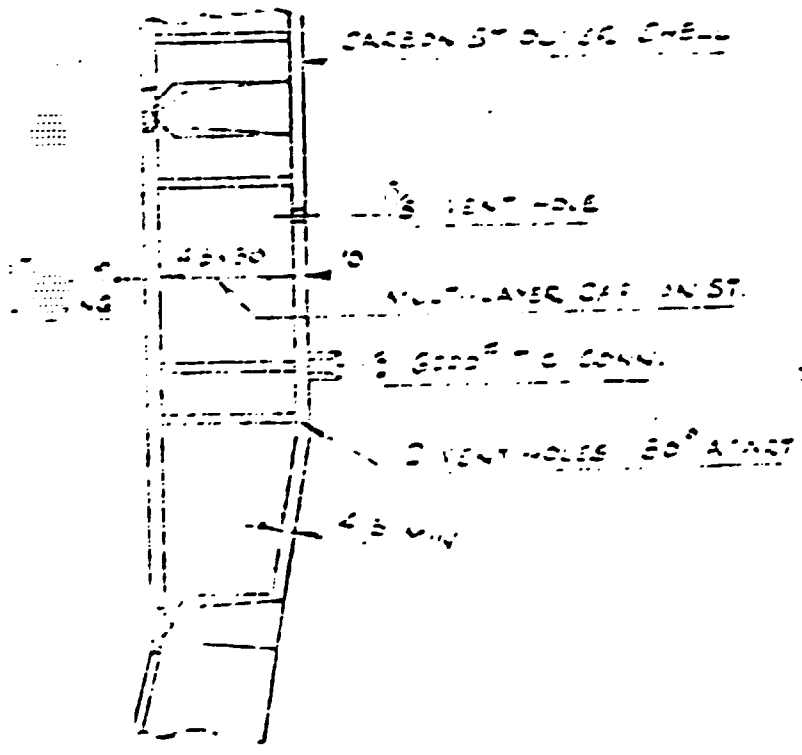
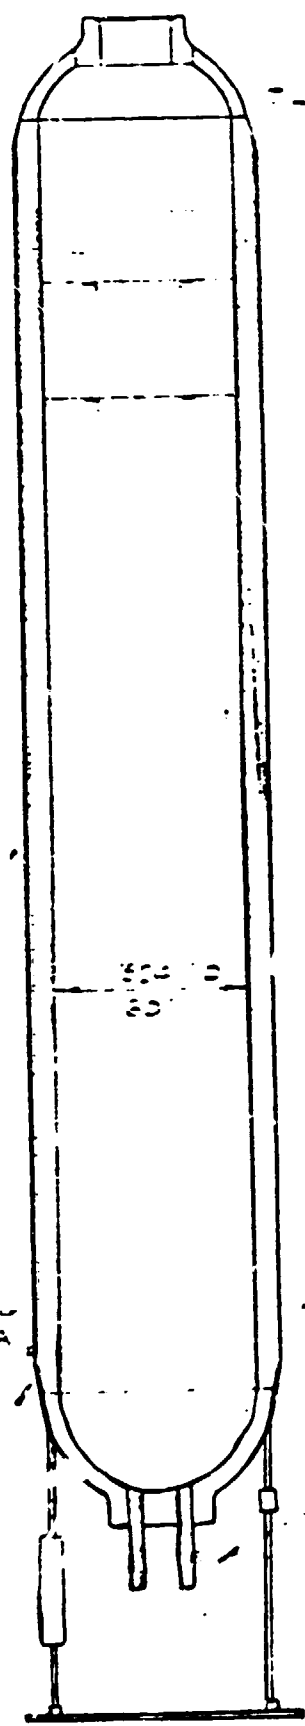
CORROSION/EROSION AREAS OF UREA REACTOR BOTTOM FORGING AT SAFCO

The failure of the bottom of urea reactor is attributed to the gradual thinning out of the S. S. overlay over a period of time. The thinning of weld overlay was due to high velocity of the fluid entering the vessel and deterioration of S. S. 316 L weld deposit. Another factor which could have contributed is the oxygen content in the CO₂ feed to the reactor. It is possible that the oxygen content was actually lower than indicated because of faulty instrumentation.

CORROSION AREAS (DOTTED)

50X50 RUPTURE THRU 1/2" THICK FORGING

- A 50X50 RUPTURE DEEP
- B 175X175
- C 116.6X116.6
- D 91.5X91.5
- E 50X50 RUPTURE POINT

MAXM COLLISION AREA FROM RUPTURE POINT (DOTTED)

4. Reassemble the bottom distributor.
5. Ultrasonically check the repaired area thoroughly for any weld defects.
6. Hydro-test the reactor to full test pressure of 5,000 psig. The rate of pressure rise, the holding time and rate of pressure drop during depressurizing are shown in the appendix-II.

It has been found that SS-316-L weld overlay is susceptible to urea attack over a period of service. A new electrode by the trade name of Thermanit 19/15 H has been developed and is claimed to be better than E-316-L. The manufacturer of the autoclave is now recommending use of this improved electrode.
