Technical Consultation on Corrosion in
Fertiliser Plants

COUNTRY PAPER FROM KUWAIT

CORROSION PROBLEMS EXPERIENCED IN AMMONIA AND UREA PLANTS*

Bahaa H. Abdel Nabi **

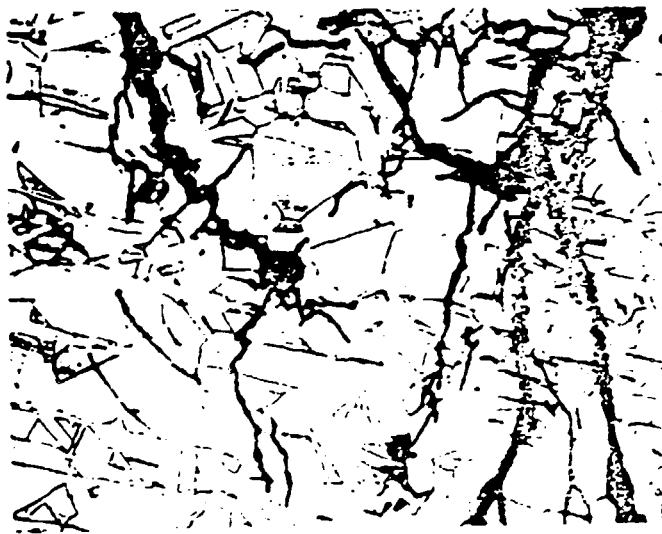
17-

- General structure of the material was found good and free of abnormalities (Micrograph No. 12)
- Numerous corrosion pits formed on local areas on back surface of the strips (Micrographs No. 13 - 17).
and
- A pattern of several cracks radiated from each of the formed pits. Cracks propagated with extensive branching and displayed a transcrystalline mode of progression (Micrographs Nos. 13 - 22).
