Expert Group Meeting on Shipbuilding  
and Shiprepair Development for Asian  
and the Pacific Countries

REPAIRS TO BRONZE PROPELLERS\*

A.K. Diyabalanage\*\*

\*\* Production Manager, Colombo Dockyard Ltd.

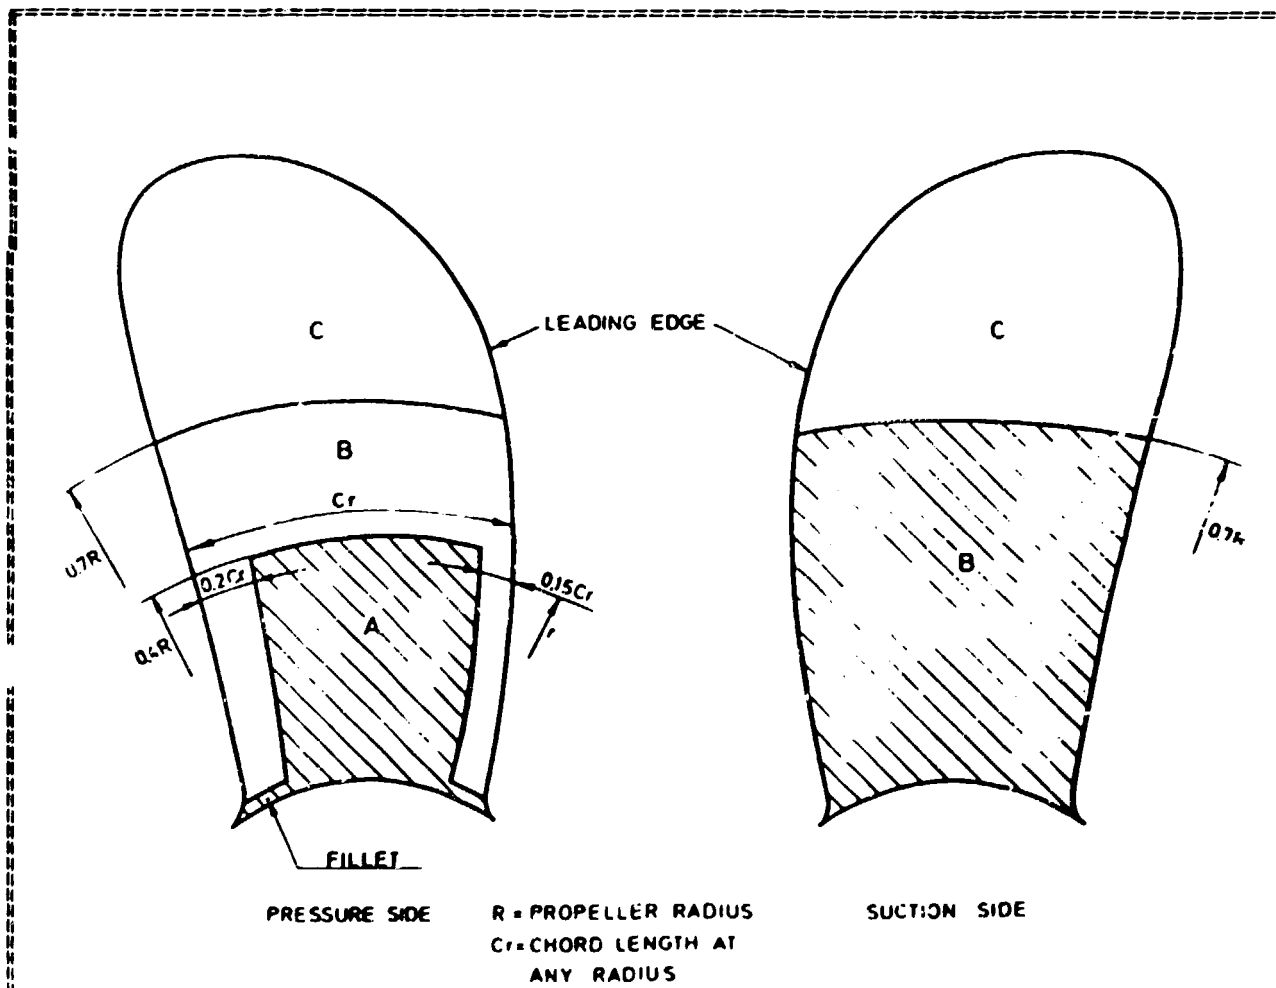
FIG1 SEVERITY ZONES

Zone A is the area on the pressure side of the blade, from and including the fillet to 0.4R and bounded on either sides by lines lying a distance of 0.15 and 0.20 times the chord length from the leading edge and the trailing edge respectively. Zone B is on the pressure side, the remaining area of the base to 0.7R and on the suction side the area from the base to 0.7R. Zone C is the area outside 0.7R on both sides of the propeller blades and the surface of the boss including the bore surface.

In Zone A, the repair by welding is normally not allowed. This is because the massive sections near the blades cause a higher degree of restraint and the consequence of the subsequent failure is greater. Here the defects that are not deeper than  $D_a = \frac{t}{50}$  mm or 2mm below minimum local thickness according to the rules, should be removed by grinding. Any defects deeper than stated requires individual consideration by Classification Surveyor and owner.

Defects that are not deeper than  $D_b = \frac{t}{40}$  or 2mm below (whichever is greater) below the minimum local thickness according to the rules, should be removed by grinding. Weld repairs in Zone B should also not be made without consultation between the owners and the Classification Society. Normally those defects that are deeper than allowable for removal by grinding may normally be repaired by welding. The extent of such repairs however should be limited and their depth should not exceed  $t/3$ . The possible repair of defects that are deeper than those referred above is to be considered by a surveyor and the owner in each separate case.

*In Zone C, weld repairs are generally permitted. The repair of weld should be in accordance with recommendations.*

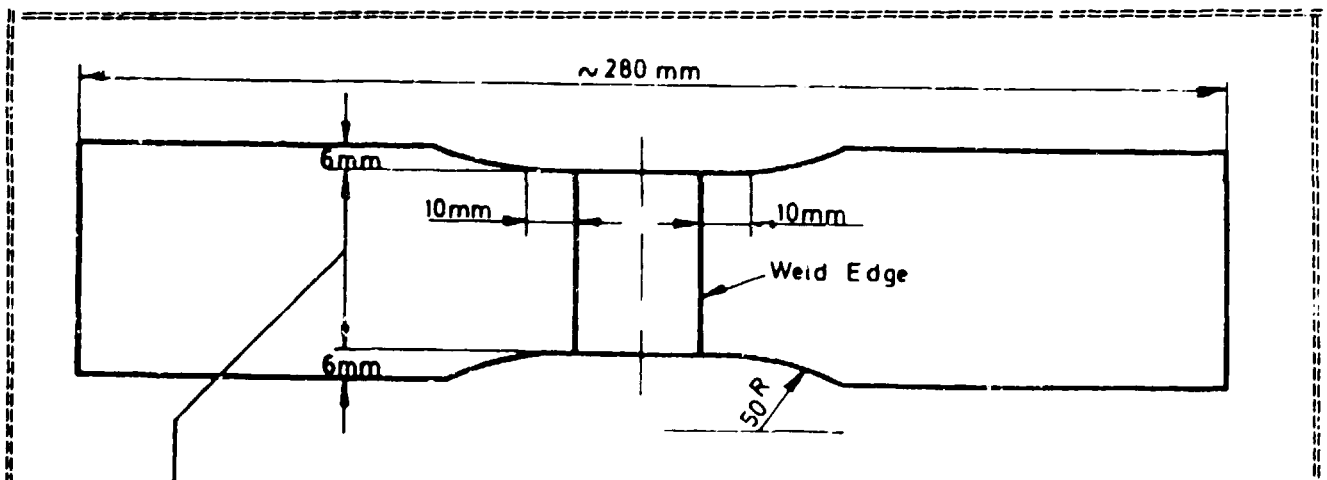
(FIGURE III)

Pre-heat temperatures of material - 150°C - 200°C for the parent material. 250°C for minimum one hour for electrodes. Work pieces cooled under controlled condition after completion of welding. The test piece finally ground, dye penetrant checks carried out, stress relieved and subjected to tensile test.

To be determined by the capacity of the tensile testing machine, but is not to be less than 13mm

TENSILE TEST
