# **Improvement of Steel Making Operations**

## **Three Non-integrated Steel Plants**

### **Arab Republic of Egypt**

**KOBE STEEL, LTD.**

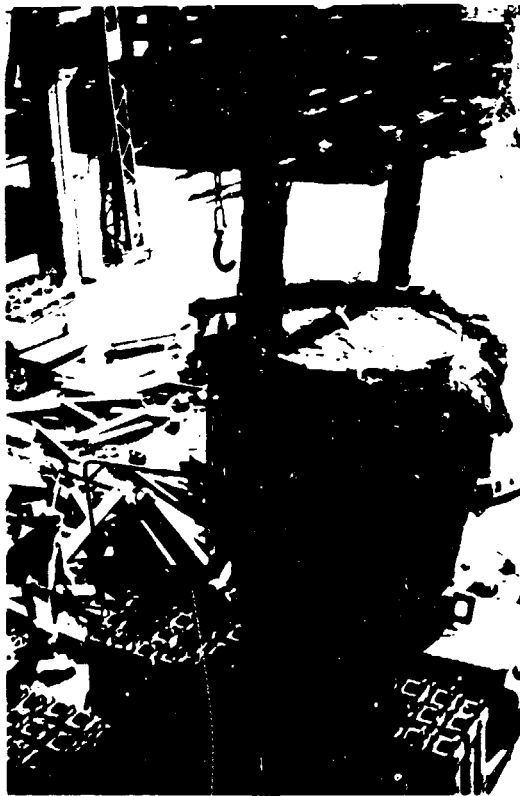
40. Dumped pit scraps and short ingots, not disposed into charging box (NATIONAL)
