Hot kiln alignment

F I N A L R E P O R T

REPORT ON HOT KILN ALIGNMENT OF THE ROTARY
KILNS OF HAWARI AND BENGHAZI CEMENT PLANTS

IN BENGHAZI - LIBYA

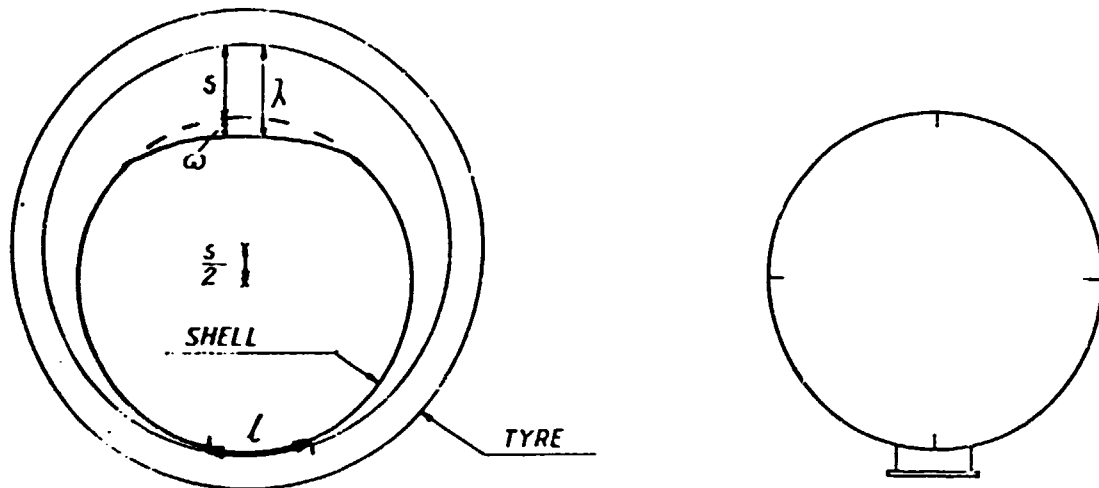
KILN SHELL TOP CLEARANCE

KILN No 1UNDERTIRING CLEARANCETYRE IDate of measurement.① $l = 19 \text{ mm}$ clearance $s = 6 \text{ mm}$ NOV. 9th 1992NOV. 12th 1992NOV. 17th 1992

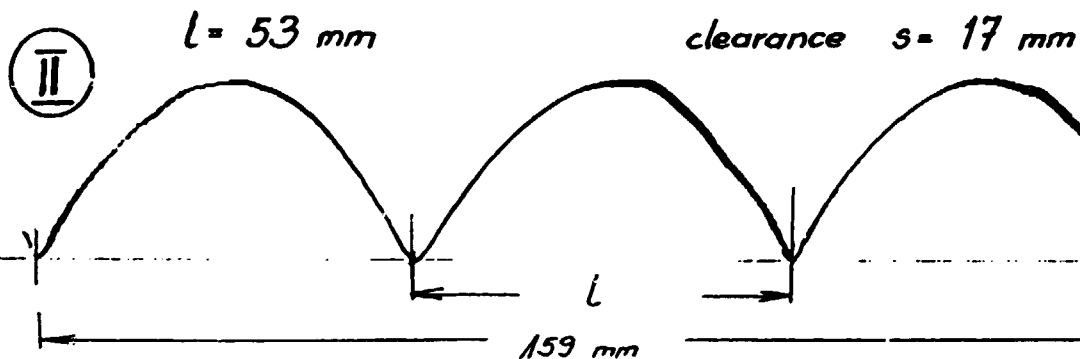
TYRE II

The undertyre clearance of the tyre No 2 has been measured for six times and the real value of this clearance is 7.5 mm. However, during the measurement taken on the 6th of Nov.1992 a considerable difference was noticed when the clearance reached 12 mm. We can only presume that the reason of such differences was caused by a momentary change of the Kiln's shell temperature near the above mentioned tyre.

- 3.5 The undertyre clearances on supports 2 and 3 are incorrect and require further adjustment which should take place during the replacement of the Kiln's shell under tyre 2 and 3. The proper value of undertyre clearance " in hot conditions " is 3 to 6 mm.

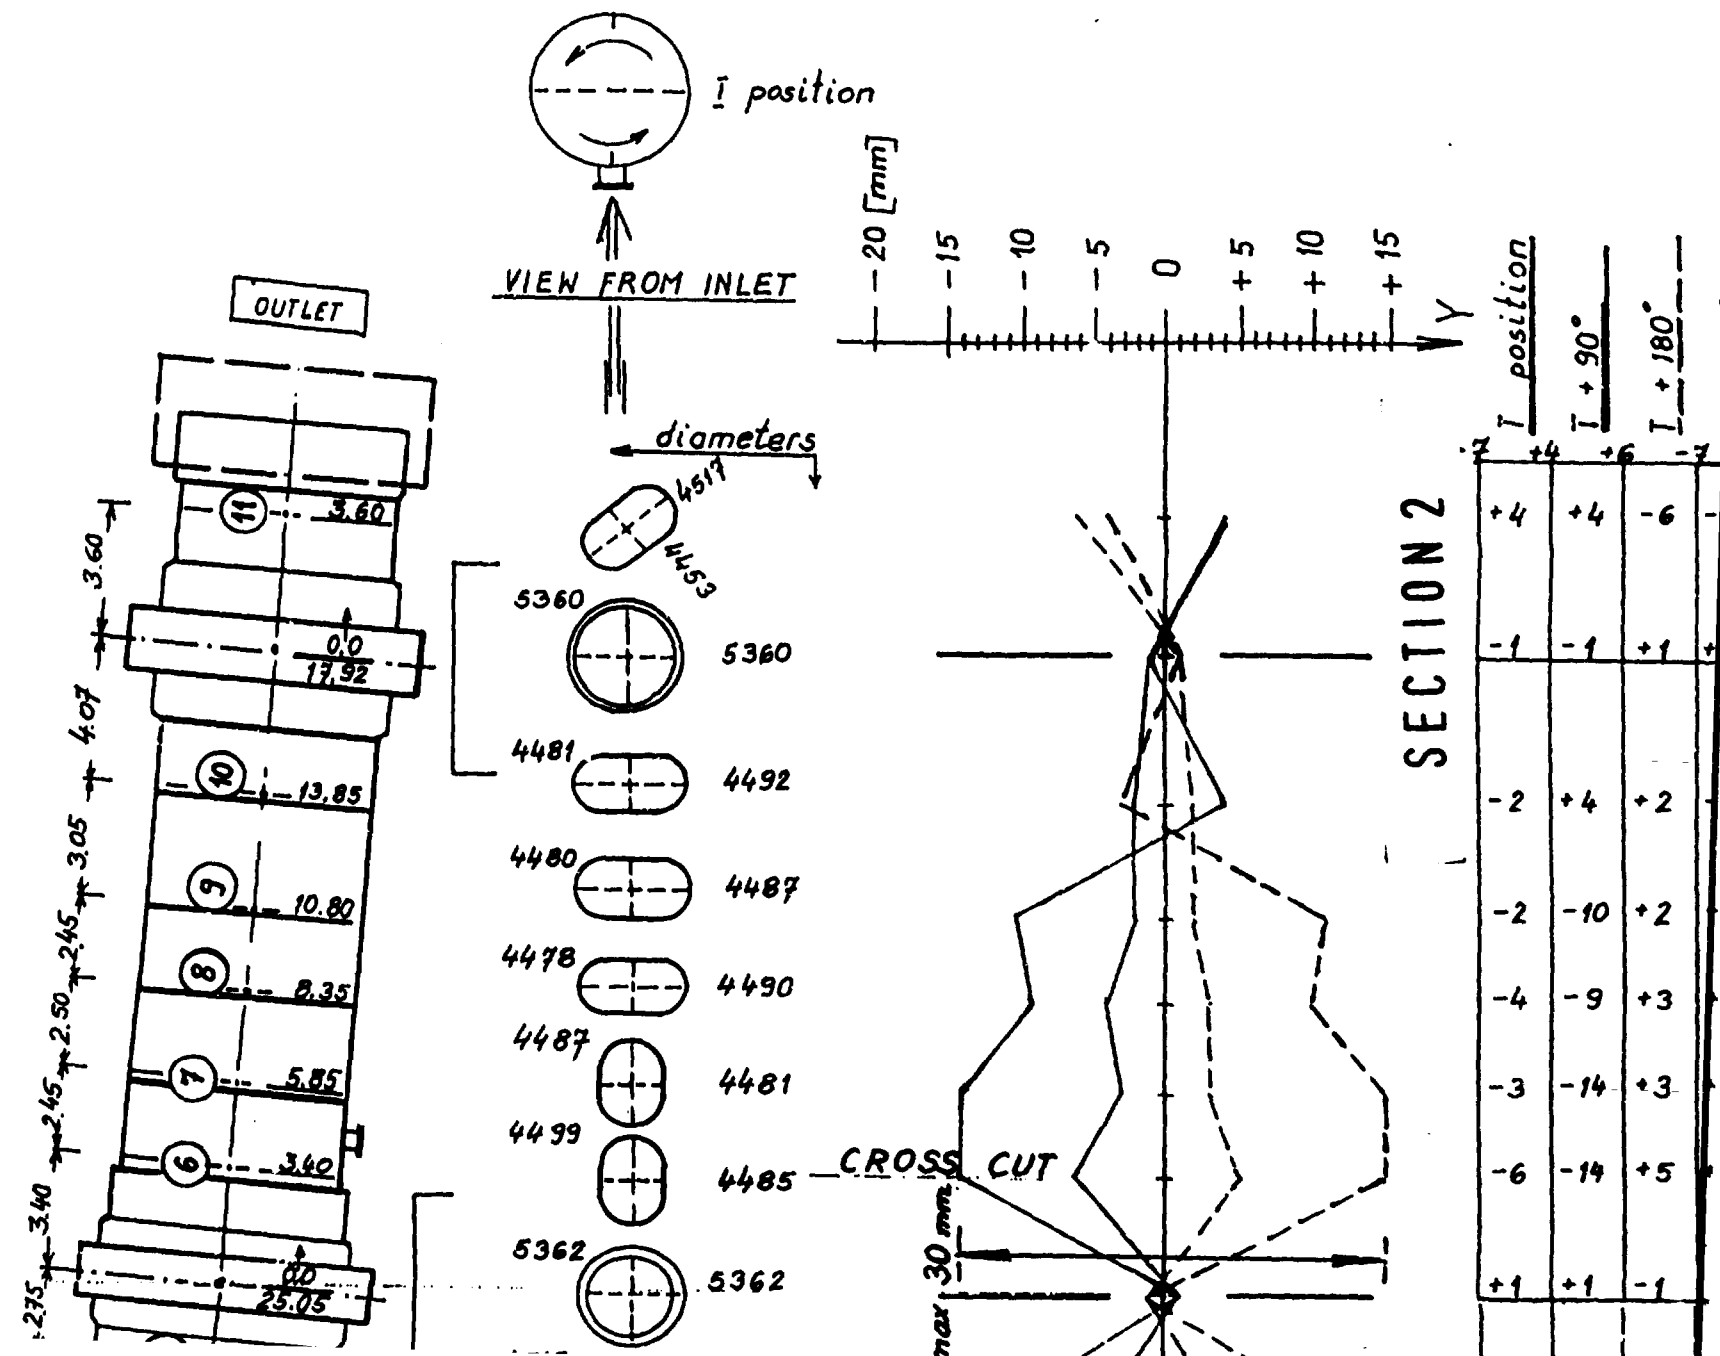
DIAGRAM OF THE KILN SHELL AXIS DEFORMATIONS

- 3.8 In addition a measurement of the Kiln's shell deformations was taken (page 13 shows the details) and a considerable deformations under the 2nd tyre were found. It is recommended to change this part in the nearest future.

The Kiln's shell condition under 2nd and 3rd tyres is poor and some parts of the shell require to be changed. (the sooner the better). The Kiln's shell deformations cause a frequent lining failure.

- 4.1 Except a poor condition of the shell near the tyre No3 we have also noticed a great number of cracks.
- 4.2 Page 13 shows all the parts of the shell that should be changed (orange coloured parts)

4.3 After a proper replacement of recommended parts there should be a significant improvement in Kiln's operation , lining failures and the whole regulation should also improve production by decreasing other failure problems.

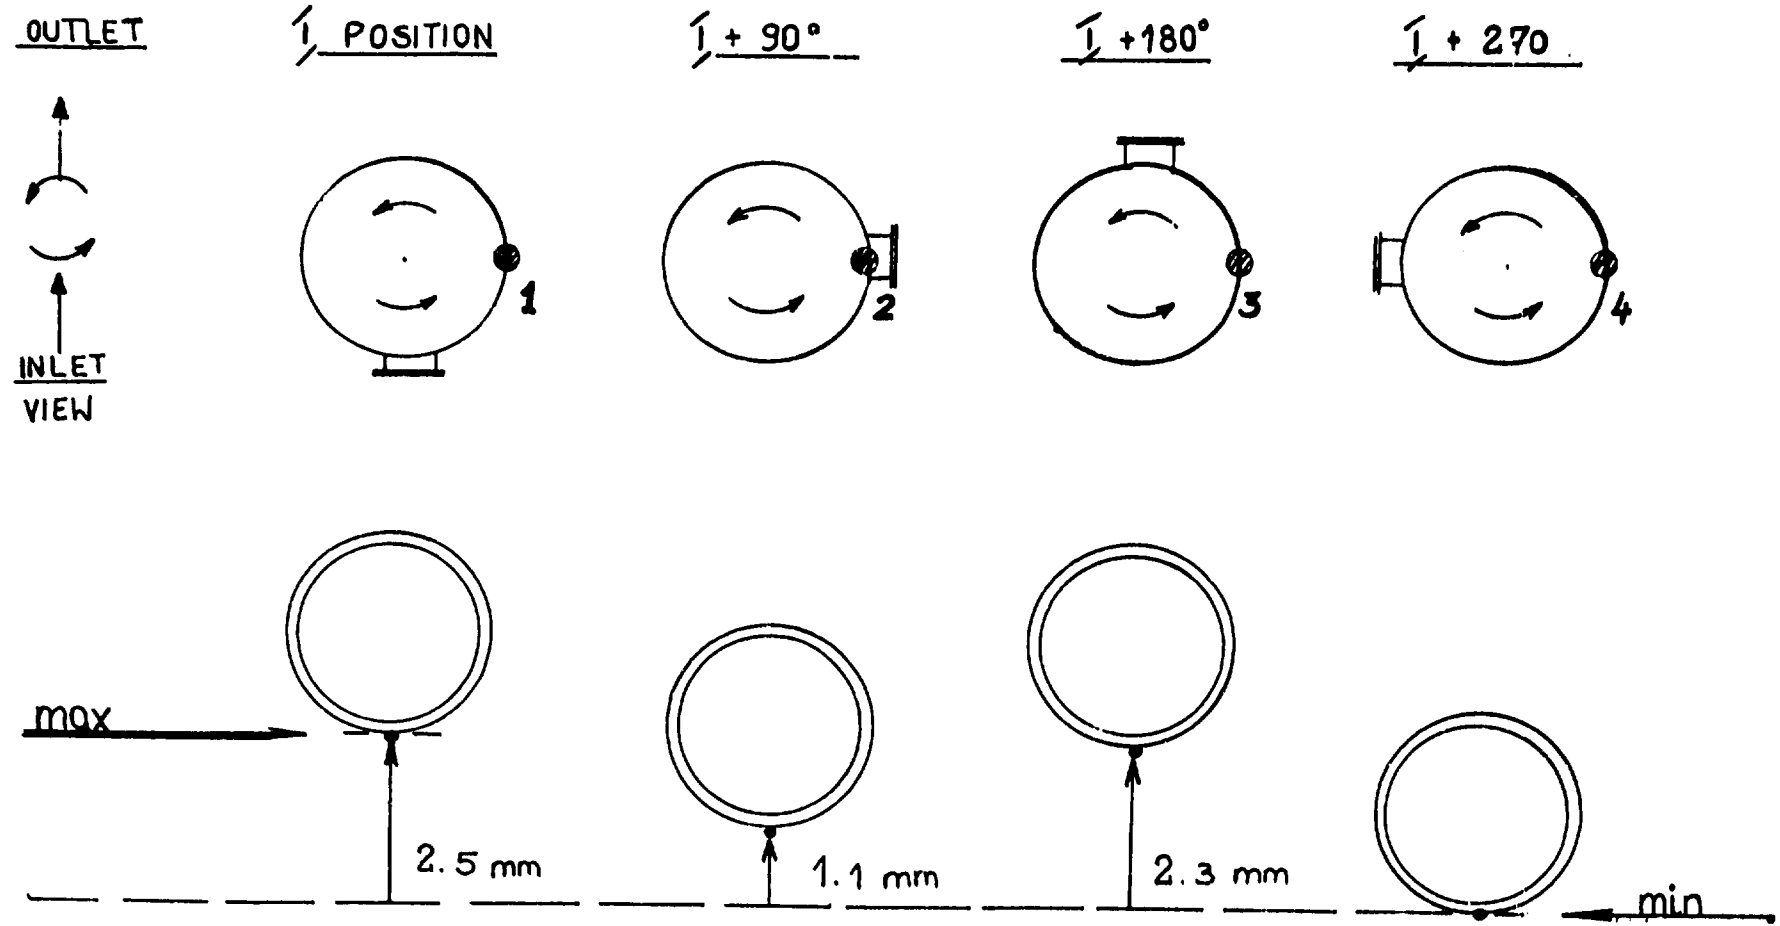
Diagram of the tyre's bottom height variation according to the Kiln position.

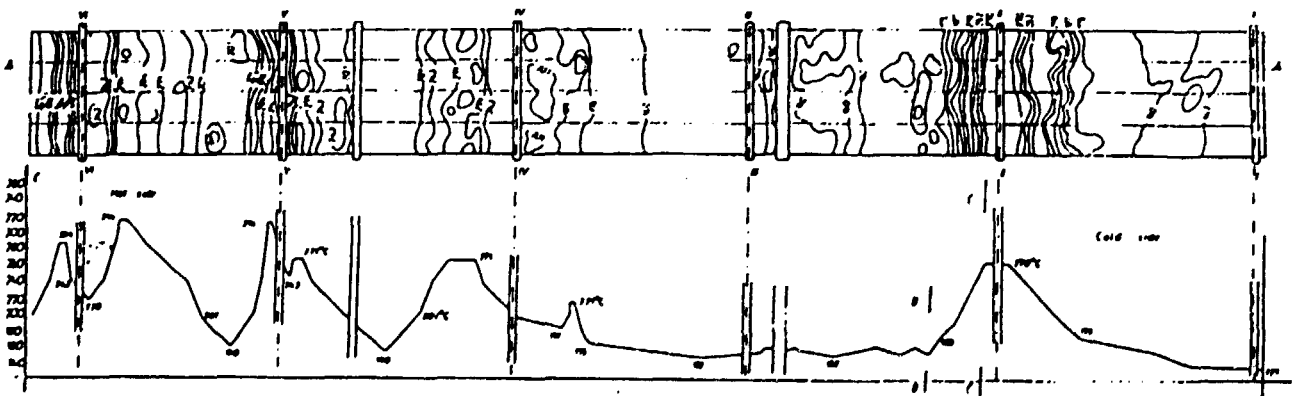
Fig. 1

Figure No. 1 presents the map of temperatures and the profile of temperature ranges of the examined kiln shell /the examination was carried out with thermo-vision camera AGA-680/ on which the temperatures distribution on the kiln shell is different and does not stick to the theoretical distribution and to that of newly-assembled kiln.

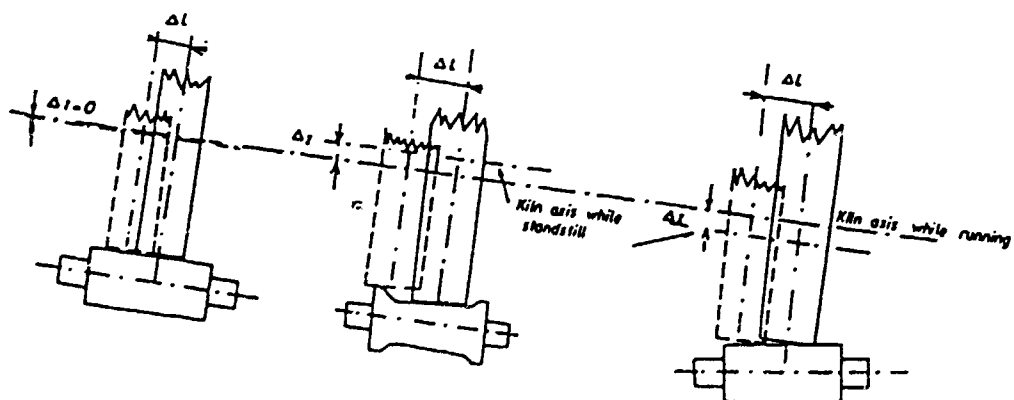
Fig. 2.1

If the roller axis is parallel to the kiln axis and if it is truly cylindrical in shape / fig. 2.1 / the deformations of kiln axis Δ_z would not occur due to the change of Δ_l tire position on the roller /this situation occurs in new kilns which are correctly assembled/

After a certain period of operation the running surfaces of rollers are as shown on figure 2.2.. and a few or a dozen millimeters of the central part is worn. Under these circumstances the deformation Δ_z vertical axis of kiln after its start-up shall be a dozen millimetres according to the rollers wear-out degree as it is presented on fig. 2.2

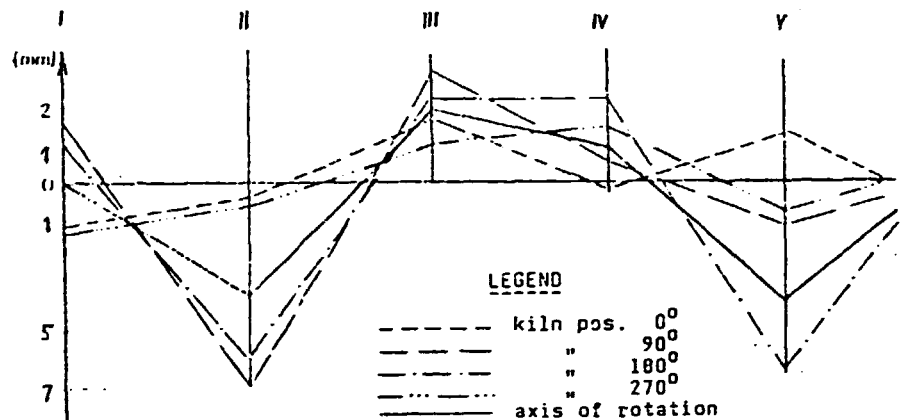
Fig. 4

Basing on the carried out measurements there was stated that geometrical axis of drum has various position in given situations and this results from local stresses as per the presented fig. 4.

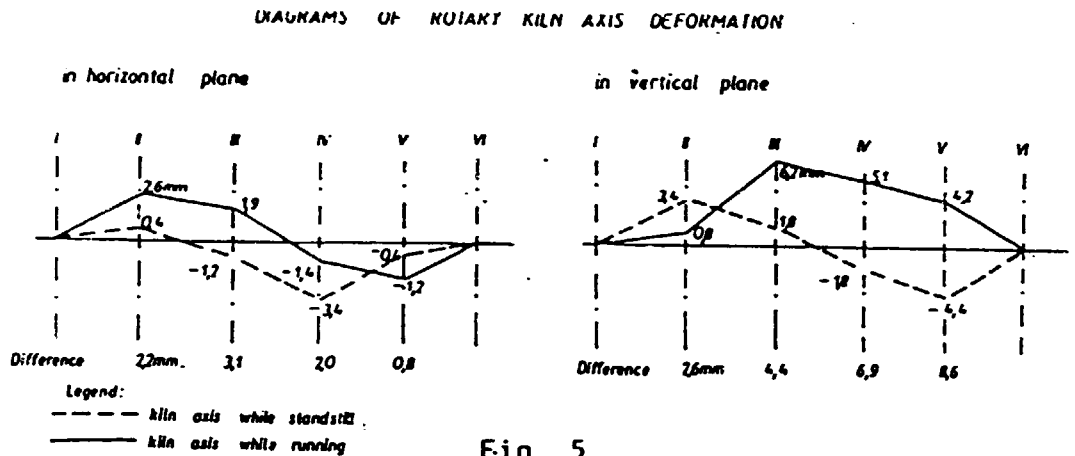
Fig. 5

The differences that were found exceed several times admissible limits of kiln axis rectilinearity deviation.

As results from the above said the kiln alignment during the standstill does not provide its rectilinearity during the operation, because even the most accurate measurement taken during the standstill defines different position of the kiln parts in relation to these parts position during the operation.

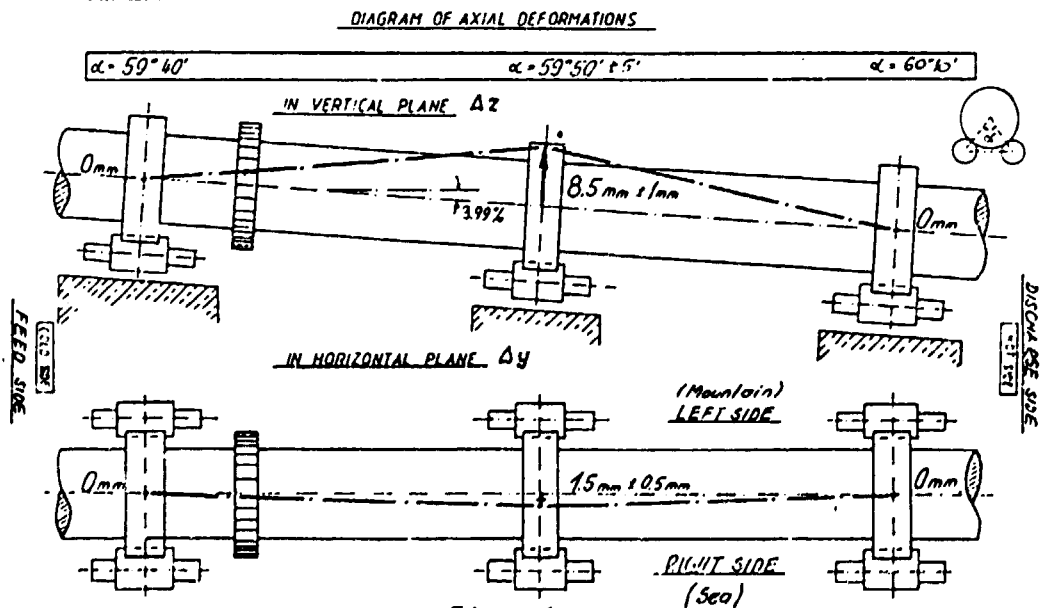
Fig. 6

Figure 6 shows the results of measurements of rotary kiln of Messrs UBE /Japan/ installed in ... obtained through hot kiln alignment method.

The kiln axis deformations are shown in both planes: horizontal Δ_y and the vertical Δ_z .

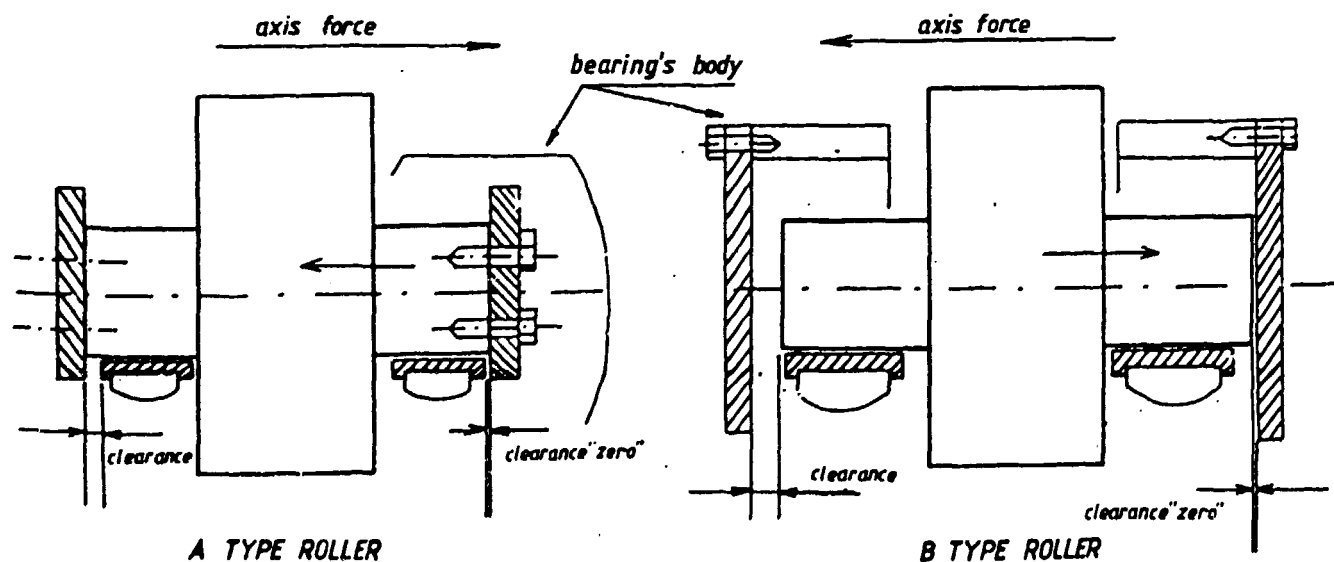
Fig. 14

As it is known from practice and experience bearings are overheated due to axial forces impact.

Figure No.14 . presents two methods /mostly applied type "A" and type "B"/ of limitation of roller pivot axialshift. The roller position is defined regarding clearances /fig. 14/ - where the clearance is "zero" there is a friction causing the bearing temperature rise. If the axial forces generated by roller axis torsions are excessive ones, the immediate temperature rise is registered in the pivot shift limitation place and then are coming down: reduced oil viscosity, rise in temperature of further parts of pivot, rise in temperature of bearing bush and the bearing seizing.

becomes normal due to the load /kiln weight/ reduction. The described operation results in kiln axis maladjustment, increased load influence on neighbouring rollers and then problems characteristic for non-aligned kiln. The correct operation should be the invert one, namely the overheated pivot should be immediately shoved to the kiln by 1 or 2 mm or the another end of roller should be shoved away from kiln and then cooled the oil and should be changed it, if possible

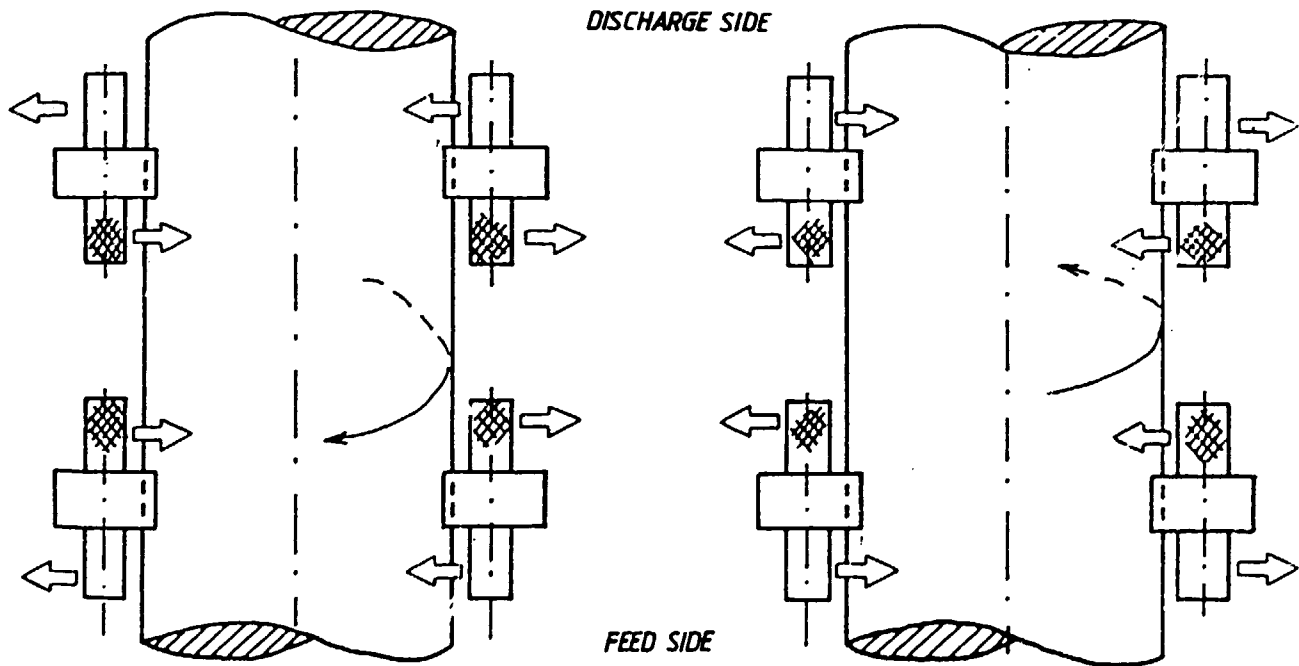
Fig. 16

Figure 16 shows the scheme of the procedure proper for rollers "A" according to the kiln rotations direction, the "overheated" bearings /pivot-bearing bush/ marked with lines and proper directions of correction shifting have been marked as well.

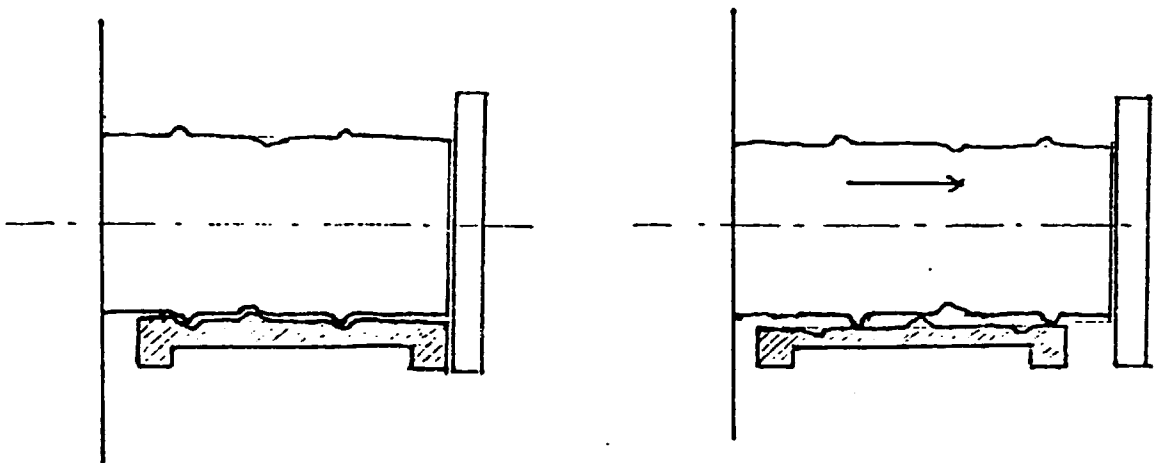
Fig. 17

Of course, the pivot surface is not perfectly smooth and its convexities and micro-grooves /fig. 17/ fit microgrooves of bearing bush.

After the roller torsion is changed the pivot is shifted and the bearing bush should fit the pivot. This causes the rise in temperature; the more cooperating parts are worn-out the higher is the rise in temperature. In this case the roller housing should be cooled, oil should be cooled and special oils or pastes should be applied. / manganese bisulphide / After a certain time the temperature usually is back to normal.
