**TECHNICAL AND ECONOMIC ASSESSMENT OF
THE VIABILITY OF REACTIVATING /
COMMISSIONING THREE INCINERATOR PLANTS
IN LAGOS - NIGERIA**

FINAL REPORT

February 1991

**Contract No.: 90/075
Project No.: SI/NIR/89/806**

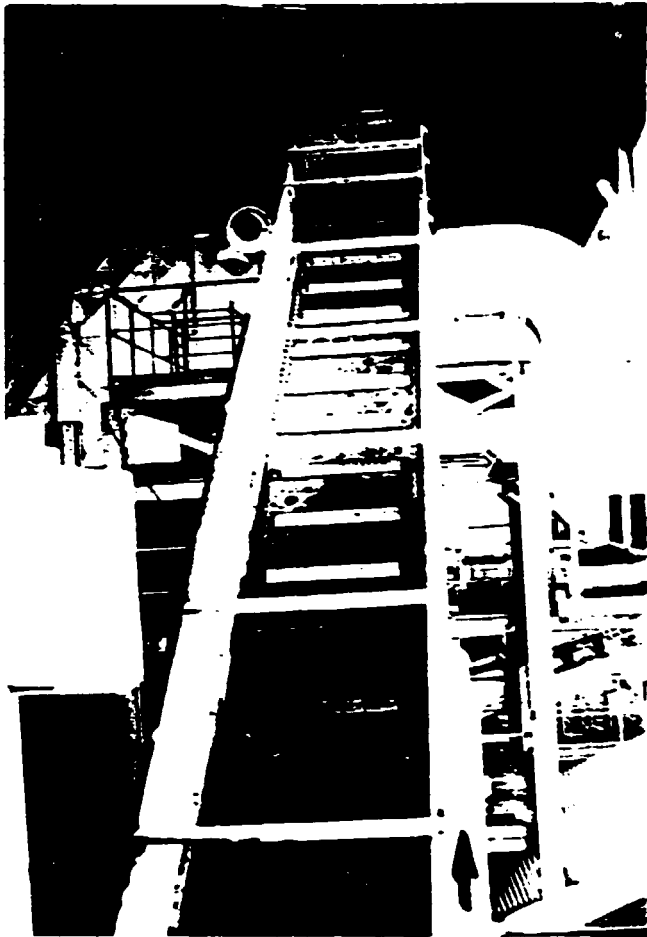
VIEW OF ASH CONVEYOR
WITHOUT COVERING
