HIGH LEVEL CONSULTANCIES AND TRAINING

DP/SYR/86/009

Technical report: Maintenance and operation of mechanical
components in fertilizer plants*

Based on the work of Zoltan SZABO, expert in maintenance
and operation of mechanical components

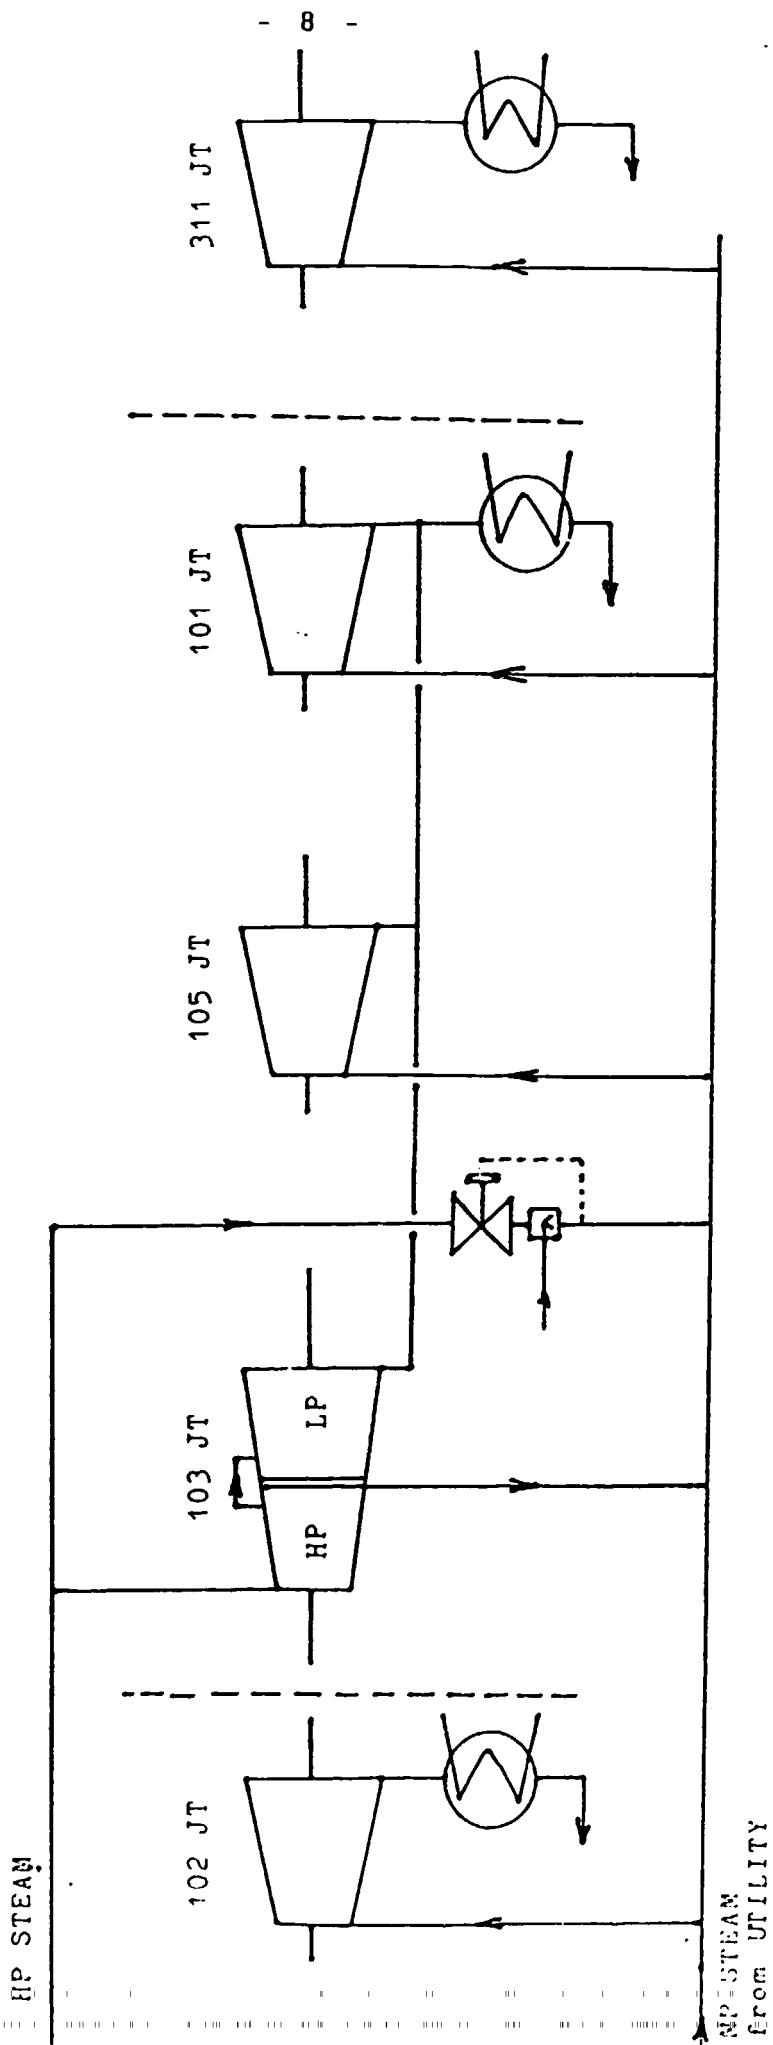
FIG. 1

The simplified steam system of the unit is shown in Fig. 1.

Advance remark: The quality of the boiler feed water is not adequate. Due to that fact salt deposits are found in the other turbines. If the turbine of the syntgas compressor is fouled, this would stop the Unit for months. Urgent action is needed!!

The manufacturer offers his expert to be present during the turbine maintenance. Without documentation the Company is advised to accept the offer and after getting the mandatory spares perform Unit turn-around. For the compressor the same procedure is to be followed.

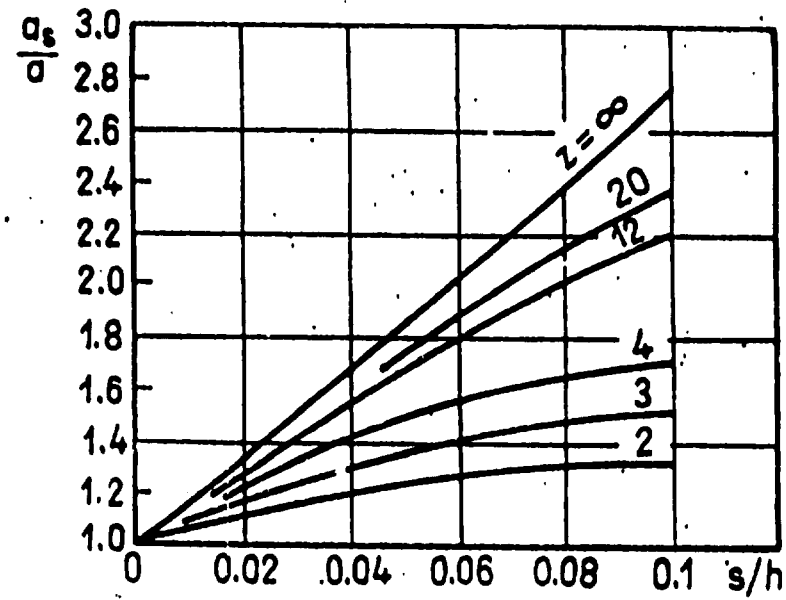
FIG. 5

With the distance between the strips denoted by b , a_s/a can be plotted against s/h and the number of strips, i . See Fig. 5.

The number of the interstage labyrinth strips is usually 4 to 5.

The edge of the strips should be rectangular, as otherwise factor a may increase by 20-25 %.
