BUILDING CONSTRUCTION
UNDER SEISMIC CONDITIONS
IN THE BALKAN REGION

REPAIR
AND STRENGTHENING
OF HISTORICAL
MONUMENTS
AND BUILDINGS
IN URBAN NUCLEI

UNDP/UNIDO PROJECT RER/79/015

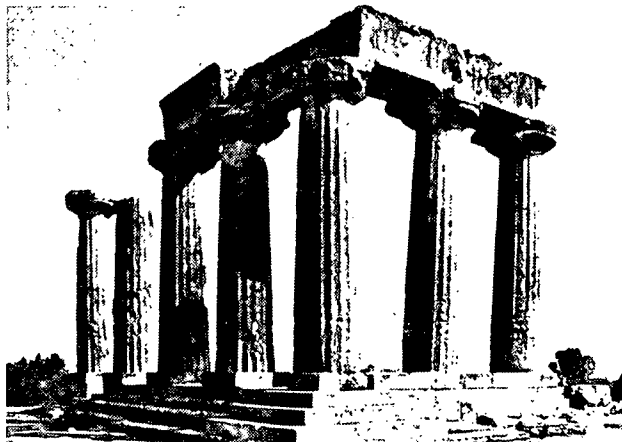
3.2 Temple of Apollo, Corinth

Masonry columns may be either monolithic - that is cut from a single block of stone as seen in Figure 3.2 - or built up from superimposed drums as seen

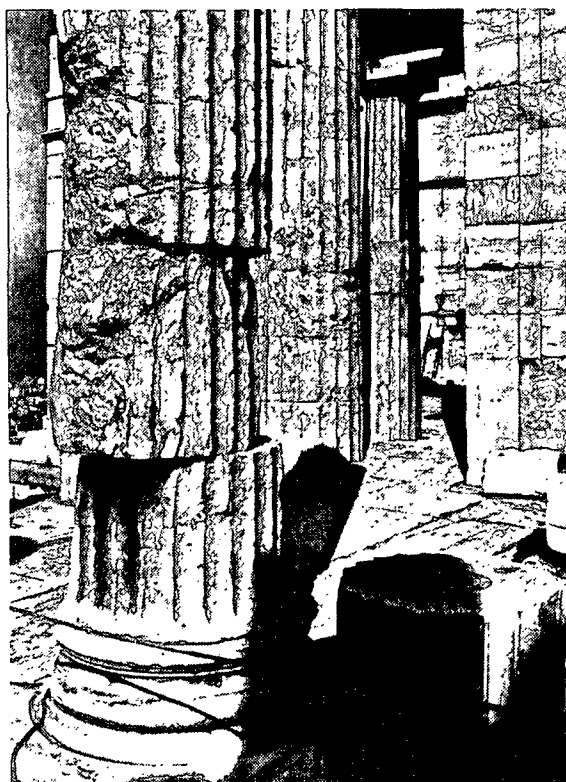
3.3 Columns of the north wing of the Propylaea, Athens

in Figure 3.3. Monolithic columns were used not only in early classical temples. They are also frequently found on a smaller scale in later buildings of other kinds, usually supporting arcades. The column of superimposed drums was used almost exclusively in the classical temple, presumably to simplify the cutting and transport of the stone. To give stability, the bearing surfaces of the drums were accurately dressed around the whole circumference and in the centre and slightly recessed elsewhere, as seen at the lower right of Figure 3.3. The drums were then set one on another without any intervening bed of mortar, though dowels were inserted to give some resistance to sliding in addition to that given by friction. In practice the frictional resistance would have been the main one, and should have prevented sliding even under earthquake loading.

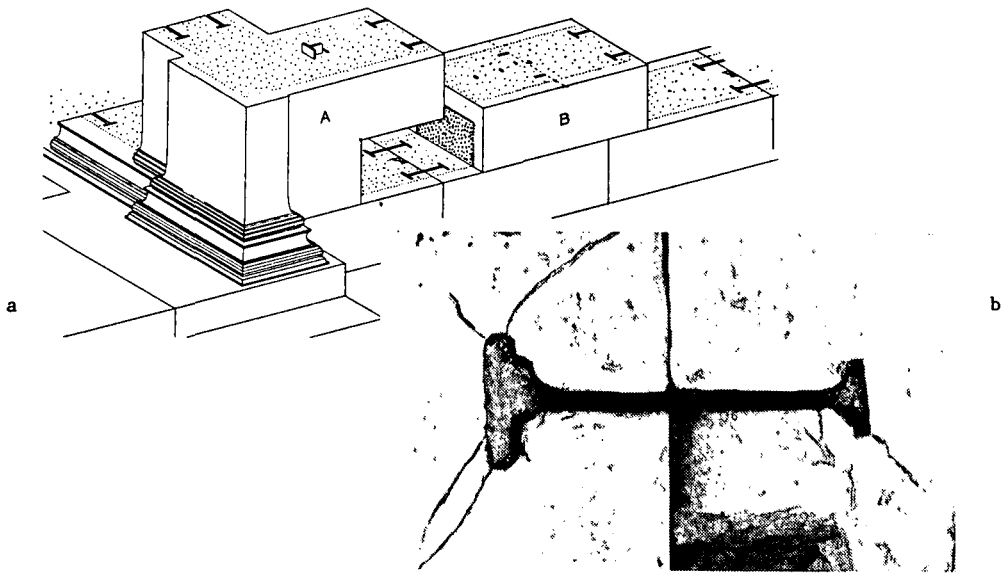
3.13 Iron cramps in the Erechtheion and Parthenon, Athens

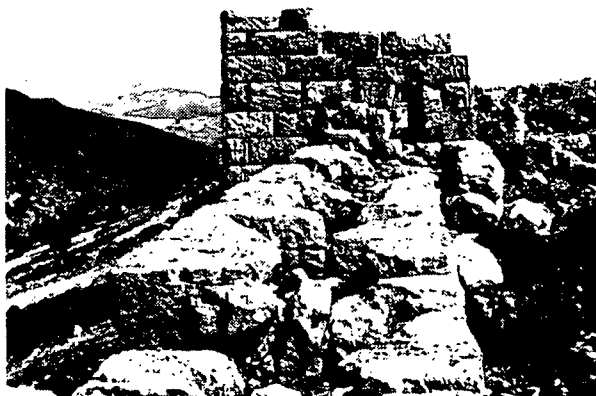
3.14 Defence wall, Eleutherai

Walls of this type are mostly defence walls or retaining walls. Those that remain have done so by virtue of their proportions and the sound construction of the facings. Figure 3.14 shows a wall preserved for its full thickness. Figure 3.15 shows one facing only remaining, both witnessing to the soundness

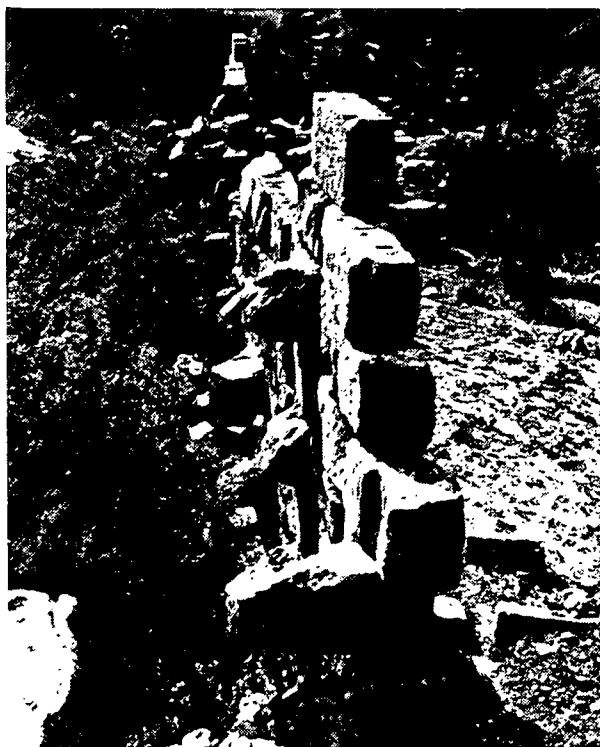
3.15 Defence wall, Messene

of its construction and exposing the blocks that originally projected into the fill for bonding purposes.

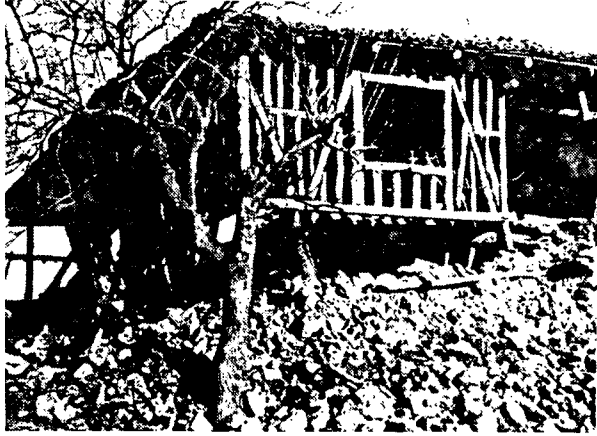
3.23 House, Gediz

in the past, probably provided the best assurance of structural survival in an earthquake - though it did so at the expense of an increased risk of destruction by an ensuing fire. This has been repeatedly demonstrated as seen, for instance, in Figure 3.23. The frame has the strength to resist in-plane horizontal loads, and energy absorption capacity is provided by slight play in the joints. A cladding of timber boards, as in Figure 3.24, improves the performance. But good performance may still be obtained when the frame is filled with masonry, though this is heavier. It will crack and any rendering will show the cracks. But, as Figures 3.25 and 3.26 show, the frame will prevent complete disintegration.

Just as the timber-framed wall behaves well, so does the complete timber-framed building or the building with fully timber-framed upper storeys on a well built masonry ground storey as seen in Figures 3.23, 3.25, and 3.87. Integral response is ensured by the connections between the framing members in all planes, shear resistance of the walls by diagonal bracing - see Figure 3.88 - and horizontal diaphragm action by the boarding of the floors. There is also just enough play in the joints to contribute to good energy absorption. Decay of the timber may, however, loosen the joints so much that they can no longer hold the structure together.

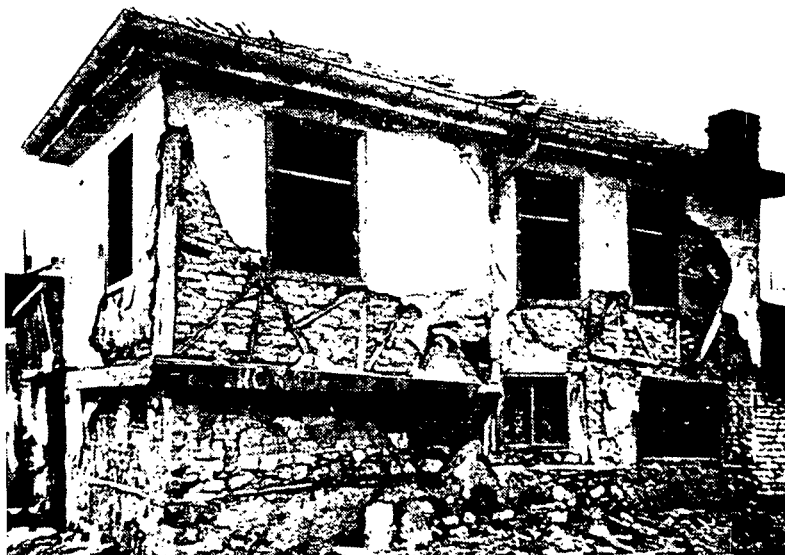
3.25 House, Skopje

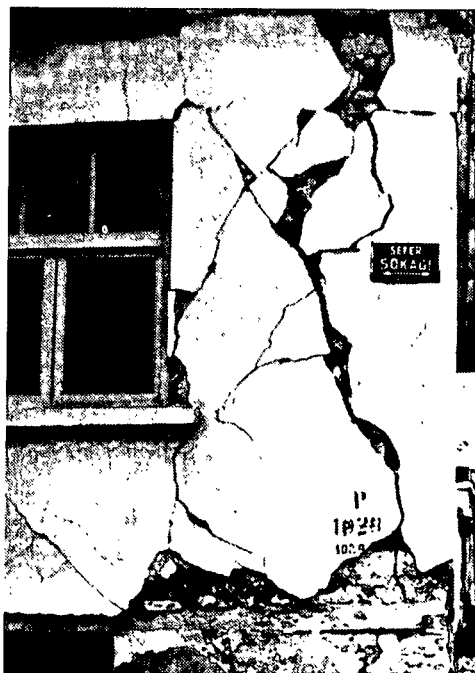
3.26 House, Turkey

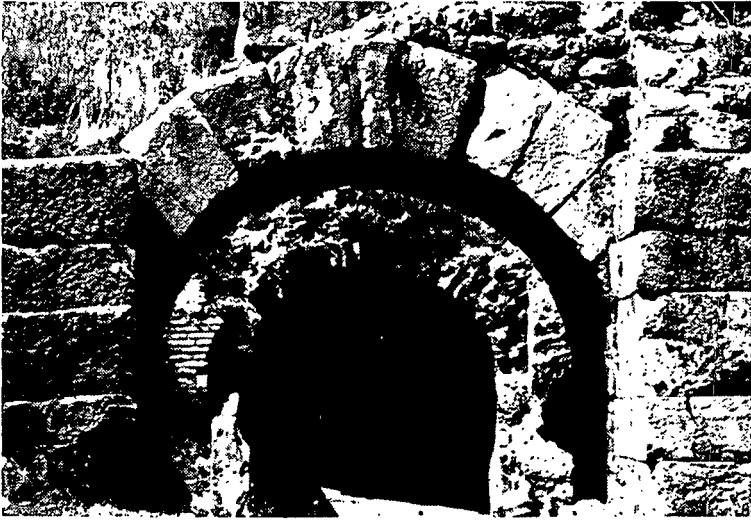
3.34 Stone voussoir arch, Ephesus

Semicircular arches of brick and stone are shown in Figures 3.34 and 3.35. They are from partly ruined structures, but their abutments have stood firm and they are not noticeably deformed. An arch can collapse only by first undergoing considerable deformation, and the manner of deformation is therefore important. If there is no spandrel above the arch and there are no limits in stresses within it, collapse can occur only when a situation like that shown in the upper sketch below arises, and movements of the supports arising independently of the arch can be accommodated as shown in the lower sketches.

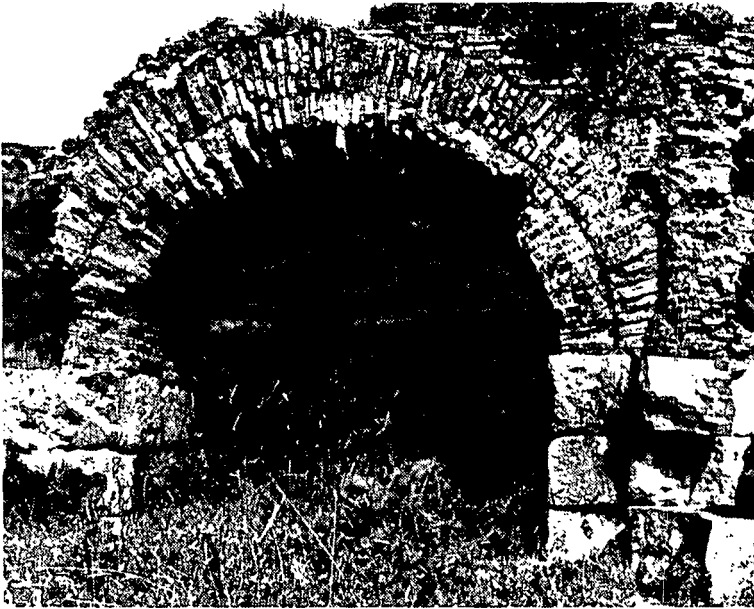
3.35 Brick arch, Ephesus

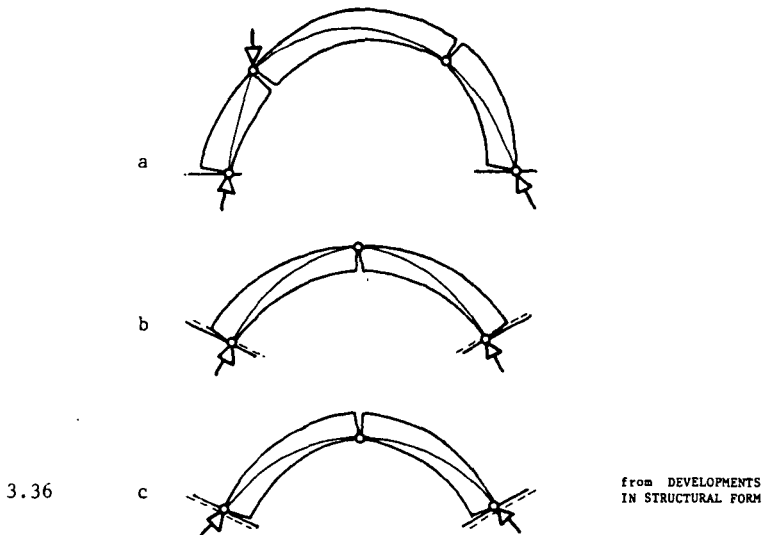
In practice, stresses cannot be ignored. The simple hinging rotations about axes on the extrados or intrados would entail impossibly high stresses and, even before the thrust lines moved out this far, there would be local splitting or crushing. This is illustrated by the sequence of photographs reproduced in Figure 3.37, though these show three different arches and the two lower ones are stiffened by the spandrels. The local splitting leads to slipping and this can lead in turn to the fall of part of the arch as seen in the bottom photograph. Figure 3.38 shows both hinging rotations and slips in a multi-tiered arcade, associated with outward inclinations of the piers towards the end of the arcade (which is at the left hand side). Slips can also occur when the supports move apart independently of the arch thrusts as seen in Figure 3.39, or when they similarly undergo a parallel relative movement as may happen to paired buttresses interconnected by arches.

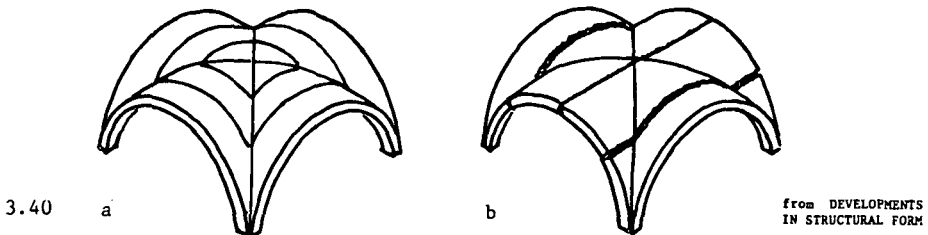
The groined vault is formed by intersecting barrels. Sometimes there are ribs along the groins with thinner masonry between them, and sometimes the barrels forming the vault are arched upwards towards its centre to give a domed form in this region. In general, the loads will be transmitted down to the groins along similar paths to those that they would have followed in the constituent barrels as sketched below, and will then pass down the arched ribs or groins.

Behaviour will, in general, be as would be expected of the constituent barrels and arches, except that, if the supports spread in relation to one barrel for instance, the other will have to split open slightly to accommodate the spread and the deformations of the first barrel. This is sketched in an idealised manner to the right of the Figure above.

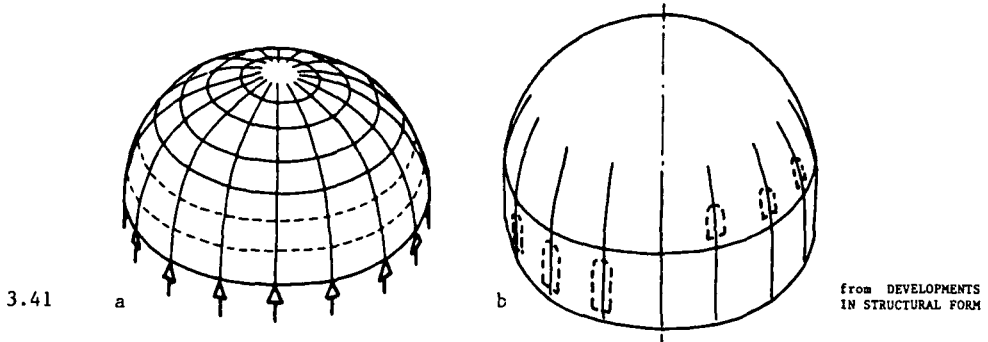
modern shells. In particular, the outward thrusts of the radial arches can be wholly contained in a hemispherical dome by circumferential tensions in the lower part as sketched at the left below, provided that there is the necessary capacity to resist this tension and there are no horizontal restraints at the base. In fact, these conditions were probably never fulfilled. The masonry could not itself resist much tension and it was frequently interrupted by a ring of windows, or set on a drum similarly interrupted. It therefore cracked radially as sketched at the right and shown in Figure 3.43, thereby making the dome act essentially as a ring of arches with a common keystone.

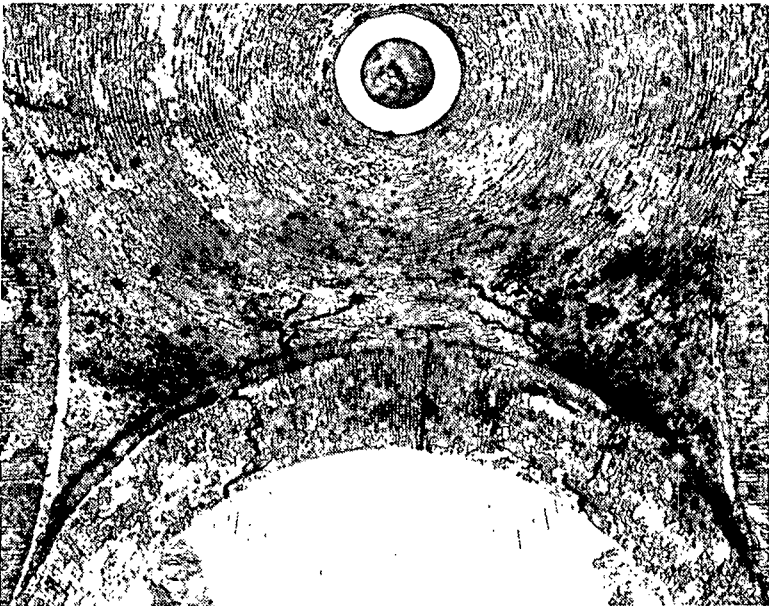
3.44 Western dome and pendentives, Hagia Irene, Istanbul

Some domes were set directly on a circular base. But many were carried on isolated piers (usually four but sometimes more), or the drums were carried in this way. This created a need for transitional elements between the polygon of arches that spanned between the piers and the dome or drum. There were two basic elements - the pendentive and the squinch. The first is sketched below and is also shown in Figure 3.44. It acts essentially as a downward continuation of the dome, thrusting outwards but carrying the thrust lower down. The cracks that develop when the supporting piers move apart involves dome, pendentives, and arches, as seen in Figure 3.44.

of the crown of the main eastern arch after the earlier development of cracks like those seen in Figure 3.44. Today the structure is more heavily buttressed and more secure.

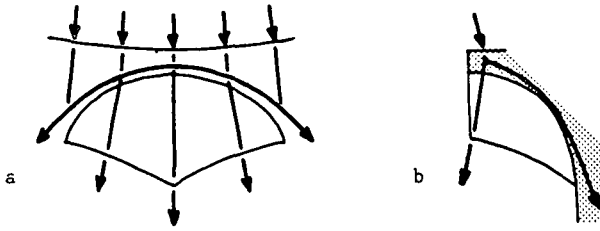
3.47

The squinch has more the character of another supporting arch, transforming a square base to an octagonal one, for instance. If the masonry were thin in relation to its surface dimensions, the loads would be carried as sketched in Figure 3.47. Usually it is filled out at the back to a pendentive-like form, so that the behaviour is closer to that of the pendentive. The simple squinch must, in any case, be capped by smaller squinches or pendentives to complete the transition to the circle, which further blurs the distinction between the two forms.

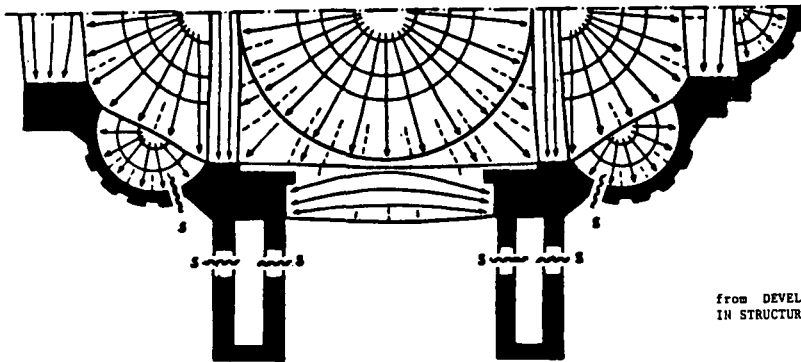
3.48 Half plan of the dome and semidomes of Hagia Sophia, Istanbul

If the dome sketched in Figure 3,41a is notionally sliced vertically in two through the crown, the resulting form is the semidome. There will be large radial forces pushing the crown outwards until these forces are balanced by the effective development of a horizontal arch behind the cut edge. All semidomes show this forward movement of the free edge in addition to the usual radial cracking of the lower part even if, as seen below and in Figures 3.45 and 3.46, a dome above later exerts opposing thrusts. These will push the free edges back as the semidomes assume the role of buttresses, but only part way because of the influence of sequence of construction when stiffnesses develop progressively as the mortar hardens.

The piers on the left support the half arches which lean against the outer wall and against the vaults inside, the upper vault being the one shown in Figure 3.50. Finally, the high-level semidomes and dome are buttressed on the side seen in Figure 3.56 and shown in the half plan in Figure 3.48 by the prominent tower-like forms seen also in the upper part of Figure 3.58. These actually consist of outer staircase towers connected to the main piers that carry the dome by arches and barrel vaults at aisle and gallery levels and by the walls shown in plan in Figure 3.48 above the gallery.

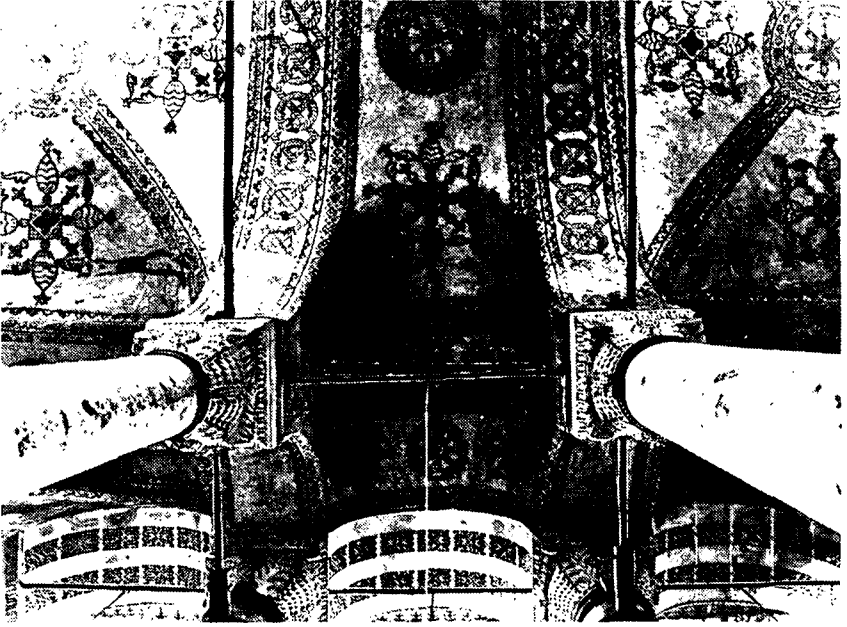
3.49 Vaults and ties, south aisle, Hagia Sophia, Istanbul

springings of arches and vaults as seen in Figures 3.49 to 3.51, but they may span between the same supports at more than one level as seen in Figure 3.52 and in the centre of Figure 3.49 (where an upper timber tie is partly hidden by the lower iron tie). In this latter case however, one 'tie' may be acting more as a strut in relation to an arch that springs at its level from the opposite side of the column. It will then be found to be of timber even when the true ties are of iron.

Free-spanning ties have the drawback that they are necessarily visible. The intrusion may be considered aesthetically unacceptable. But there is a long tradition of using them, especially in the Byzantine and Ottoman monuments in the Balkan region as seen in Figures 3.49 to 3.52 and Figure 5.29, and modern high-strength steels allow the use of smaller cross sections. Their use should not, therefore, be ruled out without full consideration.

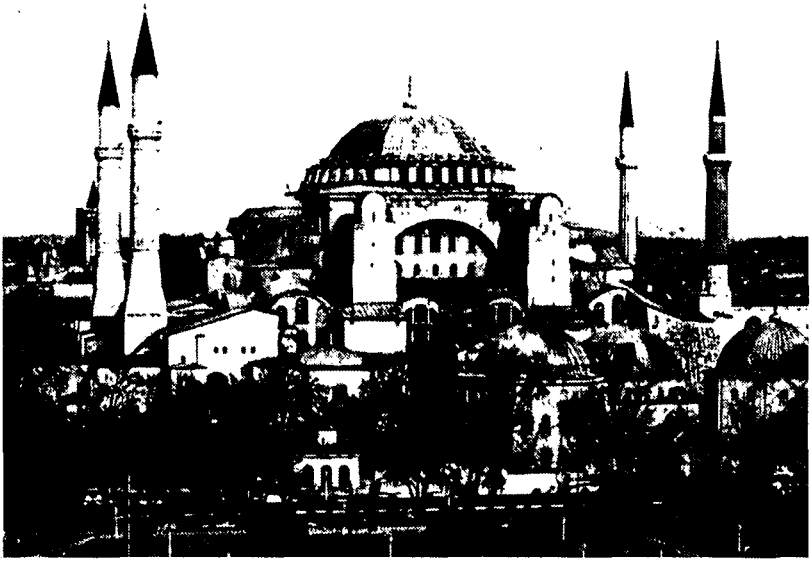
3.56 Hagia Sophia, Istanbul, from the south

Figure 3.56 shows the heavily buttressed exterior of Hagia Sophia, Istanbul. The arches and vaults of the aisles and galleries that almost completely surround the structure are buttressed by massive piers built against the lower outer walls on three sides as seen at the bottom of Figure 3.58. At this level at the west the buttresses take the 'flying' form seen in Figure 3.59.

The minaret is usually of tubular form, tall and slender, and with a stair ascending in the centre of the tube. It rises from a more solid base, and has one or more slightly projecting platforms as seen in Figures 3.56, 3.58, and 3.82. Some minarets are built of brick, others of well dressed squared stone.

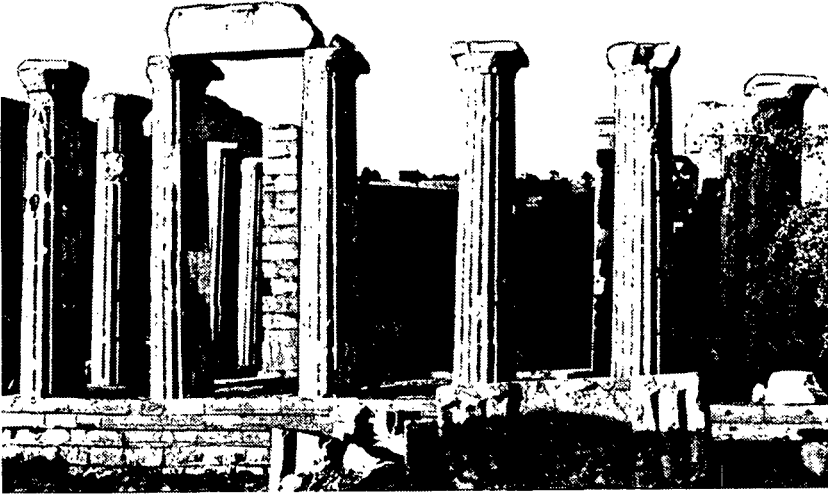
3.62 Temple of Apollo, Bassae

largely intact. Equally significantly, it survived unharmed the 1965 earthquake which badly damaged nearby Andritsaina in spite of the fact that erosion of the rock on which it stands by an underground aquifer has led to the tilting of many of its columns, as seen in Figure 3.62.

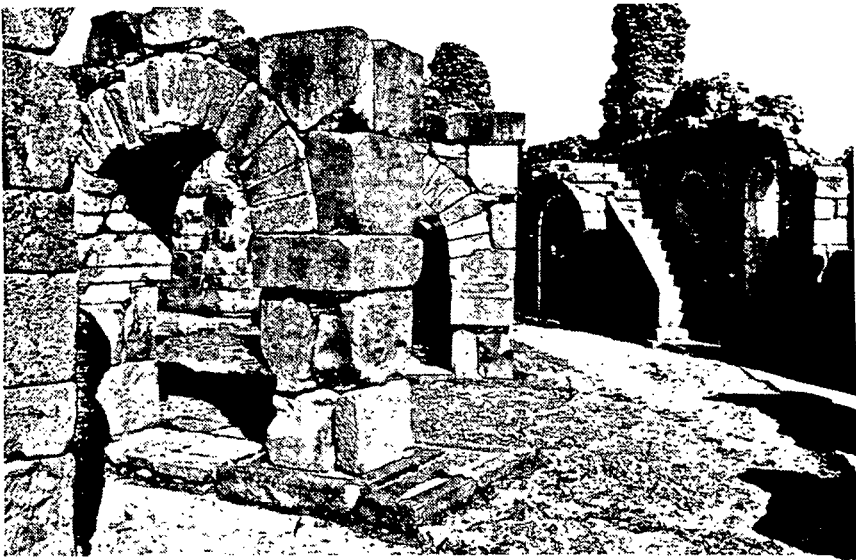
3.65 Circular structure, Asklepieion, Pergamon

The single arch on its supports, as seen at the left of Figure 3.65, is the essential component. It is also the smallest unit that must be considered when asking how any arch will behave unless the arch spans directly from rock to rock. The shape and loading determine how the arch will thrust outwards on the supports, and their stiffnesses determine how much they will give way in resisting the thrusts. Earthquakes may be particularly hazardous for the single-arch system if the horizontal ground accelerations lead to out-of-phase movements of the supports in the direction of the span, and if separations of the supports from this cause coincide with downward vertical accelerations.

Barrel, groined, or ribbed vaults often took the place of open timber roofs, or were constructed as fireproof ceilings beneath them, to remove the risk of fire associated with the open timber roof. The simplest vaulted structure is illustrated at the left below. It is the longitudinally extended counterpart of the arch on two piers seen to the left on Figure 3.65 and will behave similarly.

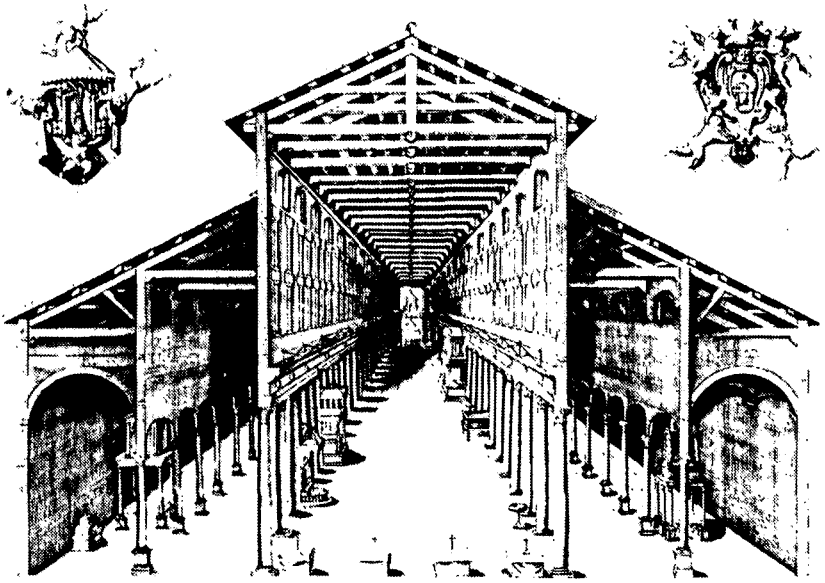
3.66 Old St Peter's, Rome (Ferrabosco after Tasselli)

The basilican church may also be approximately square in overall plan. But it is divided internally in the transverse direction only, sometimes into five aisles as seen in Figure 3.66 and sometimes into three only. To light the interior, the roof of the central section is raised to a considerable height on walls carried at ground level by open colonnades or arcades and perforated by windows above the lower outer roofs, as also seen in Figure 3.66. These walls have little lateral stiffness in themselves, and are prone to lateral buckling even in the absence of transverse seismic loads and outward thrusts from the roof. An instance may be seen below from Ravenna. Their low stiffnesses result, however, in low natural frequencies, which will usually reduce any transverse seismic loads. In some churches also, they are braced by the floors of galleries built over the outer aisles, as seen in Figure 3.67.

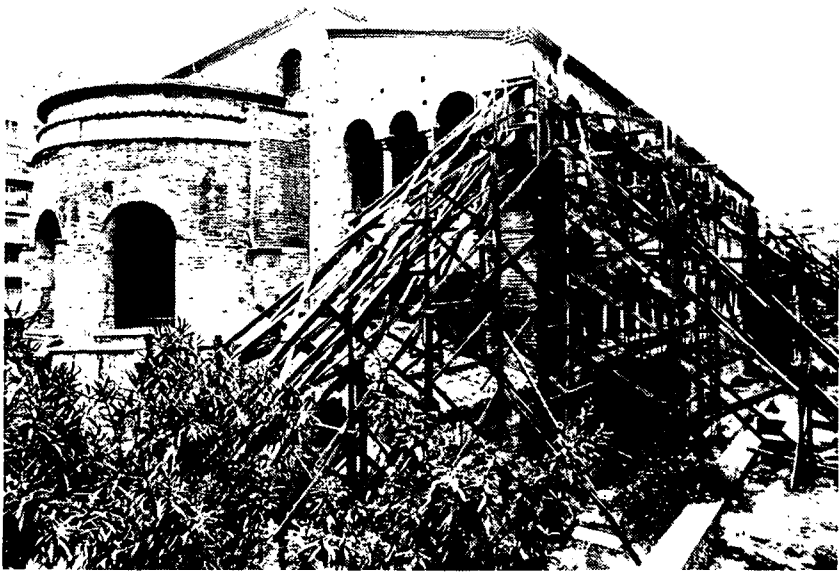
3.69 Separations in the northeast corner, Acheiropitios, Thessaloniki

Thessaloniki after the 1978 earthquake, as illustrated in Figures 3.69 and 3.70. The breaks allowed the separated sections of wall to incline outwards, only outward movements being possible to any significant extent. Had these movements been somewhat greater, some of the roof trusses might have fallen. Where roof trusses are no longer effectively tied at the feet of the rafters, their outward thrusts will, of course, make the longitudinal walls more likely to incline outwards and perhaps collapse. It is therefore important that the ties should be in good repair, and preferable that they should also be anchored to the wall heads.

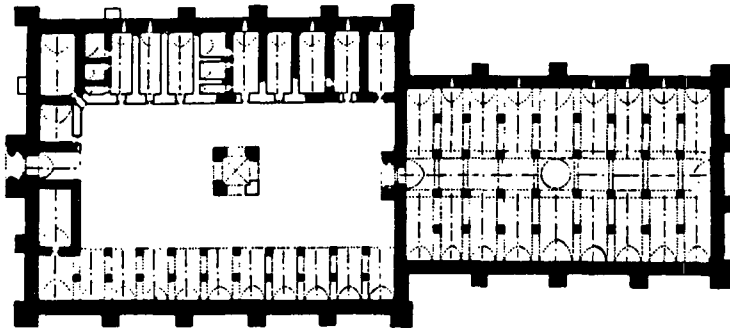
3.72 Seljuk caravanserai, Sultan Han, near Aksaray

It is rarely encountered except in domestic buildings. Much commoner is the the corresponding counterpart of the arcade. The plan below shows examples along both sides of the large entrance courtyard at the left. The enclosed range served as guest rooms and the open one as stables. Because the thrusts of the vaults neutralise one another as in an arcade except at the ends, it was possible to support the vaults of the stable range on pairs of arches only, in all intermediate positions.

It was realised, moreover, that the arcade-like range of vaulted bays could very efficiently support a higher vault aligned at right angles to the bays, as sketched to the right of Figure 3.71. This was the arrangement adopted for the large covered hall of the caravanserai shown in Figure 3.72.

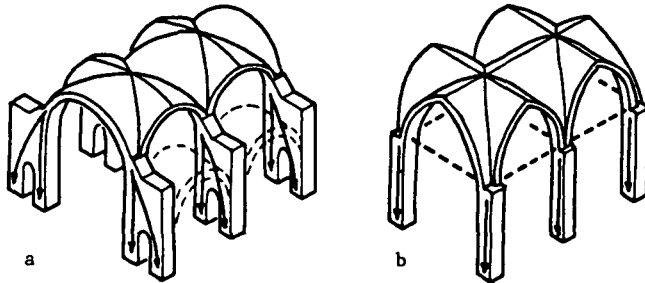
3.73

The groined vault supplanted the barrel vault in later Roman architecture, and the same sequence was repeated in the great wave of church building in Western Europe in the 12th and 13th centuries. It is found in the Balkans chiefly in later basilican-plan churches like the Cathedral of Dubrovnik and the Calvinist church of Bekes described in the case studies. As shown in the sketches below, it permits a more localised provision of support and permits a similar relationship of central nave and side aisles to that of the earlier basilican church with open timber roof. Structurally it calls for efficient buttressing of the vaults over the aisles. But the possibility existed, and was sometimes exploited, of using ties as sketched at the right to reduce the need.

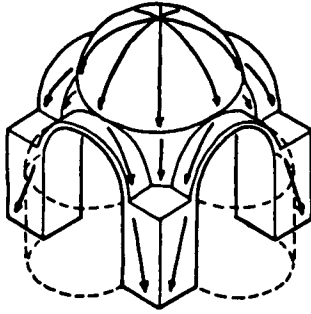
3.78

from DEVELOPMENTS
IN STRUCTURAL FORM

In other centrally planned domed structures the dome is supported on isolated piers spanned by arches with either pendentives or squinches as transitional elements. The core of the structure is then as sketched in Figure 3.78, or some variant of this.

There were two important subsequent uses of the basic form sketched in Figure 3.78. One was as the crowning feature of a vaulted church of basilican plan. An example is discussed in the case study of the Cathedral of Dubrovnik. The other was in the Ottoman mosque.

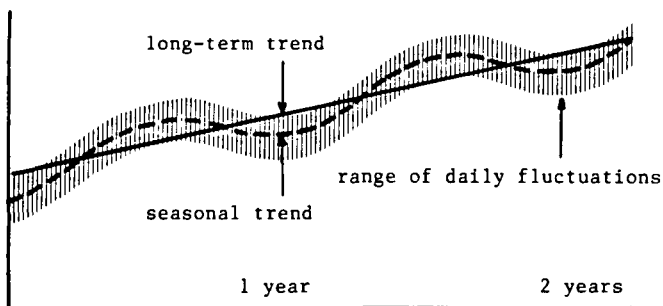
4.4 Structural movements: typical fluctuations around a long-term trend

No structure remains completely at rest. Small movements take place continuously with changes in load, changes in temperature, etc. Movements due to changes in temperature tend to have both daily and annual cycles. Since cyclic movements are not of concern, but only the continuous trend, measurements must continue for long enough and be so planned as to distinguish the continuous trend from the short-term and longer-term fluctuations around it. They should continue, if possible, for at least a year, and be taken preferably at fixed intervals and at a fixed time of day. Some of them may, with advantage, be continued during strengthening to monitor the effects of this. See the Figure below and Figure 8.8.

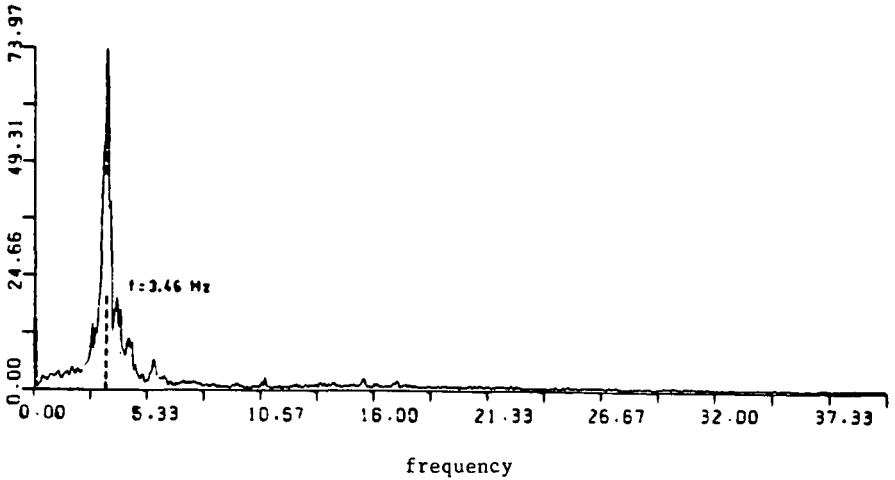
4.6 Amplitude-frequency spectrum for ambient vibrations of a tower

Natural frequencies at low amplitudes can be determined from seismograph records of ambient vibrations. Mode shapes can also be determined from relative amplitudes if simultaneous records are taken at several heights. For simple forms like towers, the fundamental frequency should be clearly defined as in Figure 4.6 overleaf. For more complex forms like some multistorey buildings,

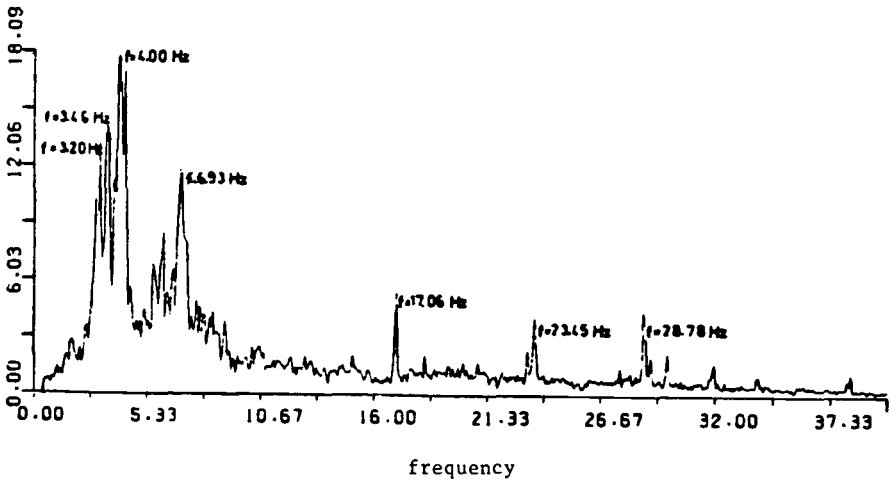
4.7 Amplitude-frequency spectrum for ambient vibrations of a building

it may be less clearly defined as in Figure 4.7. The lowest frequency at which there is a peak response should then be taken as the fundamental.

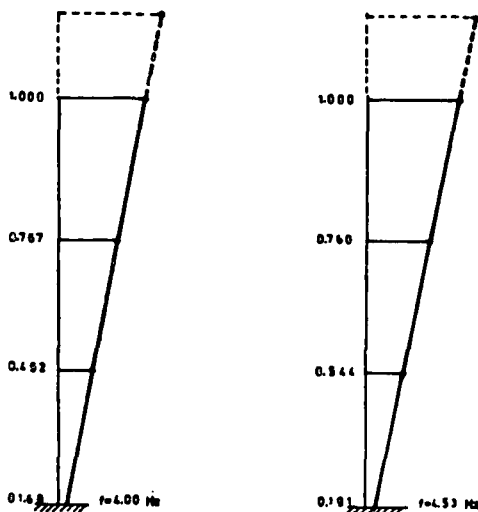
4.8 Fundamental mode shapes for a 4 storey building

- the applicability of the procedures for distributing the total base shear over the height depends on the modes of deformation under load. The usual rule assumes that the deformation is effectively that of a uniform shear beam. Measured shapes of the fundamental modes of vibration for the 3 and 4 storey buildings referred to above are of this character (as may be seen in the Figure below), so that for such buildings the normal procedure should be followed.

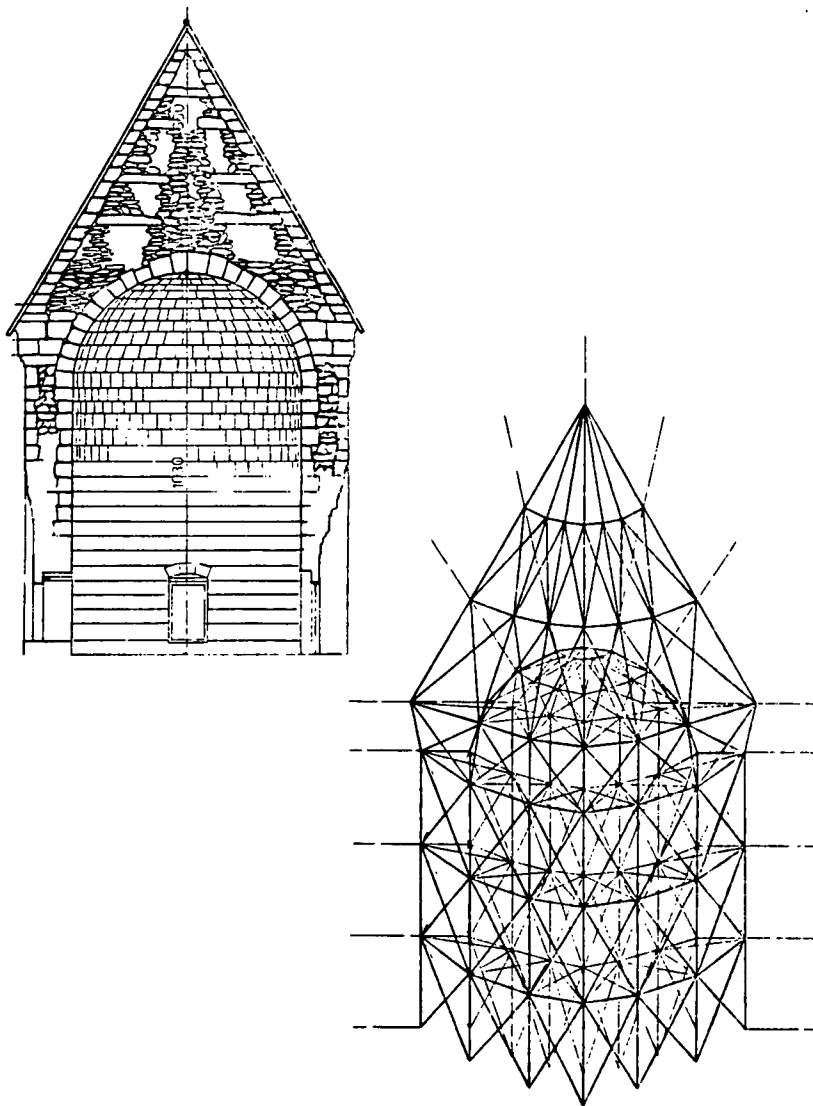
4.9 Hasan Padisah Tomb, Bitlis-Ahlat
cross section and finite-element model

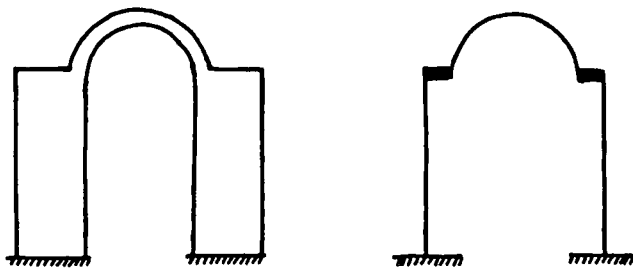
4.10 Arched system and linear frame model

For the type of structure found in many historical monuments - in which masonry piers support arches, vaults, or domes - a more complex model is required. Collapse may occur either by the development of a mechanism in the combined system of supporting and spanning elements, or by failure in shear of a support. The model must allow for both possibilities. Linear or frame models, as shown below, are nevertheless possible, combined with appropriate failure criteria for all the members.

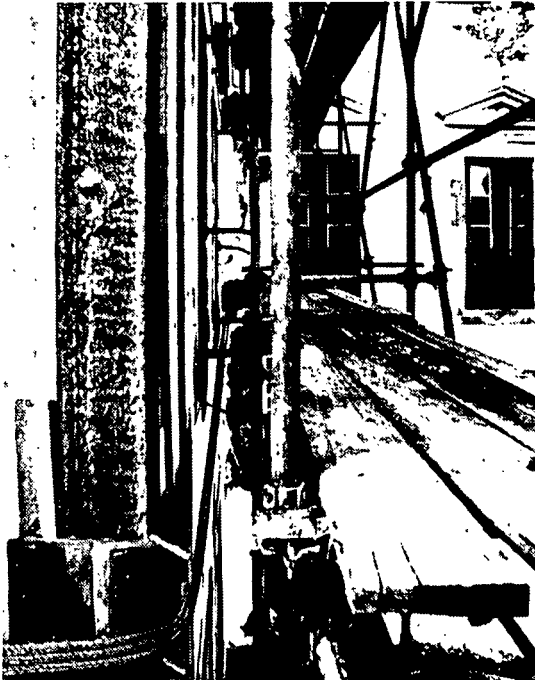
5.3 Temporary prestressed ties, Rotunda, Thessaloniki

To contain the thrusts of arches and vaults, ties should preferably be placed near the springing levels. To contain those of a dome, the tie should encircle it near the springing level, as do the ties seen in Figure 5.3. To provide temporary support to the walls of a building that have cracked apart and are leaning outwards, ties should similarly encircle at each floor level the walls at risk, as seen in Figure 5.4. A further and related use is illustrated in Figure 5.5. The epistyles had separated in the corner above the column at the left of the upper view and in the one seen through the second intercolumniation after the 1981 earthquake. They were tied together by continuous ties looped around the abacus of the second column to each side and held at suitable heights by being passed through the inclined frames that encircle the epistyles.

All ties should be prestressed sufficiently, at least, to place them in reasonable tension without further undesirable movement of the existing structure. This may call both for calculation of the desirable prestress and for continued monitoring of it - either directly or indirectly. Indirect monitoring may be possible either by accurate measurements of spans or by measurements of the widths of cracks or separations associated with the movements that have already occurred. This is referred to further in the case study of the Rotunda, Thessaloniki.

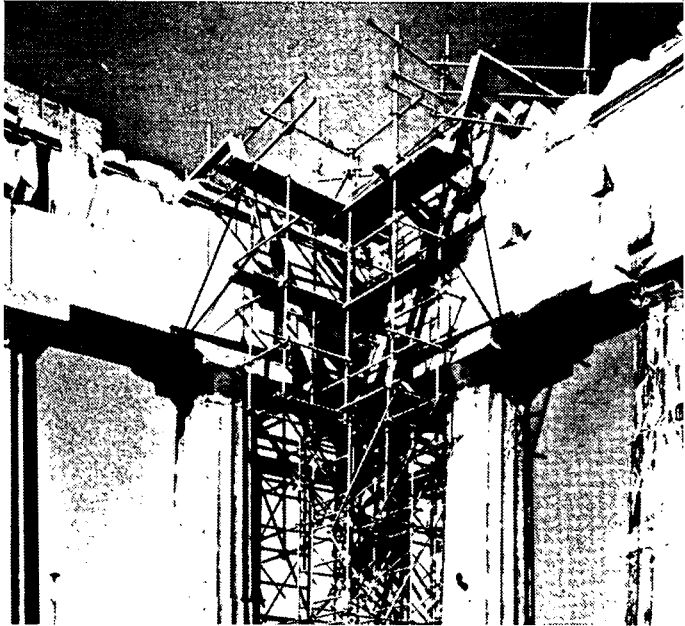
5.5 High-level temporary tying, Parthenon, Athens

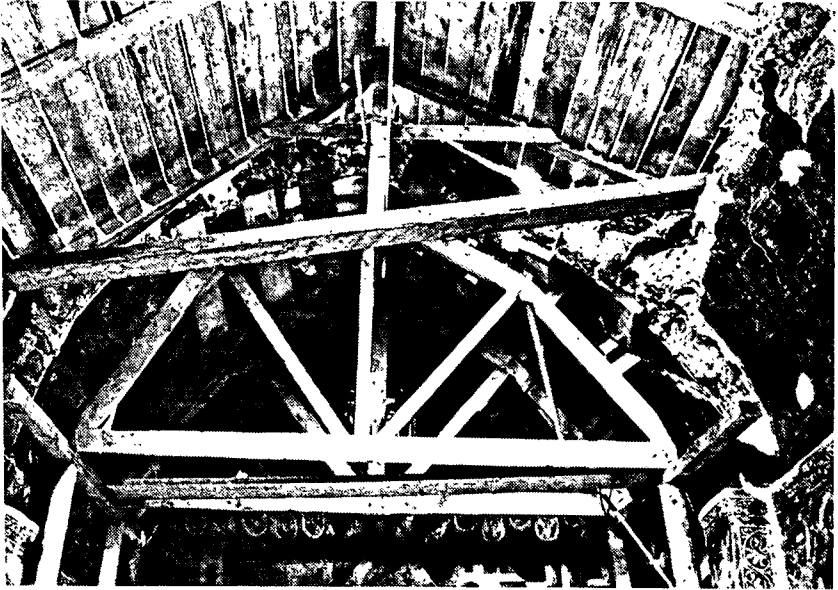
5.6 Temporary weather protection, Sveti Nikola, Gradiste Monastery

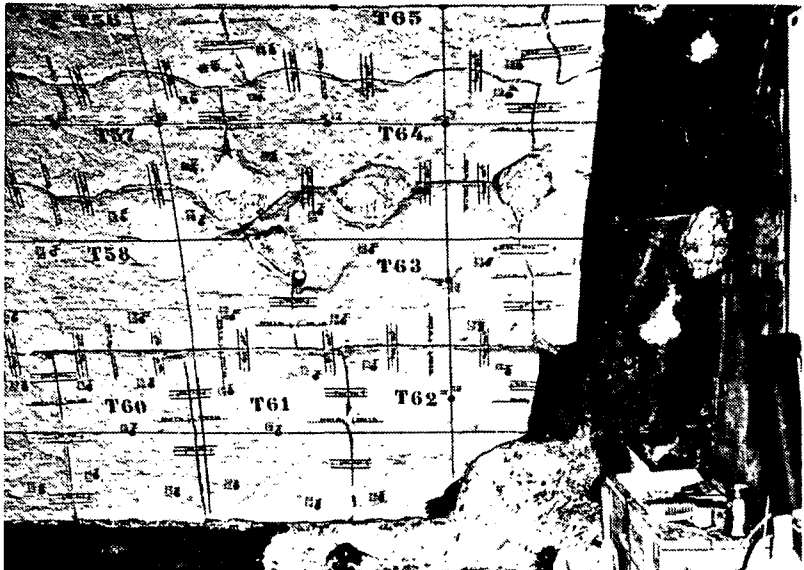
5.7 Preparation for removal of mosaics, Rotunda, Thessaloniki

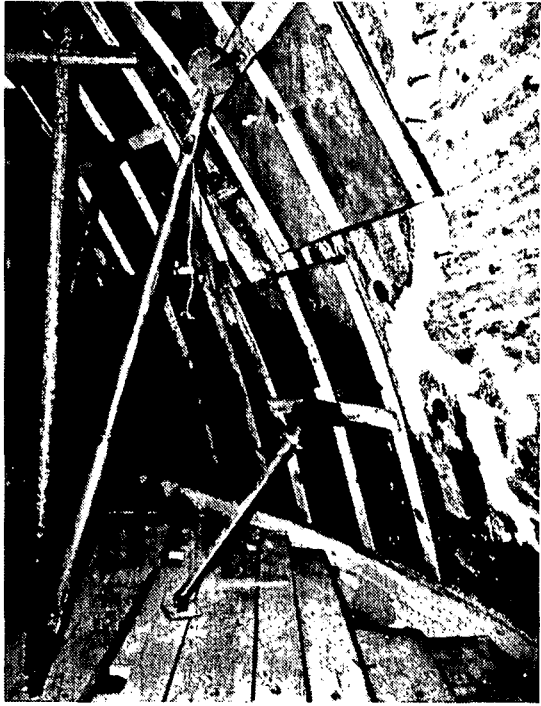
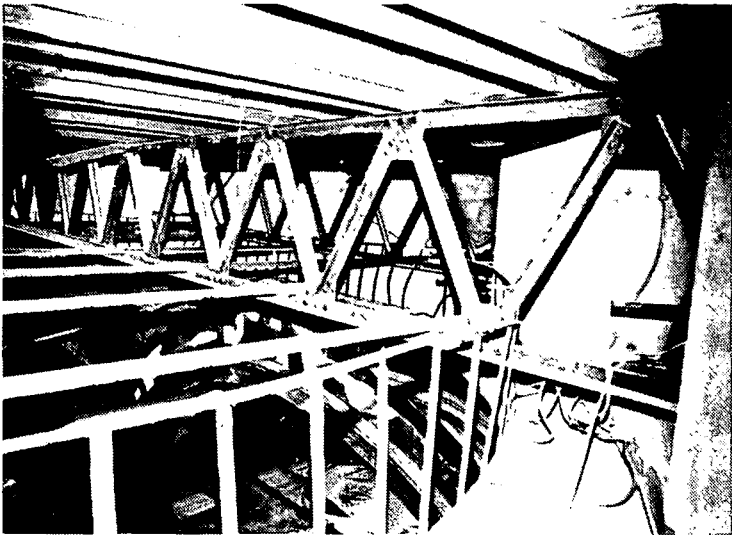
5.8 Temporary support for mosaics, Hagia Sophia, Thessaloniki

In the example illustrated in Figure 5.8, the mosaic (with its setting bed) was found to have separated from the dome (whose brickwork is exposed by a partial loss of the mosaic at the right hand side of the upper view) over most of the surface. Pending a decision on final treatment, it was supported as shown. A rigid trussed platform was erected at the springing level as seen in the lower view. Above this, several lighter boarded platforms were erected at about 2 m intervals, carried on the first by tubular steel struts. Then, from these, raking adjustable steel props were used to press slightly flexible plywood panels gently against the curved surface of the mosaic as seen in the upper view, leaving only narrow bands of mosaic unsupported between the panels. For further temporary protection, nails with circular spreader plates were driven at intervals through the mosaic into the brickwork of the dome. In a situation like this - with the springing of the dome about 20 m above the ground - a support carried up from floor level would have been too flexible, and would have tended to move differently from the stiffer masonry supporting the dome in the event of another earthquake.

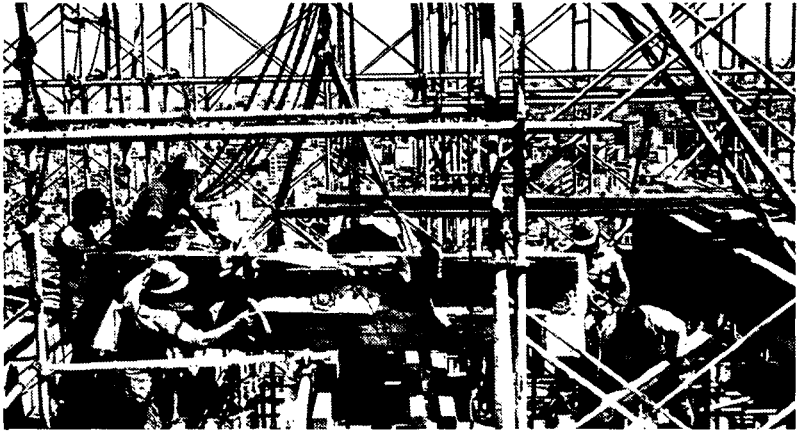
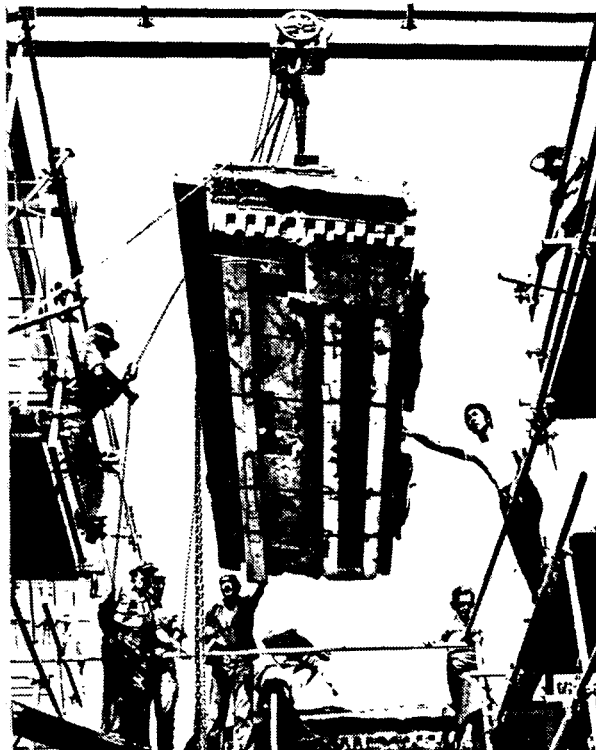
5.9 Lifting and traversing arrangements, Erechtheion, Athens

The requirement that no damage should be inflicted on the blocks of stone or other members that are taken apart calls for careful handling and may necessitate the construction of special lifting tackle and other related provisions as illustrated in Figure 5.9 and described in the case study just referred to. The other chief requirements are for careful numbering of all units, full recording of the whole procedure, and proper provision for the safe temporary storage of the units.

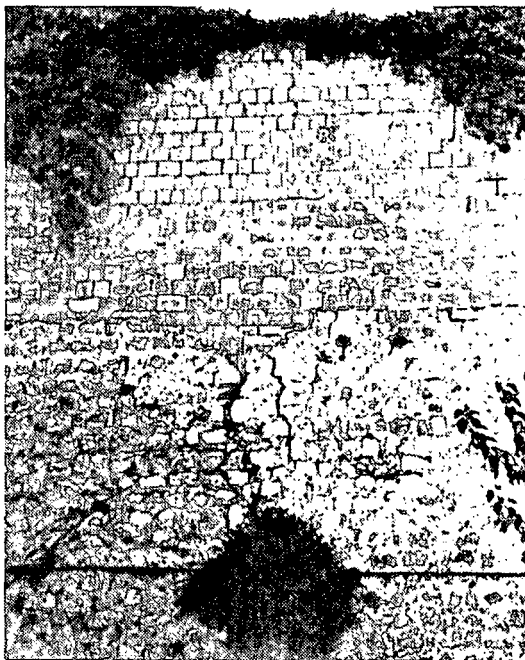
5.10 Cracking of a wall after repair, Castle of Heraklion

In the selection of natural stones, expert advice is recommended. For other materials a programme of testing may be necessary to match the most important properties of strength, modulus of elasticity, permeability (chiefly for materials to be used in external elements of the structure), thermal expansion, moisture movement, and chemical reaction. In the absence of a good match, there will be risks of separation of the new material from the old, or damage to the adjacent old material if this is weaker or (in situations where there are continual moisture movements) more permeable. The commonest mistake is to repair an external wall with new work which is too stiff and too impermeable in relation to the existing construction. In the examples illustrated in Figures 5.10 and 5.11, breaks in a defence wall and in its parapet have been made good with stronger new masonry which has cracked the old masonry seen below and led to a partial collapse in the second instance.

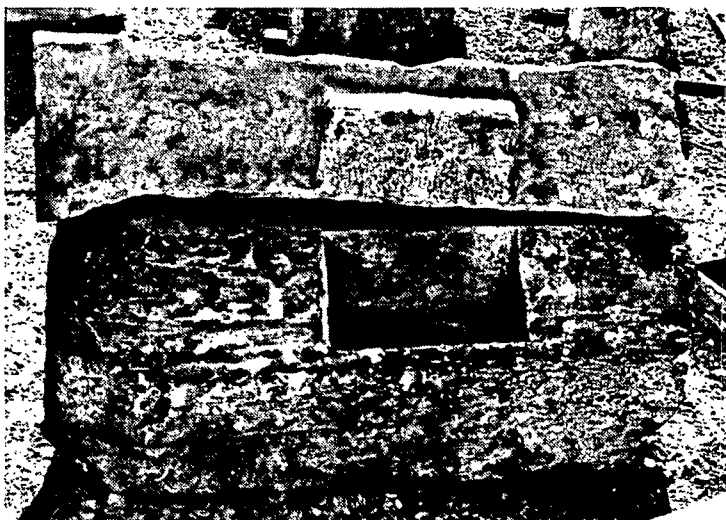
5.13 Damaged block and completion piece, Erechtheion, Athens
1902-1907 restoration

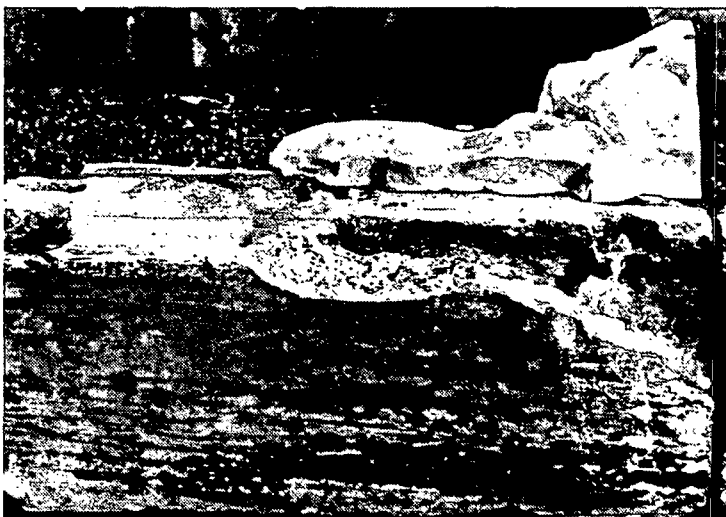
5.14 Damaged block and completion piece, Erechtheion, Athens
current restoration
