BUILDING CONSTRUCTION
UNDER SEISMIC CONDITIONS
IN THE BALKAN REGION

REPAIR
AND STRENGTHENING
OF HISTORICAL
MONUMENTS
AND BUILDINGS
IN URBAN NUCLEI

UNDP/UNIDO PROJECT RER/79/015

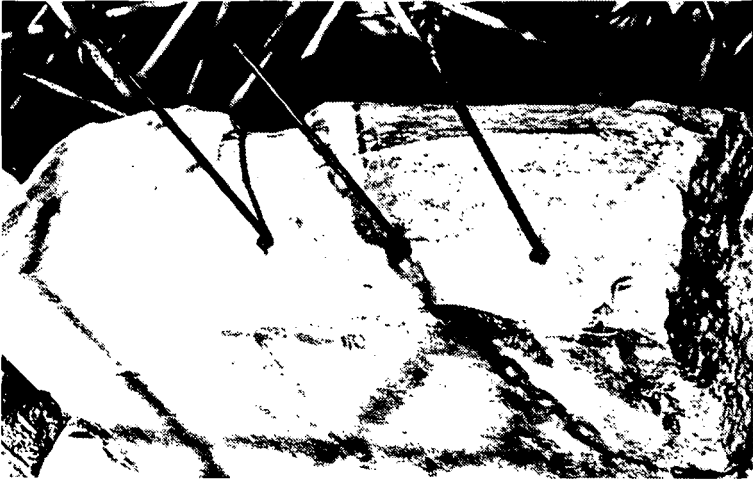
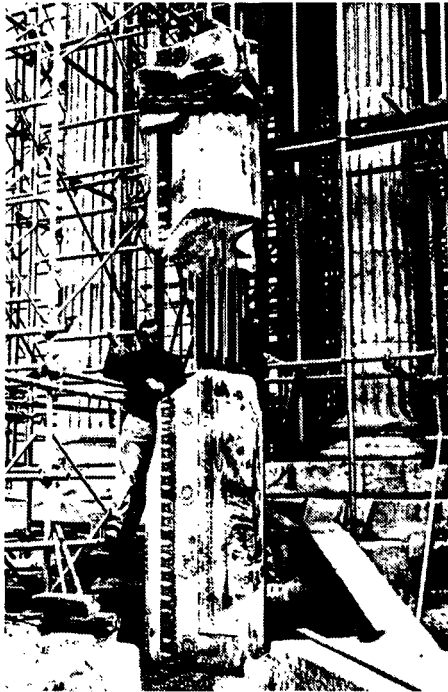
5.15 Reinforcement and connection of separated pieces, Erechtheion, Athens

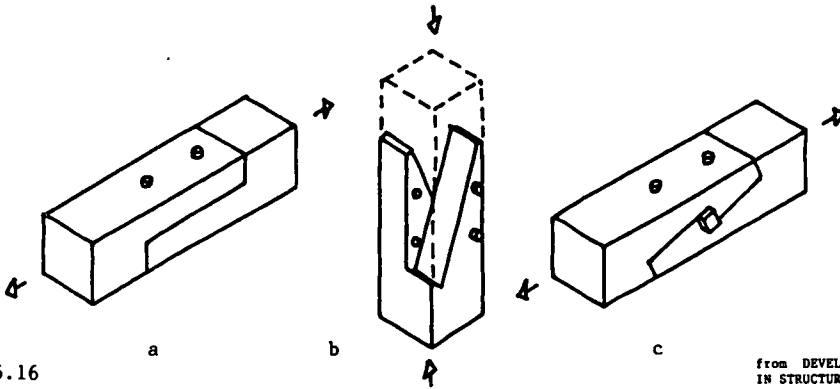
as illustrated above, will usually be appropriate, reinforced as necessary by metal plates or straps (provided that these are protected against corrosion and accessible for future inspection). Joints a and c are suitable for members subject to tension, and the scissor scarf, b, for members subject to compression. A more efficient modern alternative is illustrated below.

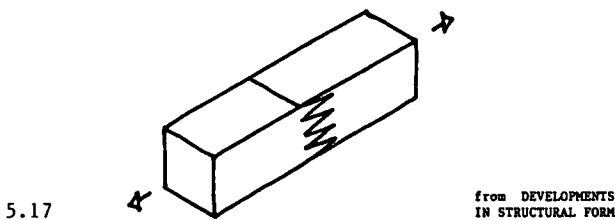
This relies on a good synthetic glue and, when new and well made using a special tool for cutting the fingers, is capable of developing the full tensile strengths of the separate pieces. Its drawback for use in a historical structure is the possible doubt about the durability of the glue in the particular environment of use.

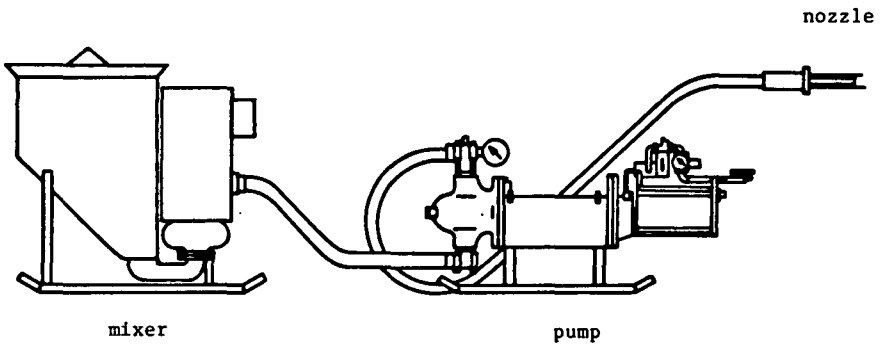
5.18 Mechanical grouting equipment

Typical mechanical grouting equipment consists of a pump, mixing tanks, hoses, and nozzles, as seen in Figure 5.18. Two mixing tanks are used alternately to prepare the mix and feed the pump, in order to permit continuous operation. In the equipment illustrated, the mixers have a volume of approximately 230 litres, and mixing lasts one minute. The piston pump is capable of developing exit pressures of 5 to 8 atmospheres, depending on the length of hose. It can pump a mortar mix with aggregate particles up to 1 mm in size. The high-pressure hoses are 40 mm in diameter and from 30 to 200 m in length.

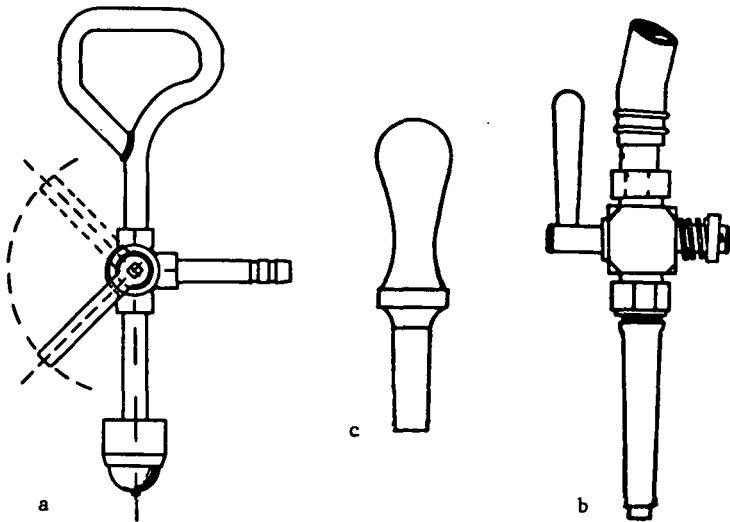
5.19 Nozzles for grouting and tapered plug

Nozzles are illustrated in Figure 5.19. The 5 mm nozzle seen at a is used for cracks up to 10 mm wide. The 10 mm nozzle at b is used for wider cracks.

Injection must proceed from the bottom upwards. To minimise the risk of damage by excessive internal pressure, the pressure at the nozzle should preferably be about 0.5 atmosphere, and not more than 1 atmosphere. Injection is interrupted each time grout appears at an entry point above the one in use, and pressure at the pump should be simultaneously reduced if the grout is being pumped. The nozzle should then be withdrawn and the short length of hose sealed with a tapered plug like that seen in Figure 5.19c.

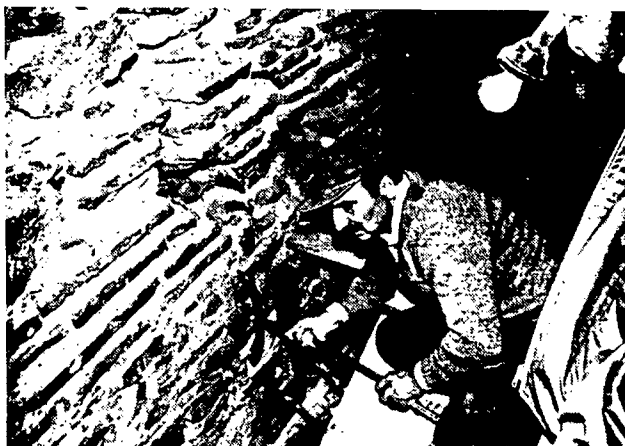
b Grouting in progress

5.20 Grouting procedure, Rotunda, Thessaloniki

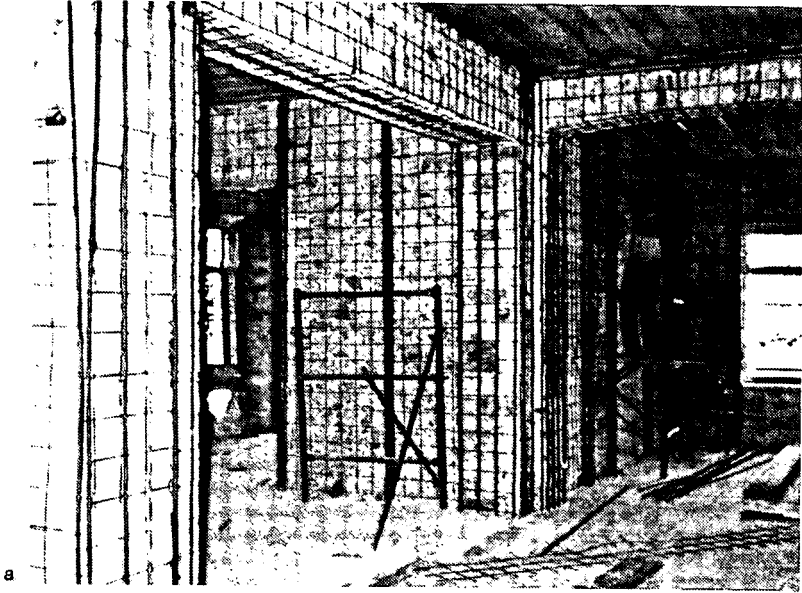
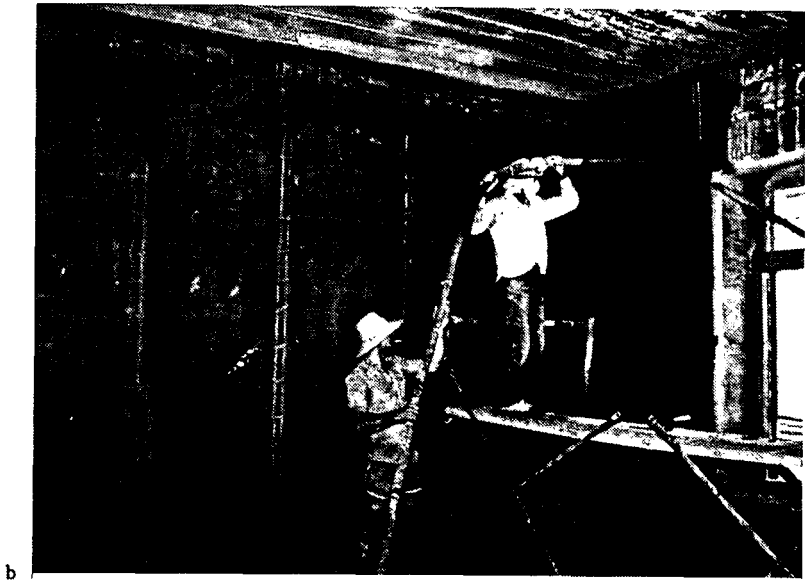
5.22 Application of reinforced concrete skins to internal walls
Hegemoneion, Samos

Careful prior stripping and cleaning of the wall surfaces is necessary, including the removal of all dust and fragments of brick or stone with air or water jets. Cracks may or may not be filled according to the circumstances and the judgement of the engineer: leaving them open may help by providing a key for the new concrete. Reinforcement is then fixed as shown above by means of metal dowels glued to the surface or by means of bars through the thickness. Ribs may be incorporated at intervals, as seen in Figure 5.22a. Concrete is usually applied by the Shotcrete or Guniting process as seen in Figure 5.22b. Typical thicknesses are from 30 to 80 mm. While work is proceeding, some temporary support may be required for floor or roof members.

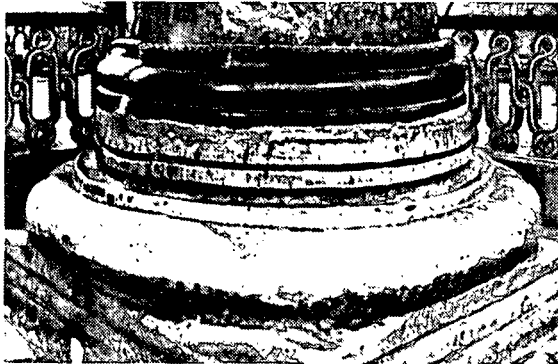
5.23 Base of a monolithic column, Hagia Sophia, Istanbul

Experience shows that both monolithic columns and columns constructed from superimposed drums accurately cut and fitted together behave very well unless the horizontal bearing area has, somewhere, been considerably reduced - usually by deliberate cutting into the stone or other human action. The best strengthening measure is the restoration of the original bearing area. It is difficult, however, to do this effectively by adding patches: these too readily break away if rocking commences. Perhaps the only really effective procedure is the replacement of the damaged drum (or of a drum-like section of a damaged monolithic column) by a new drum. A possible alternative for the monolithic column is the fitting of a patch of similar stone cut as described in section 5.4.2, followed by local circumferential prestressing by means of an encircling band. An early precedent for this is to be found in the use of bronze bands around the tops and bottoms of all monolithic marble columns in Hagia Sophia, Istanbul, as seen below.

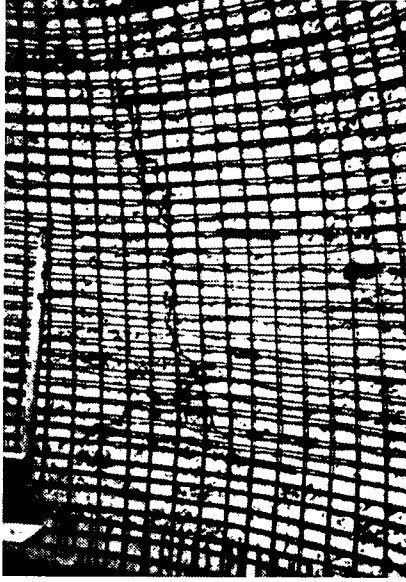
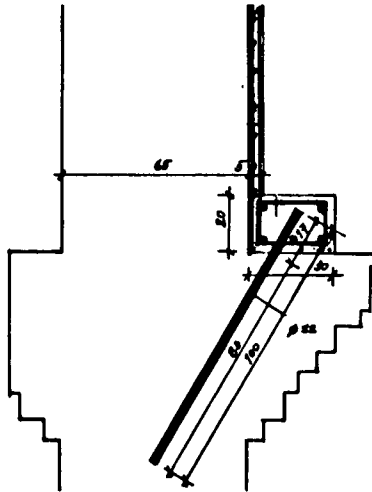
5.24 Strengthening of the dome, Cathedral of Dubrovnik

be able to withstand the forces exerted by a prestressed tie, and where its complete replacement by a reinforced concrete shell is inadmissible. An example is illustrated in Figure 5.24 and further described in the case study. It will be seen that the new skin is continuous with the tie and that both are anchored to the base structure.

The dome will be strengthened primarily by a reinforced concrete ring 300 mm square in cross section at level E in Figure 11.6a. This ring, seen in more detail in Figure 5.24b, will be provided with anchors projecting downwards into the top ring of the drum to give the necessary improvement in safety of the dome against overturning.

Further strengthening will be achieved by the application of an internal skin of reinforced gunite, 50 mm thick, as seen in Figure 5.24a. This skin will obviate the need for separate filling of the cracks.

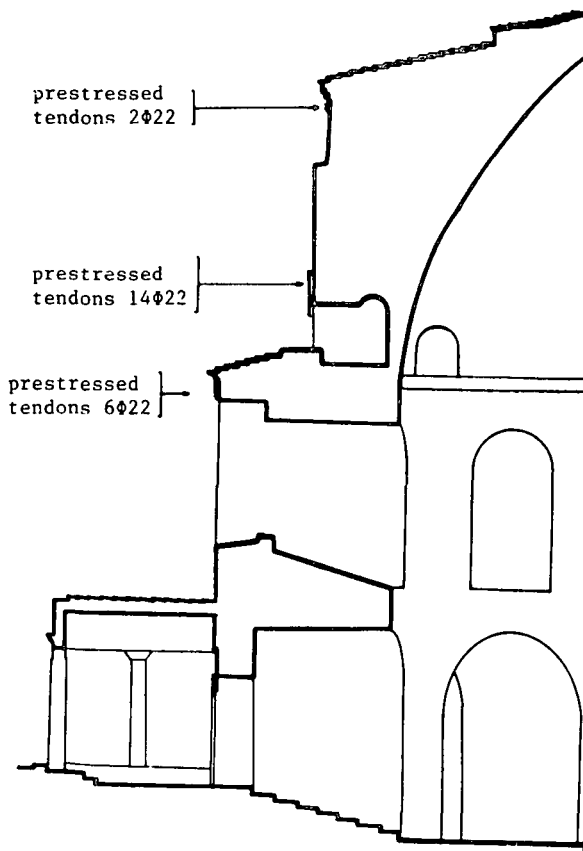
5.25 Strengthening of the dome, Rotunda, Thessaloniki

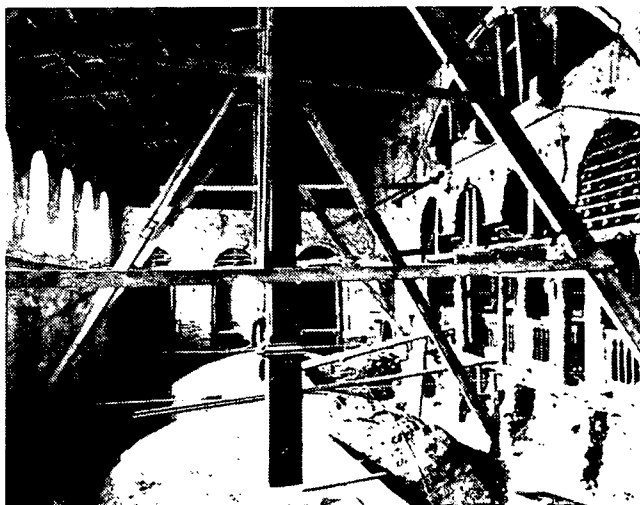
5.26 Fills removed over side aisle and narthex vaults,
Hagia Sophia, Thessaloniki

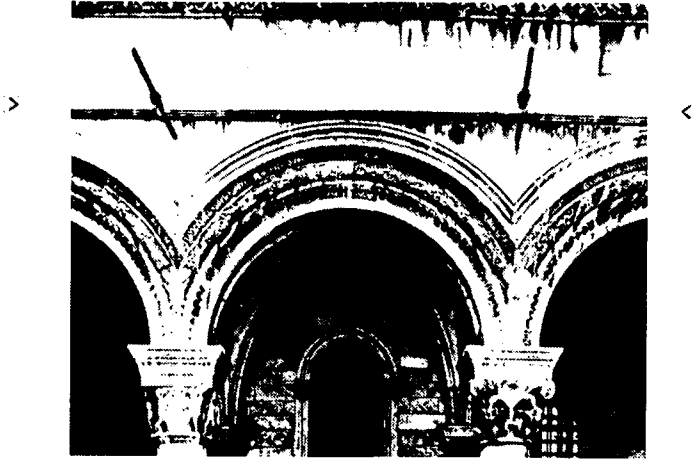
5.27 Tie anchorage, Rector's Palace, Dubrovnik

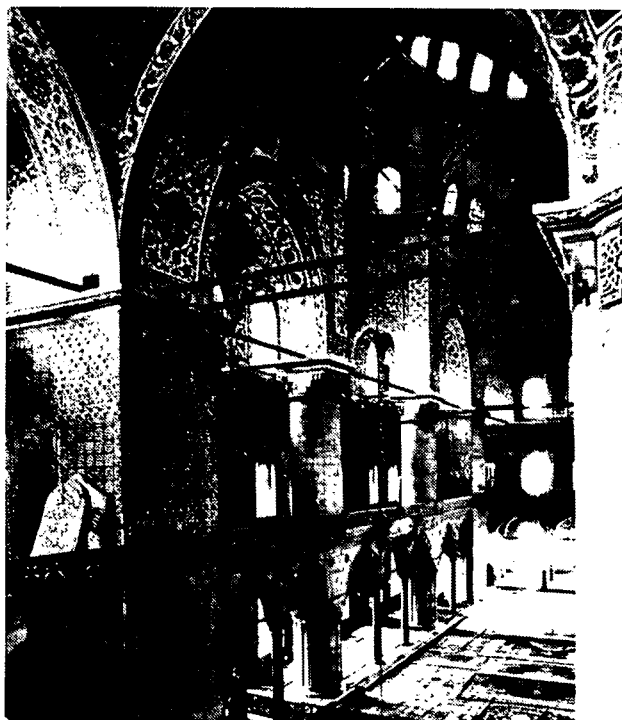
5.29 Iron ties, Mosque of Sultan Ahmet, Istanbul

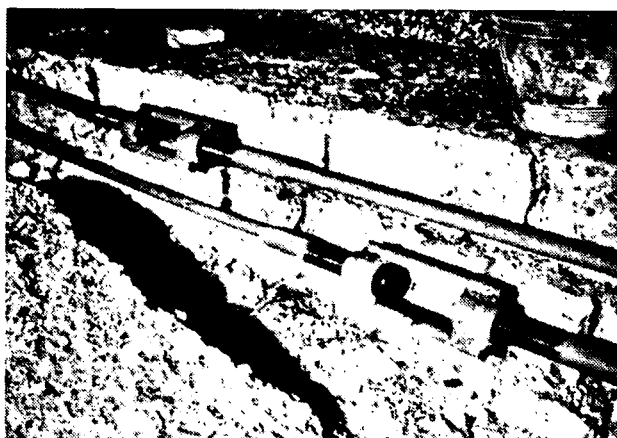
5.30 New ties, Cathedral, Dubrovnik

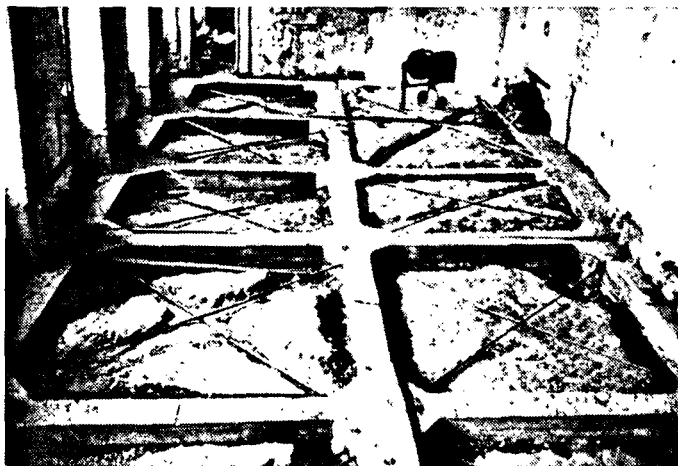
5.31 Diaphragm system above ground floor vaults, Rector's Palace, Dubrovnik

Ties to vaulted floors can, if they are set at the higher level just referred to, form part of a trussed diaphragm system as illustrated in Figure 5.31. This will have a stiffness comparable with that of the reinforced concrete systems referred to in the previous section. But there will be less risk of causing damage to the vertical bearing structure because this will now usually be of a different form.

At first floor level, the west facade would be supported by means of a grid of reinforced concrete beams and steel diagonals laid over the stone groin vaults as indicated in Figure 15.7 and shown also in Figure 5.31. This grid would transmit horizontal forces to the corner towers, where reinforced concrete slabs would be provided. The atrium would be strengthened by a system of steel ties, also shown in Figure 15.7. All these reinforcements would be hidden below the existing floor levels. Connections to the existing masonry would again be by steel anchors, as shown in Figure 15.5.

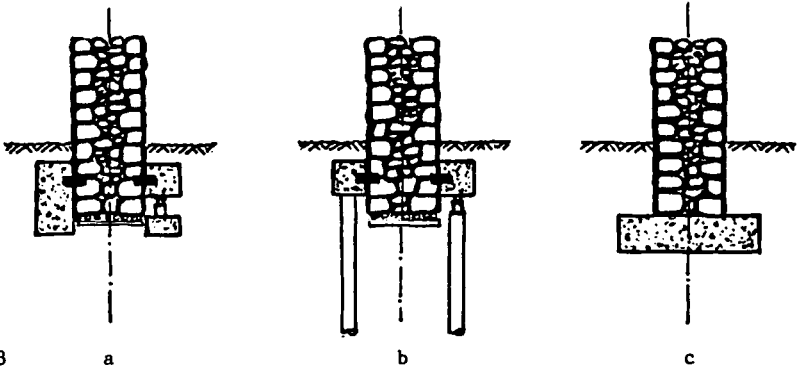
Inadequate existing footings may be strengthened most readily by casting new reinforced concrete members alongside them, after providing for the necessary shear transfer as shown in Figure 5.32. The sketches at a below illustrate the principle with and without provision for jacking to ensure transfer of load to the new members without further settlement. Alternatively, the existing footings may be underpinned with wider reinforced concrete members, as sketched at c below, following normal underpinning procedures.

Where it seems desirable to carry the loads of the superstructure to a lower firmer stratum, new piles must be driven. Usually it will be preferable to drive them alongside (rather than beneath) the existing footings. This again calls for the casting of new reinforced concrete members alongside the existing footings with adequate shear connection, as sketched at b above. Provision for jacking, as shown at the right of the sketch, will usually be necessary to ensure a proper transfer of loads to the piles.

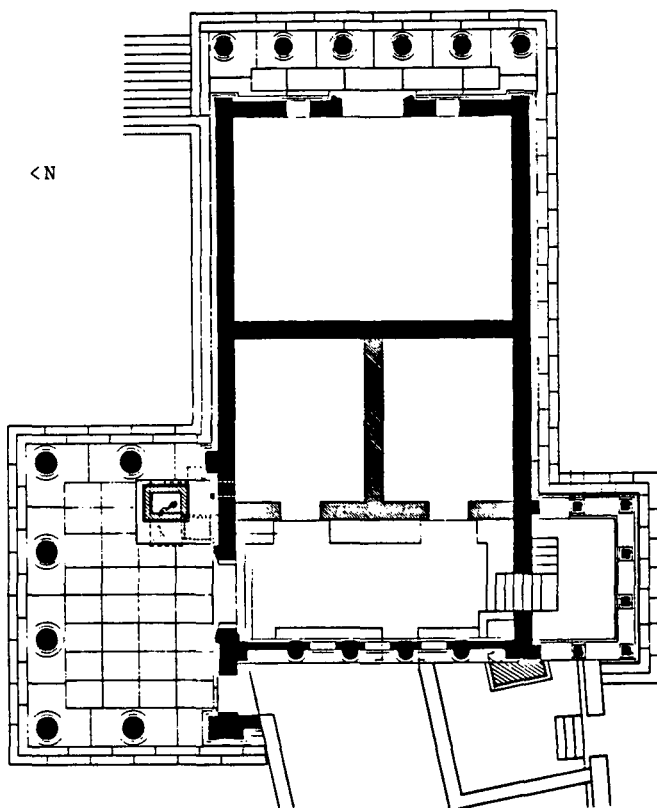
7.1 Restored original plan (1:200)

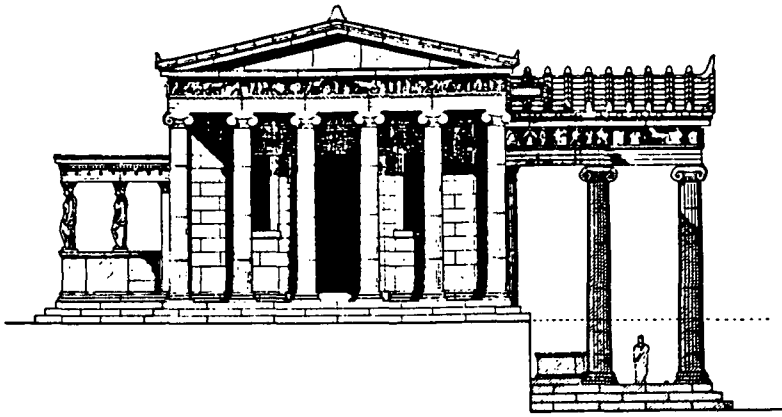
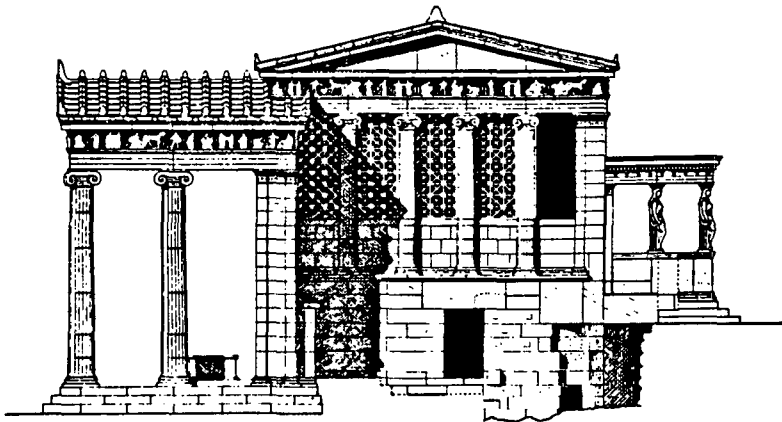
from the east

from the west

7.2 Restored original elevations (1:200)

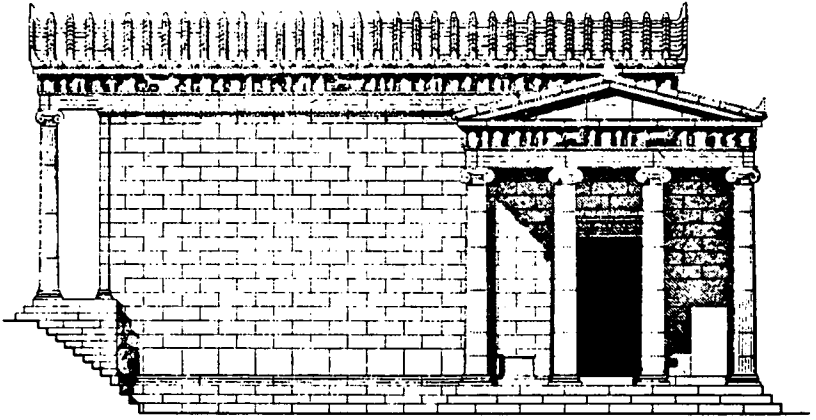
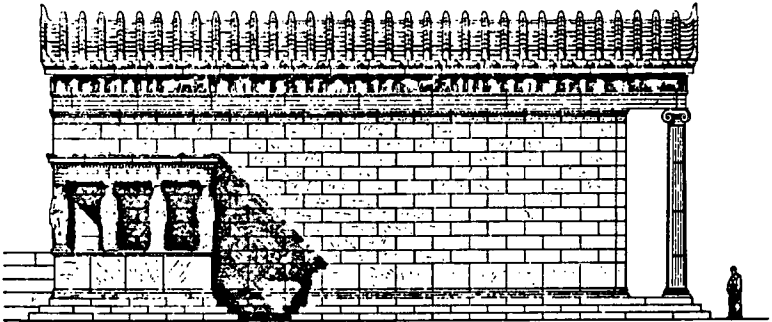
north side

south side

7.3 Restored original elevations (1:200)

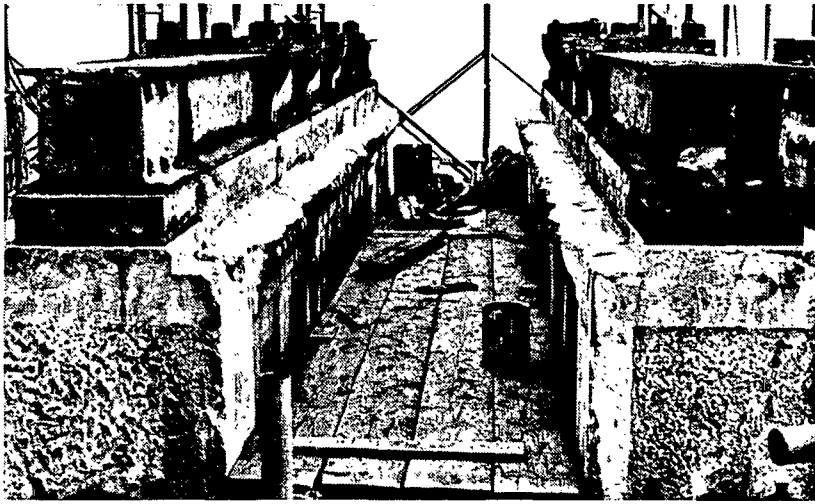
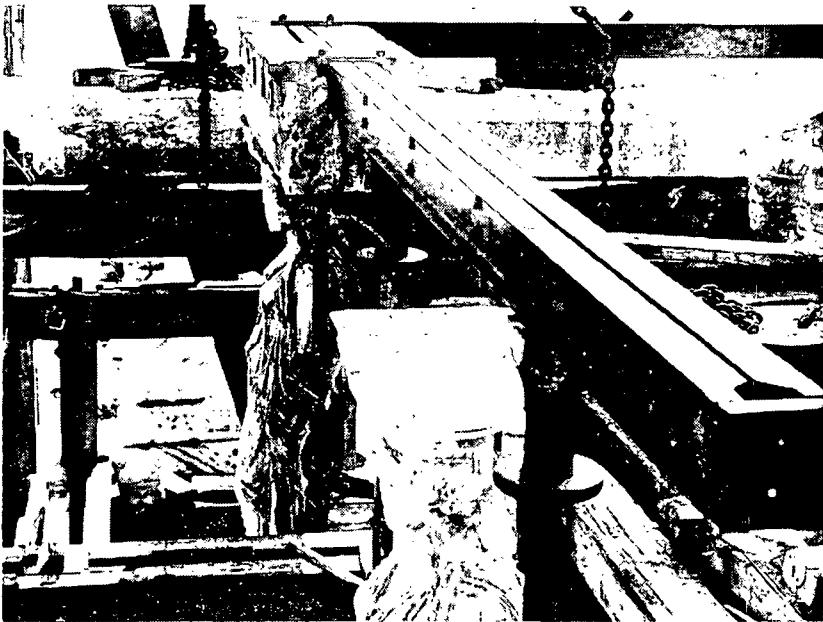
north porch

south porch

7.4 Steel supporting beams installed in 1902-08

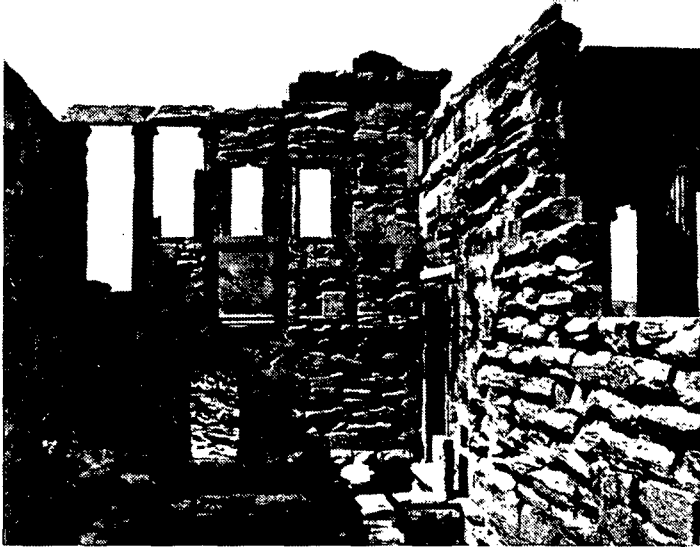
7.7 View of the interior from the east

General views of the structure as it existed after the 1902-08 reconstruction and up to the start of the works described here are reproduced in Figures 7.6 and 7.7, and may be compared with the view towards the end of the Turkish occupation reproduced in Figure 7.5. The diminution of the strength of the walls by fire damage is apparent from Figure 7.7 and from the detail

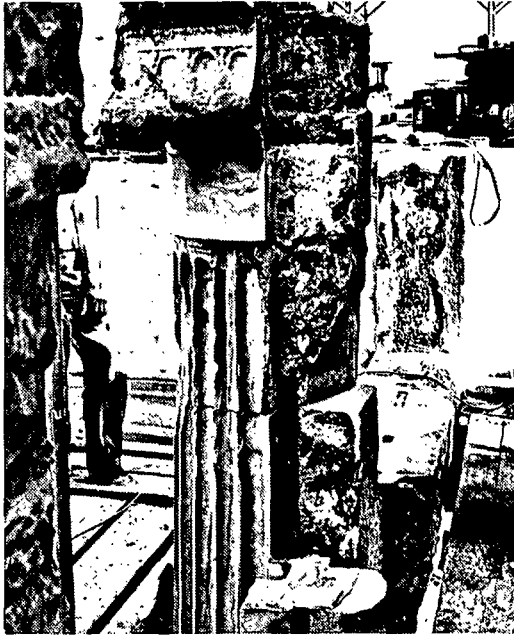
7.9 Fracture of a semicolumn due to rusting of iron reinforcement

The cause of most of the cracking of the marble had been established as swelling of the embedded iron due to corrosion, the corrosion having been accelerated by the inadequate protection given to the iron in the previous restoration, by recent air pollution, and by the greater exposure that resulted from the initial cracking and opening of the bed joints.

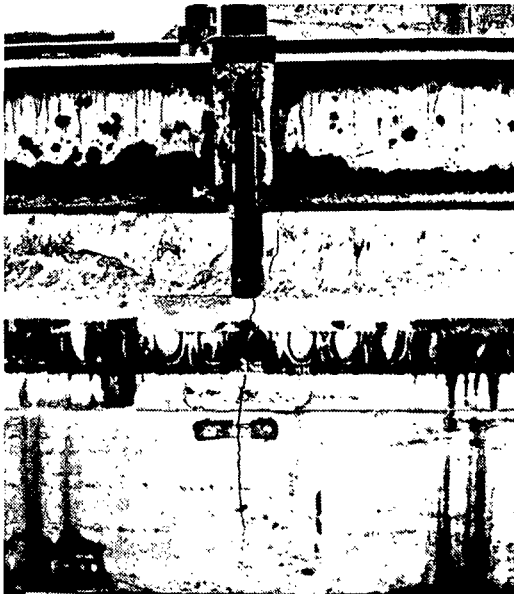
7.10 Fracture of an architrave of the north porch due to rusting of hangers

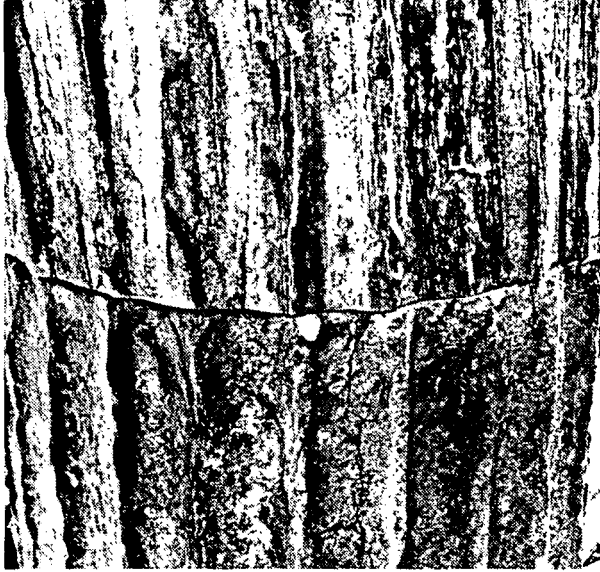
7.11 Fractures on the edges of column drums, east porch

Damage directly attributable to past earthquakes was slight. It could be seen, for instance, in local fractures near the edges of column drums and bases in the east porch, caused by rocking of the drums on one another. Examples are shown in Figures 7.11 and 7.12.

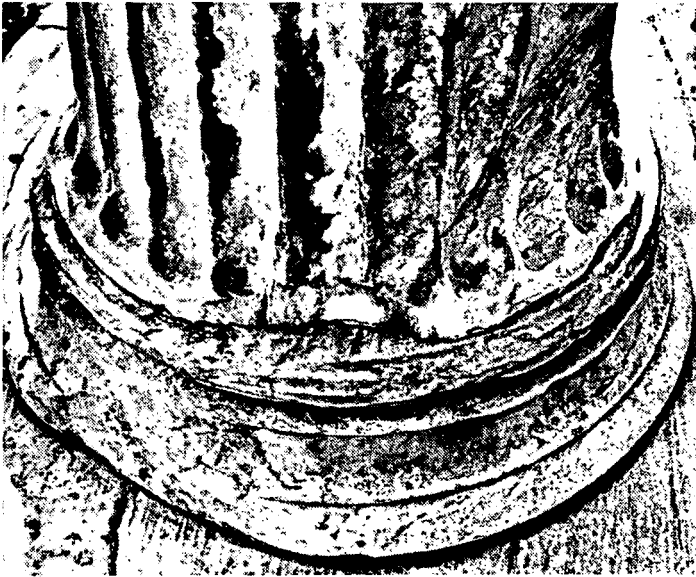
7.12 Fractures at the foot of a column, east porch

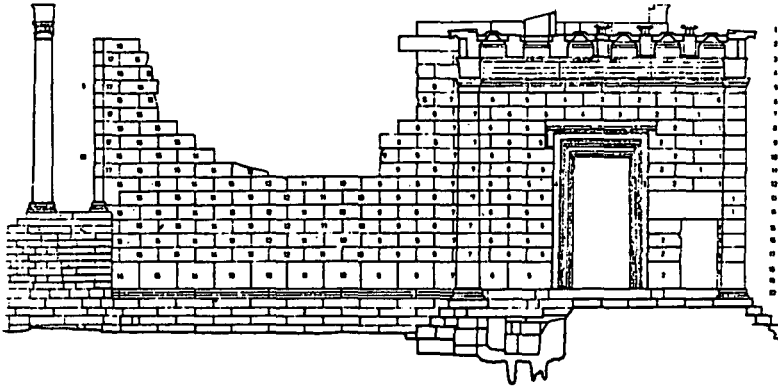
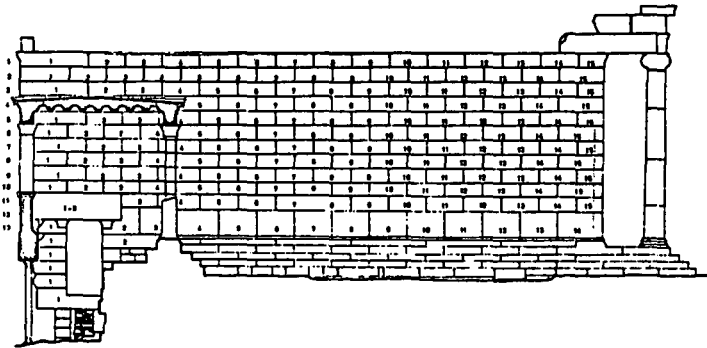
north elevation (1:200)

south elevation (1:200)

7.13 Survey drawings

On the basis of the detailed investigations, tentative schemes were prepared. Figure 7.13 shows elevations of the north and south walls with all blocks identified for reassembly (where necessary) to the height existing at the commencement of the works. Figure 7.14 shows a scheme for a fuller reconstruction of the north side, including the replacement (if necessary by copies) of the missing corner column of the east porch and the missing epistyle above it. It may be compared with Figure 7.6 showing the existing state. Figures 7.15 to 7.17 show three of the schemes considered for the support of the roof of the south porch.

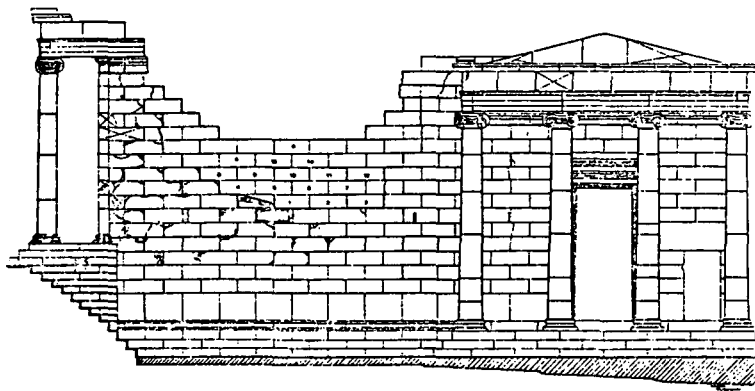
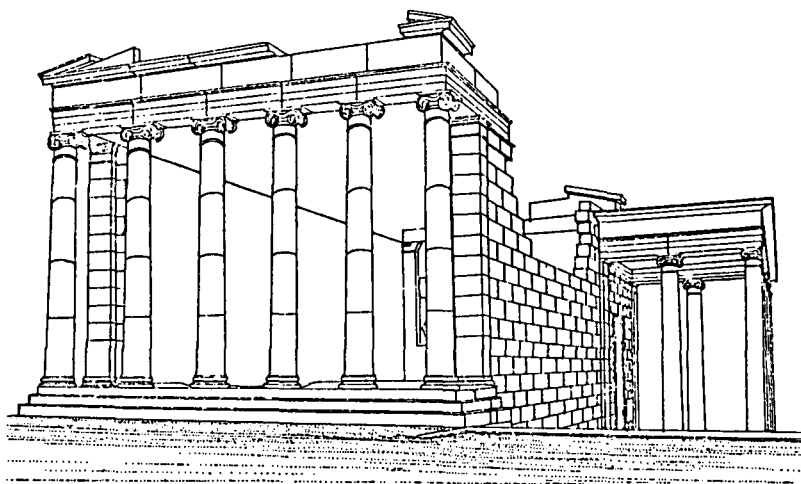
north elevation (1:200)

view from the north east

7.14 Proposed reconstruction of the north side

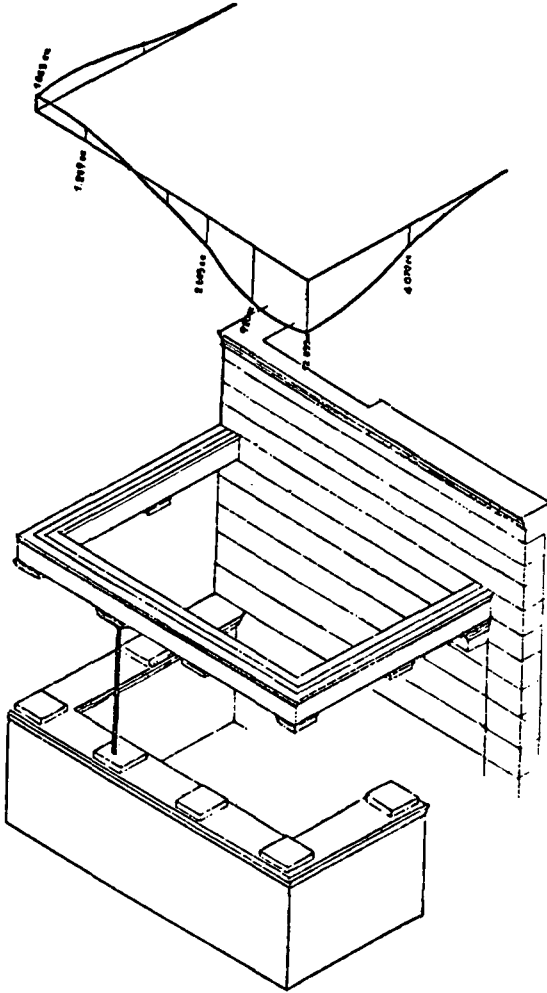
7.15 First proposal for supporting the roof of the south porch (1:100)

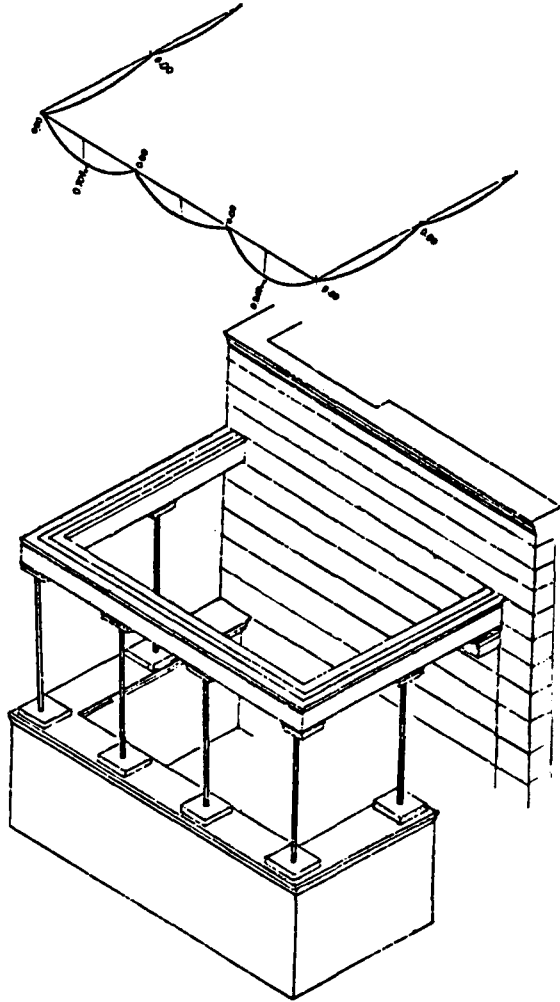
7.16 .Second proposal for supporting the roof of the south porch (1:100)
(as finally selected)

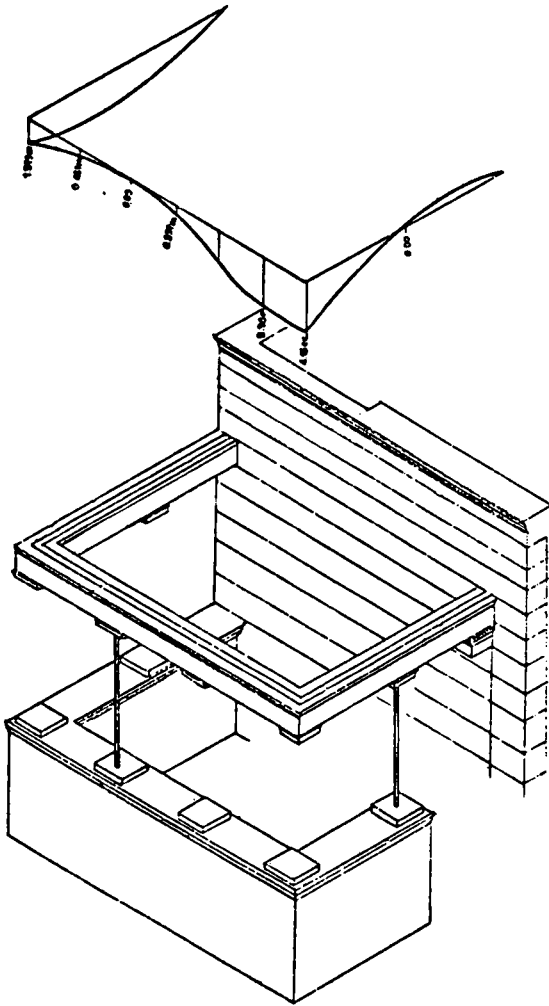
7.17 Third proposal for supporting the roof of the south porch (1:100)

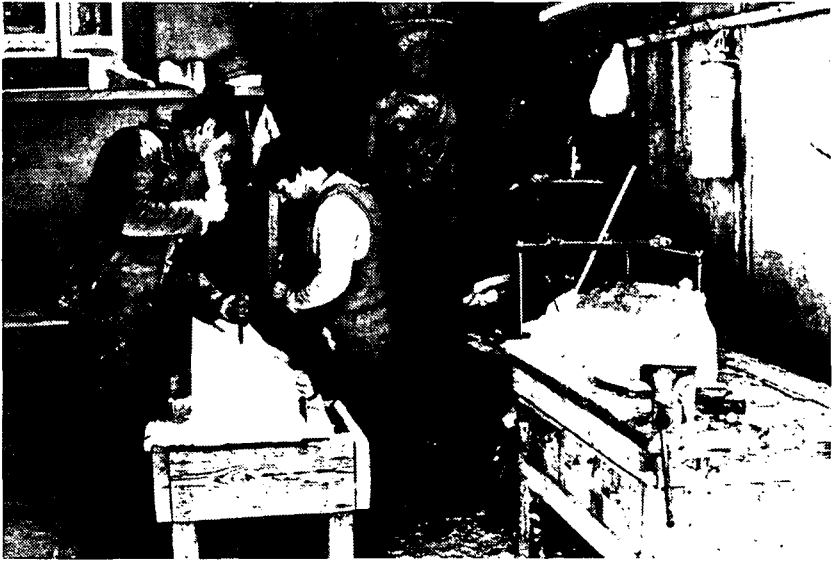
7.18 Cutting a completion piece for a broken block

Where a part of the original block was missing, it was first necessary to make a new completion piece. In the previous restoration, this operation had been simplified by first cutting into the block as shown in Figure 5.13. This was now considered inadmissible for the reasons given in section 5.4.2. Instead, new completion pieces were cut to fit the untouched face of the break as described in that section and illustrated below and in Figure 5.14, using a similar Pentelic marble.

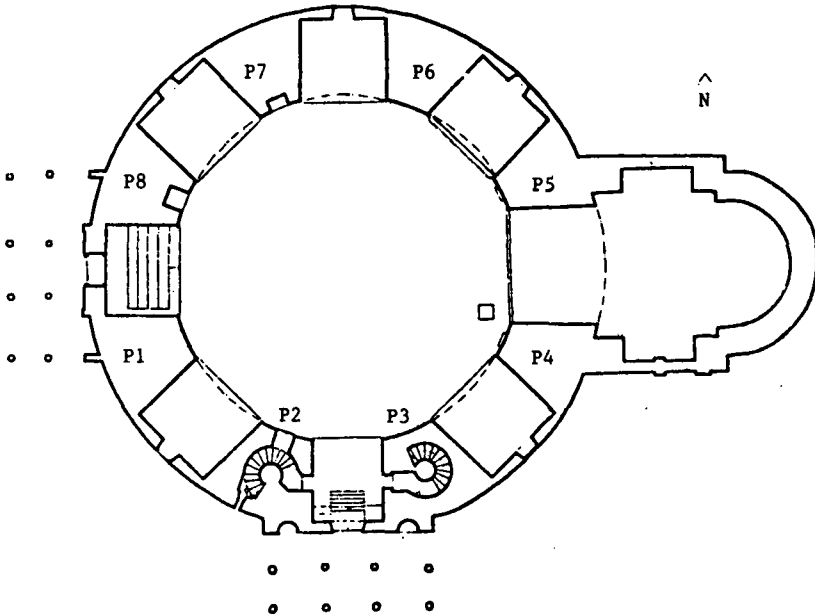
8.1 Plan at ground level (1:400)

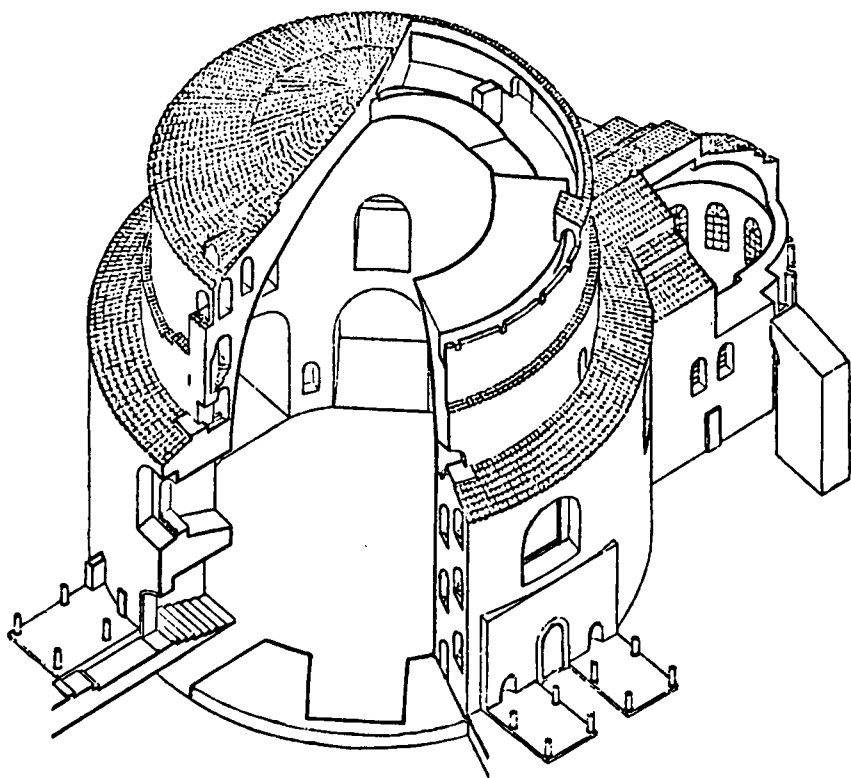
8.3 Cut-away isometric view from the southwest (1:400)

The original structure has survived substantially intact, as shown below and in Figures 8.2 and 8.3, although it has undergone a number of adaptations.

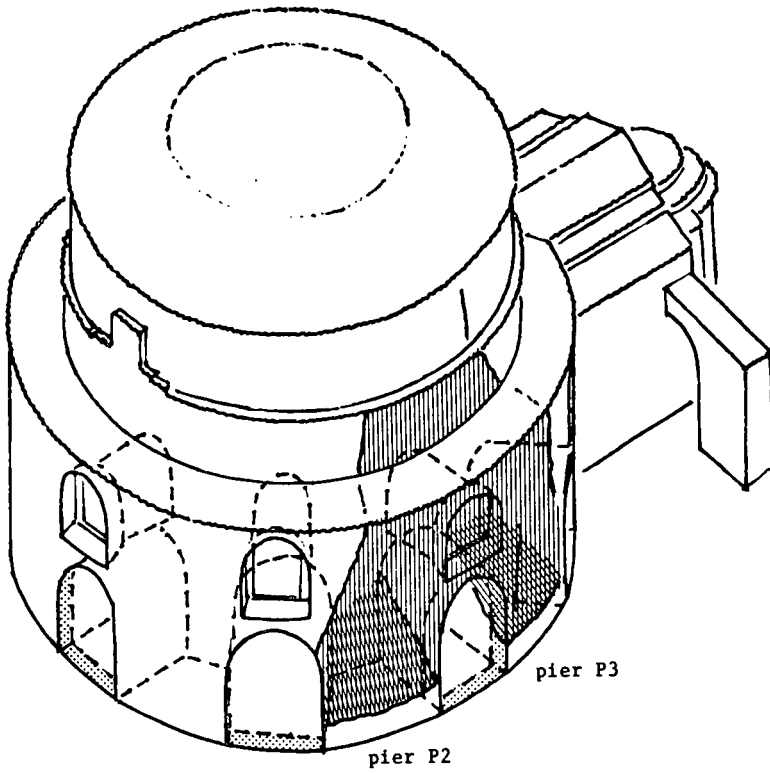
8.4 The main sliding cracks on the southern piers P2 and P3

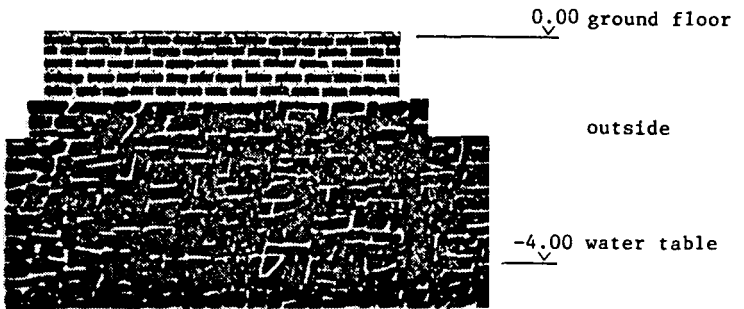
8.7 Vertical section of the Roman foundation (1:100)

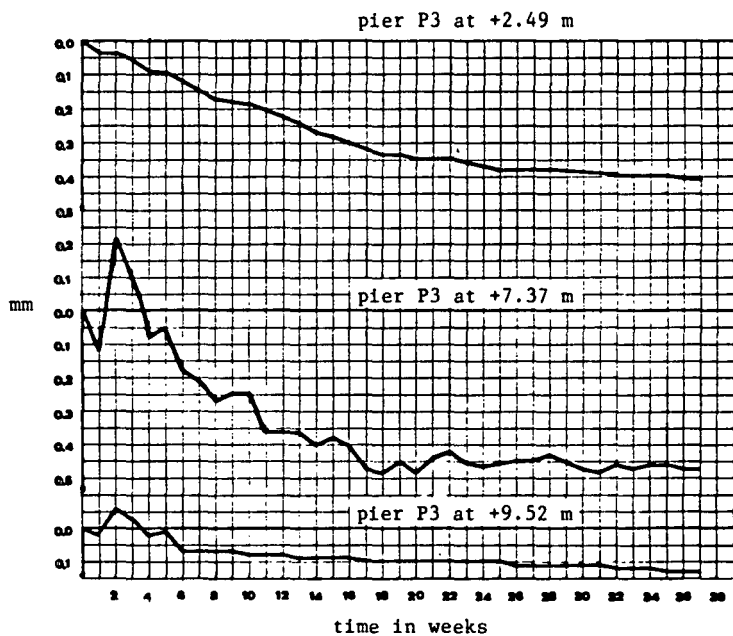
8.8 Variation of crack widths with time

Subsequent movements at the cracks were then recorded by means of suitable

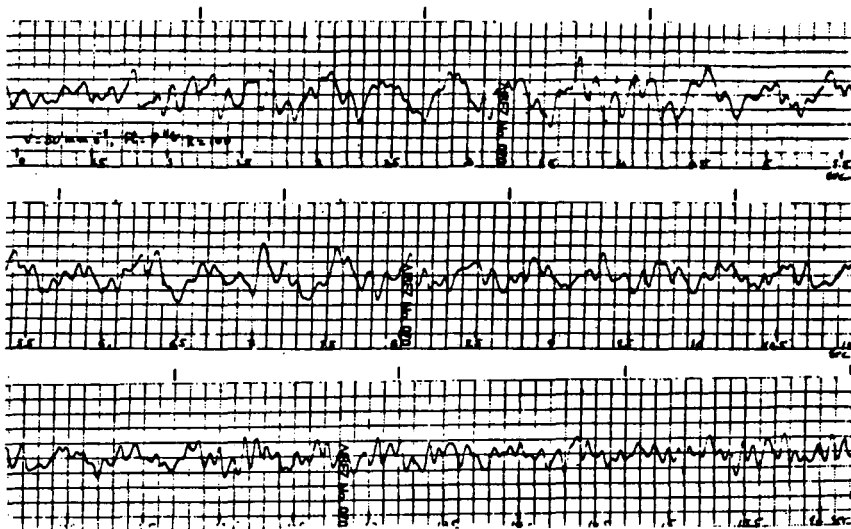
8.11 Records of ambient vibrations

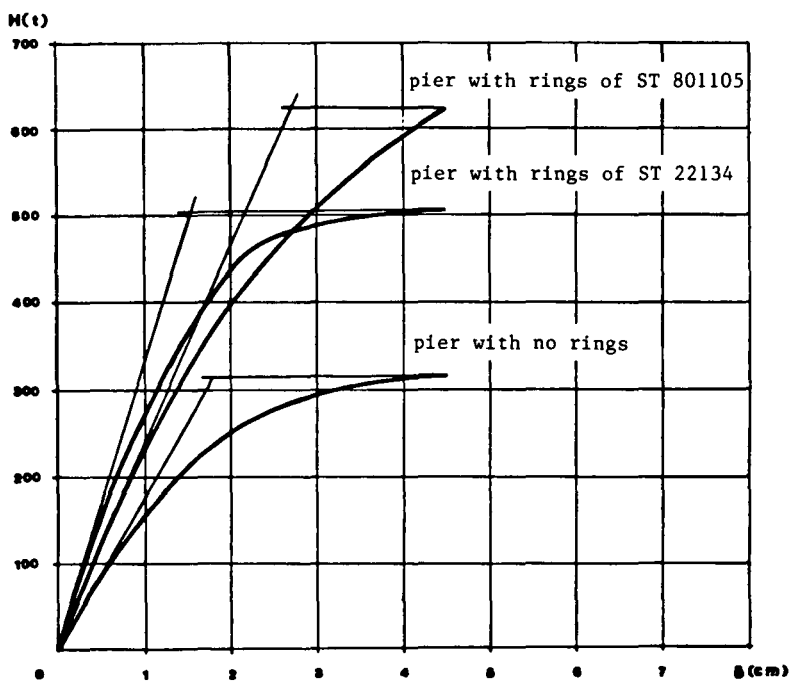
8.12 Calculated curves of load v horizontal deflection for the piers

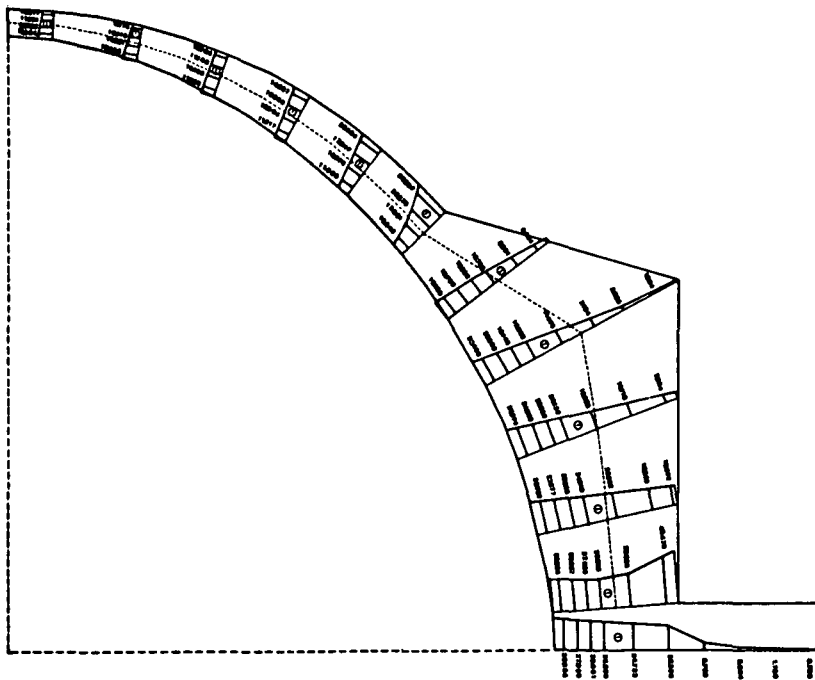
8.13 Calculated distribution of meridional stresses in the dome

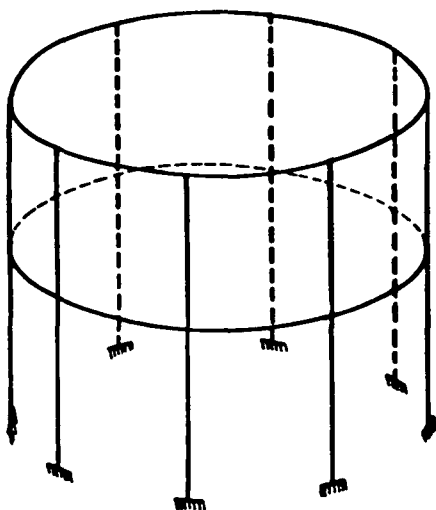
8.14 Frame model of the dome support system

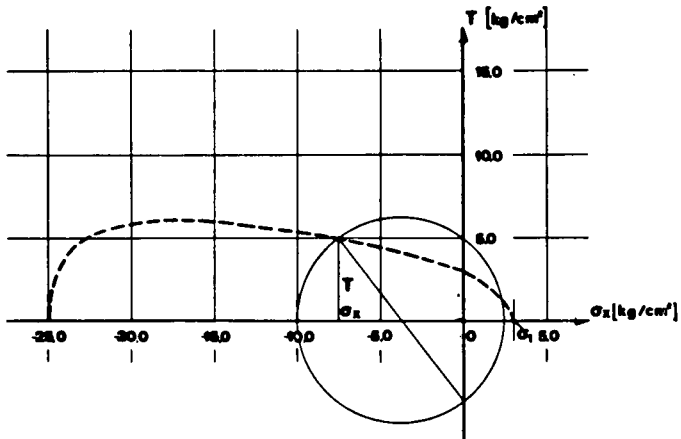
8.15 Strength of the masonry in combined shear and compression

Since failure was possible in shear as well as by rotation, it was necessary to establish failure criteria for the masonry in combined compression and shear. The tests referred to in section 8.5.3 gave directly only the uniaxial compressive strength and the bond strength between bricks and mortar. Uniaxial tensile strength was given indirectly by the bending strength. An envelope of ultimate strength in combined shear and compression was therefore obtained on the analogy of the curves for low-strength concretes having similar compressive and tensile strengths, as shown in Figure 8.15.

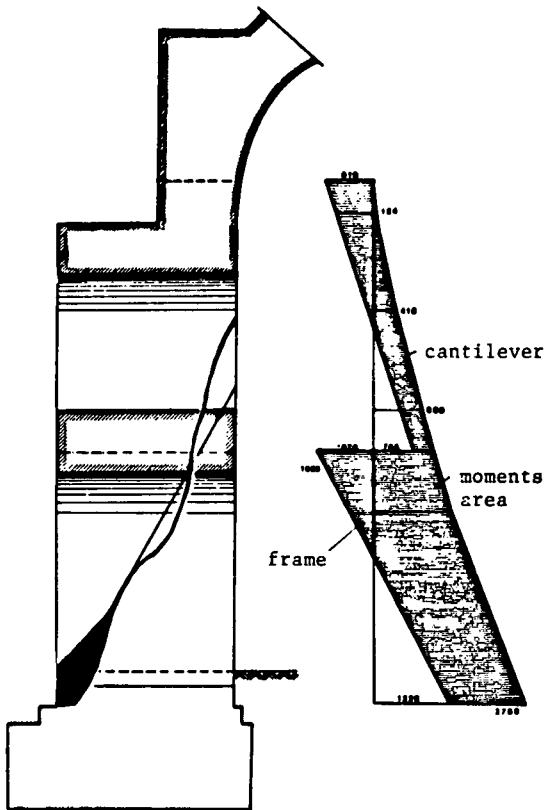
8.16 Cracked pier with staircase

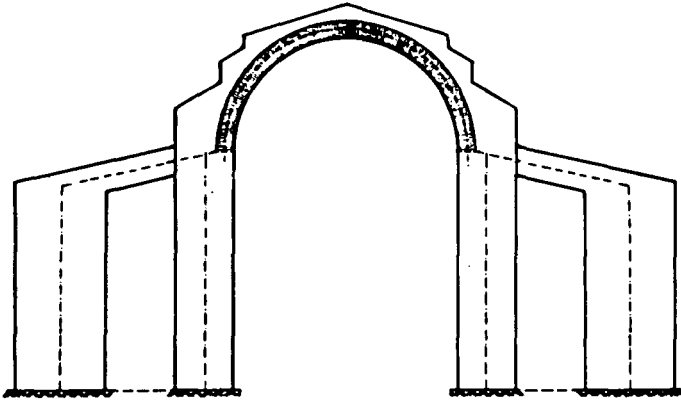
8.17 Cross section of the Christian chancel (1:250)

An initial ultimate load analysis of the chancel, following the step-by-step graphical procedure illustrated in Figure 9.3 and described in the accompanying case study, indicated a factor of safety of about 67% for gravity load alone. It seemed unlikely that the apse would add sufficiently to the total strength to prevent collapse, even without an earthquake. This suggested either that the flying buttresses were erected at the same time as the chancel, or that the present heavy covering of the vault seen in Figure 8.17 is a latter addition and that the buttresses were added when the addition was made.
