BUILDING CONSTRUCTION
UNDER SEISMIC CONDITIONS
IN THE BALKAN REGION

REPAIR
AND STRENGTHENING
OF HISTORICAL
MONUMENTS
AND BUILDINGS
IN URBAN NUCLEI

UNDP/UNIDO PROJECT RER/79/015

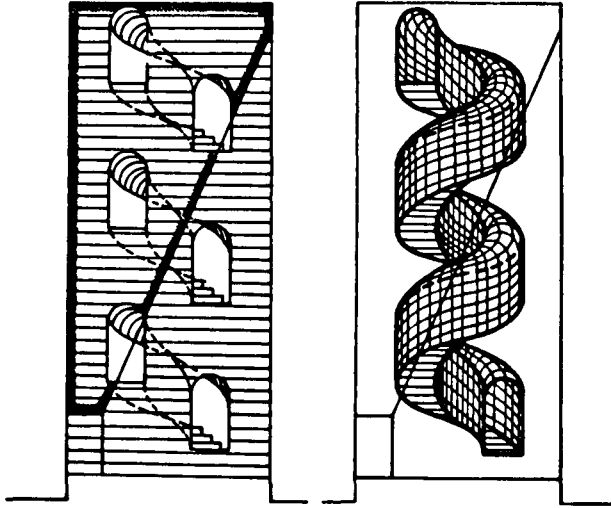
8.18 Reinforcement of piers P2 and P3 (diagrammatic)

- the application of an internal reinforced concrete (gunite) skin to each helical stairway, as shown in Figure 8.18b, using as reinforcement high-strength deformed bars of an austenitic stainless steel alloyed with chromium, nickel, and molybdenum.
- the stitching of the piers throughout their height as shown in Figures 8.18a and 8.19, using prestressed bars of the same steel, protected by means of a cement grout of high alkali content. (Prestressing steels were not used because there would have been difficulty in providing adequate anchorage within the masonry.)

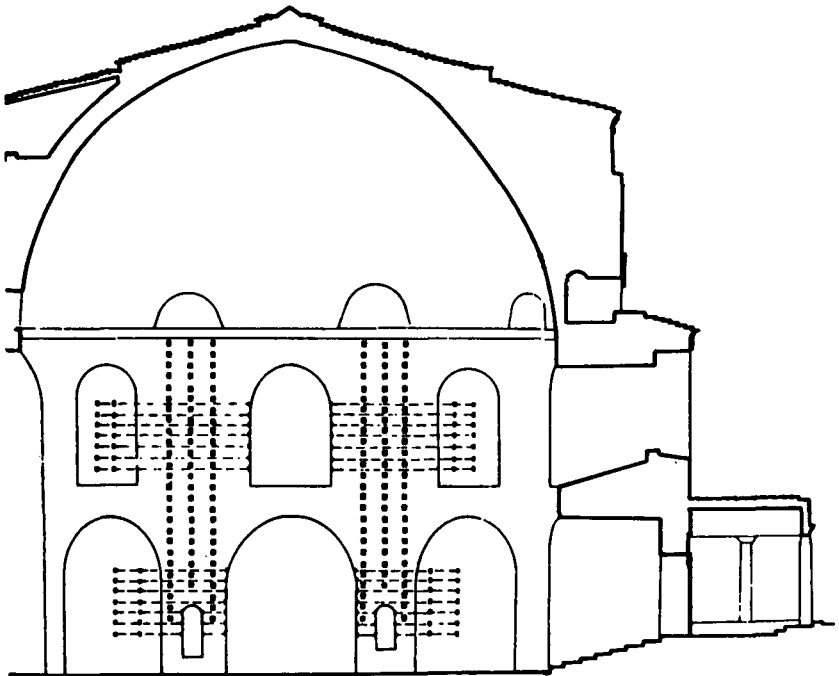
8.19 Internal elevation of reinforcement of piers P2 and P3 (1:250)

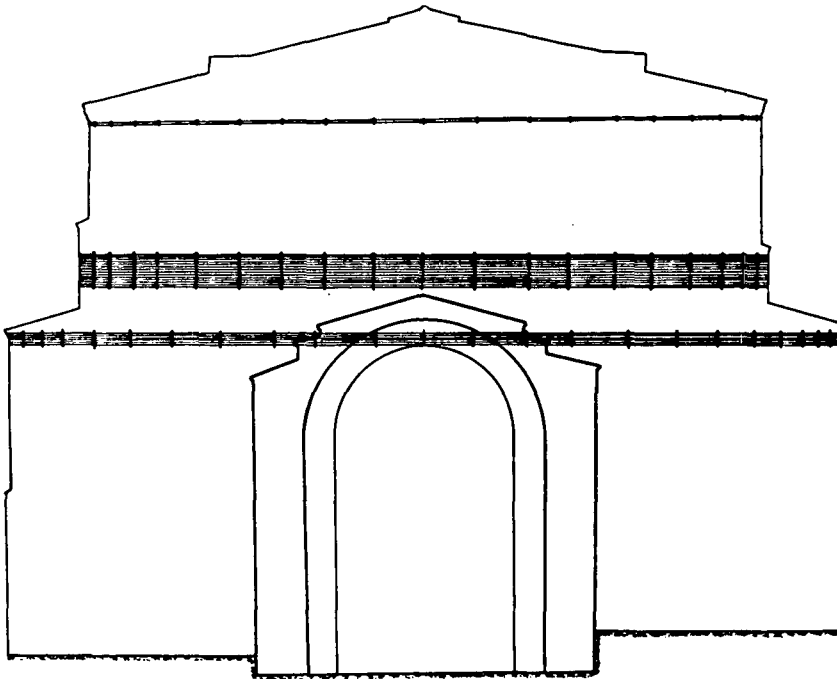
8.20 External elevation of permanent prestressed tie rings (1:250)

- the grouting of all cracks in the piers.
- the installation of permanent mild steel (ST 37) rings on the external face of the monument as shown in Figures 5.25 and 8.20. These rings should be protected by a lead coating. (This would be a reversible intervention, and mild steel was proposed because it would give greater ductility and because the age of the structure limited the risk of relaxation due to creep of the masonry.)
- the initial stressing of these rings to 50% of the final prestress, with the simultaneous removal of the temporary rings.
- the grouting of all radial cracks in the upper and intermediate masonry rings.
- the final stressing of the mild steel rings.

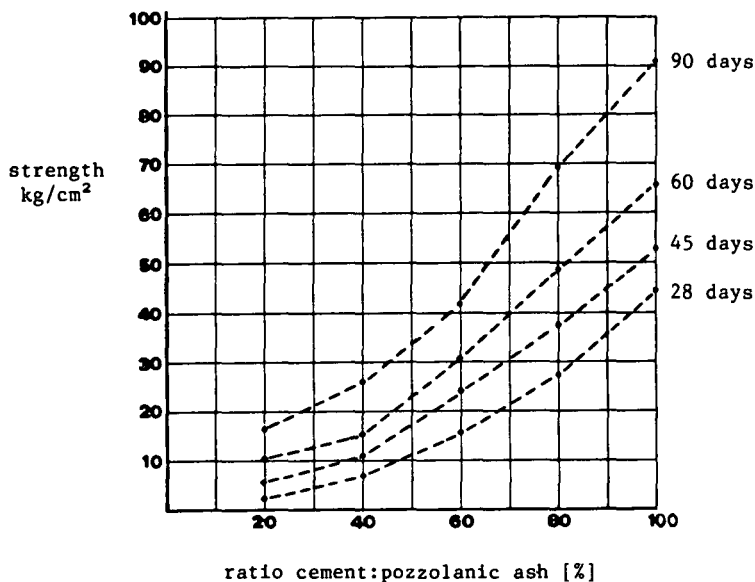
8.21 Typical variations of compressive strength of class III grouts

For each mix, specimens were prepared according to current specifications to determine bleeding and sedimentation, shrinkage, flexural strength, compressive strength, bond between bricks and grout, and modulus of elasticity. The strength tests covered periods of up to 9 months. Some results are shown below.

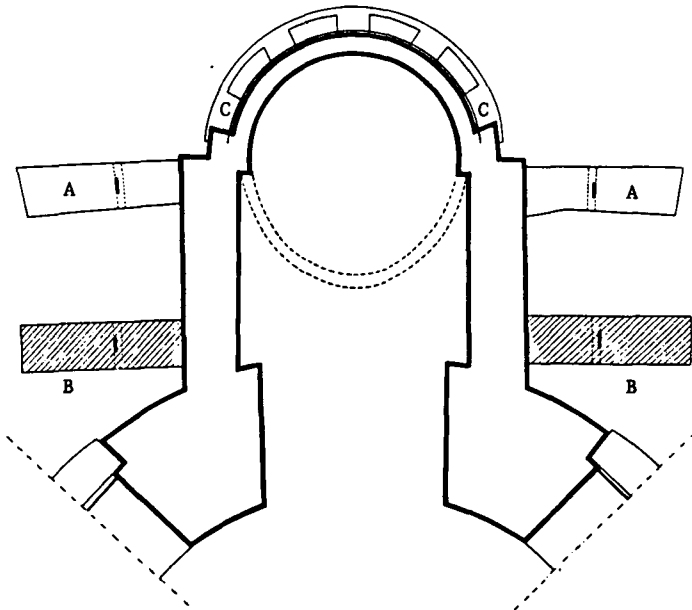
8.22 Proposals for strengthening the Christian part (1:250)

- the grouting of existing cracks.
- the installation of temporary transverse ties at the springing level of the vault.
- the strengthening of the existing flying buttresses (A,A below).
- the construction of an additional pair of flying buttresses (B,B below), or, as an alternative to this, the installation of permanent prestressed ties across the vault.
- the removal of the temporary ties.
- the grouting of any fresh cracks.
- the local strengthening of the apse by prestressed peripheral ties (C,C below).

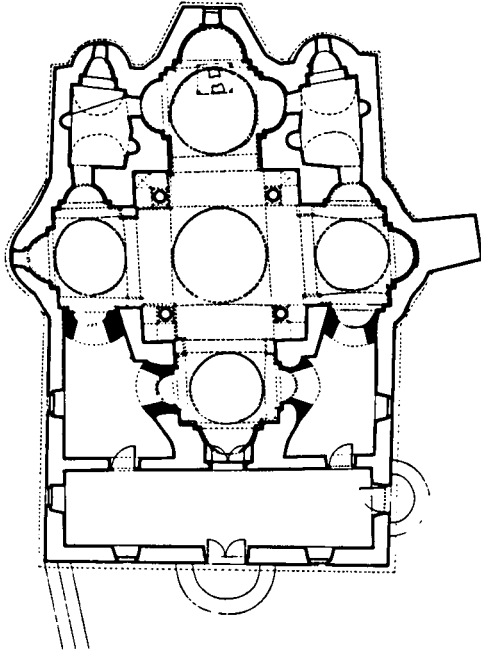
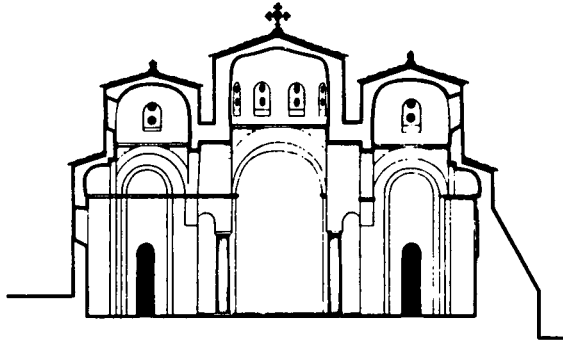
9.2 Plan and cross section looking east (1:200)

The main body of the church was built in about 870 AD, with a central dome and four slightly smaller domes around it over the arms of a cross, as seen in Figures 9.1 and 9.2. In 1915, a narthex was added at the west, and a buttress was built against the south arm of the cross at about the same time. The interior is frescoed.

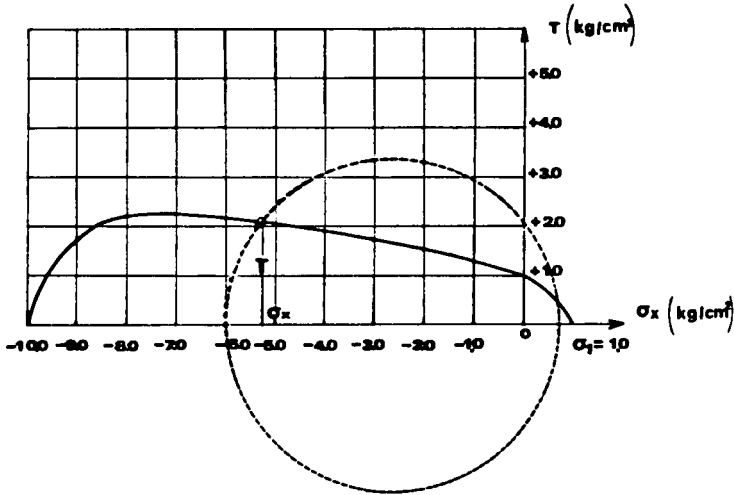
9.3 Strength of the masonry in combined shear and compression

Failure criteria for the cross sections of the piers and arches (CS I and CS II) were first plotted as interaction curves between moment (M) and direct force (N) (Figure 9.4c) and between direct stress (σ) and shear stress (τ) (Figure 9.3), derived on the following assumptions:

For response under seismic load, the same procedure is followed up to full service (gravity) load, and then continued with increasing horizontal load until a collapse mechanism forms. At each step of the analysis it is now necessary, however, to check that no shear failure will occur in the supporting system. This is done by means of the curve representing the ultimate strength of the masonry in combined shear and compression reproduced in Figure 9.3.

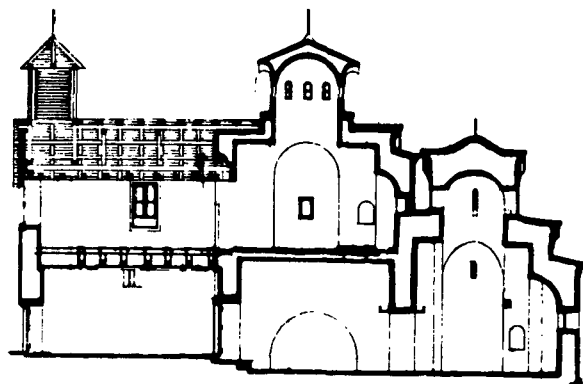
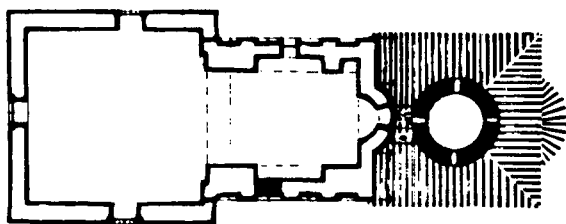
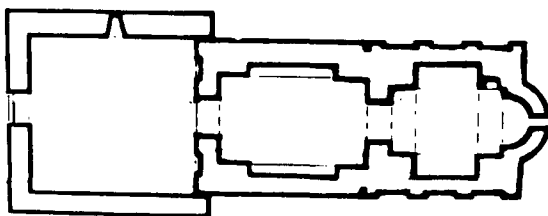
10.2 Longitudinal section and plans of the upper and lower levels (1:200)

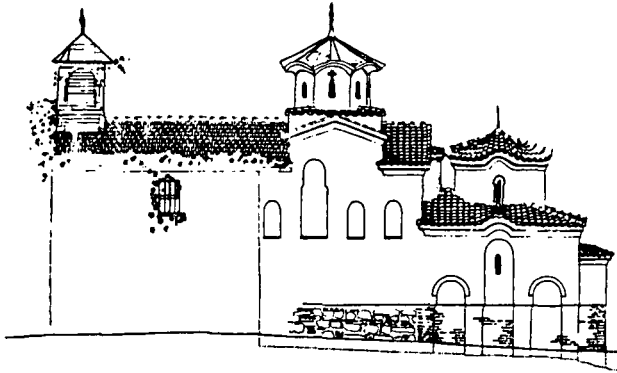
10.3 Elevation from the south (1:200)

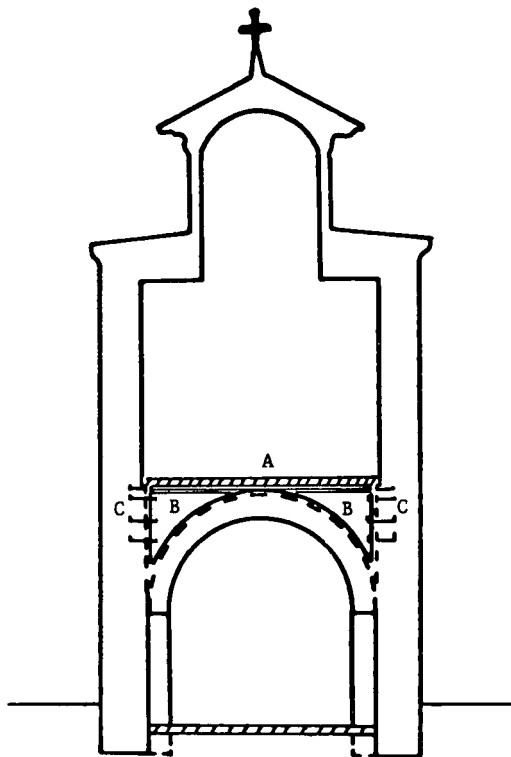
10.4 Diagrammatic transverse cross section through the Kaloyanic Church showing the new stiffening diaphragm (approximately 1:100)

This diaphragm (A in Figure 10.4) has vertical ribs (B,B in Figure 10.4) which follow the curve of the extrados of the vault, and is connected to the side walls by steel anchors (C,C in Figure 10.4).

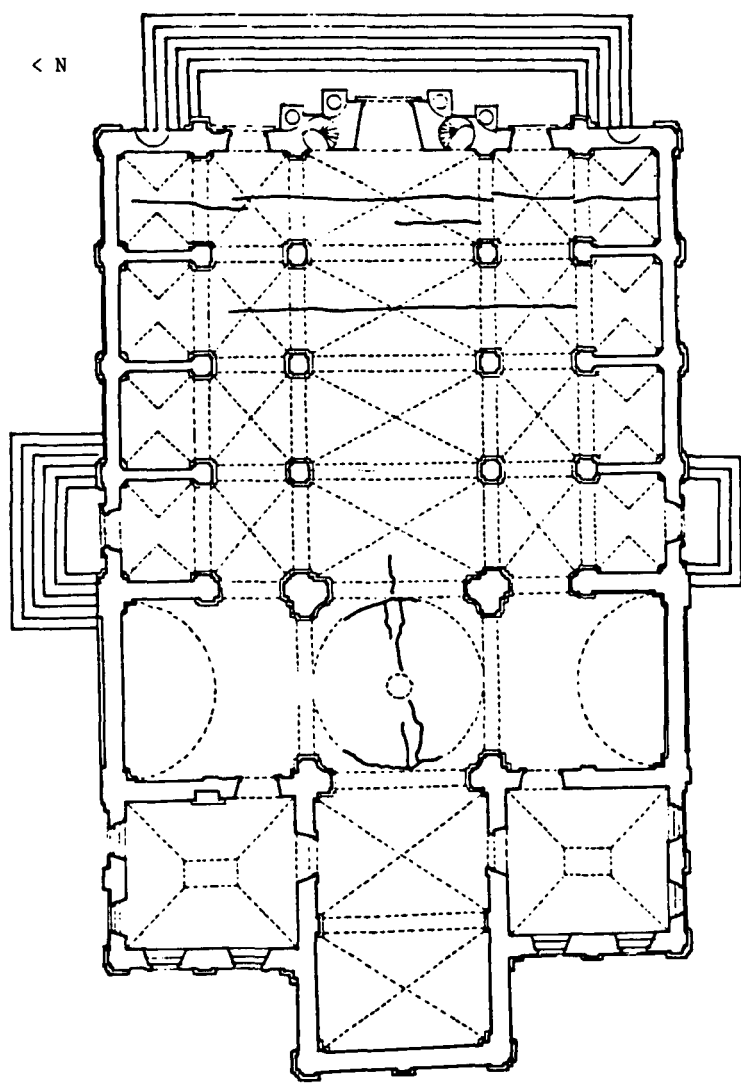
11.2 Plan showing cracking of the dome and other vaults (1:250)

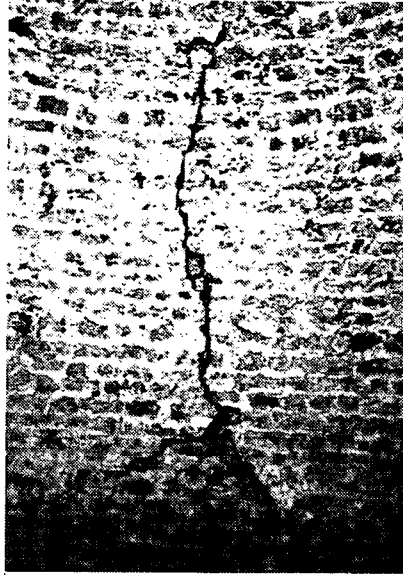
11.3 Cracking of the dome

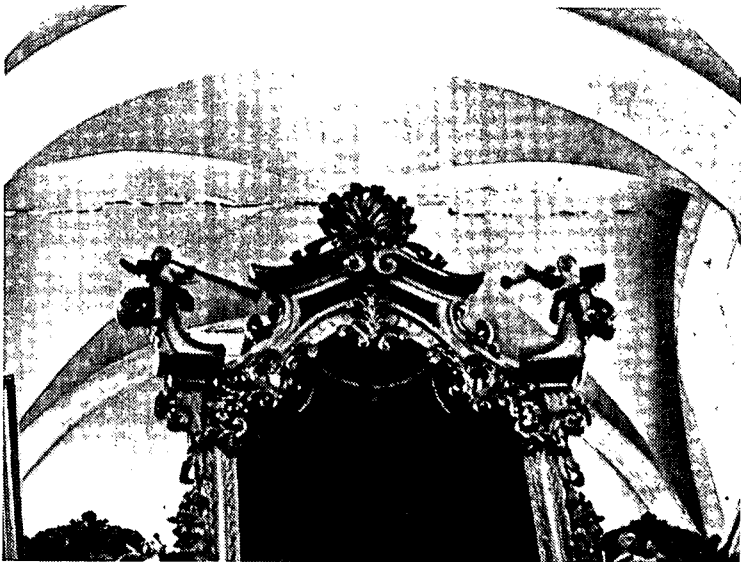
11.4 Cracking of the easternmost vault of the nave (looking east)

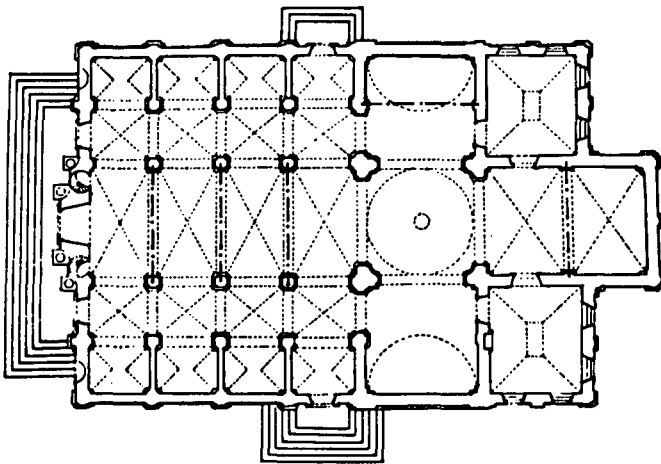
11.5 Existing high-level ties

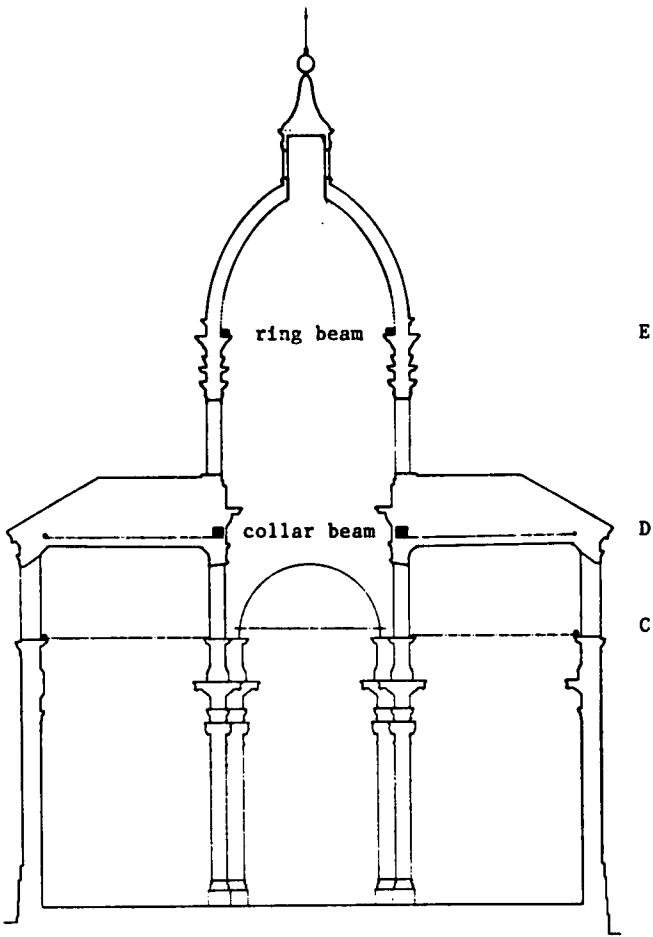
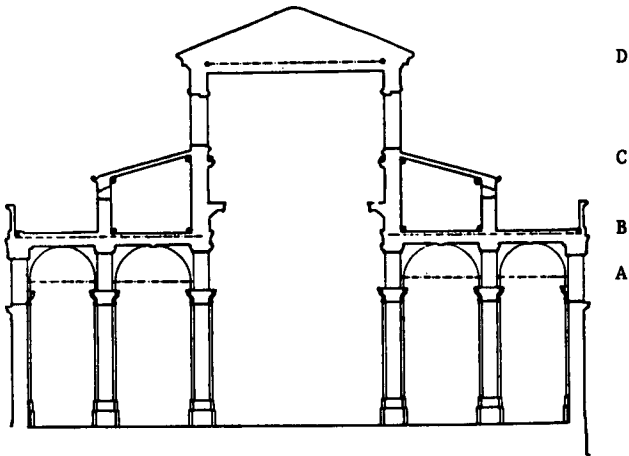
11.6 Transverse sections showing new ties and collar and ring beams (1:250)

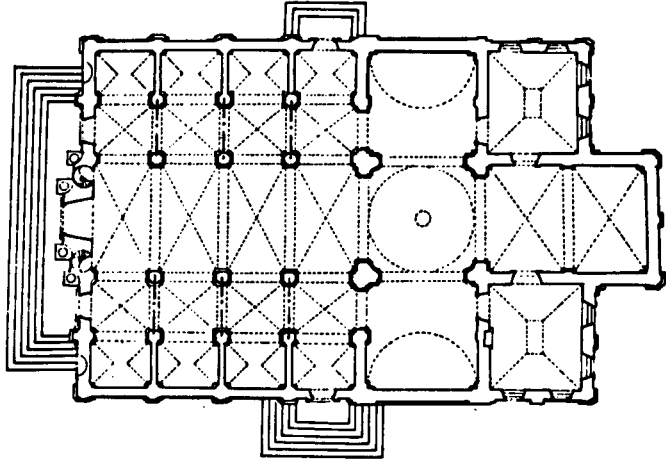
11.7 New ties at level A (1:400)

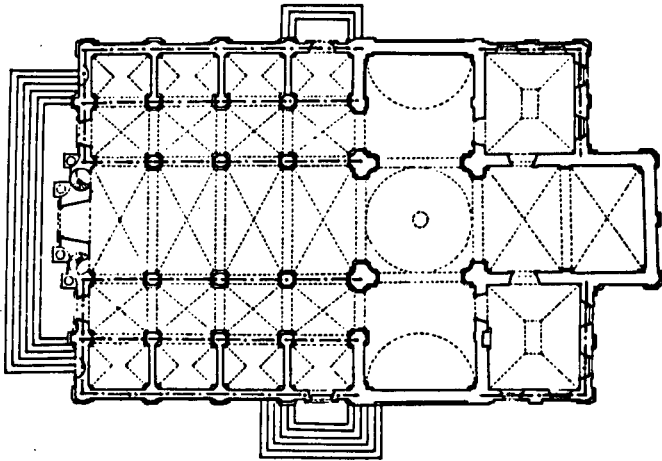
11.8 New ties at level B (1:400)

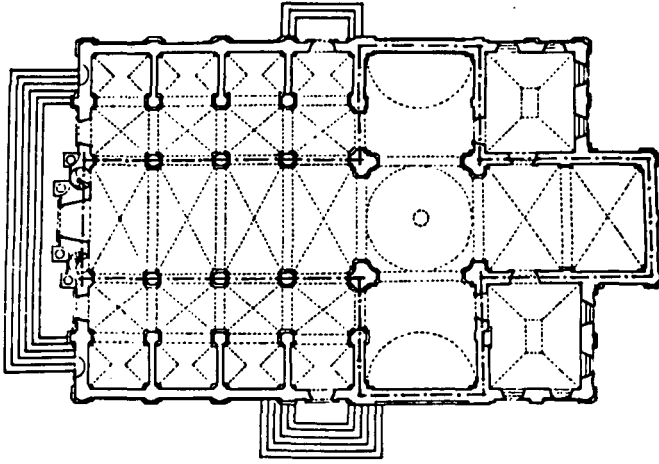
11.9 New ties at level C (1:400)

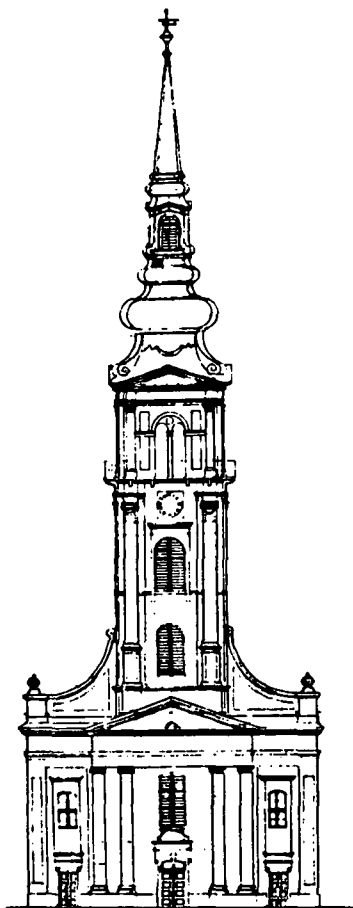
12.1 The entrance facade (1:400)

one end, the southwest. Over it rises a tower which, with its steeple, is 57 m high. In its lower part this tower, as seen in Figures 12.1 and 12.3, is much more massive in construction than the rest of the church, but there is no structural separation. The steeple is framed in timber, as is the single main roof of the church.

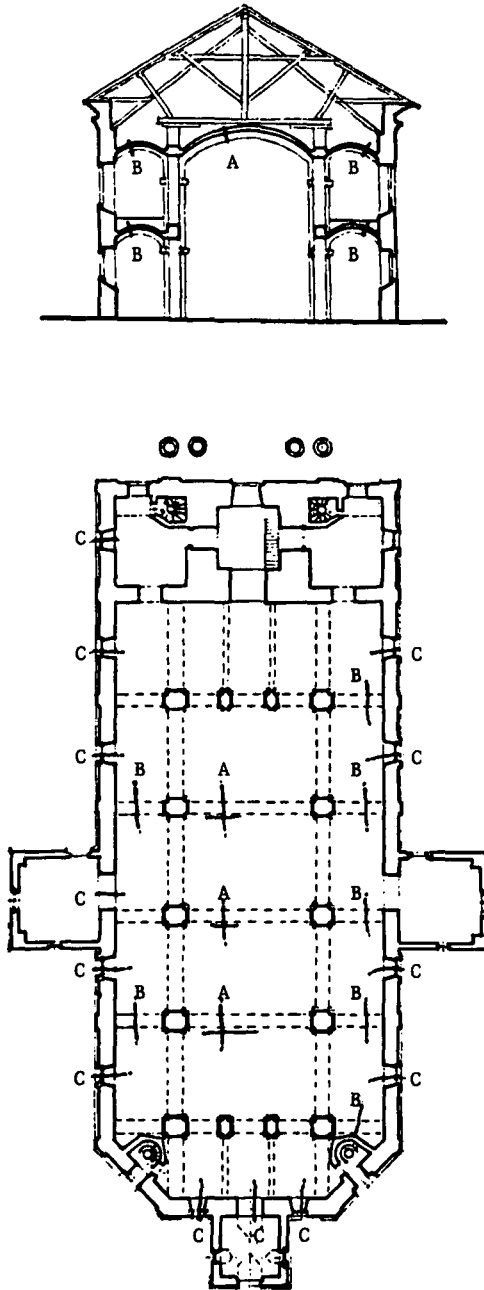
12.3 Transverse section and plan showing the principal cracks (1:400)

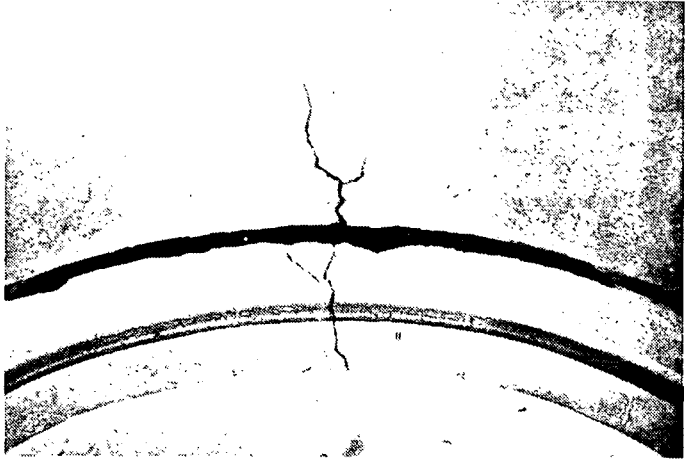
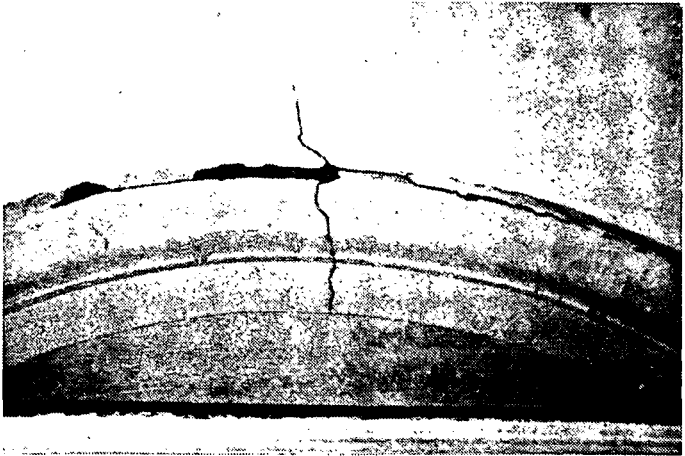
12.4 Cracking of the transverse arches and vaults of the nave

The main damage took the form of extensive cracking of the vaults, the supporting arches, and the upper parts of the side walls. This damage is summarised opposite and shown further in Figures 12.4 and 12.5. It was consistent with a predominant ground movement along the longitudinal axis of the church, as was the crack at ground level at the main entrance that is seen below. Crack widths at the upper levels were of the order of 10 mm, and diminished lower down.

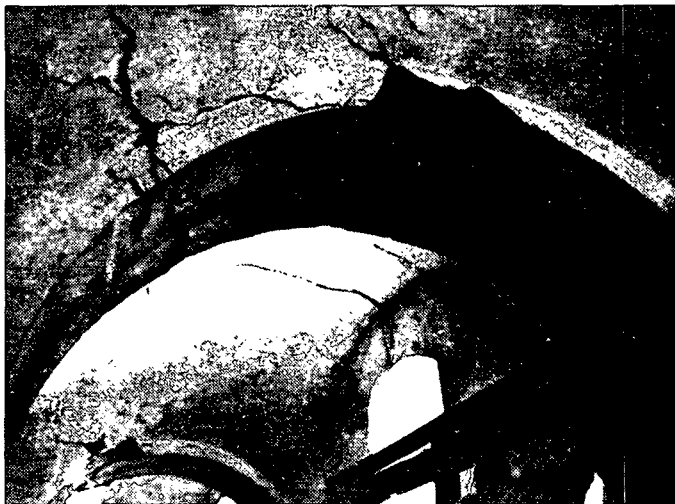
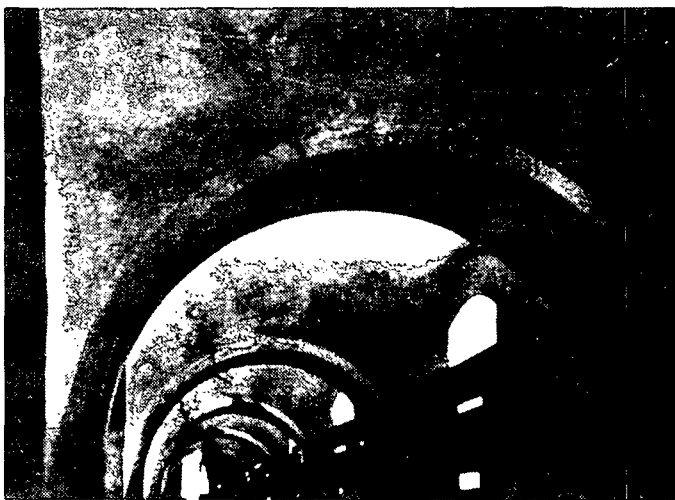
12.5 Cracking of the transverse arches and vaults of the side gallery

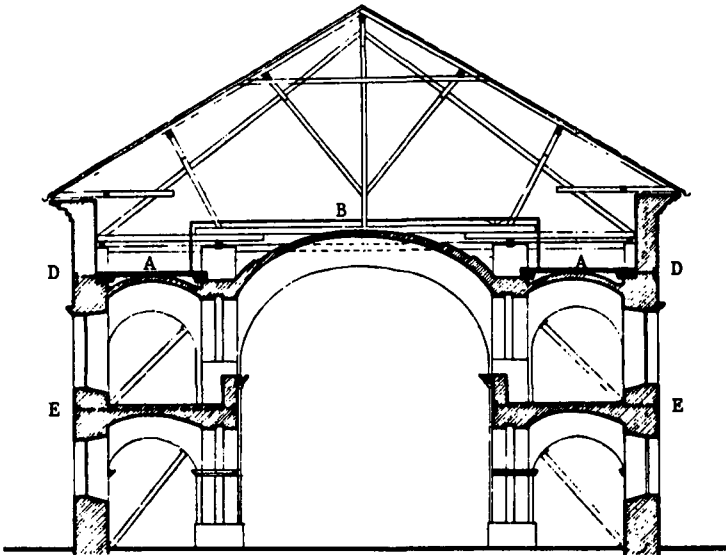
12.6 Transverse section (1:200)

The scheme adopted is illustrated in Figures 12.6 to 12.9. It comprised:

- a reinforced concrete slab, 100 mm thick, over the gallery vault at each side, marked A in Figures 12.6, 12.7 and 12.9.
- transverse reinforced concrete beams 1000 mm deep and 600 mm wide (400 mm wide at the entrance end) over the transverse arches carrying the vault of the main nave, marked B in Figures 12.6, 12.8 and 12.9, these beams being connected to the slabs just referred to over the gallery vaults.
- further reinforced concrete beams, 600 mm deep and 400 mm wide, marked C in Figure 12.9, to complete the horizontal ring system at this level.
- steel ties at approximately 1.8 m centres, marked D in Figures 12.6 and 12.9, to anchor the outer walls to this ring system.
- a second system of steel ties, marked E in Figures 12.6 and 12.7, at the

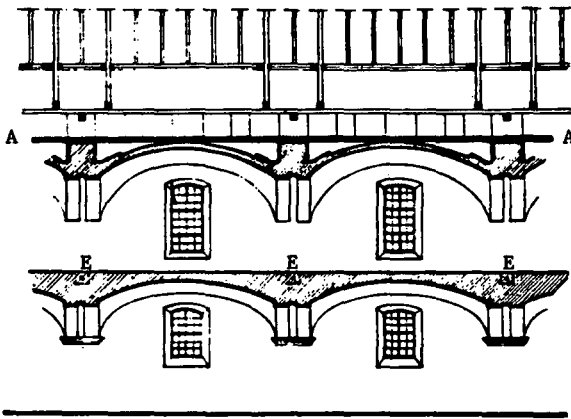
12.7 Detail of longitudinal section through side aisle and gallery (1:200)

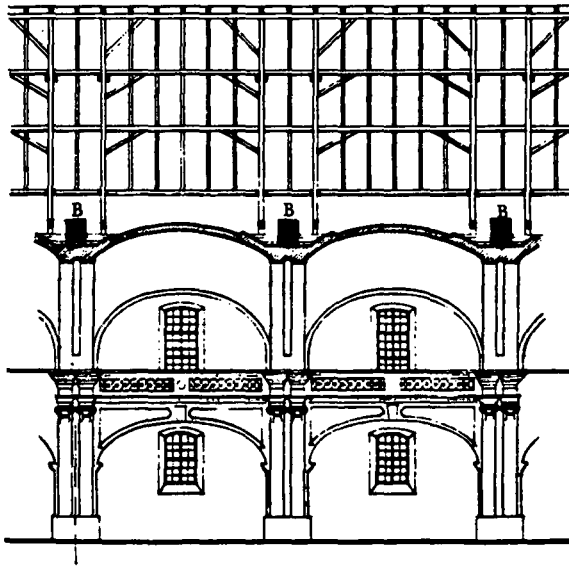
12.8 Detail of longitudinal section through the nave (1:200)

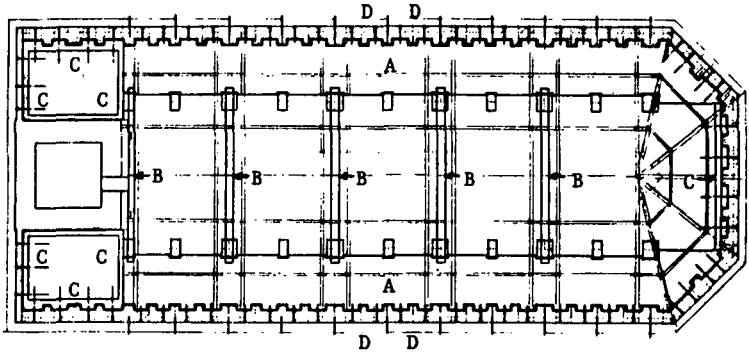
12.9 Plan at roof level (1:400)

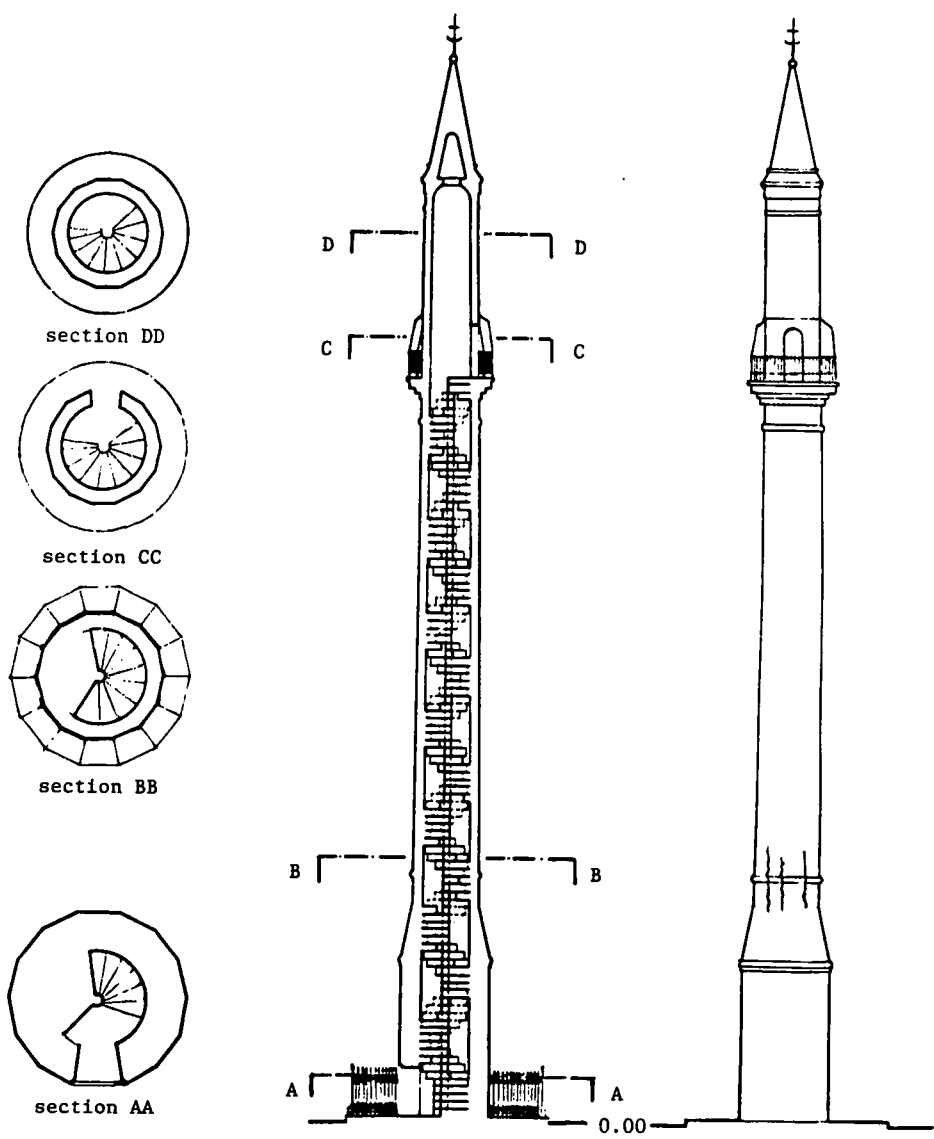
13.2 Plans, section, and elevation of the minaret before strengthening (1:200)

The minaret, before strengthening, is illustrated below and in Figures 13.2 and 13.3. It is 37 m high, with a circular muezzin's balcony at the +25.54 m

The principal damage visible in 1970 was series of vertical cracks around the whole circumference of the lower part of the tower. Though hardly discernable in Figure 13.3, they are indicated in the elevation at the right of Figure 13.2.

A precise survey, from which Figure 13.2 is taken, indicated no deviation from the vertical.

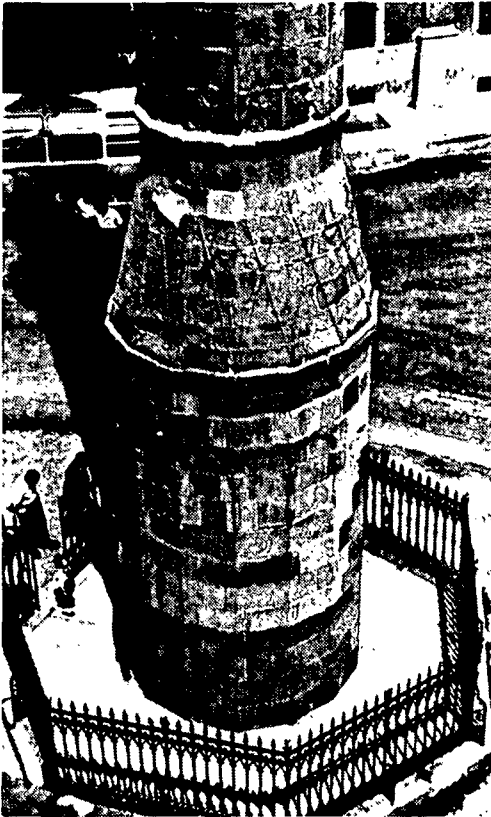
13.3 View of the base in 1970

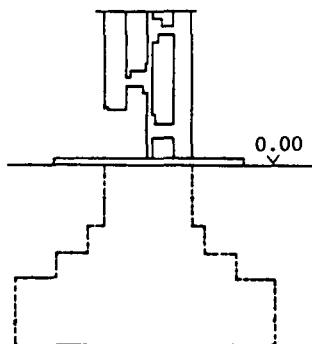
13.4 Assumed cross section of the foundation (1:200)

The form of the foundation that was assumed for purposes of calculation is shown below.

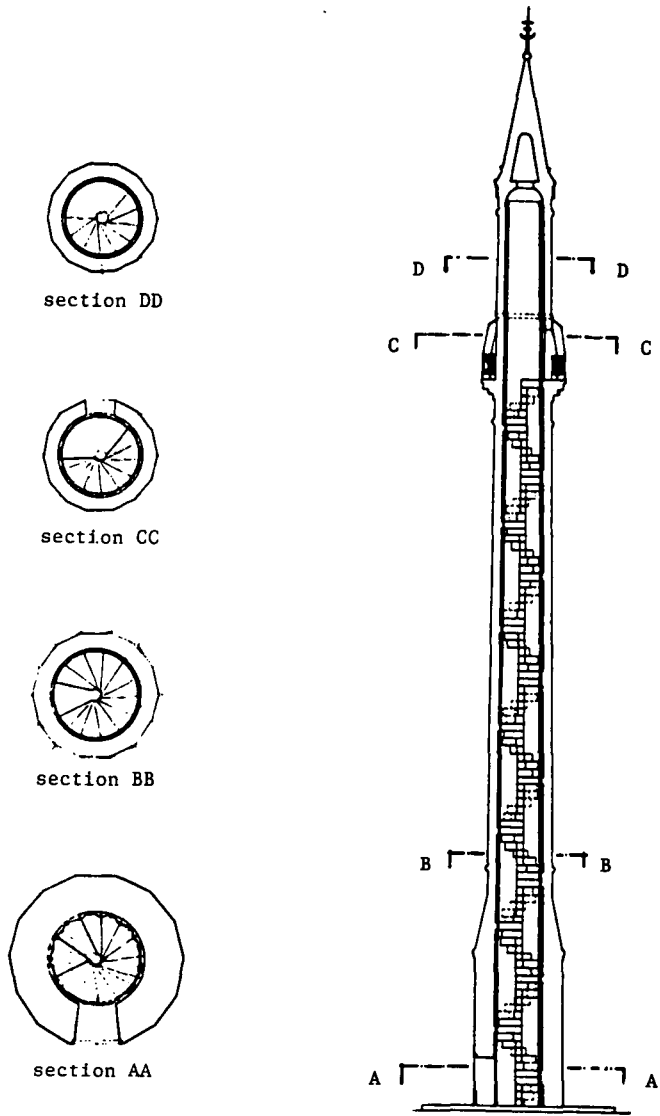
13.5 Plans and vertical section of the minaret after strengthening (1:200)

A skin, 60 mm thick, was constructed over the whole internal surface of the tower wall, as shown in Figure 13.5.

Grade C28 concrete was used, and was pumped in place. It was reinforced with 20 mm and 22 mm vertical steel bars and 8 mm helical bars following the ascending stair. The vertical reinforcement was made continuous by thread-bars through 30 mm holes drilled in the stairs close to the wall, and by ensuring adequate laps of successive lengths of bar.

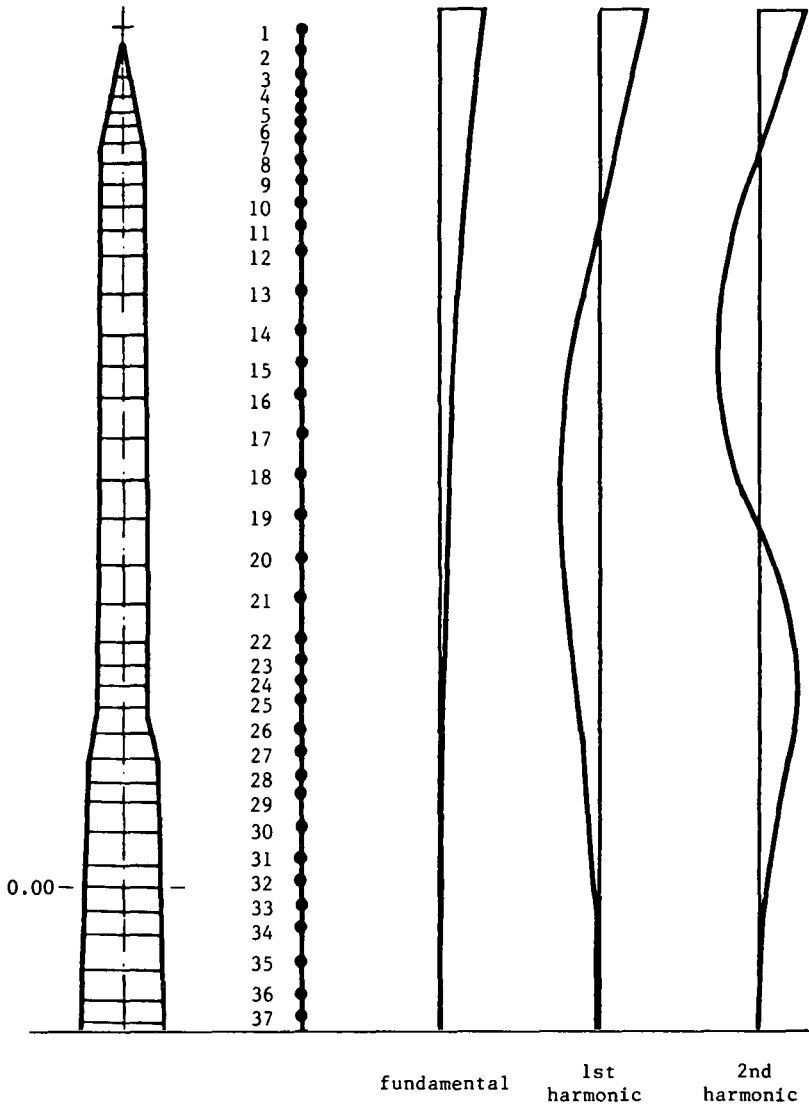
13.6 Structural model and first three mode shapes

The mass of the structure was assumed to be concentrated at 38 points, as shown in Figure 13.6, and the stiffness of the foundation was represented by horizontal, vertical, and rocking springs at ground (0.00) level. The elastic modulus of the masonry was taken as 16000 MN/m², and damping was neglected. Necessary integrals were calculated by Simpson's rule.

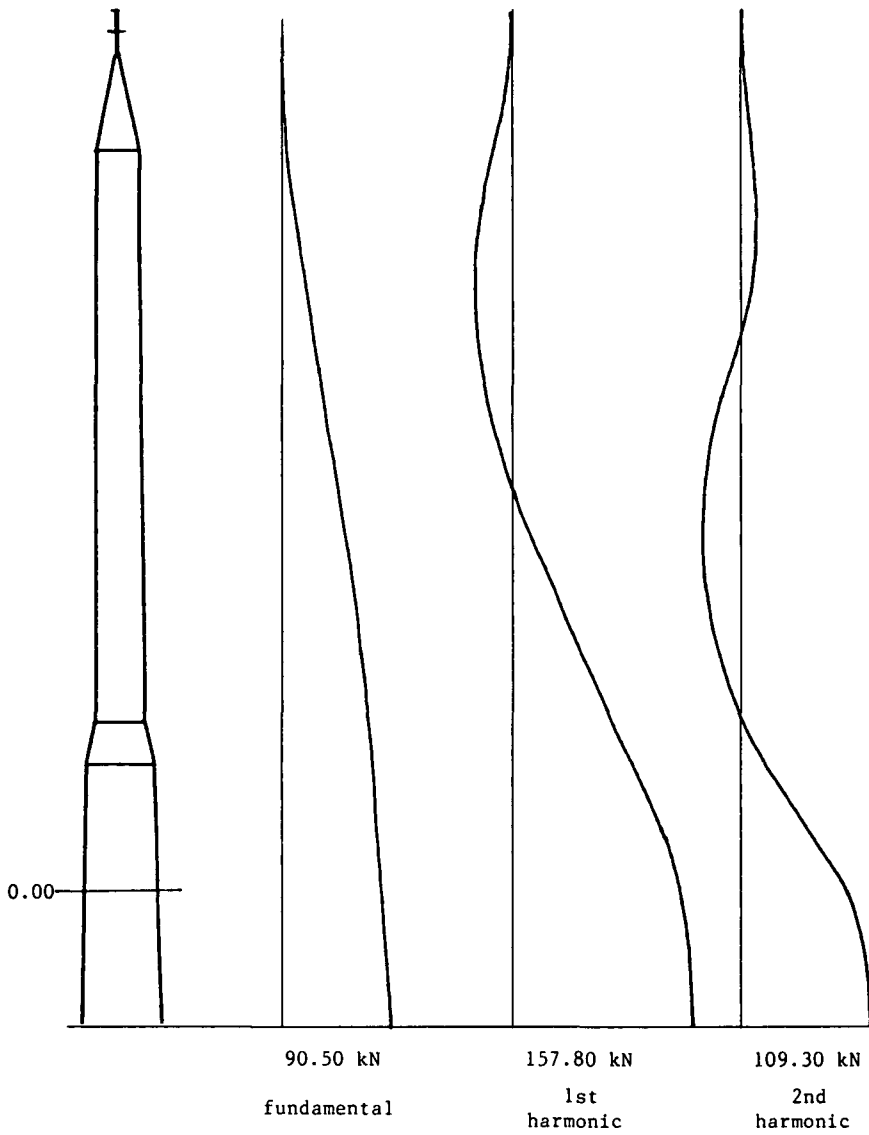
13.7 Modal seismic shear forces in the unstrengthened state
(1 cm = 50 kN)

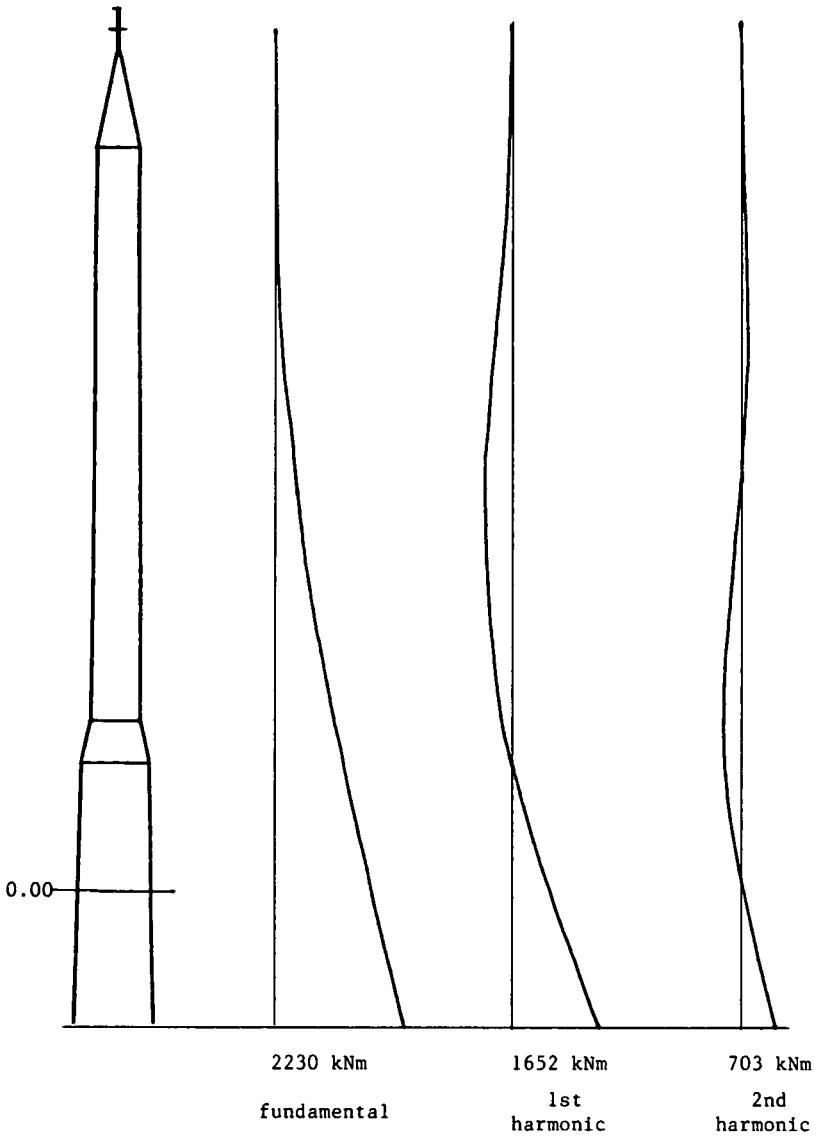
13.8 Modal seismic moments in the unstrengthened state
(1 cm = 1000 kNm)

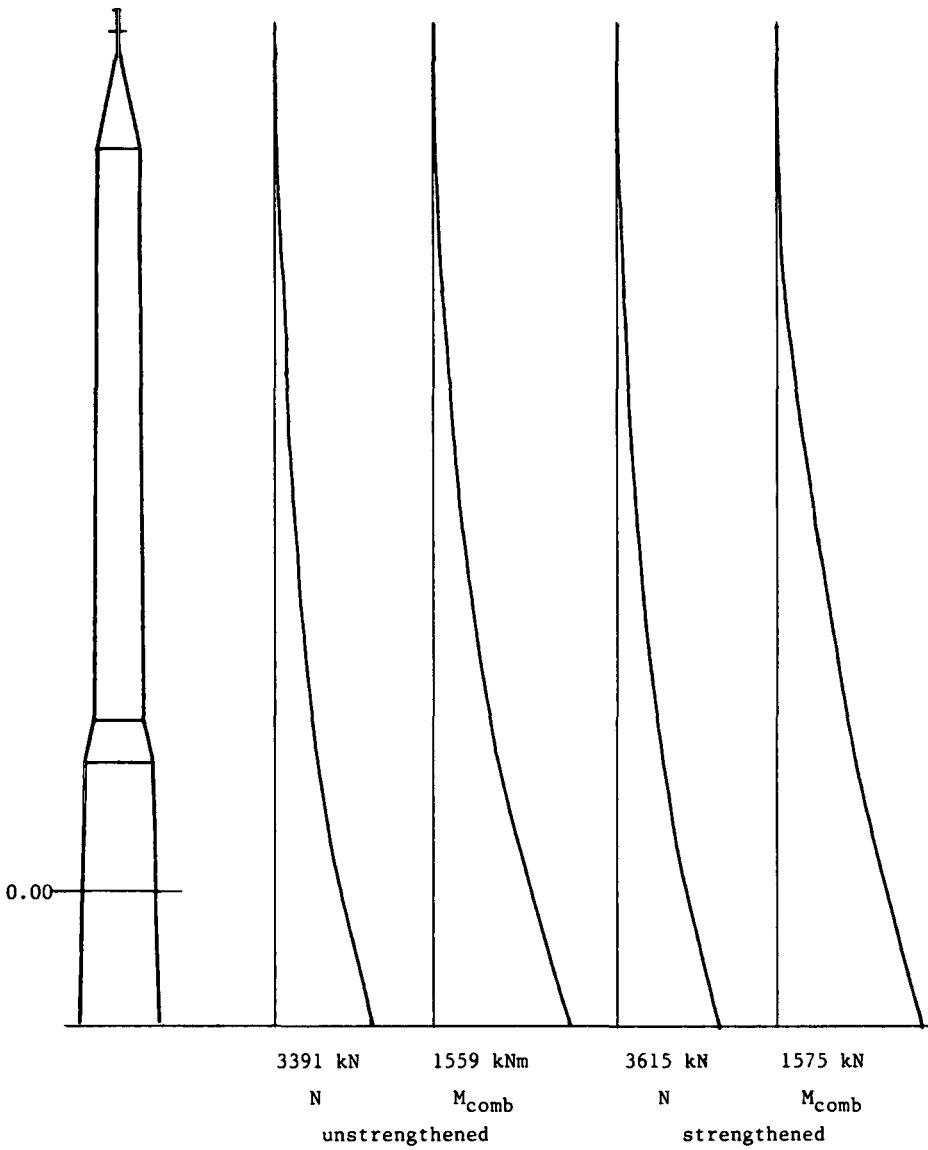
13.9 Normal forces and combined seismic moments in both states
(1 cm = 2000 kN or 1000 kNm)

Combined moments for both unstrengthened and strengthened states are plotted in Figure 13.9, together with the corresponding normal forces.

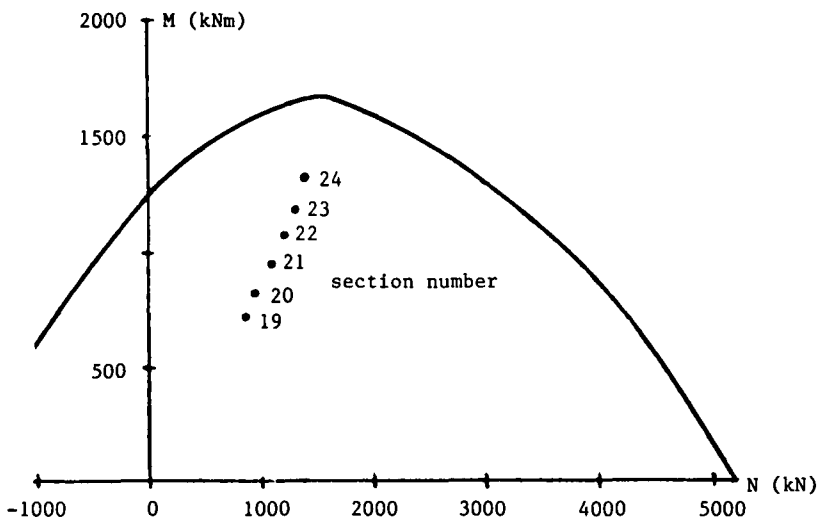
13.10 Ultimate bearing capacity and safety of the cylindrical portion after strengthening

For the assumed intensity of MSK VII, the unstrengthened structure was again found to have been unsafe, whereas the strengthened structure was safe. As shown below, the moments in the critical sections in the lower part of the main cylindrical portion are well within the ultimate bearing capacity after strengthening.

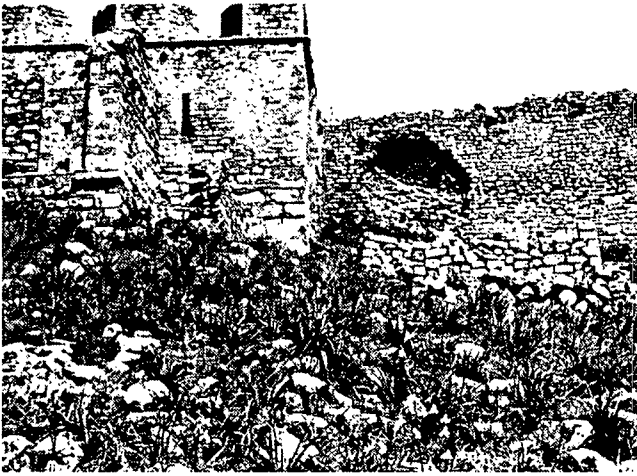
14.2 Damage initiated by gunfire, Castle of Acrocorinth

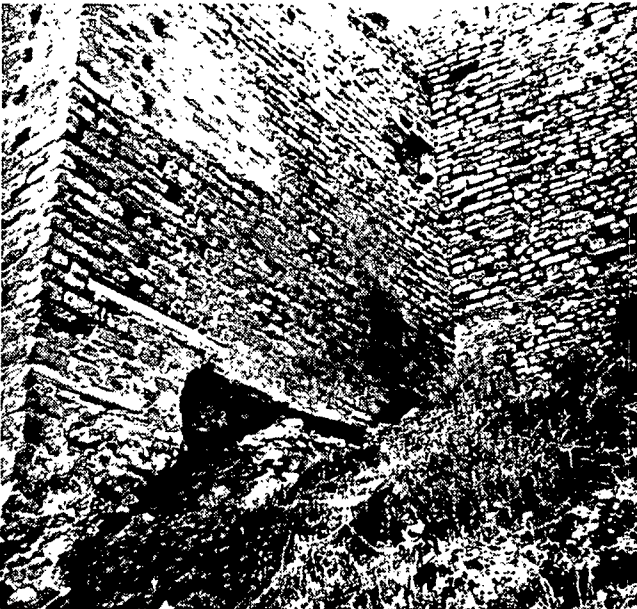
14.3 Partial erosion of foundation, Castle of Acrocorinth

Soil erosion can reduce or partly remove the support at the base of a wall. In the case illustrated in Figure 14.3, some of the support has been removed in this way and the wall above has been left bridging over the gap between rock outcrops on which the adjacent sections of wall stand. In Figure 14.4, a potentially dangerous situation is shown in which erosion alongside the outer face of the wall has laid bare the foundation courses on this side (Figure 14.4b), while the ground level on the inside has risen considerably and created earth pressures tending to overturn the wall.

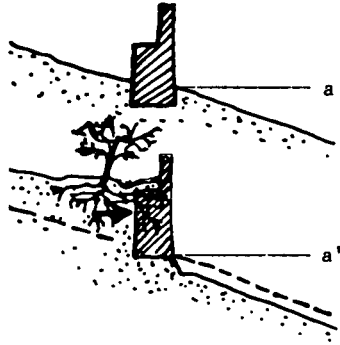
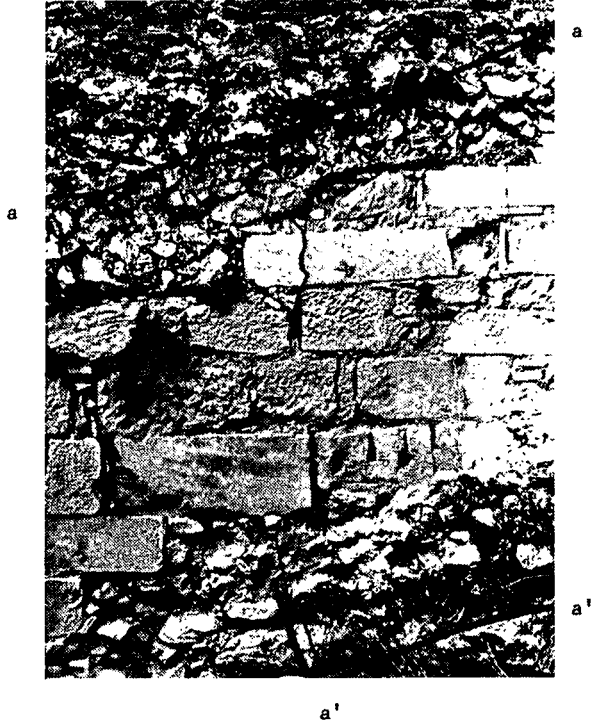
a Original and subsequent states

b Foundation laid bare on the outer face

14.4 Castle of Levadhia

Because defence walls stand in the open, they are more prone than other structures to damage by the roots of growing vegetation, particularly in situations like that shown in Figure 14.4a, and in situations where poor drainage leads to dampness and local erosion of the facings.

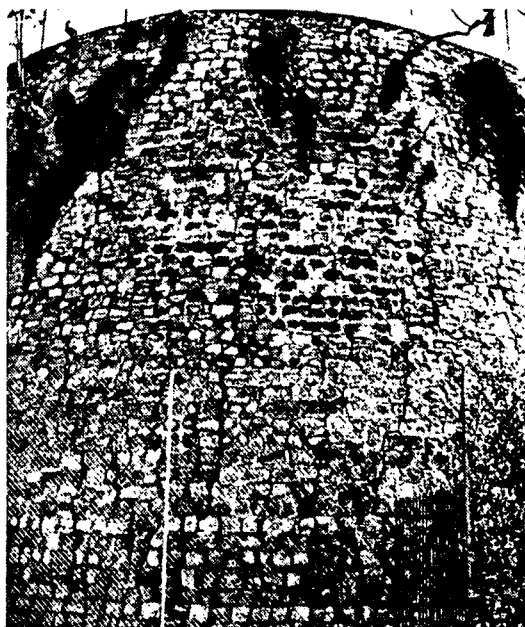
14.5 Castle of Heraklion

Other damage has been caused by differential settlements. Figure 14.5 shows numerous vertical cracks caused by differential settlement of the soft sedimentary underlying soil.

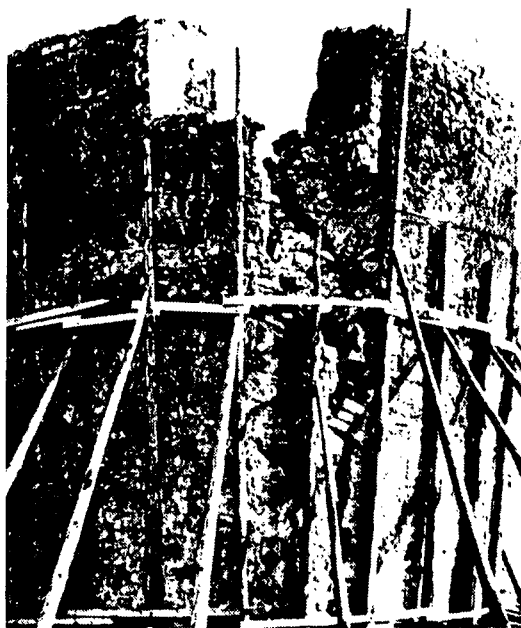
14.6 Tower in the Budva defence wall

Instances may be seen in Figures 14.6 and 14.7. There was almost certainly pre-existing vertical cracking of the tower in Budva, while the damage in the castle of Skyros was largely due to movement of the subsoil. It is also probable that the collapsed overhanging section of the tower seen in Figure 3.87 was of later date than the wall below.
