BUILDING CONSTRUCTION
UNDER SEISMIC CONDITIONS
IN THE BALKAN REGION

REPAIR
AND STRENGTHENING
OF HISTORICAL
MONUMENTS
AND BUILDINGS
IN URBAN NUCLEI

UNDP/UNIDO PROJECT RER/79/015

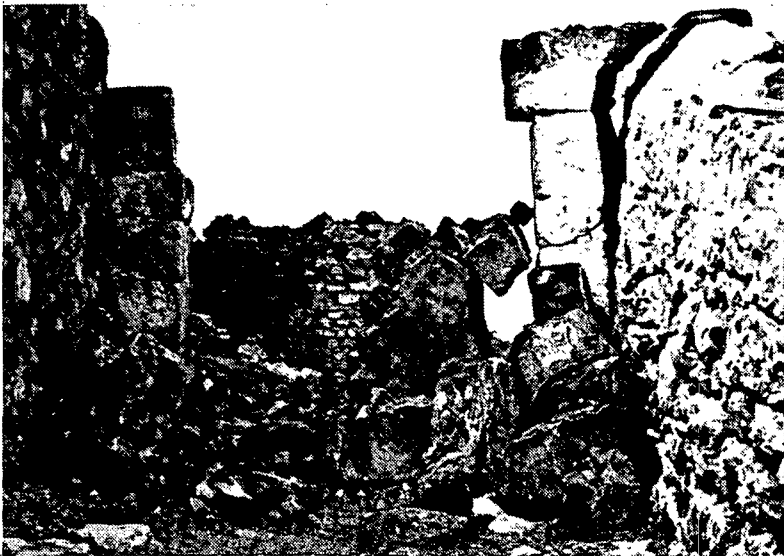
14.7 Castle of Skyros

Instances may be seen in Figures 14.6 and 14.7. There was almost certainly pre-existing vertical cracking of the tower in Budva, while the damage in the castle of Skyros was largely due to movement of the subsoil. It is also probable that the collapsed overhanging section of the tower seen in Figure 3.87 was of later date than the wall below.

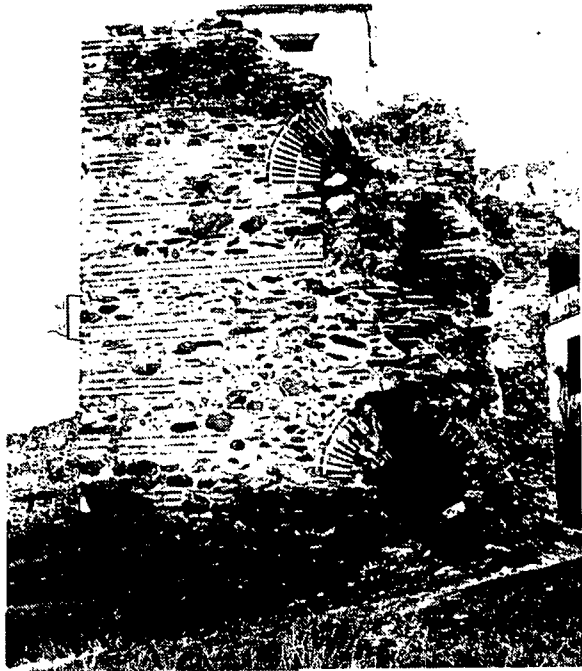
14.8 Tower 15 before and after repair, Thessaloniki

As with other types of structure, the best safeguard against future damage is possibly good maintenance, for which some permanent arrangement is, in this case, particularly desirable. Such an arrangement does already exist in some places. Figures 14.8 to 14.10 illustrate recent repairs of the walls of Thessaloniki after the 1978 earthquake by the group responsible for their conservation.

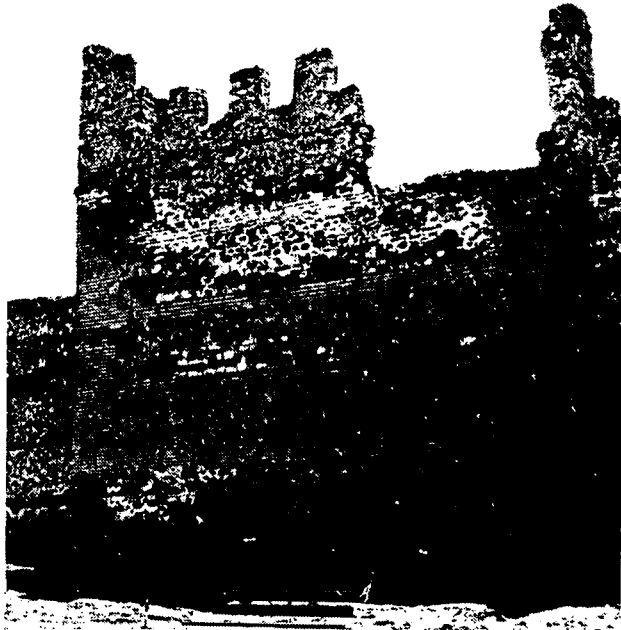
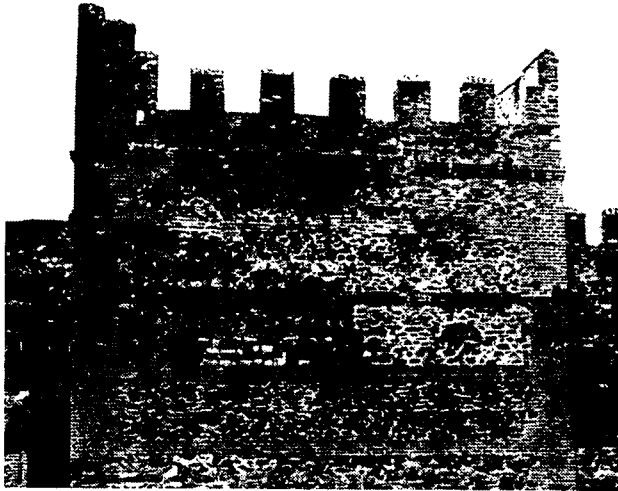
14.9 Tower 27 before and after repair, Thessaloniki

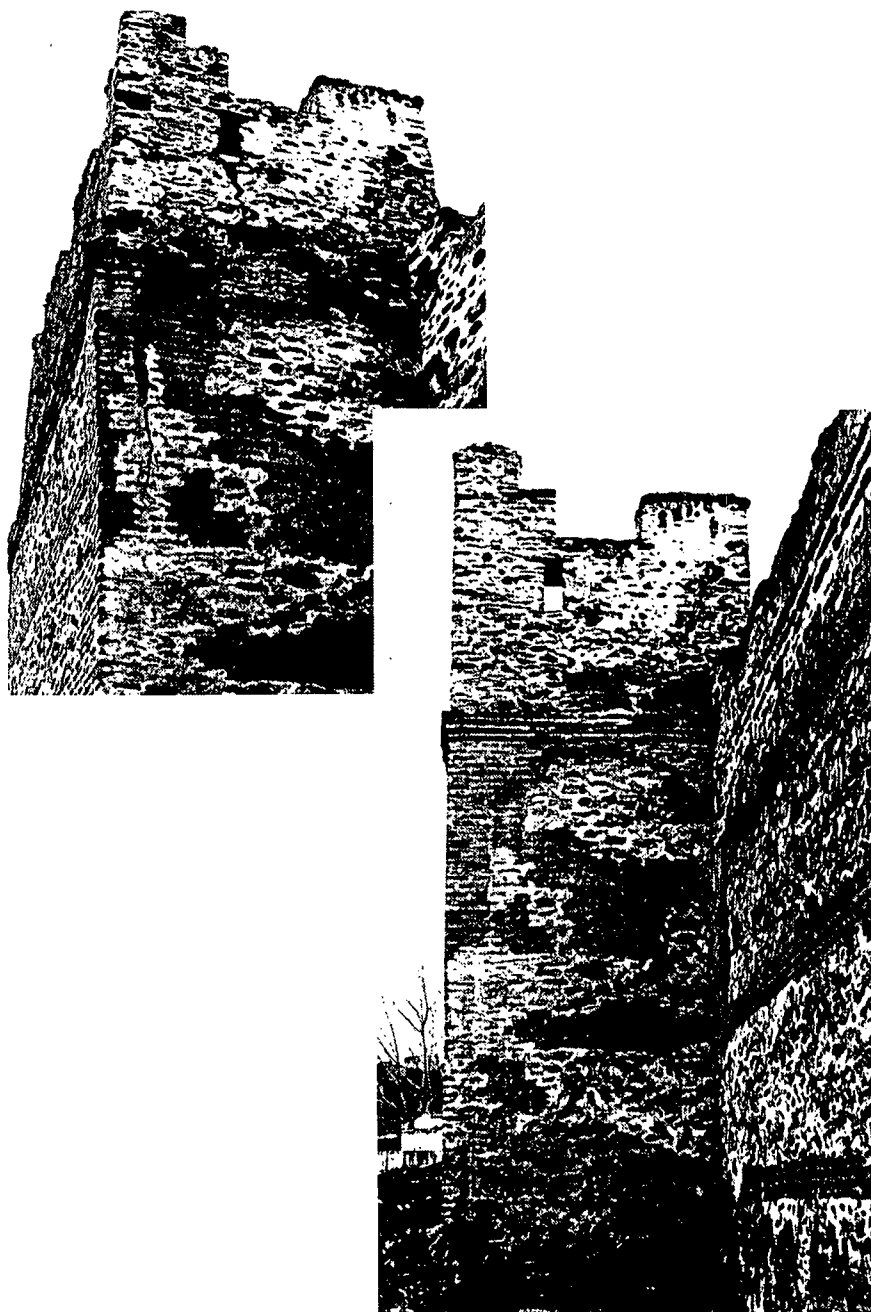
14.10 Tower 33 before and after repair, Thessaloniki

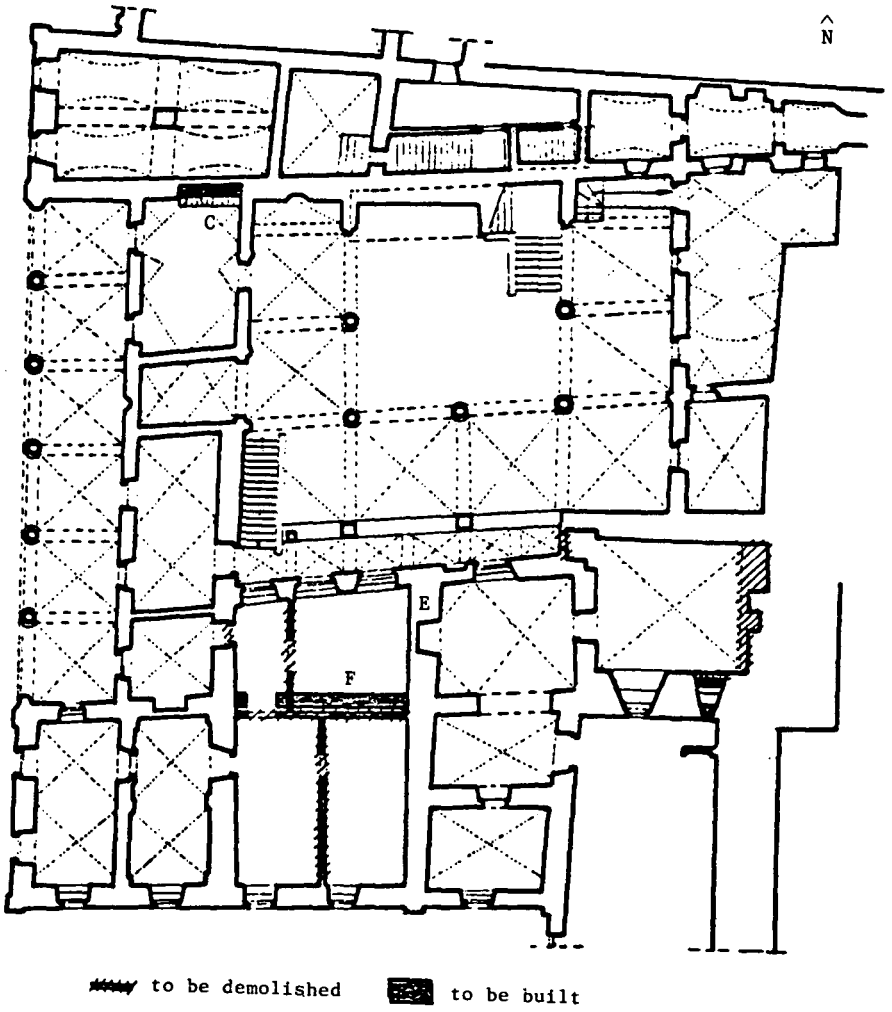
15.3 Mezzanine plan showing demolitions and new constructions
(1:250)

The layout at ground level, seen opposite, remained sound in general, with strong cross and longitudinal walls and mainly solid floors but with some weakness introduced by the open colonnade of the west front. At mezzanine level (Figure 15.3) however, a heavy wall marked E stood on a vault below in place of the ground level walls marked A and B, and the spine wall of the south wing was missing at F. The south wall of the north tower was also weakened by a cutting for a stairway at C.

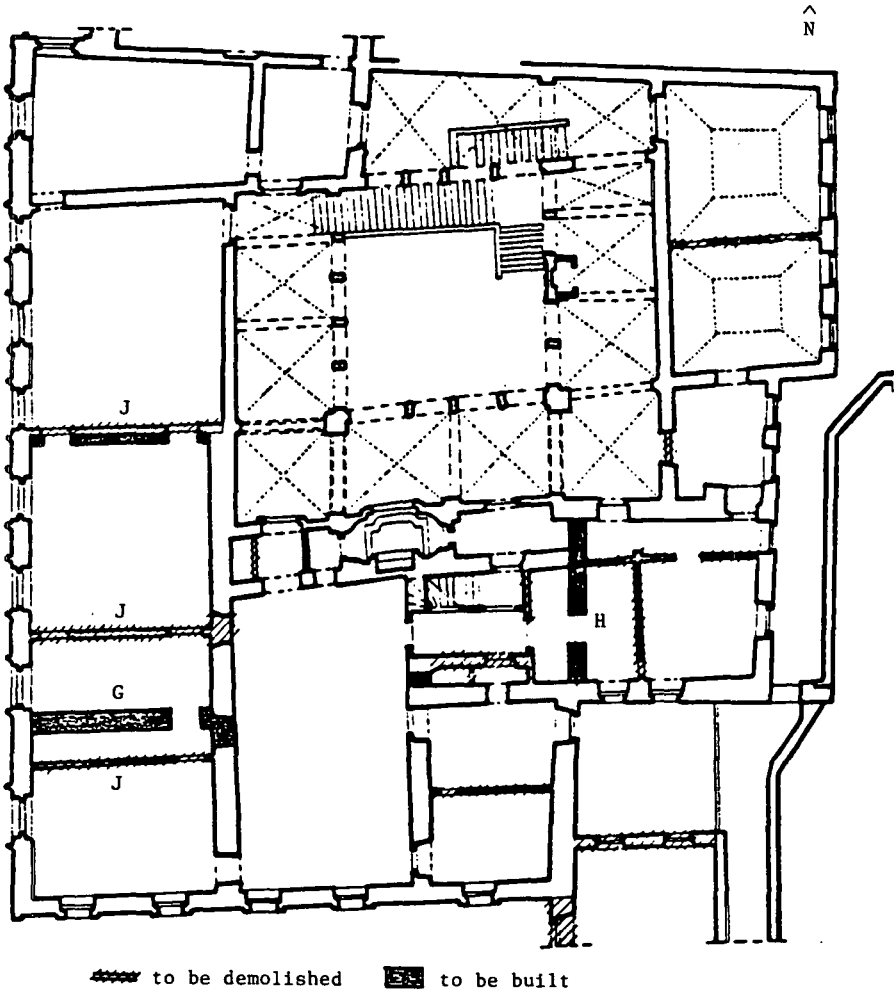
15.4 First floor plan showing demolitions and new constructions
(1:250)

The construction of new stone walls was planned at C and D at ground level (Figure 15.2), at F and C at mezzanine level (Figure 15.3), and at G and H at first floor level (Figure 15.4). The new walls would be connected to the existing walls by steel anchor bars proportioned to resist seismic shear forces. Some partitions and some internal brick facing walls that had been added previously to cover areas of surface dampness would, at the same time, be removed as indicated in the same figures.

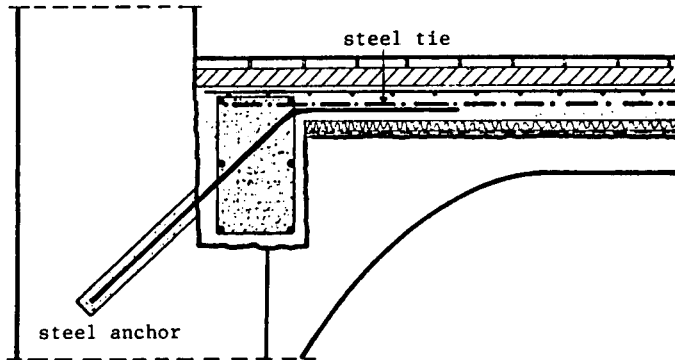
15.5 Anchorage of a horizontal diaphragm in the wall masonry

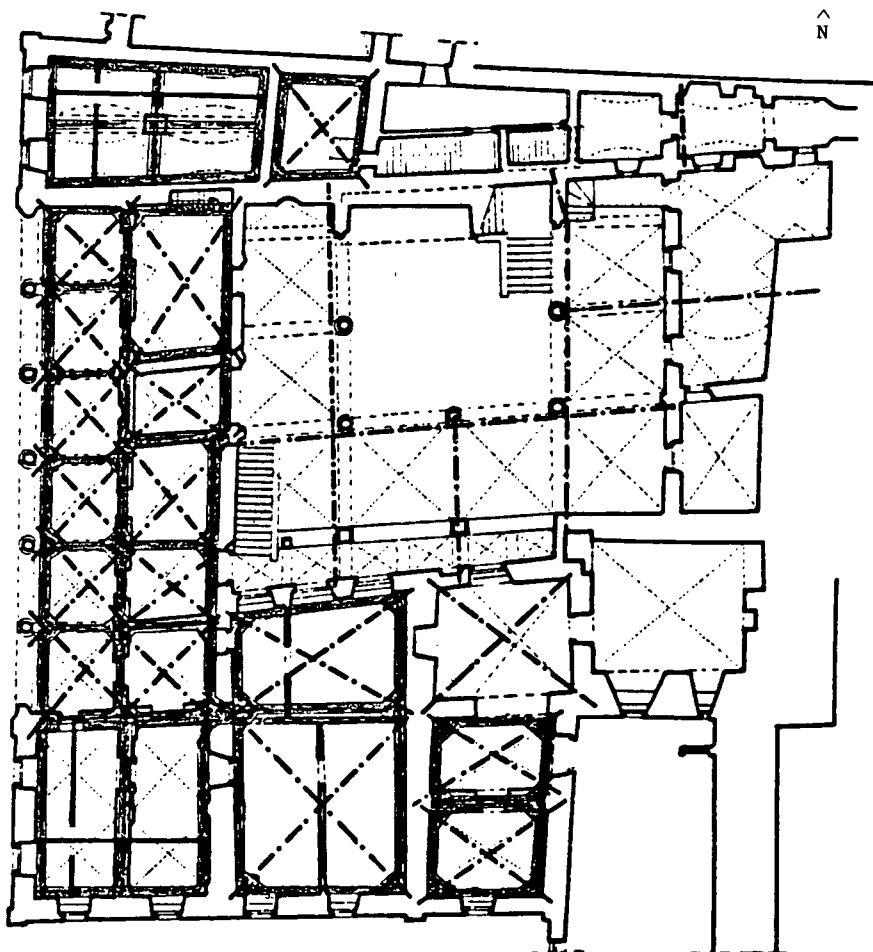
15.7 First floor plan showing new ties and diaphragm beams
(1:250)

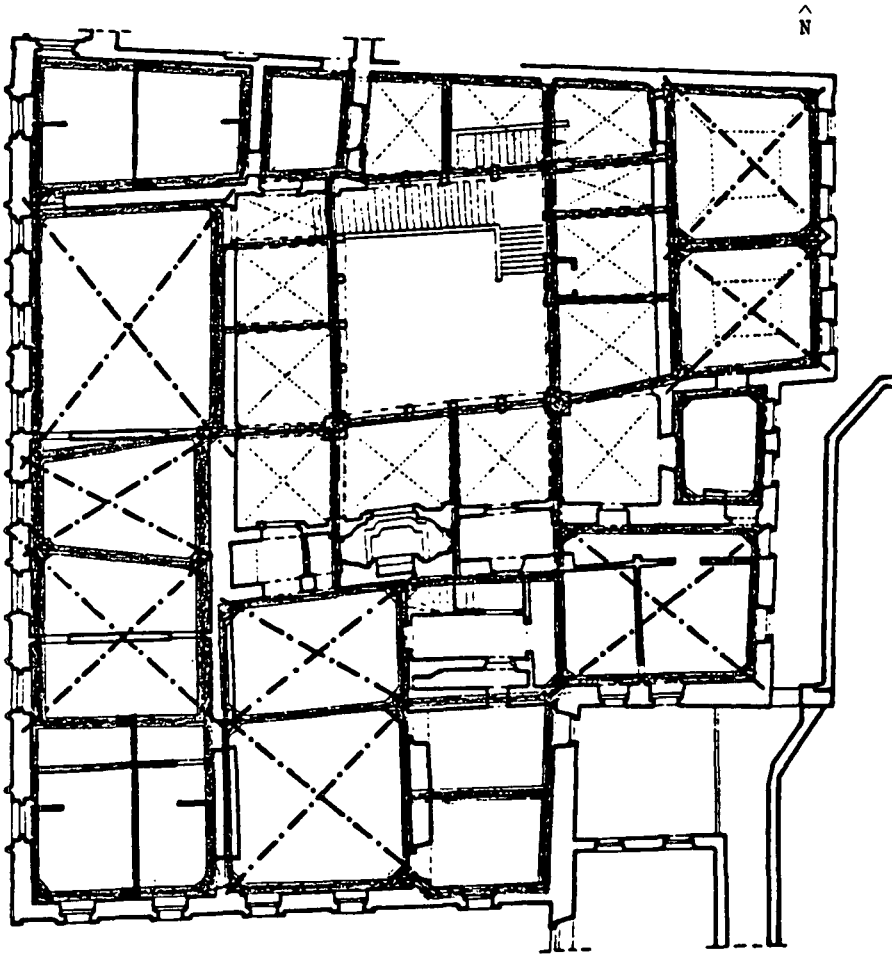
15.8 Second floor plan showing new ties and diaphragm beams
(1:250)

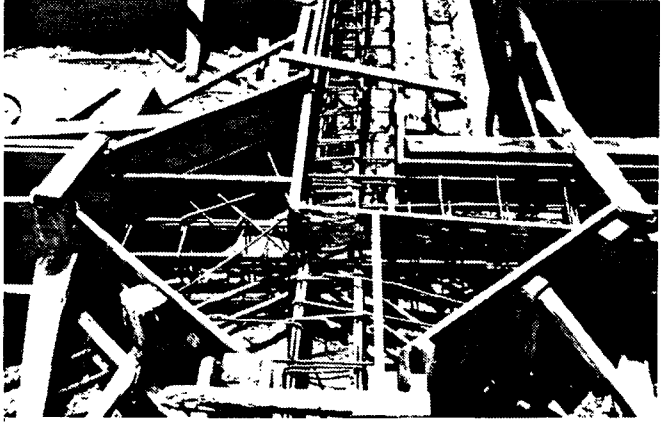
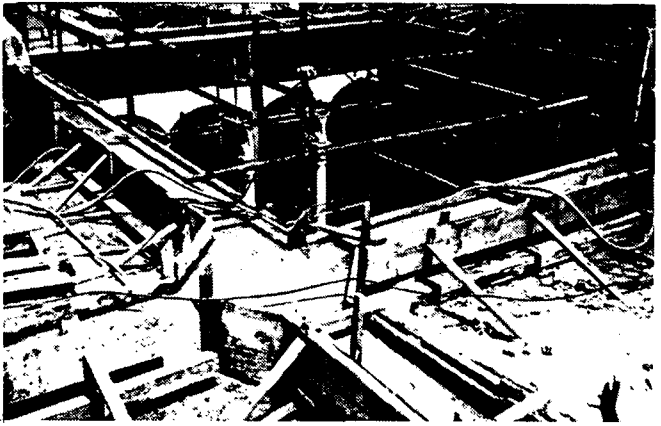
15.9 Details of the second floor diaphragm under construction

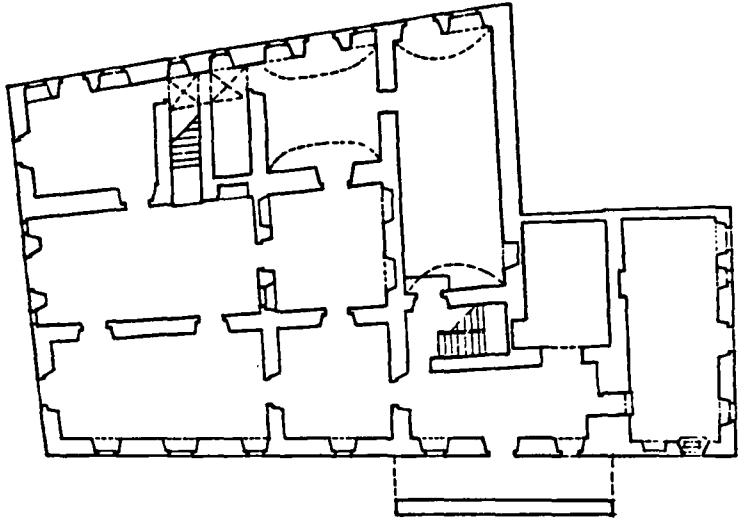
16.2 Ground plan (1:250)

The main building, seen below and towards the left of Figures 16.2 and 16.3, was constructed in the 18th century. It is of three storeys plus a basement.

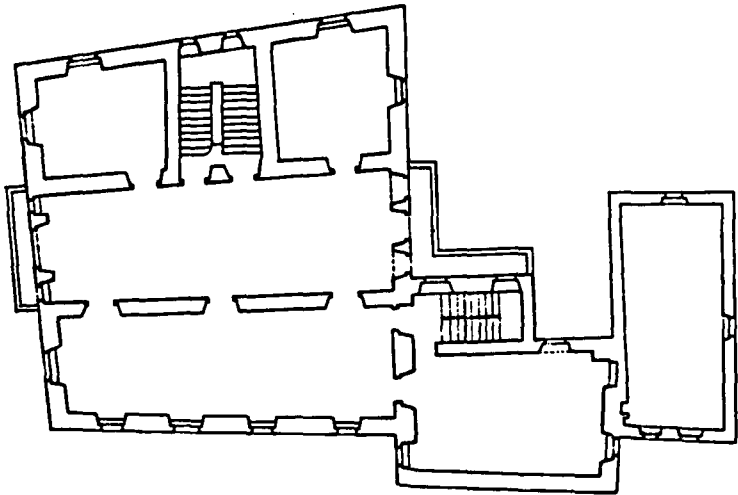
16.3 Second floor plan (1:250)

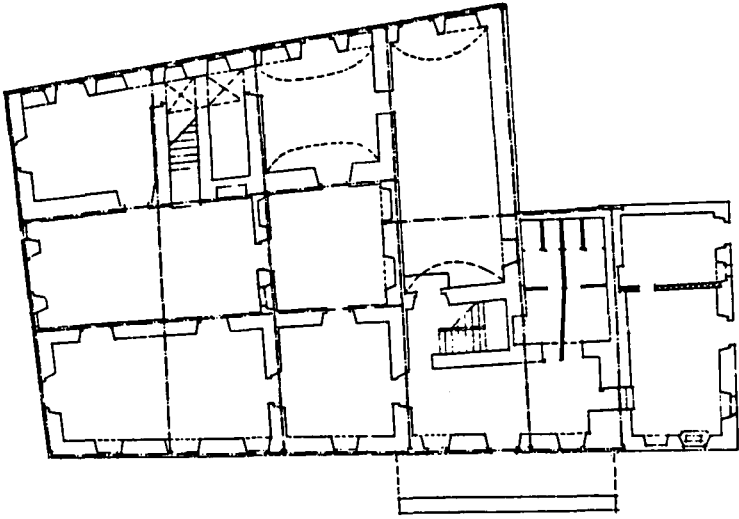
16.4 Ground plan showing proposed ties at ceiling level (1:250)

The project involved the replacement of all the existing timber floors by reinforced concrete slabs, a new roof of reinforced concrete, the insertion of steel ties in chases cut at each ceiling level along both the external and internal walls as shown in Figures 16.4 and 16.5, and extensive work on the foundations.

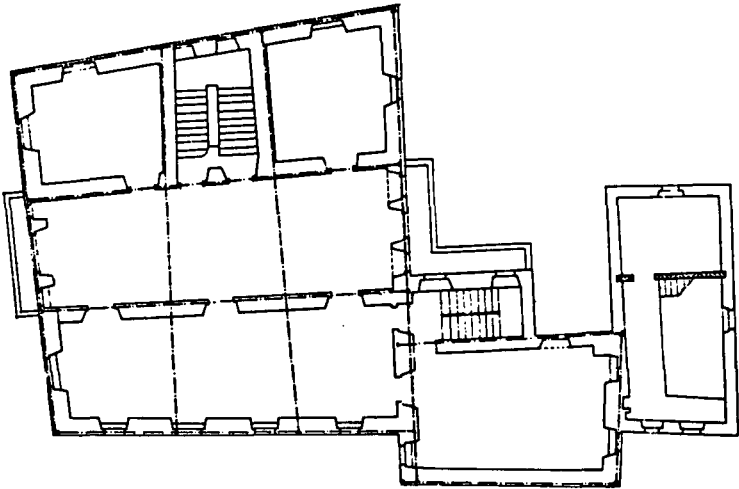
16.5 Second floor plan showing proposed ties at ceiling level (1:250)

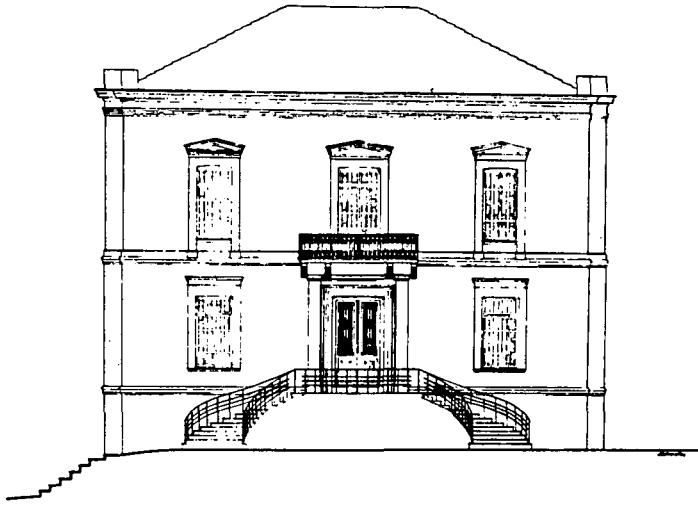
17.2 East elevation (1:200)

The structure was built towards the end of the 19th century as the second house of the ruler of Samos. It is of three storeys, but built on sloping ground so that it is entered directly at first floor level at the east side (Figures 17.2 to 17.5). The view below shows the full height on the west side. The architectural detailing is typical Greek neo-classical stucco.

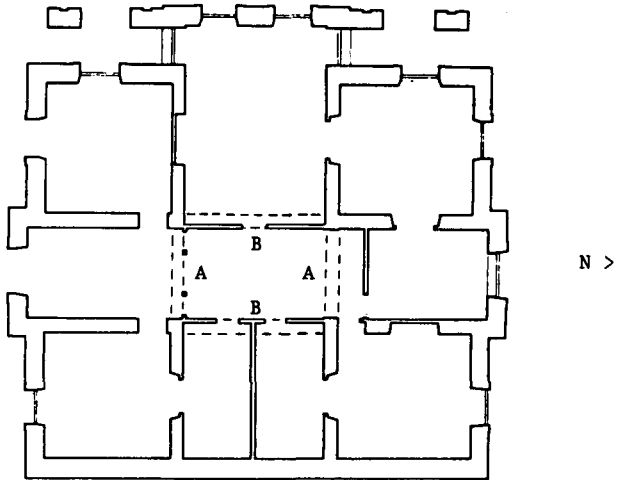
17.3 Ground plan (1:200)

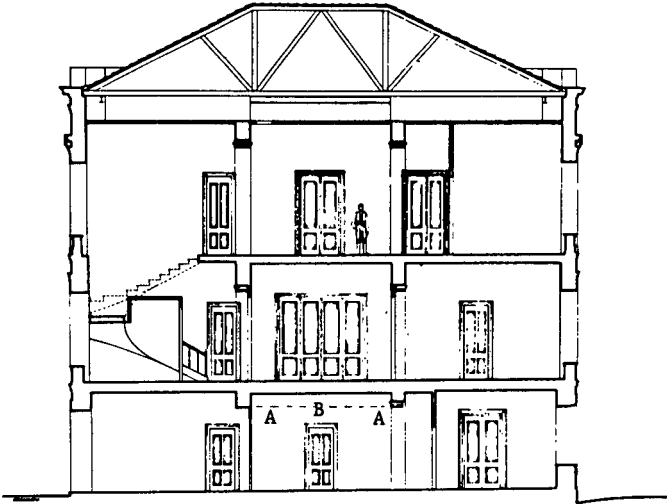
17.4 Section on the north-south axis (1:200)

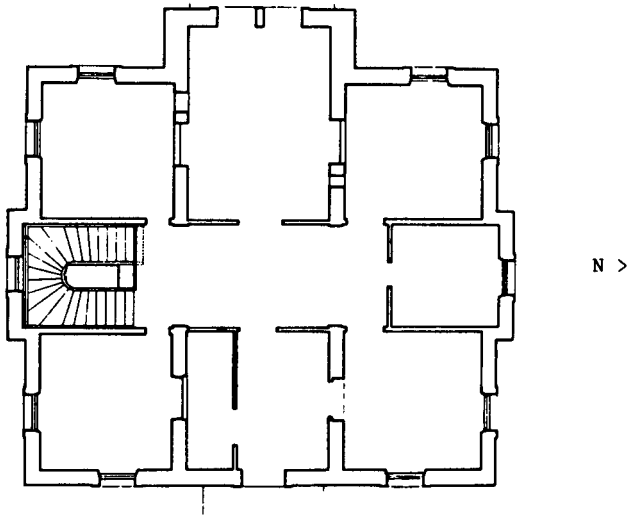
17.5 Second floor plan (1:200)

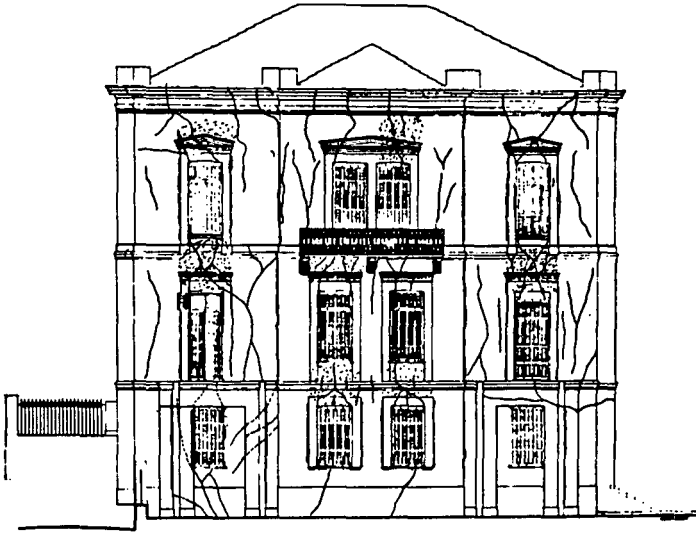
17.6 Cracking and other surface damage on the west elevation (1:200)

No collapse of the walls had occurred. But there was extensive cracking, especially on the west front as seen opposite, and there were associated separations of unbonded junctions and bows and inclinations from the vertical. The cracks were up to 30 mm in width.

Detailed surveys were then made of the cracks (as seen opposite), and of the inclinations from the vertical and other distortions and damages of the above-ground structure. To disclose the full extent of the cracks, the surface stucco was removed as necessary.

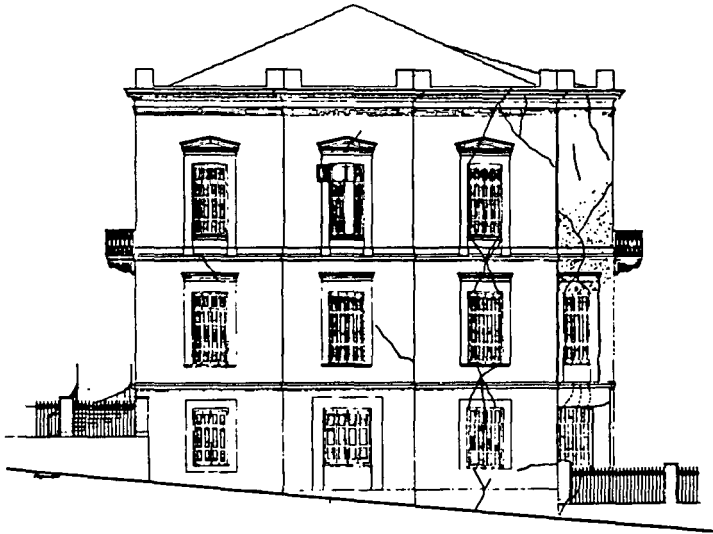
17.7 Cracking and other surface damage on the north elevation (1:200)

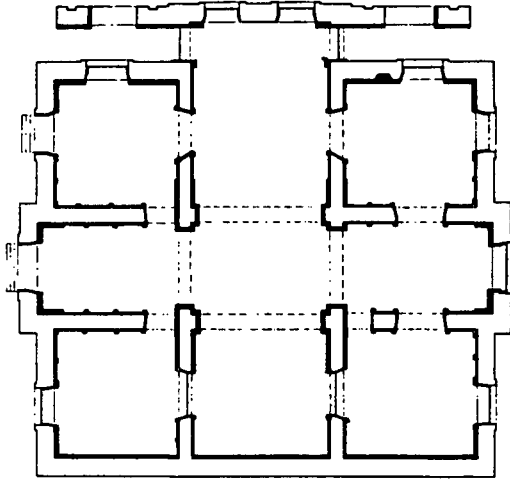
17.8 Strengthening of the walls at ground level (1:200)

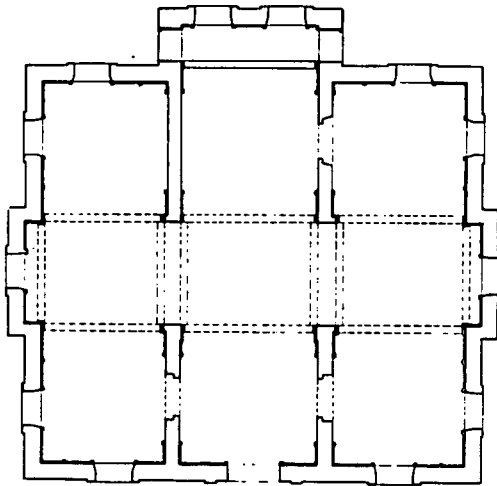
17.9 Strengthening of the walls at first floor level (1:200)

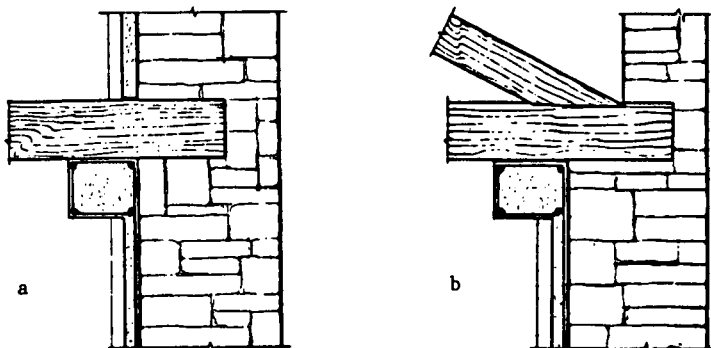
17.11 Typical vertical sections at floor and roof levels (1:20)

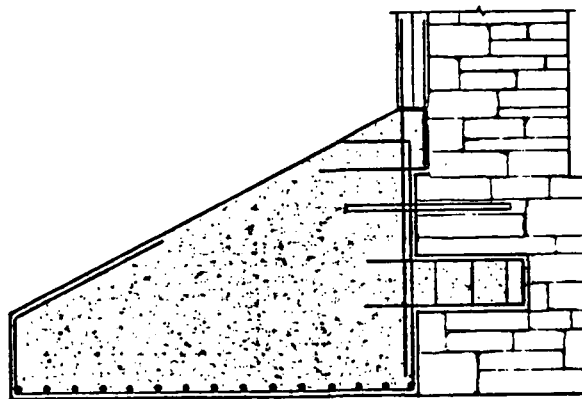
17.12 Typical vertical section of the foundation strengthening (1:20)

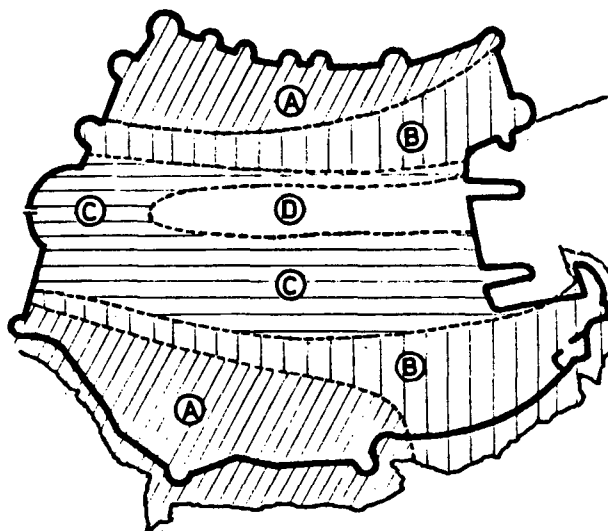
18.2 Seismic microzoning of Dubrovnik old town (1:5000)

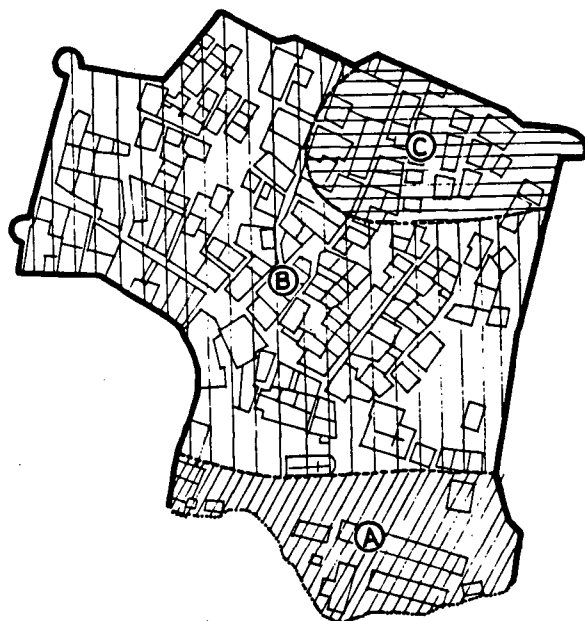
18.3 Seismic microzoning of Budva old town (1:2500)

Most of the area of the old walled town that is marked B or C in Figure 18.3 is densely built upon with two-, three-, and four-storey houses, many with shops or similar premises at ground level.

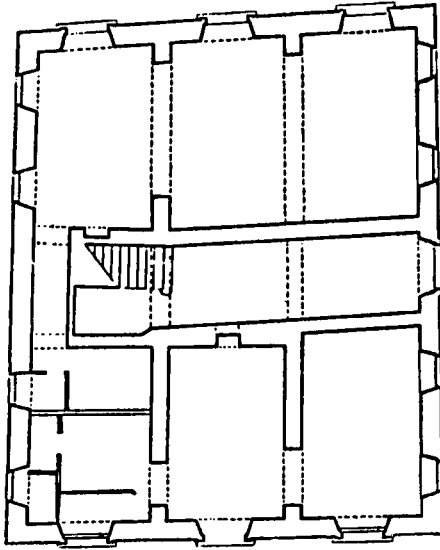
18.5 Building in Ulica M Pracata, Dubrovnik, ground plan (1:200)

This building, seen below and in Figures 18.5 and 18.6, stands in a district

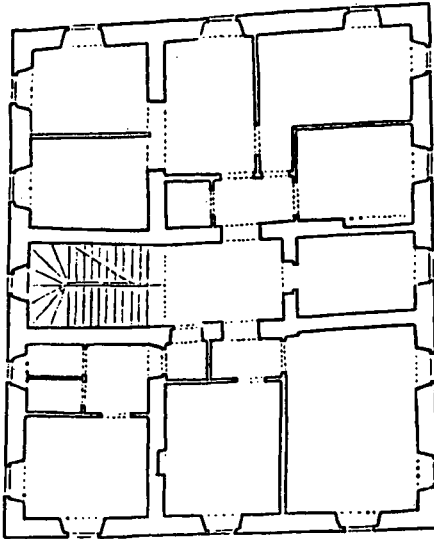
18.6 Building in Ulica M Pracata, Dubrovnik, first floor plan (1:200)

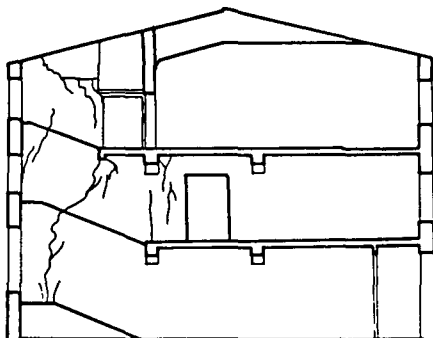
18.7 Building in Ulica M Pracata, Dubrovnik, section (1:200)

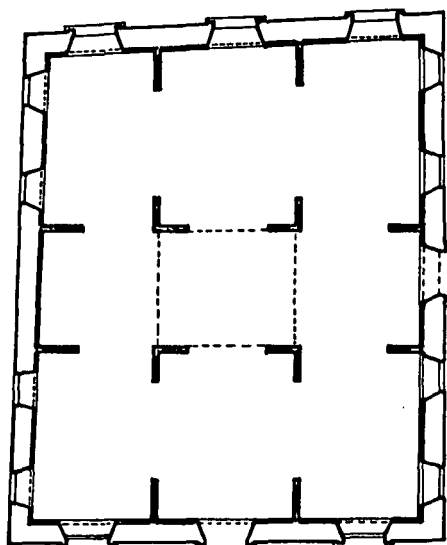
18.8 Building in Ulica M Pracata, Dubrovnik, ground plan (1:200)
showing new internal structure

It was decided to retain and repair only the external walls. Internally, a new structure of reinforced concrete walls will be built as shown in Figures 18.8 and 18.9, with reinforced concrete floor slabs. The external walls will be strengthened by applying 50 mm skins of reinforced gunite anchored to the masonry by steel bolts and to the new internal structure by reinforced concrete collar beams at floor levels. The timber roof will be replaced by a reinforced concrete one similar in form.

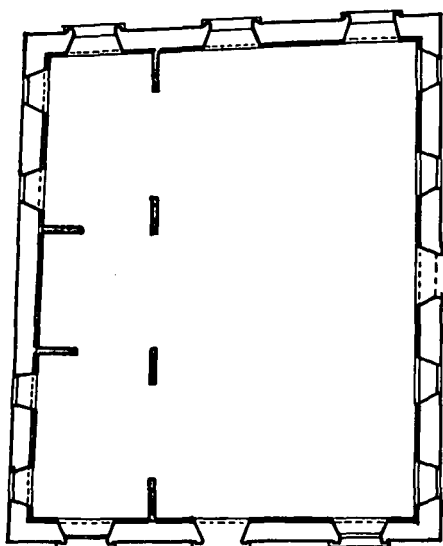
18.9 Building in Ulica M Pracata, Dubrovnik, first floor plan (1:200)
showing new internal structure

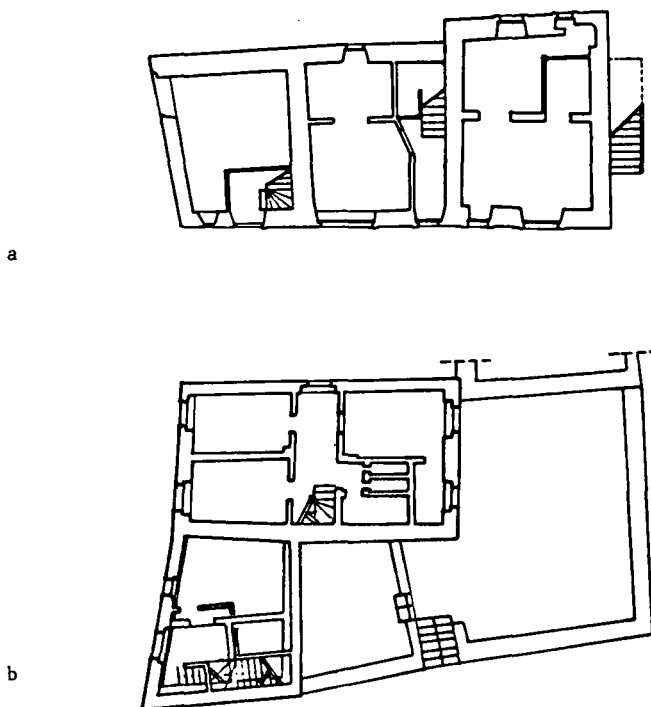
18.10 Plans of typical building blocks, Budva old town (1:200)

Individual buildings abut directly on one another to form irregularly shaped blocks as seen above and in Figure 18.3.

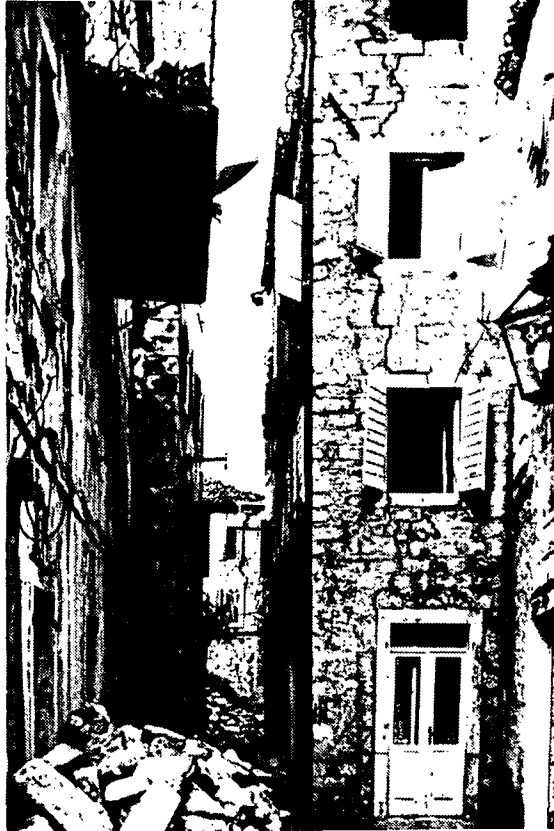
18.11 Damaged buildings, Budva old town

Cracking of the external walls was concentrated in the weak undersill panels,

as seen below and (when further developed) in Figure 3.89. The corners, however, were usually undamaged and were clearly the strong points of the structure which had prevented more extensive collapses where cracking was severe.

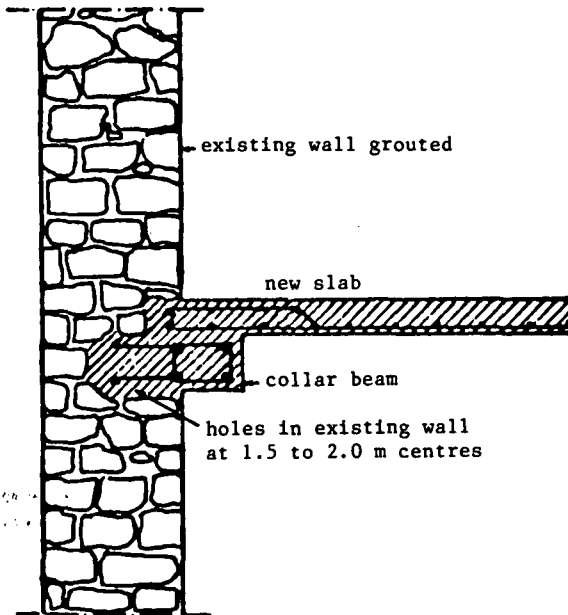
18.12 Detail of connection of floor slab to existing wall, Budva (1:20)

The proposal prepared by the Skopje Institute of Earthquake Engineering and Engineering Seismology (IZIIS) envisaged, on the other hand, the replacement of all the existing timber floors by slabs of reinforced concrete. Connection of these slabs to the existing walls would necessitate some cutting into the walls as shown below. But it was also proposed to strengthen all walls by grouting, to strengthen them further by the application of internal reinforced concrete skins where this seemed necessary, and to build new walls of stone-faced concrete in some cases. An example with a typical detail are shown in Figures 18.13 and 18.14. This further strengthening would reduce the risk of damage from the introduction of the reinforced concrete floors that was referred to in section 5.7.5.

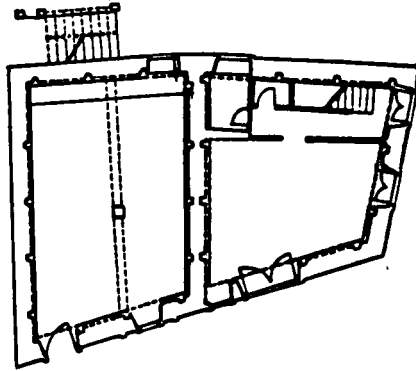
18.13 Building in Budva showing proposed strengthening (1:100)

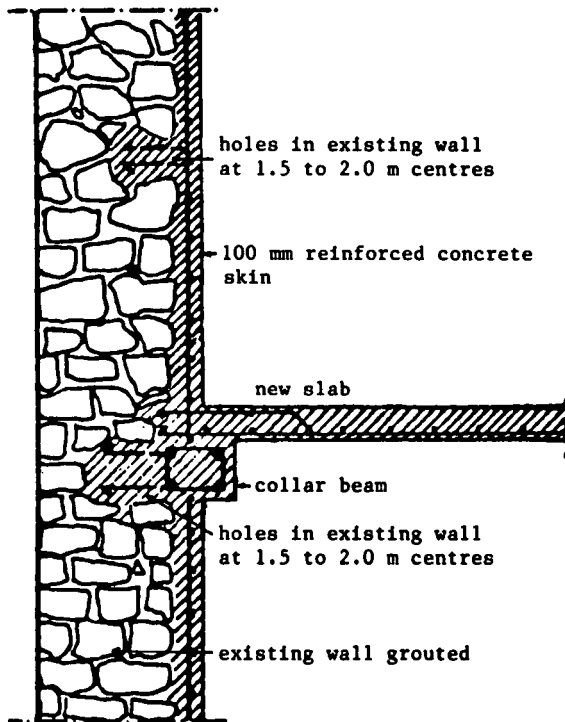
18.14 Detail of wall strengthening and floor slab, Budva (1:20)

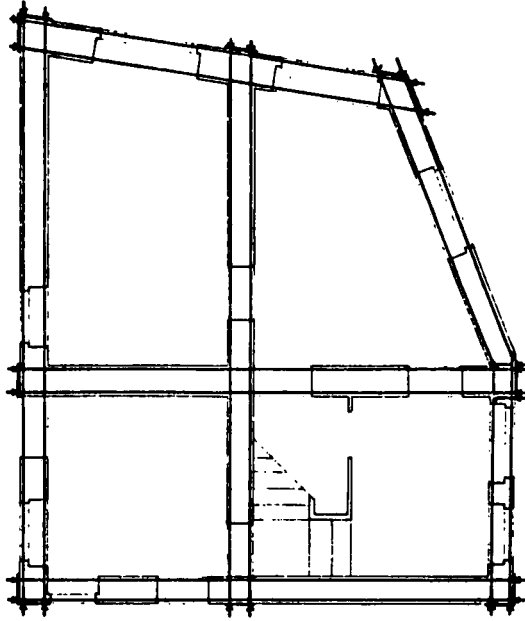
18.15 Building in Lusevera, ground plan showing ties (1:100)

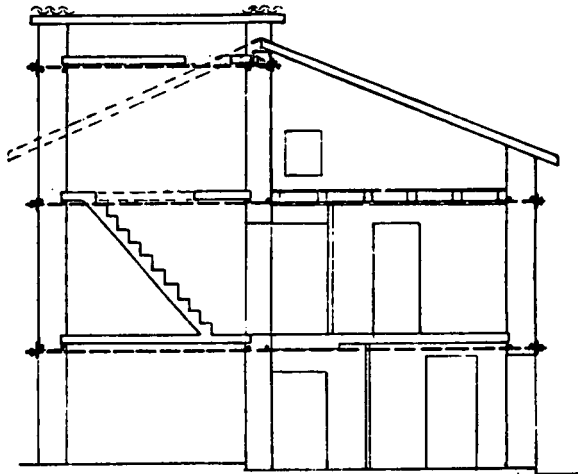
18.16 Building in Lusevera, section showing ties (1:100)

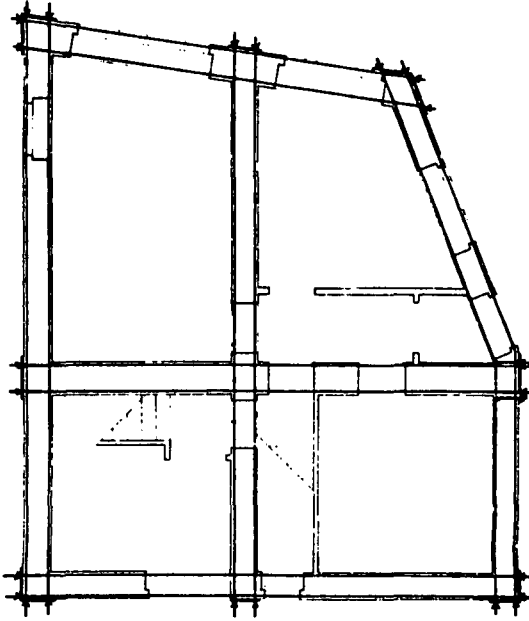
18.17 Building in Lusevera, first floor plan showing ties (1:100)

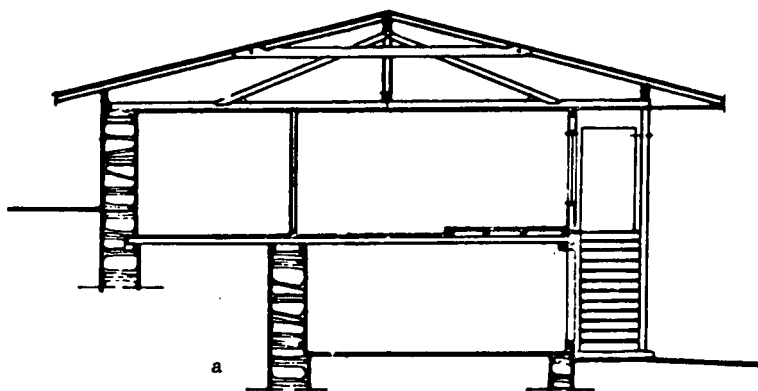
Typical framing of a wall of the upper floor is shown at b below. The joints rely to some extent on iron nails and clamps. Usually the frame is filled with either burnt or unburnt brick and the whole surface, both inside and out, is plastered or boarded.

cross section

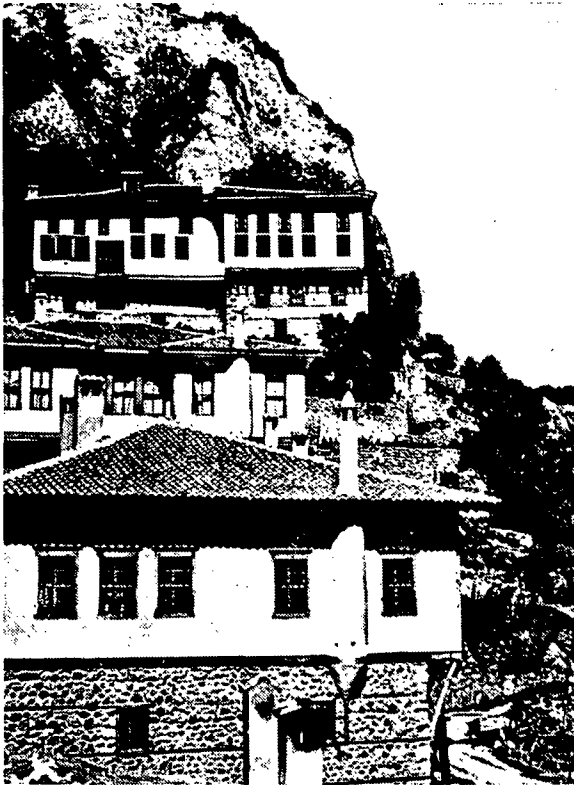
18.20 Typical houses restored

In Bulgaria, the former method is used for buildings considered to be of national importance, and the latter for buildings of less importance or buildings where it is considered to be impracticable to achieve the desired performance by the former method. A group of buildings recently restored is shown below.
