**UNIVERSIDAD NACIONAL
EXPERIMENTAL DE GUAYANA**

**UNIDO PROJECT SI/VEN/94/801
ADVISORY ASSISTANCE ON INTRODUCTION OF ALTERNATIVE
GOLD MINING AND EXTRACTION TECHNIQUES AVOIDING
MERCURY POLLUTION**

Ciudad Guayana, October 1995

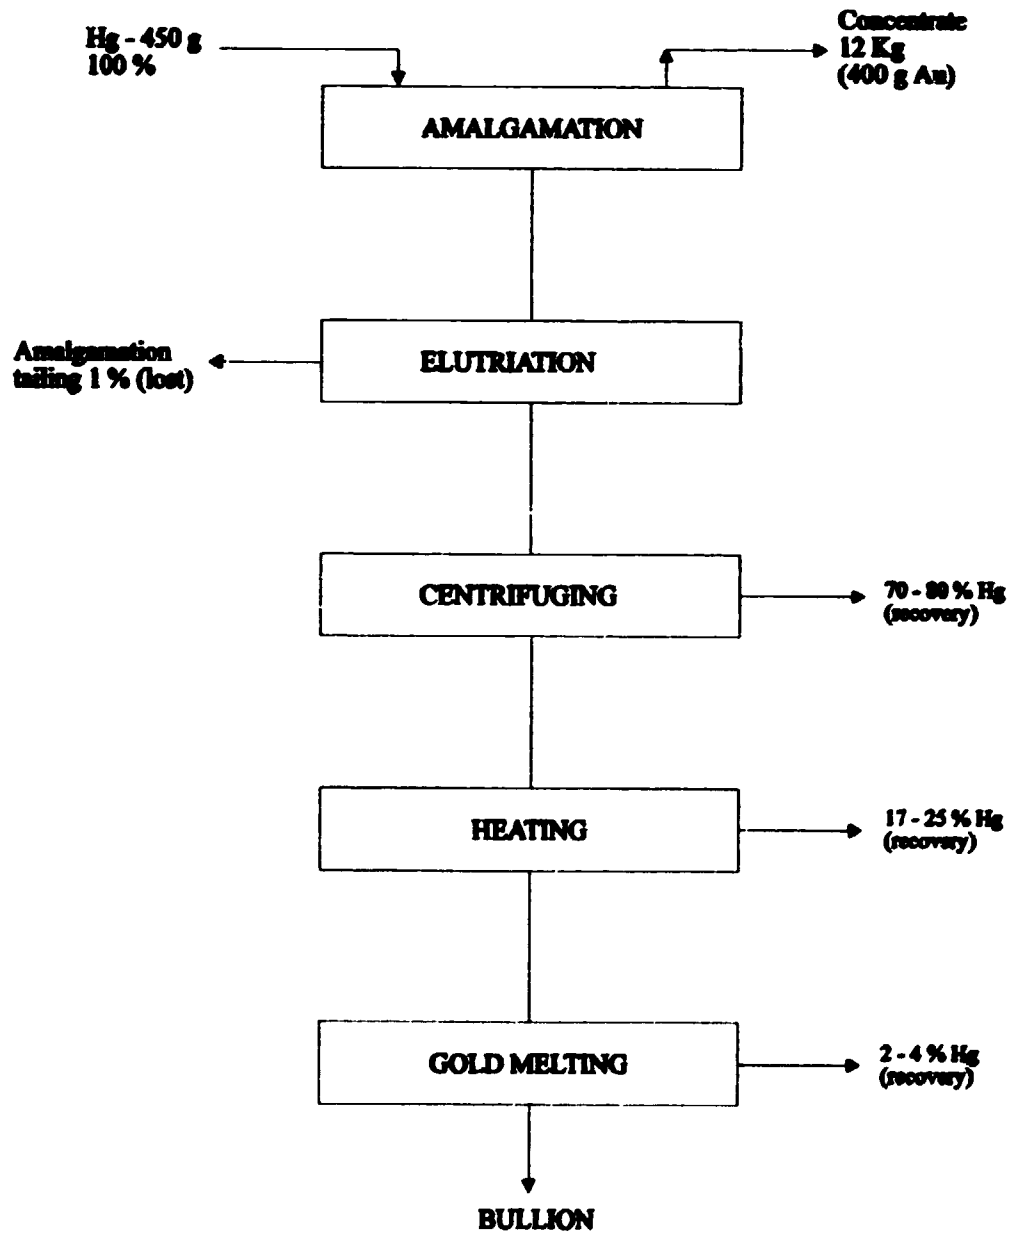
Figure 5. Balance of mercury in the amalgamation steps at Carhuachi's Gold Recovery Center.

This research was done towards finding out the balance of mercury in the different steps of the process of gold recovery.

Two volumes of concentrate, 12 and 14 Kg each, were processed through the different steps used at Carhuachi's Gold Recovery Center which were previously added 450 and 300 g of metallic mercury, respectively (this difference is due to the fact that the criteria for adding mercury to the concentrates is giving by miners). We can see in Figure 5 the percentage of mercury lost in the amalgamation tailing (1%), as well as the recovering ranges in the centrifuging steps (70-80%), heating (17-25%) and gold-melting (2-4%). Volatilized mercury during heating and gold-melting is recovered in two ways: using water-cooled serpentine condensers and a mantel to take the vapors towards a nebulizer which contains an iodine solution. Mercury entering the atmosphere can represent as much as 50 % of that introduced into the amalgamation process when retorts are not used (Veiga, 1.994).
