TECHNICAL ADVICE ON
ASEISMIC CONSTRUCTION STRENGTHENING AND REPAIR OF BUILDINGS

MEXICO

Technical report: Findings and recommendations
of a team of earthquake specialists*

Based on the work of
J. G. Bouwkamp, G. G. Penelis, M. Ö. Erdik,
M. Velkov, E. Dulácska and H. Sandi

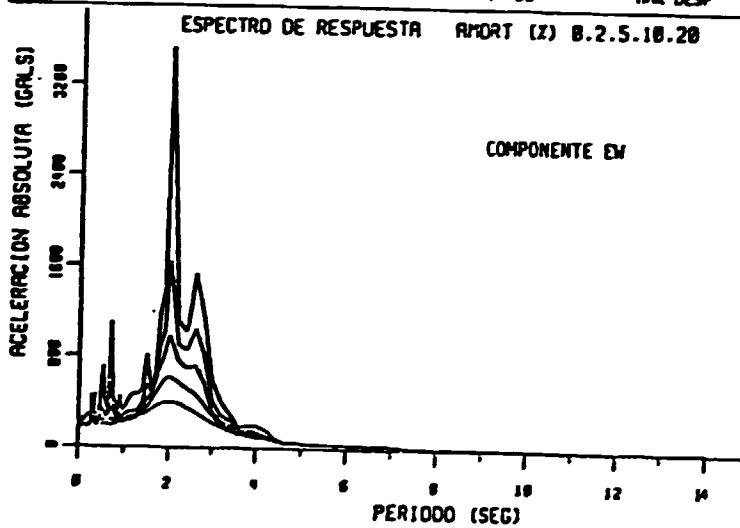
Figure 7. Linear Response Spectra for the NS and EW acceleration components recorded at the SCT Location.

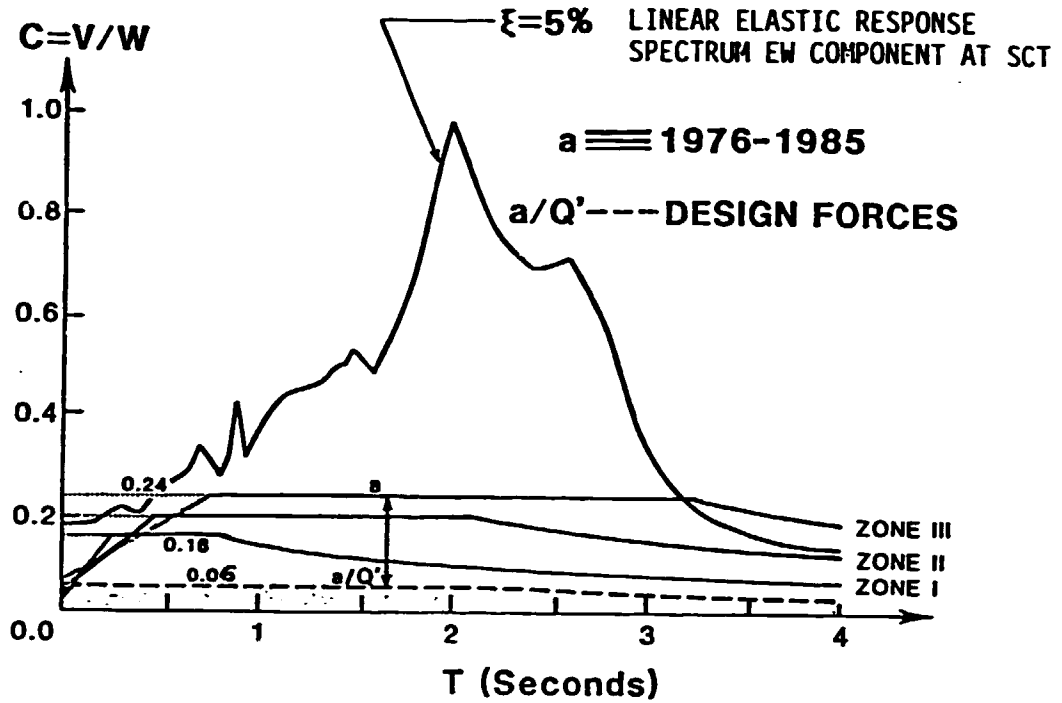
Fig. 9. Comparison of the 5% Damped Linear Elastic Response Spectrum of the EW Component of the Acceleration Record recorded at SCT with the 5% Damped Linear Elastic Spectra used by the Mexican Code (1976) and with the Design Forces for a Ductility Factor of $Q = 4$.

the period since 1976, waffle-slab failures alone constituted about 70% (21+18 or 39 versus 56). R.C. framed-type structures built in the same period accounted for almost 20% of the collapsed or severely damaged structures built since 1976. This observation is particularly important because a new code for seismic resistant design was introduced in 1976. Clearly, this code needed modification. In fact, such changes were introduced shortly after the earthquake, with the stipulation that the design coefficient C (see Fig. 9) should be increased from 0.24 to 0.40 for structures located in the central area of Mexico City.

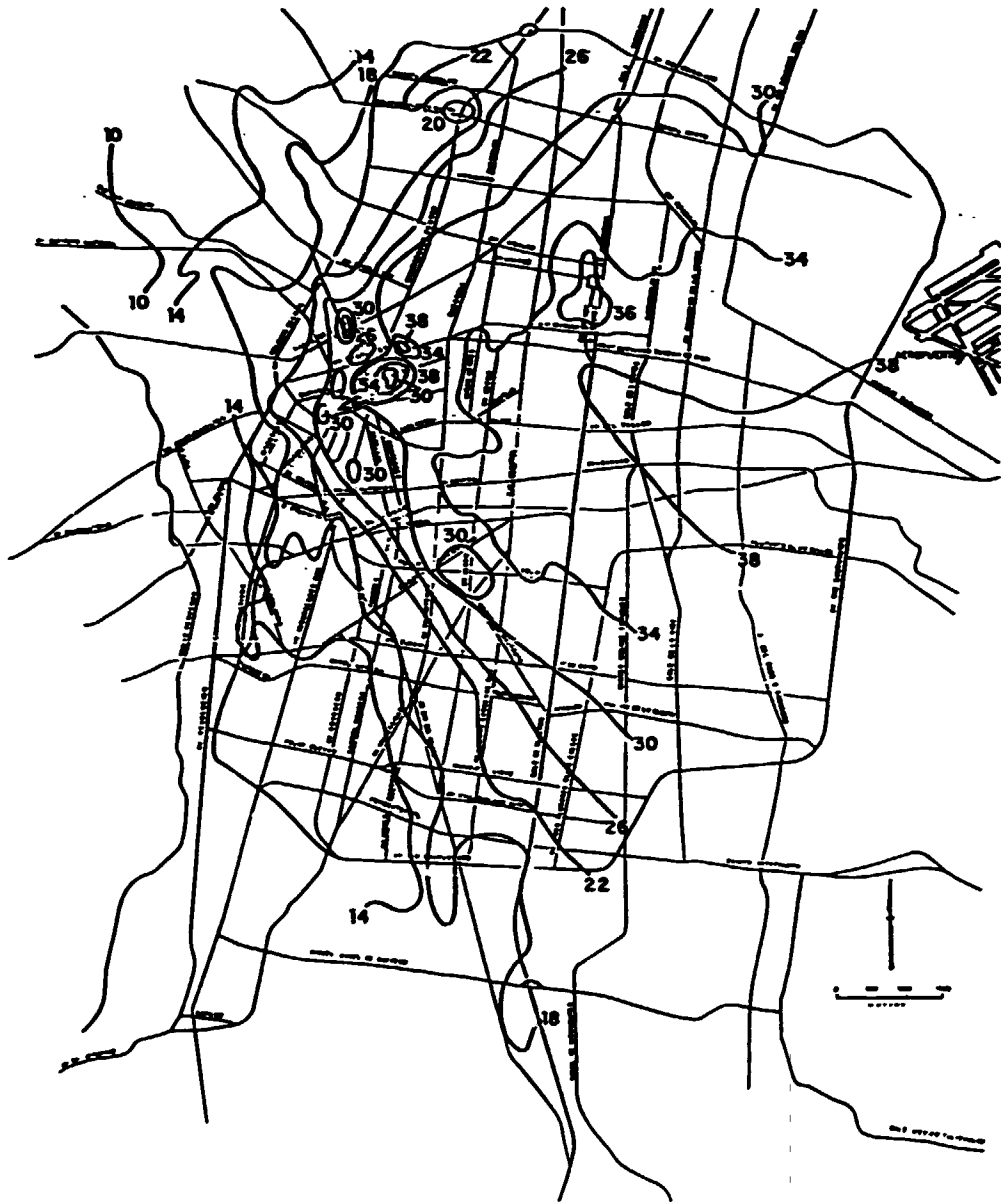
Figure 11. Curves indicating Depth to First Layer of Firm Soil

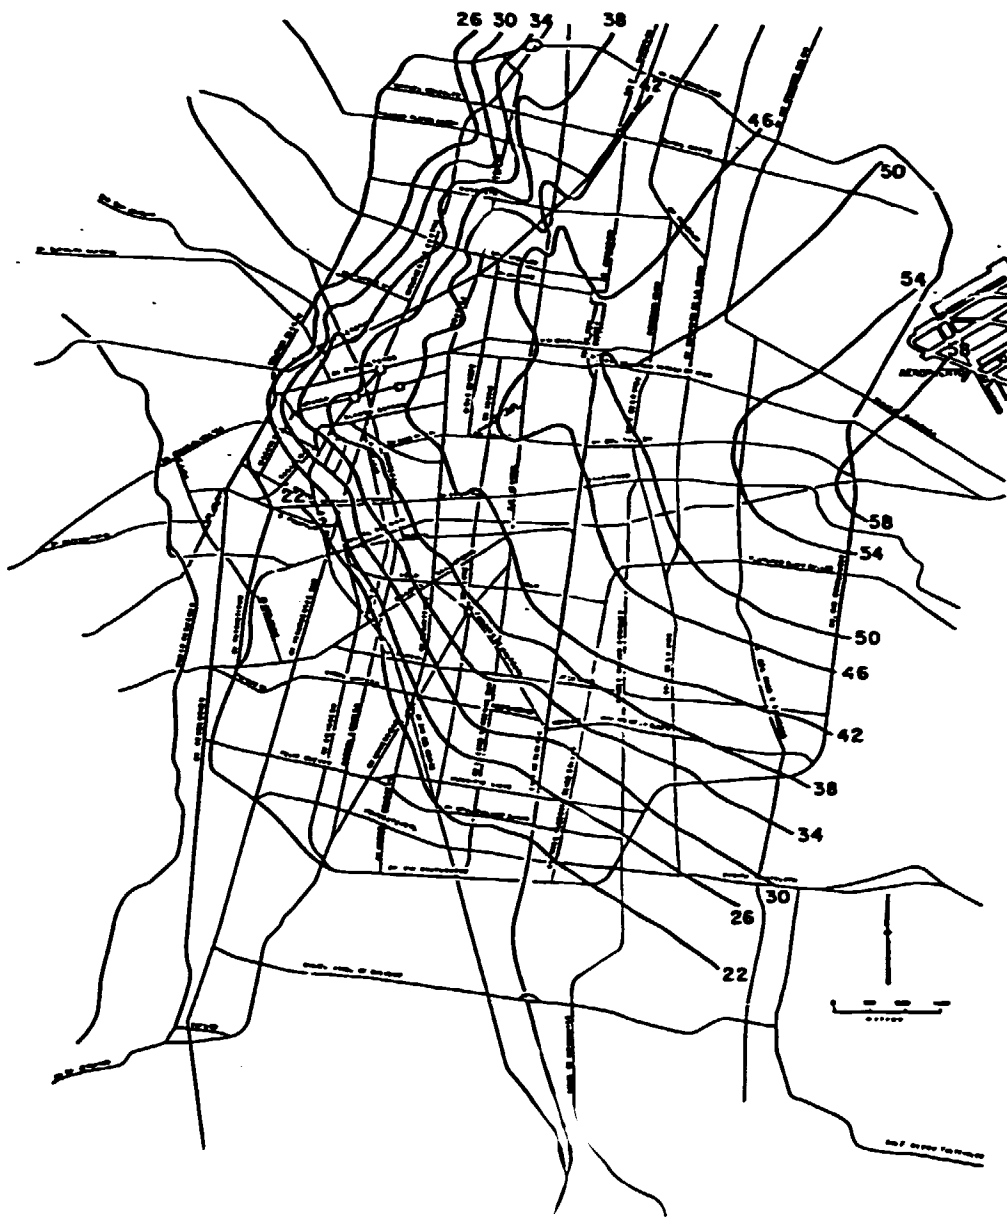
Figure 12. Curves indicating depth to Second Layer of Firm Soils (Deep Deposits)

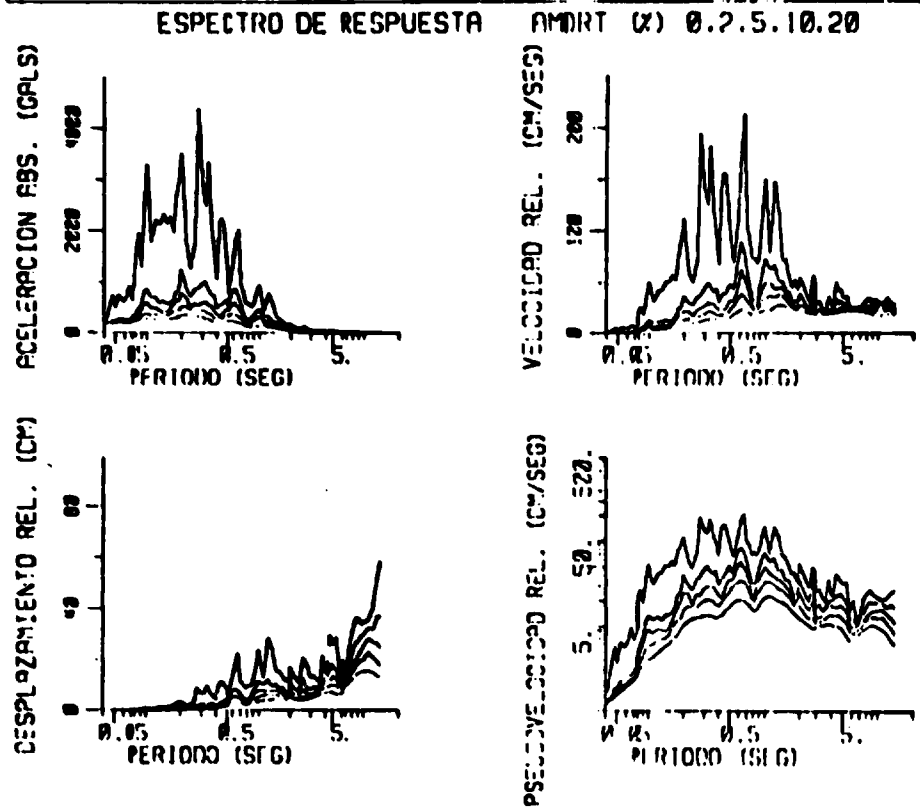
Fig. RP.14

SISMO	GRO-MICH	REGISTRO	ZACA09091901.T	CORRECCION
DATOS	10E1	ESTA	ZCA	CALTECH.
FECHA	050919	INST	D3 146	FILTRO 0.070 0.000 45.0 47.0
HORA	13:17:56	COMP	MWV	A1
EPIC	17.600 100.470	MOM	13:17:55	MW DEFL 101.00 -101.17
"	7.0	DUR	00:00	MW V11 13.00 -13.95
"	37	DIST	00	MW H101 0.00 0.50

Fig 11. Espectros de respuesta de la componente E-W del acelerograma ZACATULA-19 sept 95.

No.	Title	Source
RP.1	Preliminary epicenter location	Fig.1 of /V.II.A.7/
RP.2	Location of digital accelerographs in Mexico City	Fig.2 of /V.II.A.7/
RP.3	Subsoil zonation of Mexico City	Fig.3 of /V.II.A.1/
RP.4	Subsoil profiles in Mexico City	Fig.4 of /V.II.A.1/
RP.5	Equal depth curves of the deep deposits	Fig.5 of /V.II.A.1/
RP.6	Location of collapsed or severely damaged buildings	Fig.1 of /V.II.A.1/
RP.7	Location of damaged zones	Fig.2 of /V.II.A.1/
RP.8	Response spectra, Mexico City, CU, outdoor	Fig.8 of /V.II.A.7
RP.9	Response spectra, Mexico City, Tacubaya	Fig.14 of /V.II.A.7/
RP.10	Response spectra, Mexico City, Viveros de Coyoacan	Fig.13 of /V.II.A.7/
RP.11	Response spectra, Mexico City, SCT	Fig.10 of /V.II.A.7/
RP.12	Response spectra, Mexico City, Cde A , front of refrigerator	Fig.12 of /V.II.A.7/
RP.13	Response spectra, Zacatula, NS	Fig.10 of /V.II.A.8/
RP.14	Response spectra, Zacatula, EW	Fig.11 of /V.II.A.8/
