# **Improvement of Steel Making Operations**

## **Three Non-integrated Steel Plants**

### **Arab Republic of Egypt**

**KOBE STEEL, LTD.**

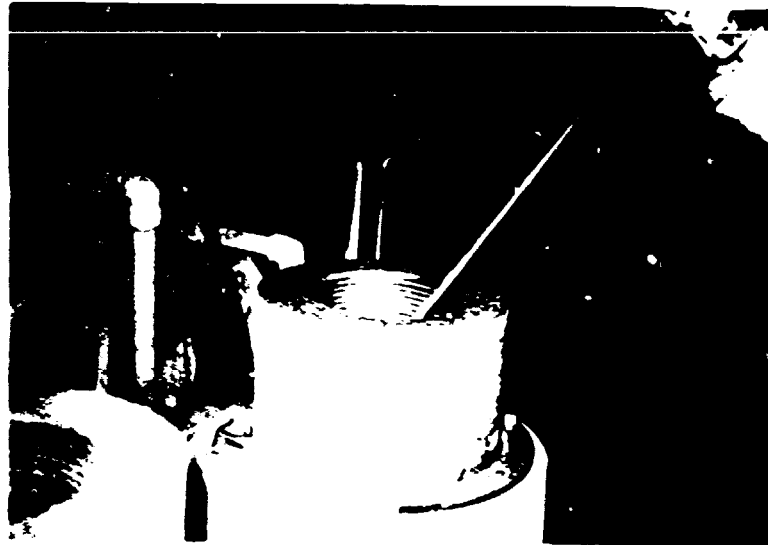
11. Removing dust from an electrode joint by compressed air (KOBE)

11a. Inside the joint before screwing nipple

11b. Around the face of the joint before final fastening

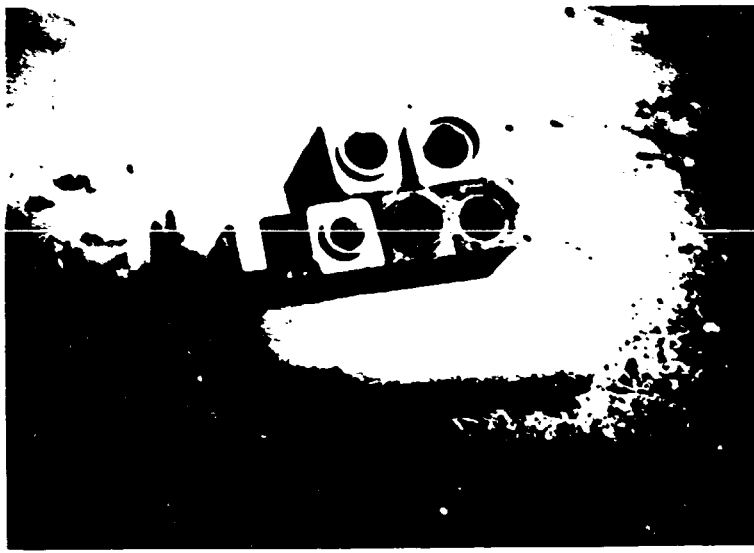
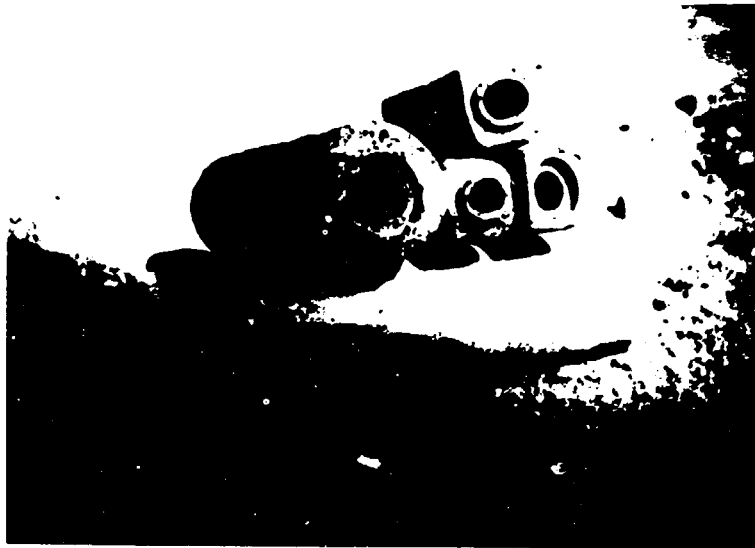
16. Imperfect shape of ingot making bricks

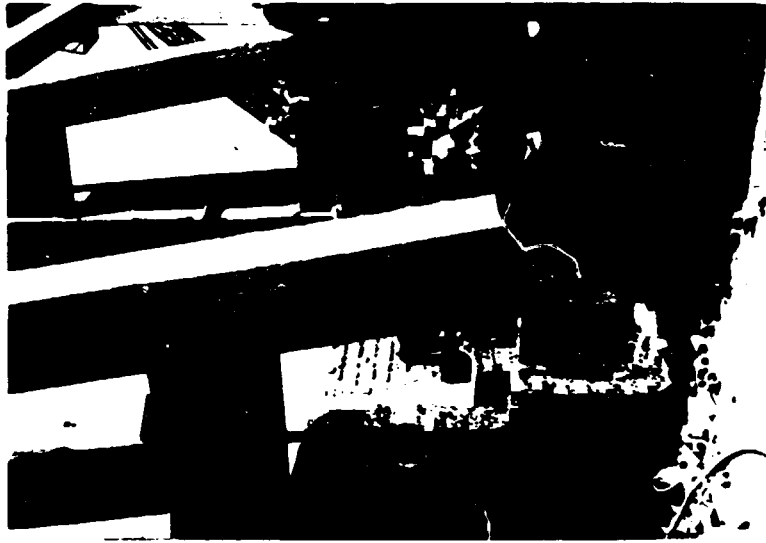
17. Improper outdoor storage of bricks

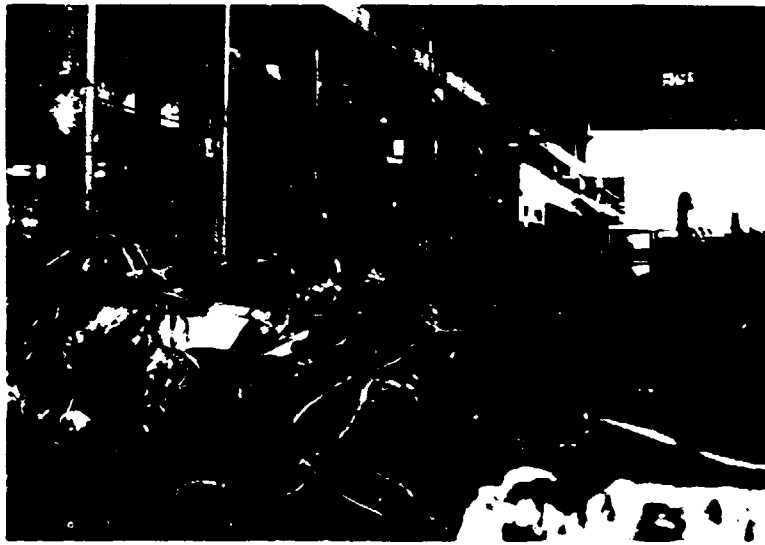
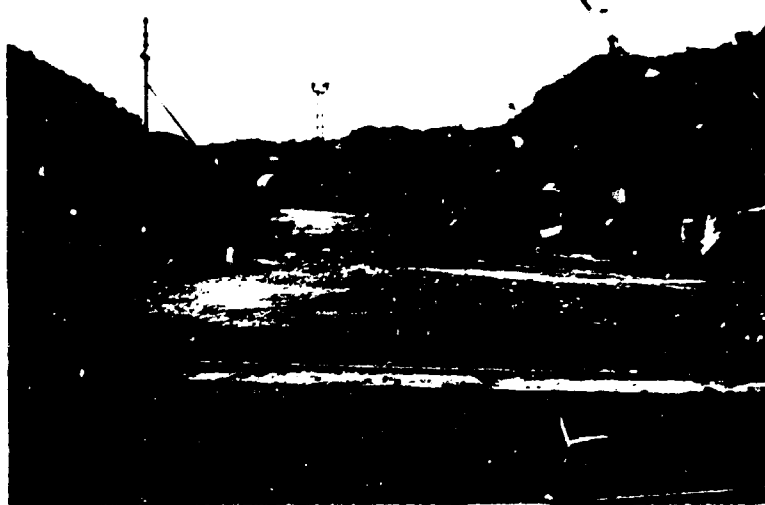
27. Raw material yard

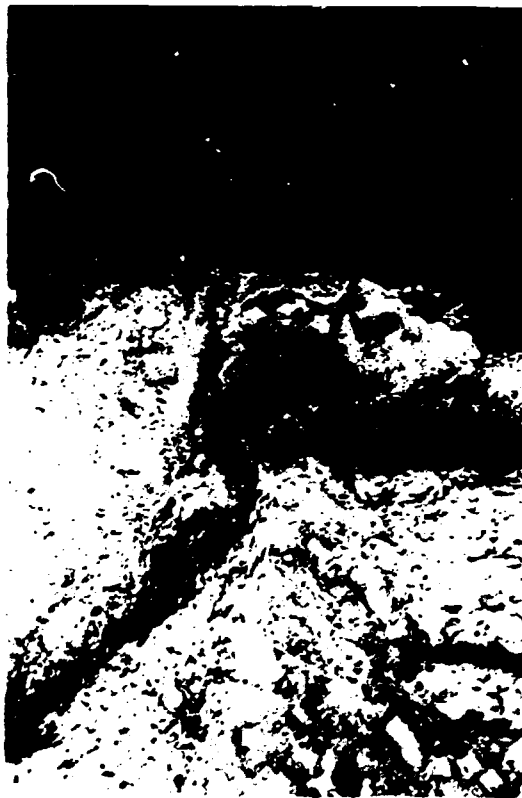
29. Elevated and deformed hearth on tap hole  
side (COPPER)
