Improvement of Steel Making Operations

Three Non-integrated Steel Plants

Arab Republic of Egypt

June, 1977

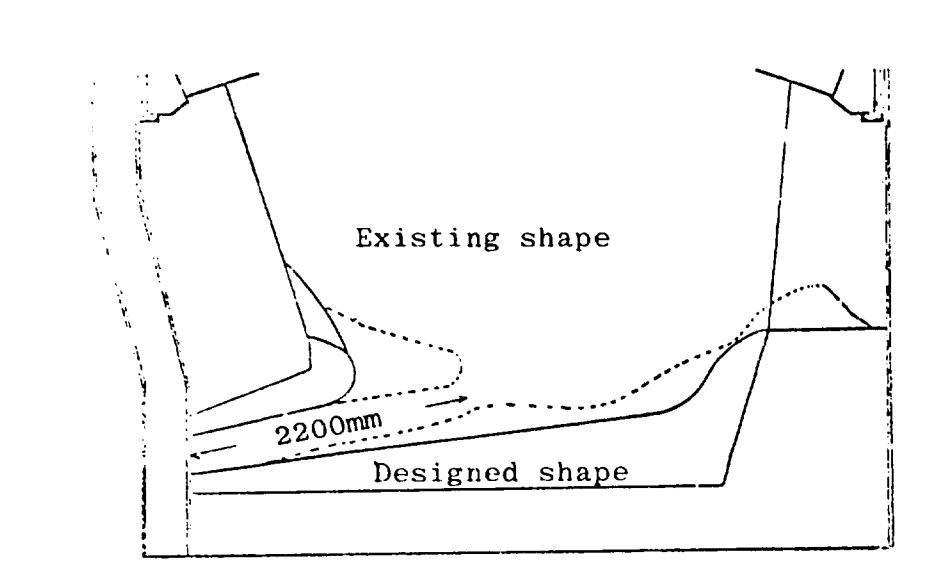
21. Irregular hearth shape, deviating from the original design (NATIONAL)

Generally, due to insufficient maintenance, the hearth becomes excessively elevated and deformed and the shape of the tap hole also is distorted. The designed shape of the hearth and tap hole should be maintained. It is recommended that the repairing methods under normal and ab.ormal conditions be improved. Satisfactory maintenance of the hearth will bring about the following results:

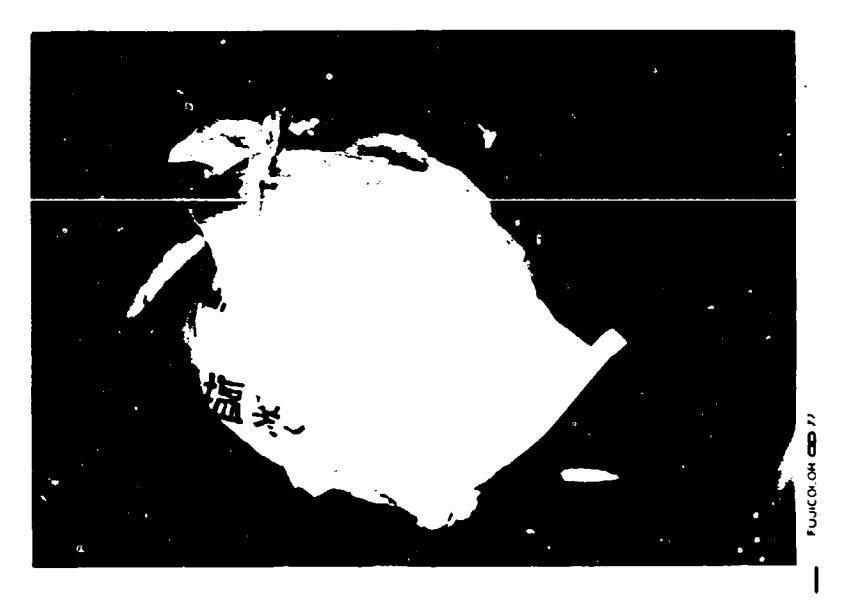
5. Repair tools for tap hole (KOBE)

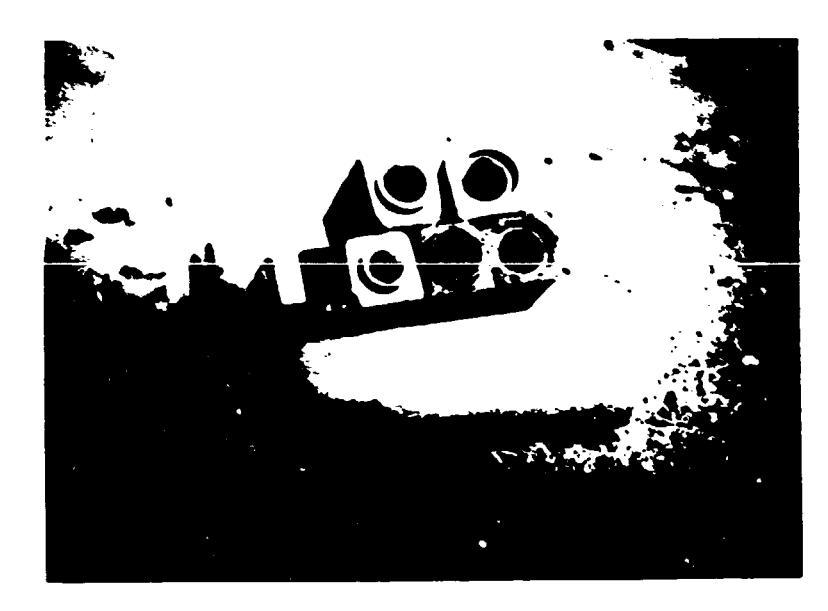
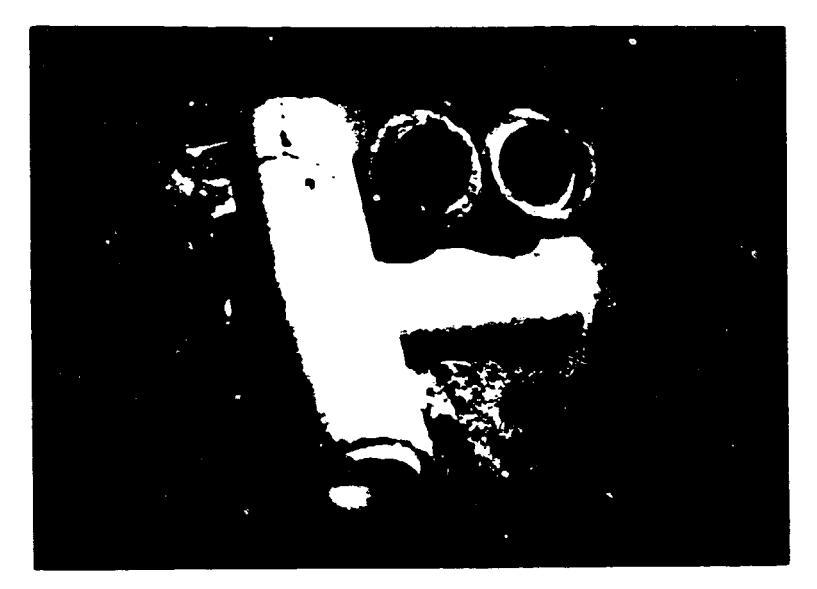
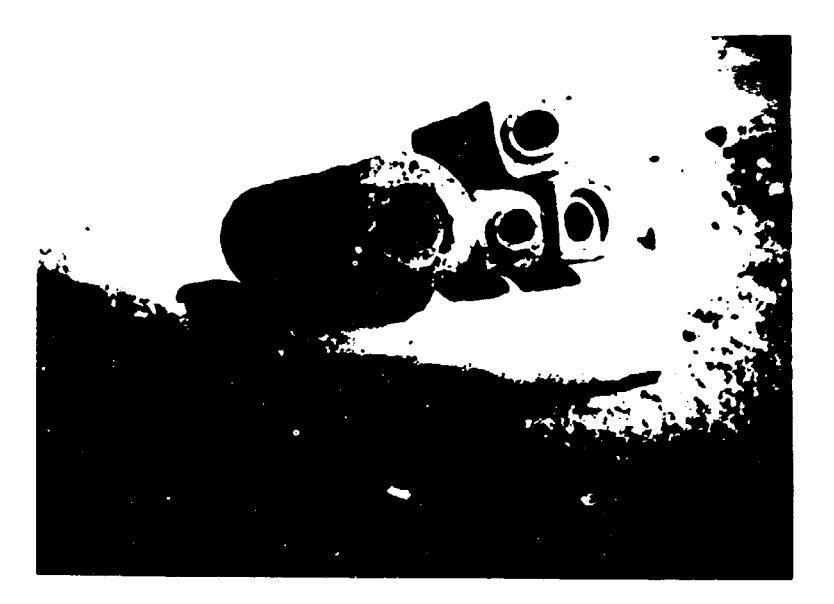
16. Imperfect shape of ingot making bricks

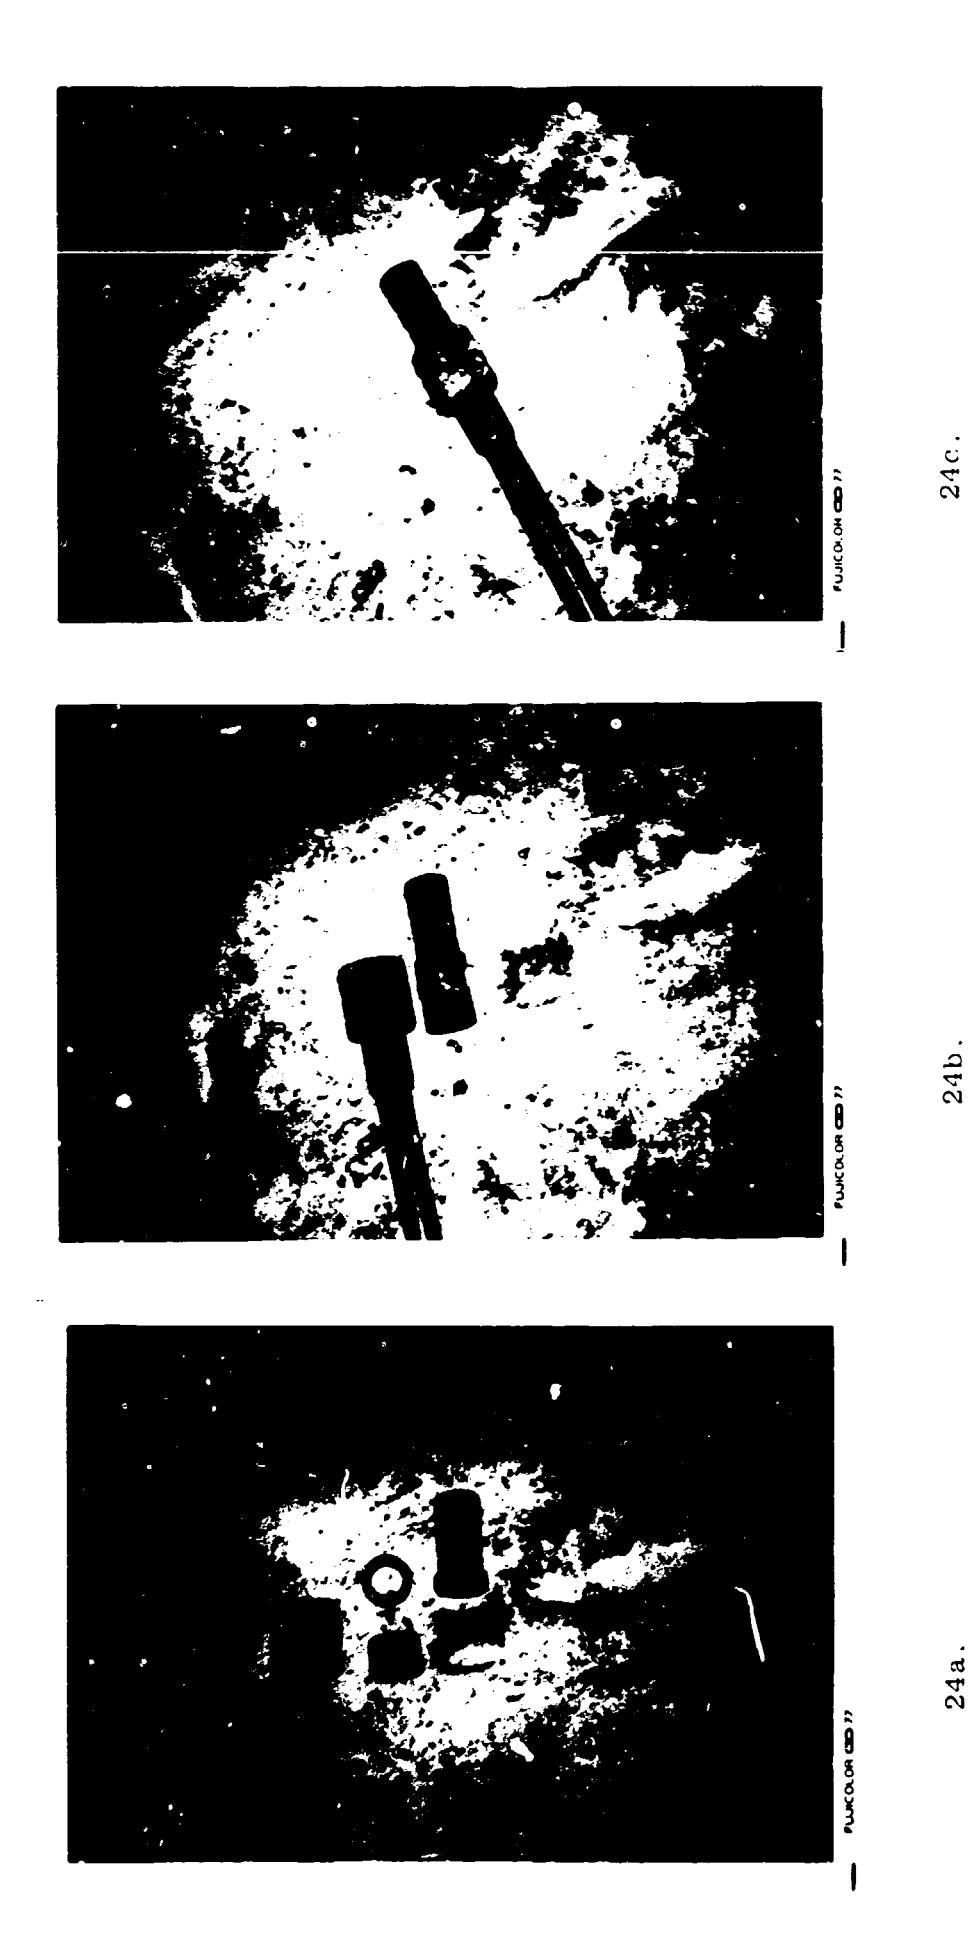
23. Steel adhesion on the mould (COPPER)

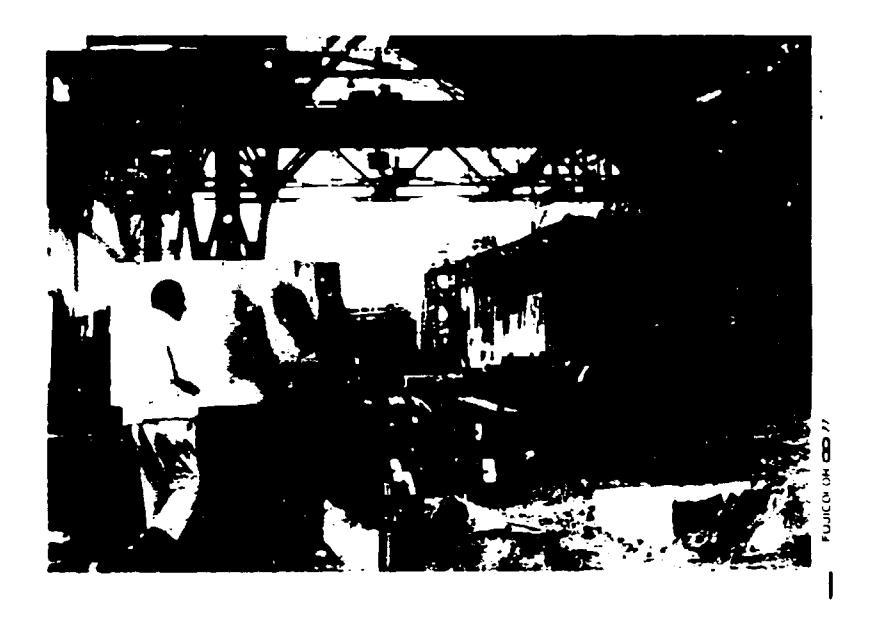
33a. (NATIONAL)

- 31. Improper classification and assortment of scraps (NATIONAL)
- 32. Improper loading of scraps into charging boxes (NATIONAL)
- 33. Arrangement in front of furnace

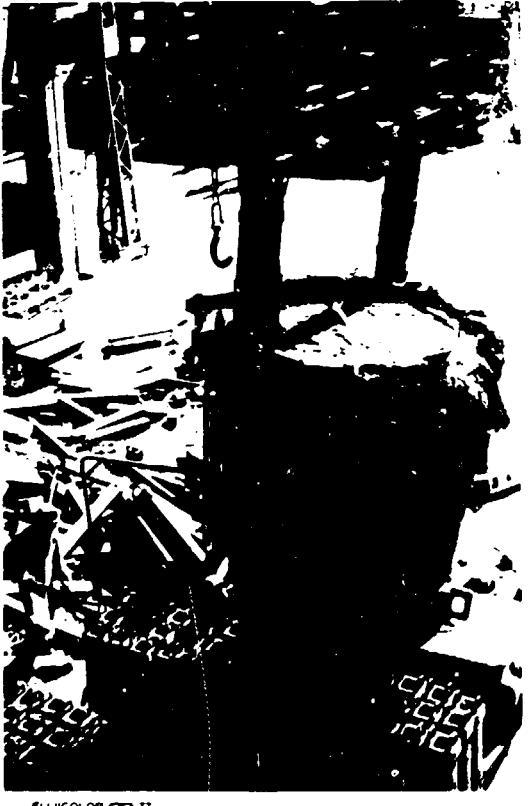
41. Steel adhesion on ladle (NATIONAL)

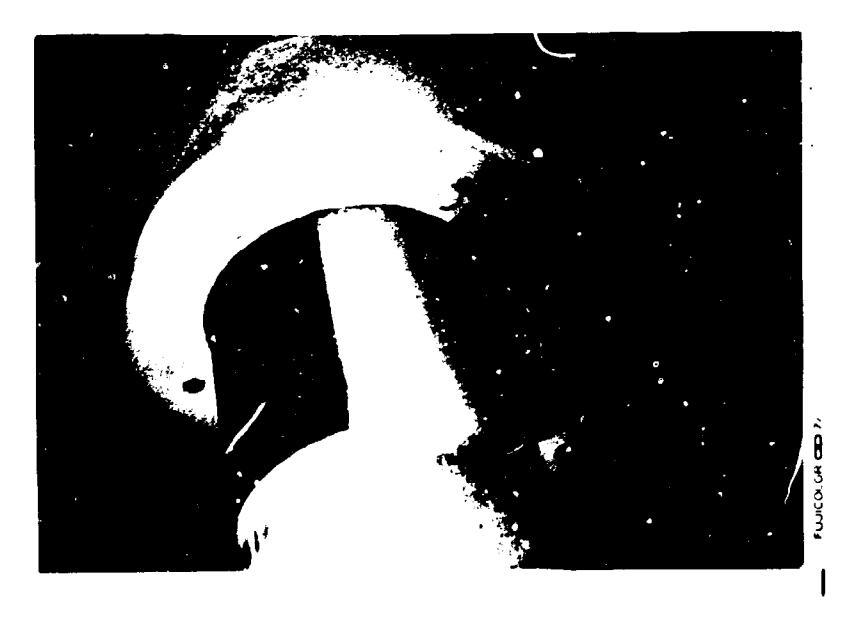
42. Imperfect closing of charging door (DELTA)

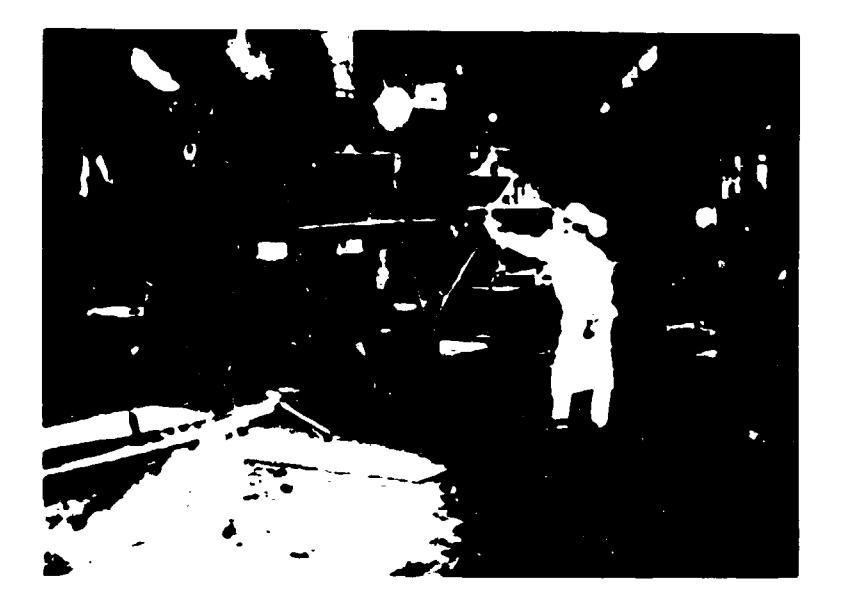
53. Handrail on tap hole side deck (KOBE)
