**TECHNICAL AND ECONOMIC ASSESSMENT OF
THE VIABILITY OF REACTIVATING /
COMMISSIONING THREE INCINERATOR PLANTS
IN LAGOS - NIGERIA**

FINAL REPORT

February 1991

**Contract No.: 90/075
Project No.: SI/NIR/89/806**

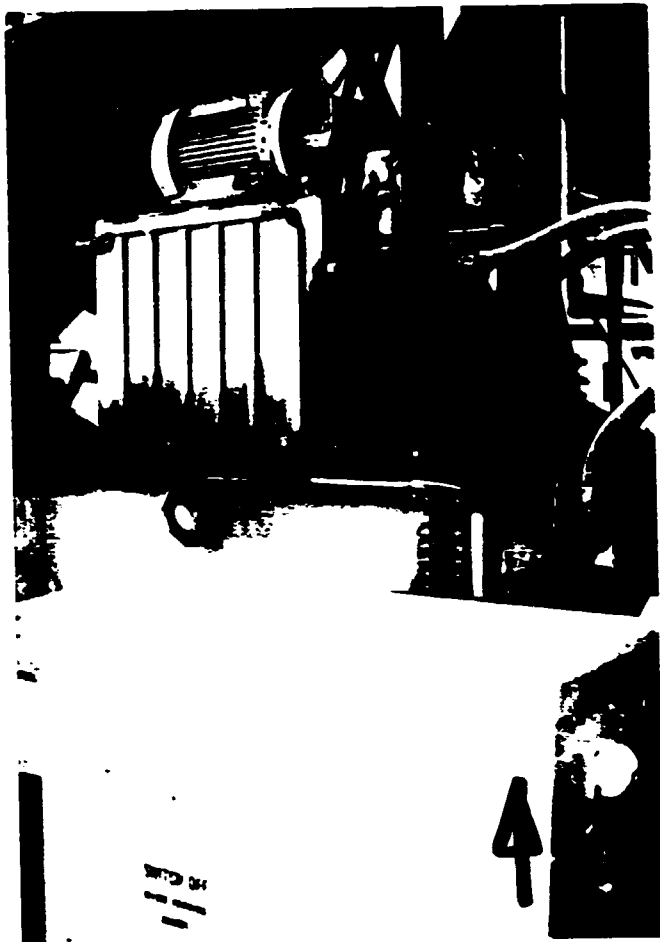
VIEW OF METAL PRESS

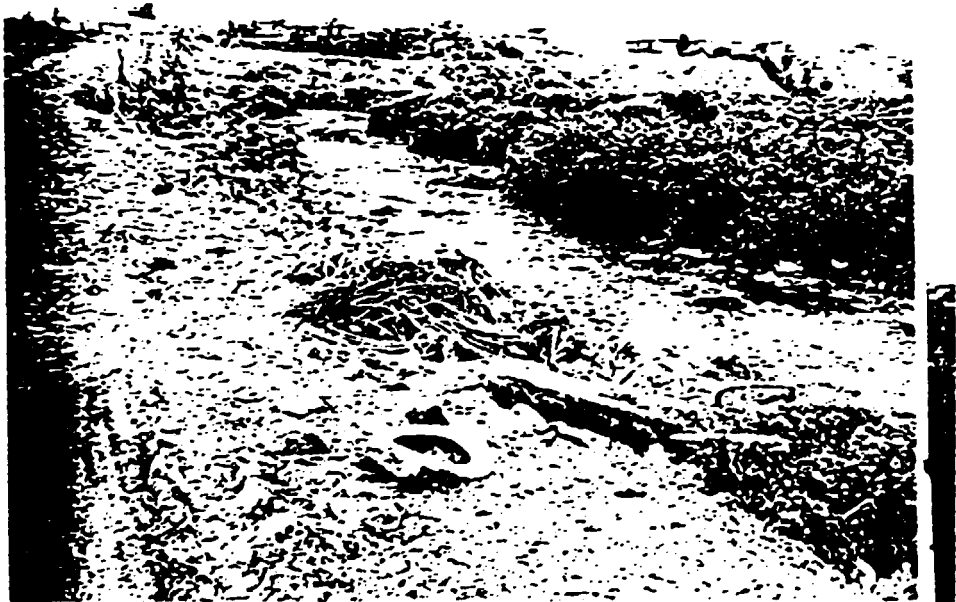
ABEOKUTA

- Uncontrolled landfill,
- without fence
- impermeabilisation absent
- children and women, especially, regularly comb the site in search of items of economic value to them, using their bare hands and without any protective clothing
- very close to residential area
- the landfill is used by inhabitants as a walkway
- one bulldozer is assigned to the landfill for the waste flattening
- periodical earth movement for coverage of the waste is not carried out
- access road heavily damaged

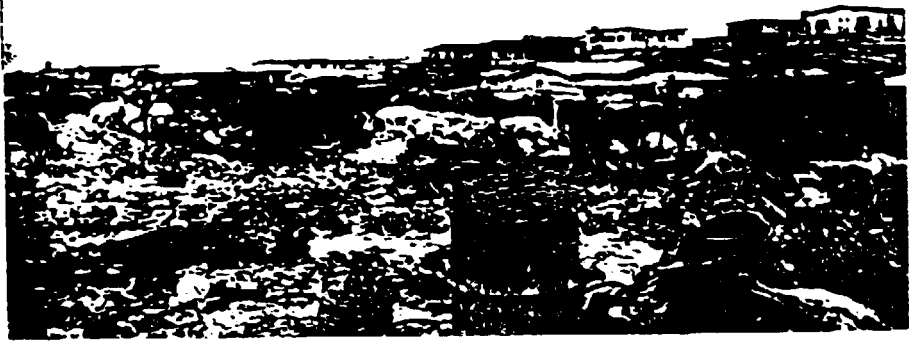
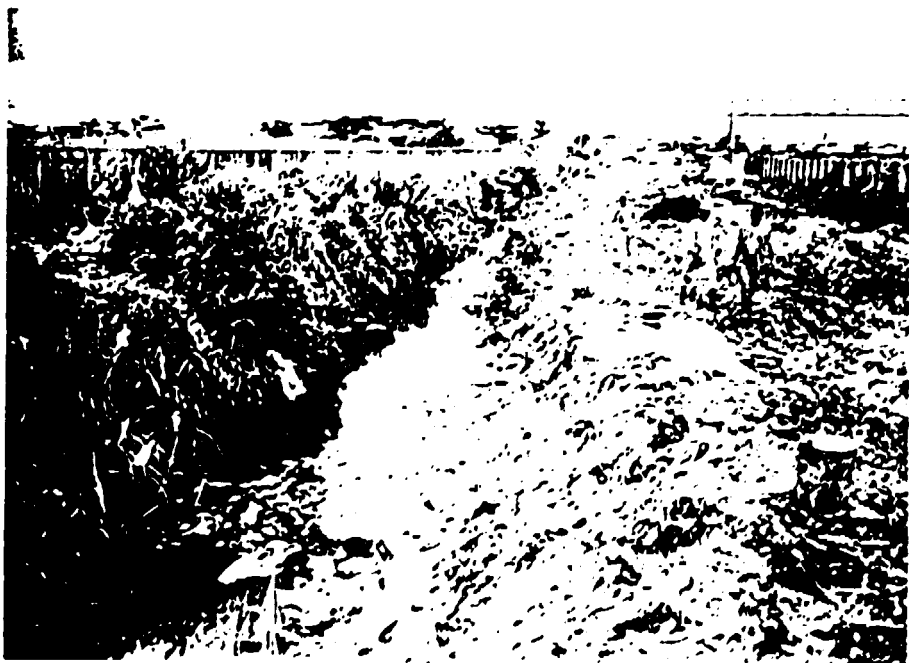
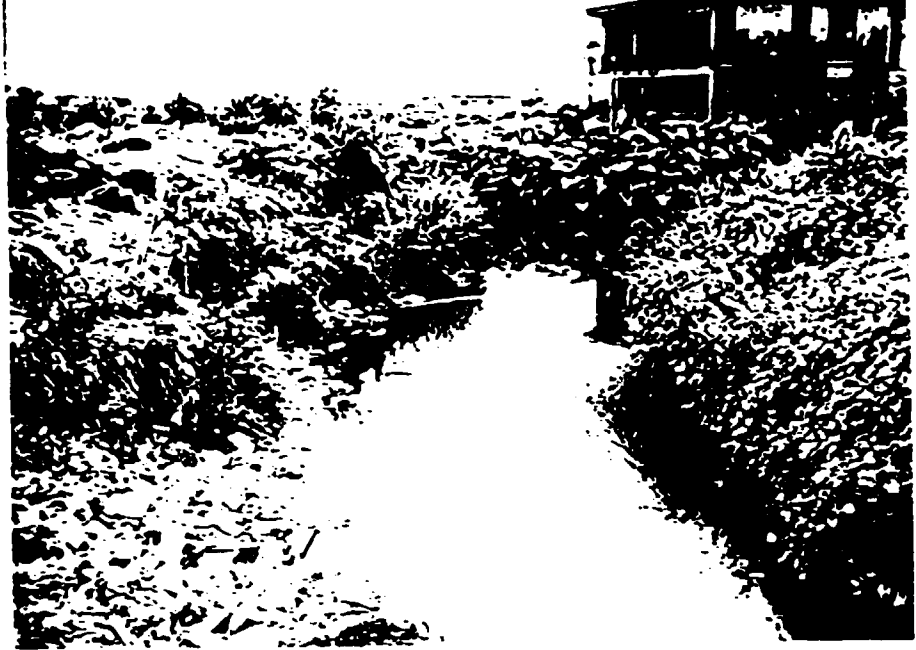
SHOMOLU ANTHONY VILLAGE

- Uncontrolled landfill
- without fence
- impermeabilisation absent
- children and women, especially, regularly comb the site in search of items of economic value to them, using their bare hands without any protective clothing
- very close to residential area
- one bulldozer is assigned to the landfill for the waste flattening
- periodical earth movement for coverage of the waste is not carried out
- access road heavily damaged

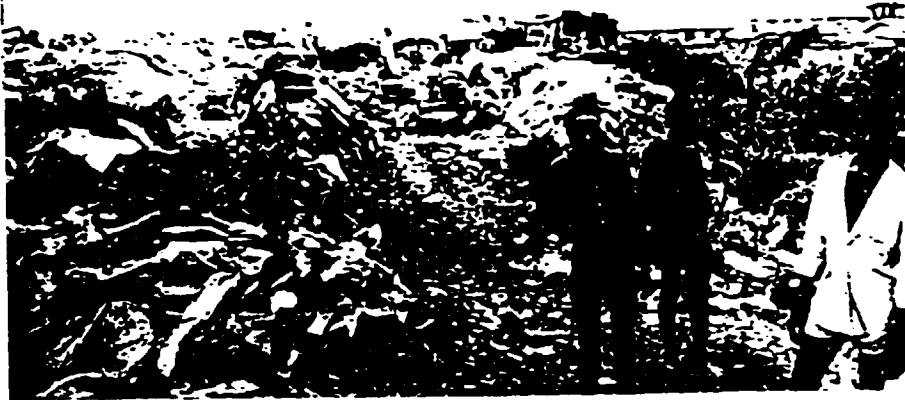
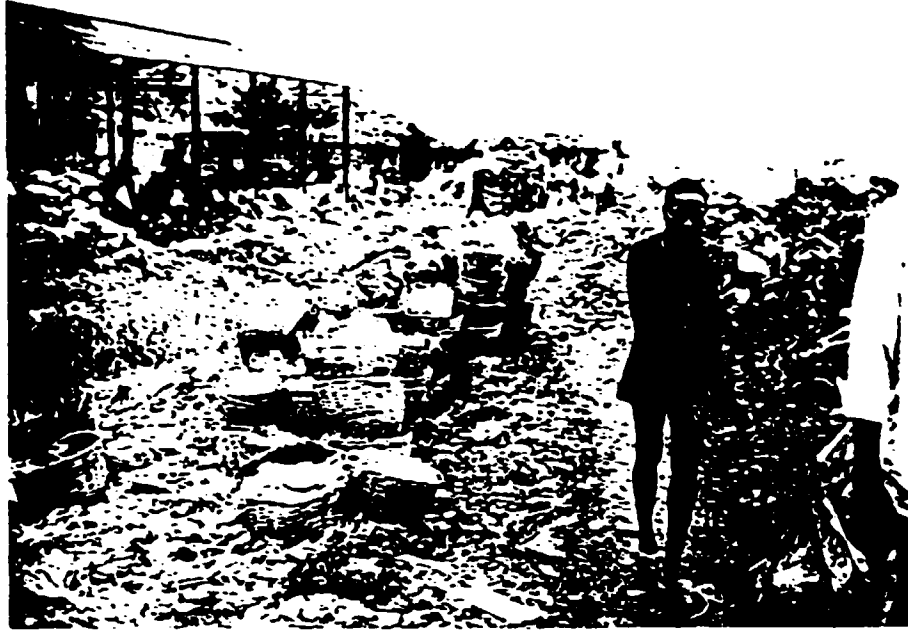
ISOLO MUSHIM

- Located in industrial area
- partial fence with controlled access
- uncontrolled landfill
- impermeabilisation absent
- children and women, especially, regularly comb the site in search of items of economic value to them, using their bare hands without any protective clothing
- one bulldozer is assigned to the landfill for the waste flattening
- periodical earth movement for coverage of the waste is not carried out
- the landfill located in Municipal Lagos is sufficiently distant from residential area
- access road heavily damaged

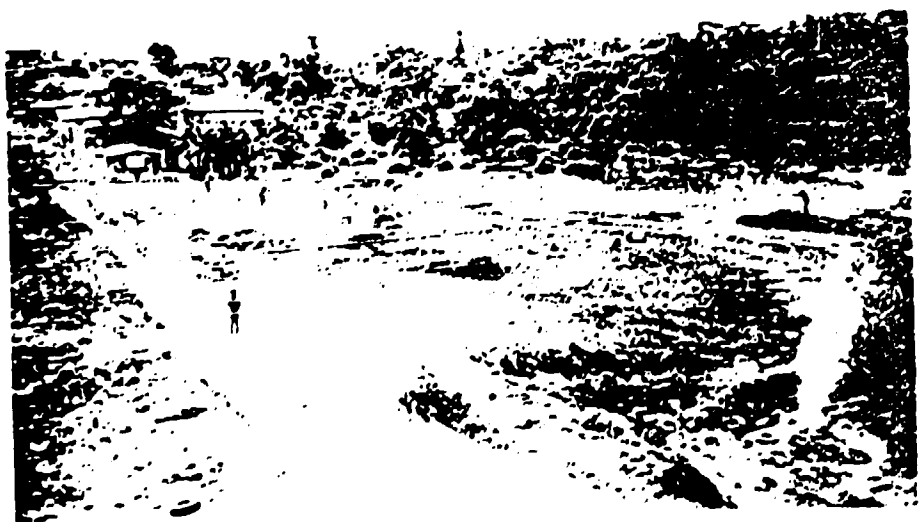
OJOTA

- Located in a large swampy valley along the express way
- uncontrolled landfill
- without fence
- impermeabilisation absent
- children and women, especially, regularly comb the site in search of items of economic value to them, using their bare hands without any protective clothing
- periodical earth movement for coverage of the waste is not carried out
- one bulldozer is assigned to the landfill for flattening of the waste
- access road heavily damaged

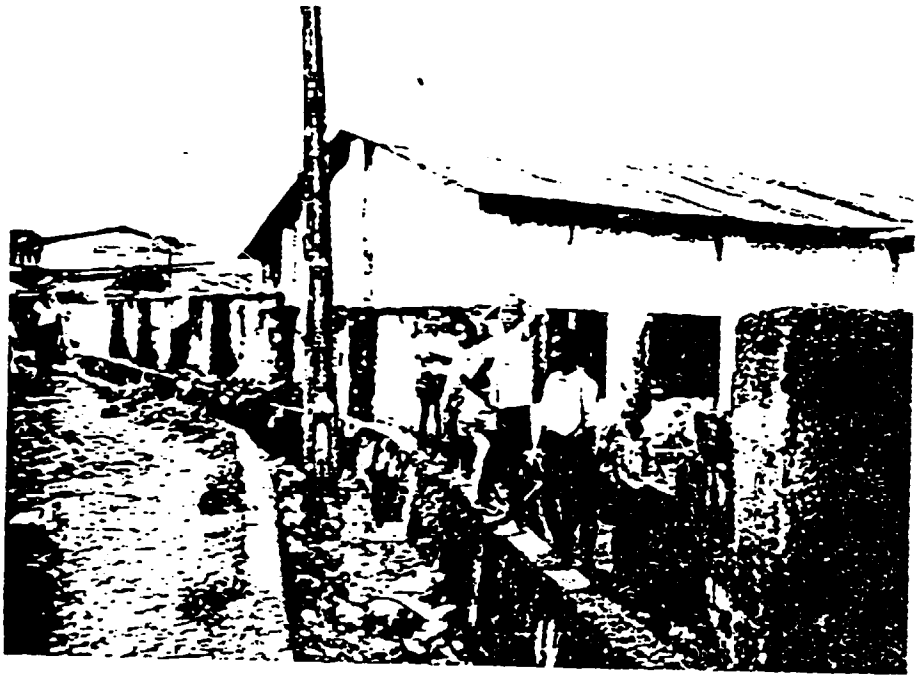
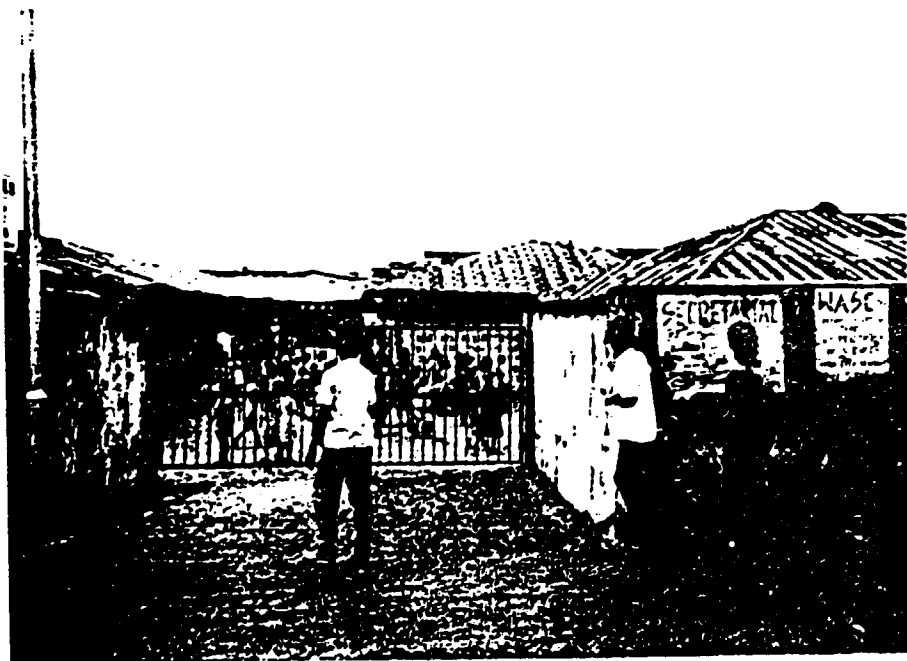
ACHAKPO

The distance from residential buildings does not respect any minimum standards, consequently thousands of inhabitants live in close proximity to unsanitary and unhealthy conditions.

On the basis of above conditions, it appears absolutely inappropriate to collect refuse from homes, public squares and roads and dump them in these fills where they decay and emit bad odours apart from constituting a breeding ground for insects and worms. All these, occur within the territorial boundary of Lagos which creates an imminent hazard to millions of inhabitants of the city.

The envisaged final solution is not limited to the reactivation/commissioning of the three incinerating plants. It also should include the reorganisation of the landfills, which is highly desirable and recommended.
